**RE: Sub-Slab Depressurization System Construction Completion Report
43-18 56th Street, Woodside, New York
Brownfield Cleanup Program Site Number C241129
LEA Comm. No. 07MD012.010**

**SUB-SLAB DEPRESSURIZATION SYSTEM
CONSTRUCTION COMPLETION REPORT**

**43-18 46th Street
Woodside, New York**

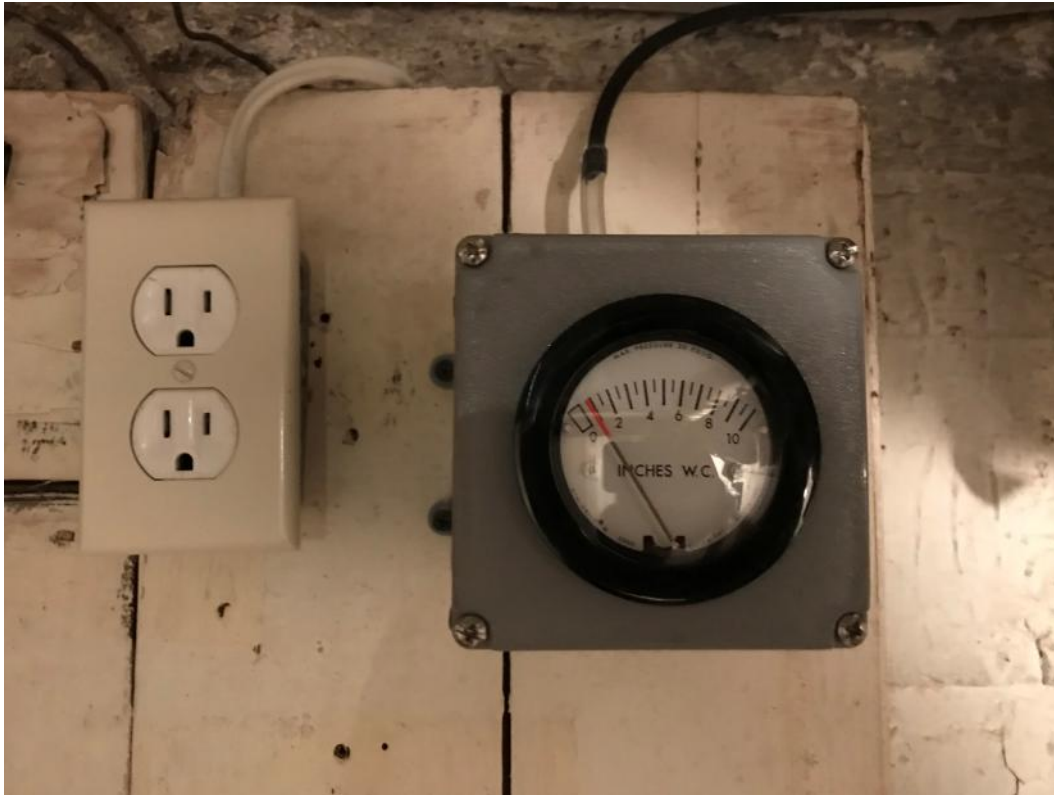
The SSD system should operate continuously. The SSD system is equipped with a Magnehelic style vacuum meter that has been installed in the basement. This meter is an instrument that measures pressure with a column of water. The SSD system is functioning properly if the meter is reading greater than 0 inches of water column, as illustrated below in Figure 3.

Figure 3. Properly functioning vacuum meter

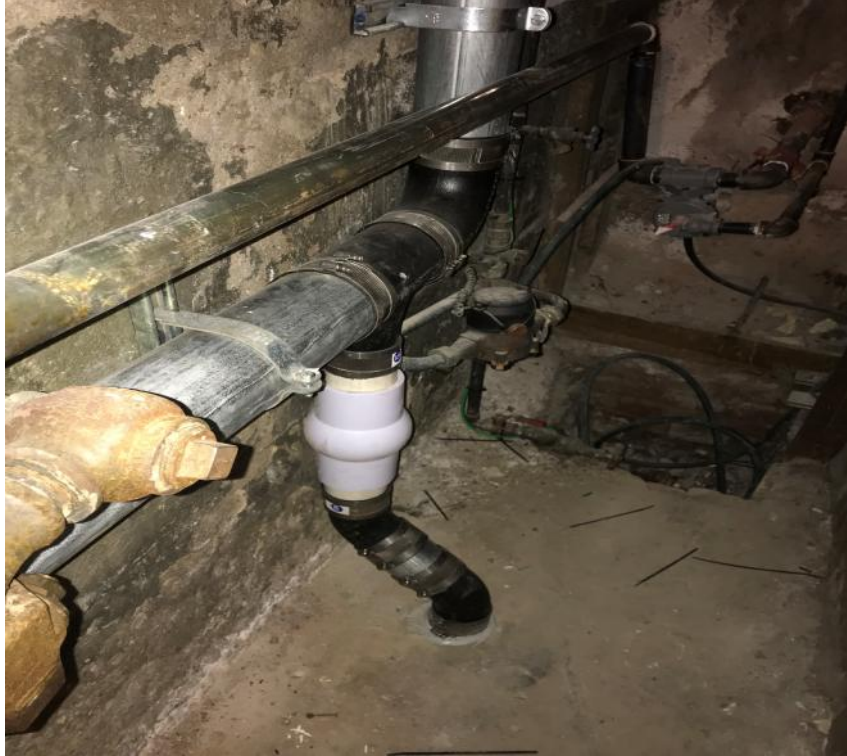
Photograph #1 – Suction point S1

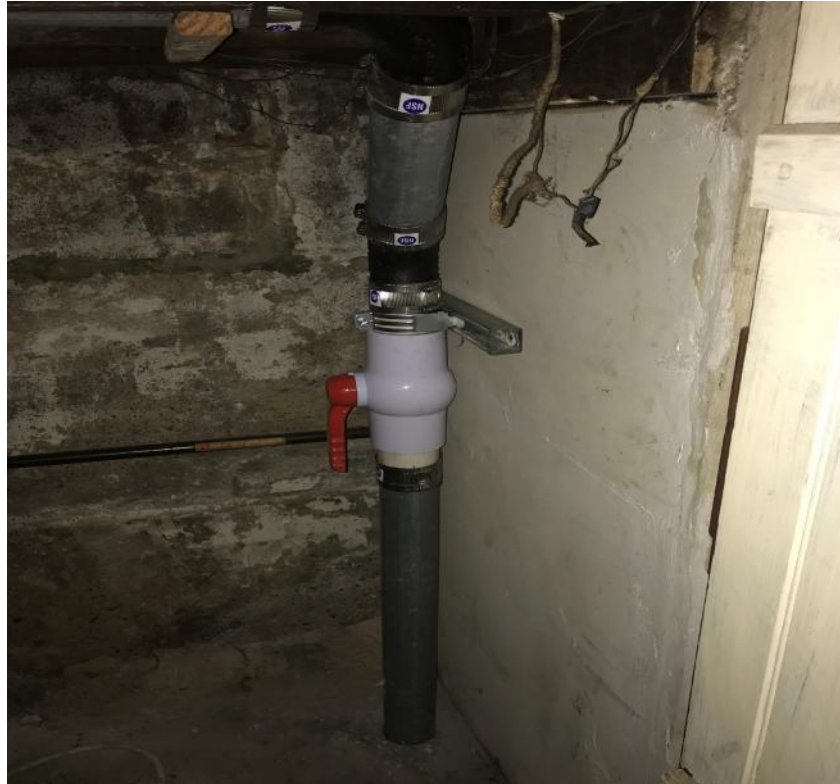
Photograph #2 – Suction point S2

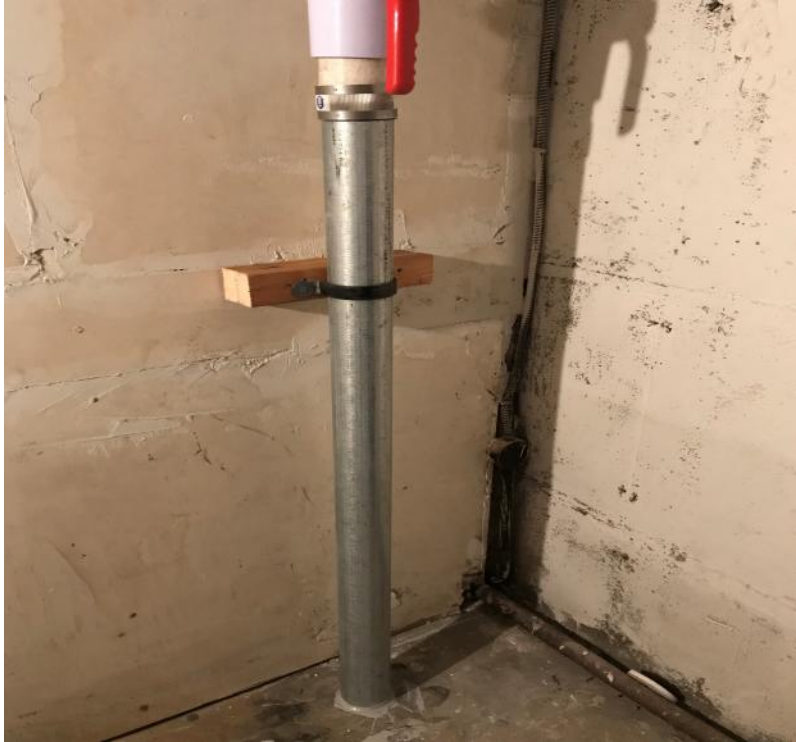
Photograph #3 – Suction point S3

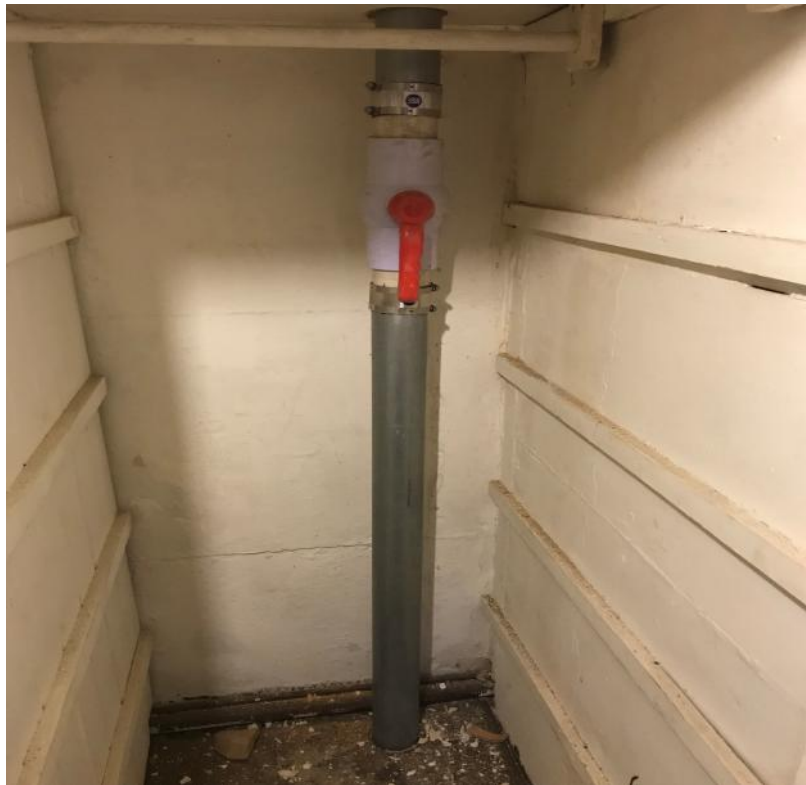
Photograph #4 – Suction point S4

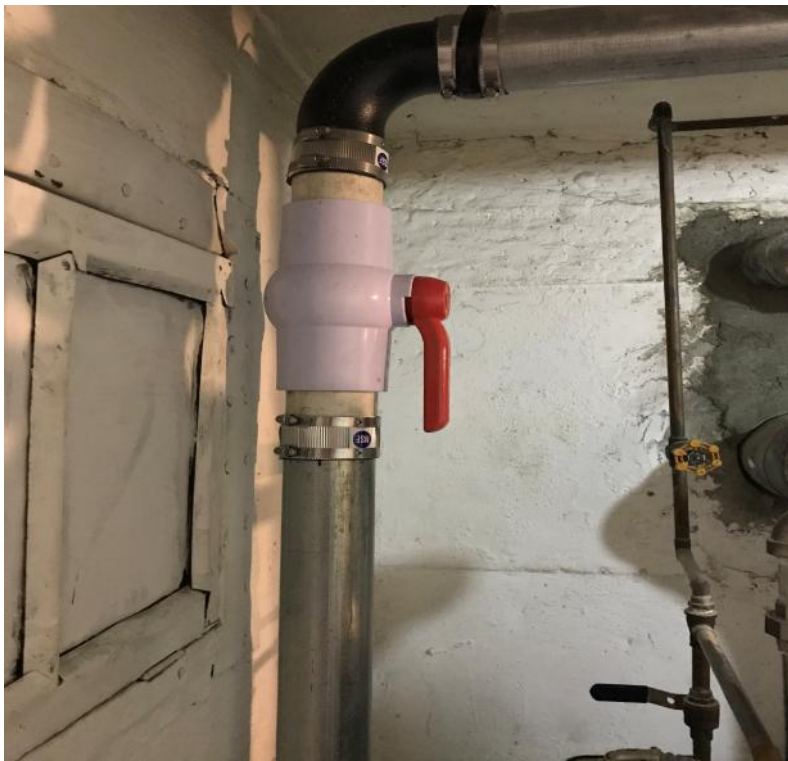
Photograph #5 – Suction point S5 PVC ball valve

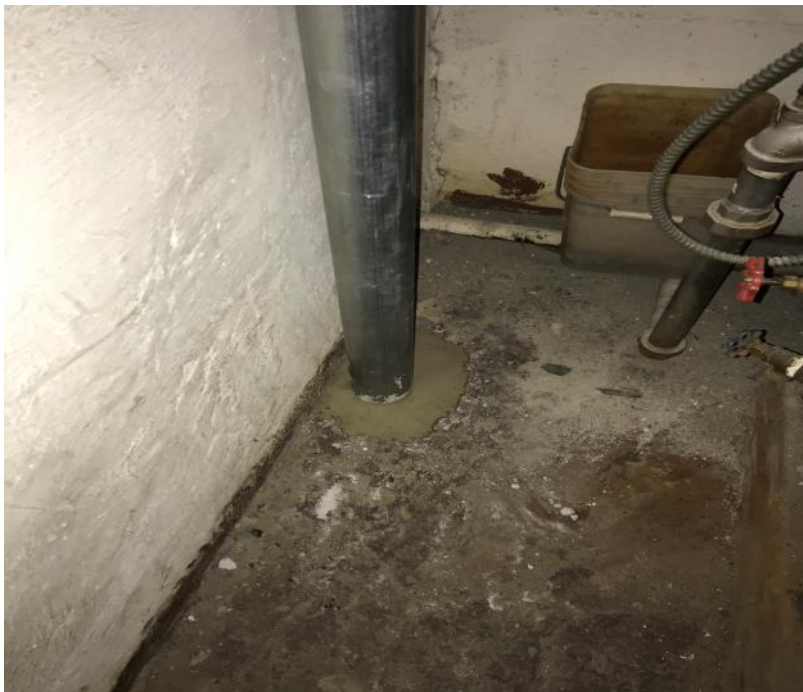
Photograph #6 – Suction point S5 floor seal

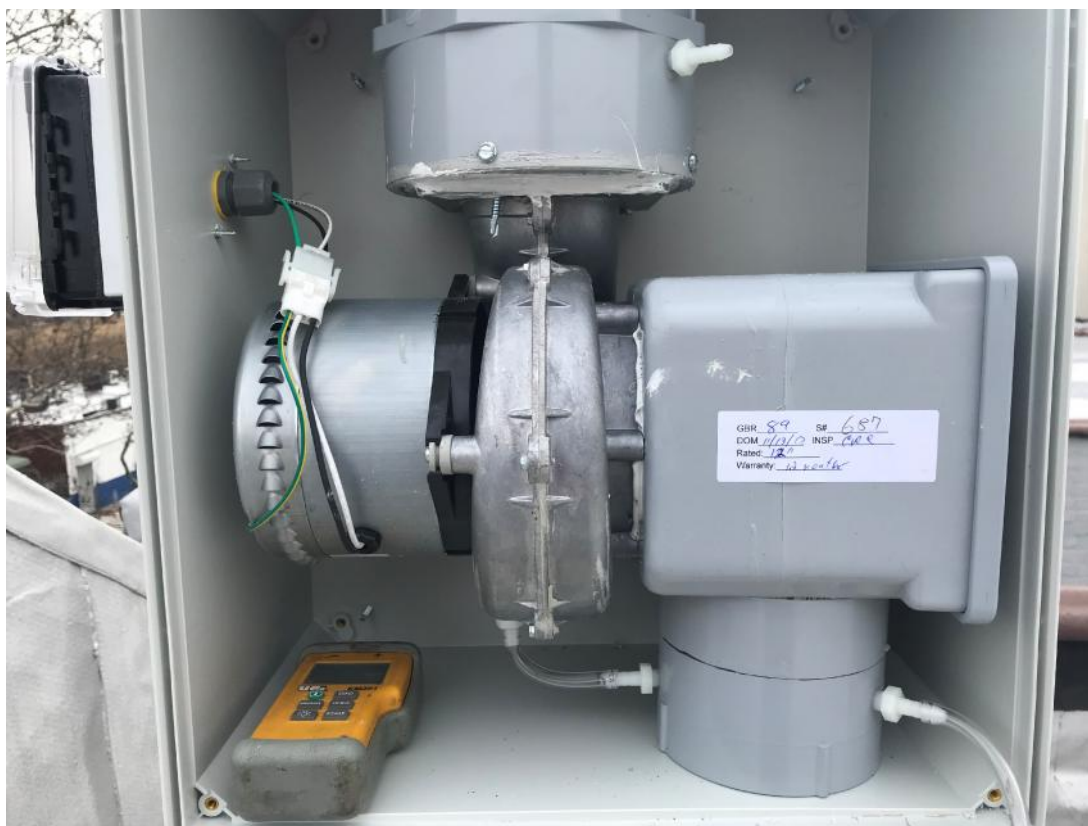
Photograph #7 – GBR89 fan

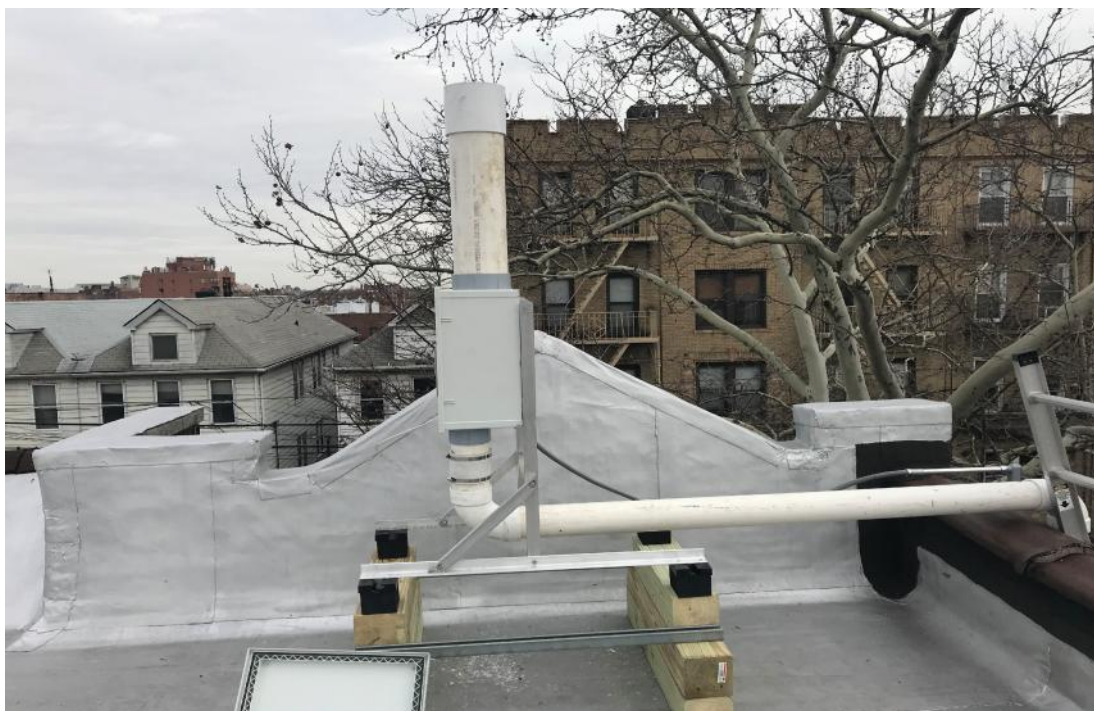
Photograph #8 –GBR89 mounted on roof

Exterior piping for the SSD system was connected to a GBR 89 fan installed on the eastern portion of the roof. Electrical conduit was routed from the fan to the existing circuit breaker box located in the utility room by a licensed electrician. The fan and all electrical components are rated for outdoor use.

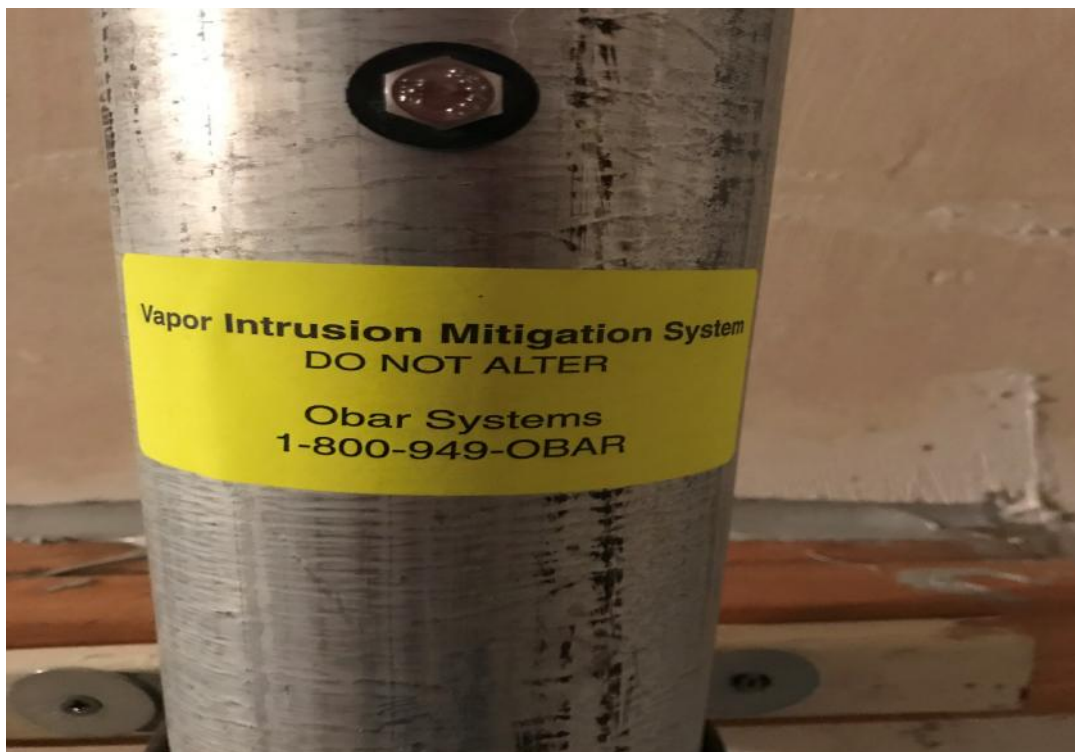
Photograph #10 – System labeling

Labeling of system components was conducted in accordance with the *Generic Work Plan – Sub-Slab Vapor Depressurization System Installation*. Labels stating “Vapor Intrusion Mitigation System Do Not Alter” were placed on piping associated with each vacuum point. Each label contains a phone number to call if any issues arise. The electrical circuit used to control the depressurization fan was labeled as “VIM fan”.
