Finalized Remedial Investigation Work Plan

REMEDIAL INVESTIGATION WORK PLAN

34-11 BEACH CHANNEL DRIVE SITE FAR ROCKAWAY, QUEENS, NEW YORK

NYSDEC BCP SITE No. C241141

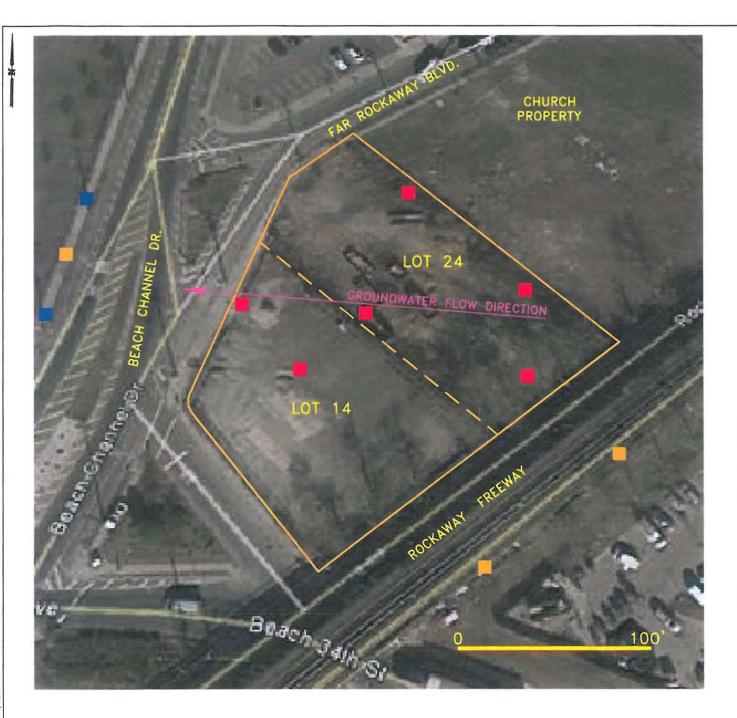
A site plan showing the proposed RI sampling locations is presented in Figure 3.1.1. The procedures for each type of sampling are described below. Quality assurance/quality control (QA/QC) procedures are presented in Section 4.

- SHALLOW AND INTERMEDIATE-LEVEL WELLS WITH CONTINUOUS SOIL SAMPLING
- SHALLOW AND INTERMEDIATE-LEVEL WELLS
- SOIL VAPOR SAMPLE

Soil vapor sampling will be performed at three offsite locations, as shown on Figure 3.1.1. At each location a direct-push rig will be used to install a temporary vapor sampling point to a depth of approximately five feet below the grade (estimated to be above the water table and nearly equivalent to the base of the nearby residence foundations). A bentonite seal will be placed so as to seal the sampling point from the surrounding atmosphere. Following installation, three to five volumes of air shall be purged through the polyethylene tubing using an air pump so as to ensure that a representative sample is obtained. To confirm the integrity of the bentonite seal a helium tracer gas will be confined over the surface seal and the potential presence of helium in the polyethylene tubing will be checked with a helium meter. Following purging and the seal integrity check, the soil vapor sample shall be collected into a laboratory-supplied Summa canister equipped with a calibrated flow controller. The flow controller will be set so as not to exceed 0.2 liters per minute. FPM shall observe the flow controller and shall seal the canister while some vacuum remains. Upon completion of sampling, the canister shall be sealed, labeled, managed, transported, and tracked as described in Section 3.3. The soil vapor sample locations will be identified using a GPS.
