FORMER HYGRADE PLATING SITE  
QUEENS COUNTY  
LONG ISLAND CITY, NEW YORK

## 2024 PERIODIC REVIEW REPORT

Reporting Period: April 22, 2023 to April 22, 2024

NYSDEC BCP Site No. C241148

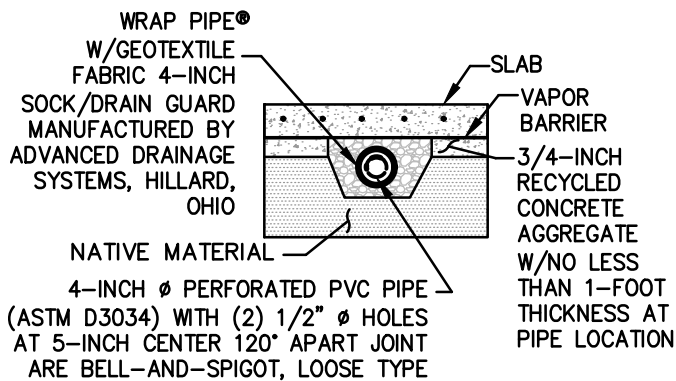
TYPICAL VENT PIPE  
CROSS-SECTION (NTS)

- 1) SSDS: A sub-slab vent was installed below the basement floor and then a riser was extended to the roof. The vent was then covered with aggregate followed by a 20-mil vapor barrier. A fan was connected to the riser to complete the SSDS.

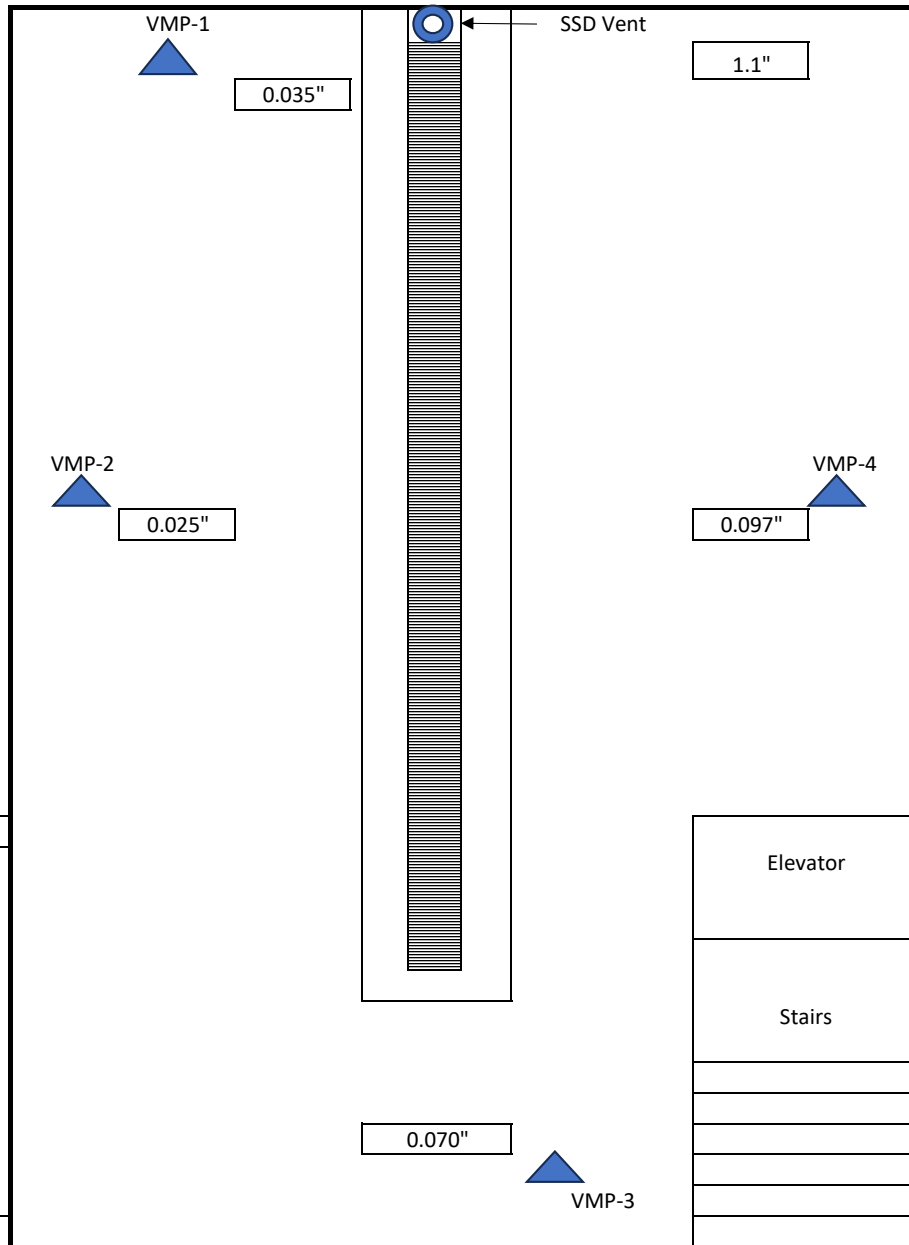
INDOOR AIR SAMPLE  
LOCATION  
Figure 3

In accordance with the SMP, an indoor air sample was collected during the winter heating season, in the basement of the former Hygrade Plating Site. A sample location map is included on Figure 3. A sample was collected using a Summa Canister calibrated to collect air for an 8-hour period. The sample was delivered to Phoenix Environmental Laboratories, Inc., an ELAP-approved Laboratory, and was analyzed for halogenated volatile organic compounds using EPA Method TO-15.
