***REMEDIAL INVESTIGATION REPORT***

**CPB – Property  
Block 15950, Lot 29  
Far Rockaway, New York**

*TRC Job Number: 174788*

August 2015

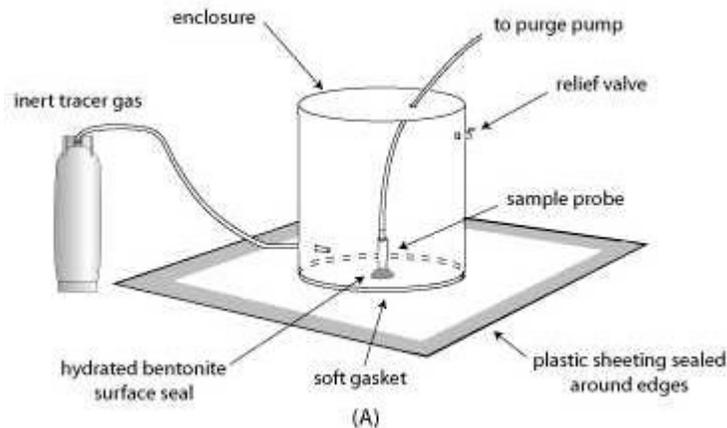
(Reference: Figure 2.4a from the NYS DOH VIG)

Pursuant to the VIG, helium was used to test the surface seal at each temporary sampling location (VIG p26). The schematic included as Figure 2.4a in the VIG (shown below) was used as the basis for the tracer gas testing.

A sheet of polyethylene liner was placed over the ground surface at the sampling point, with a perforation to allow the sampling point riser to extend above the liner. An enclosed container, consisting of an approximately one gallon stainless steel container, was placed over the top of the sampling point. It included a perforation to allow sample tubing to exit the container and one to allow helium tracer gas to be injected into the container. A relief valve was installed to allow for venting of the container before removal, after tracer gas sampling was completed.

A portable helium detector, provided by Pine Environmental Services, was used to check the purge gas for the presence of helium. As described in the VIG, minor leaking at the probe seal should not materially affect the usability of the soil gas sampling results and therefore, the mere presence of helium in the sample or purge gas should not affect data quality. However, helium concentrations greater than 10% or 100,000 ppmv in the purge gas would indicate a substantial surface leak. Helium concentrations greater than 100,000 ppmv were not detected in the purge gas at any sample locations. A photograph of the soil gas sampling set-up is provided in Appendix A.

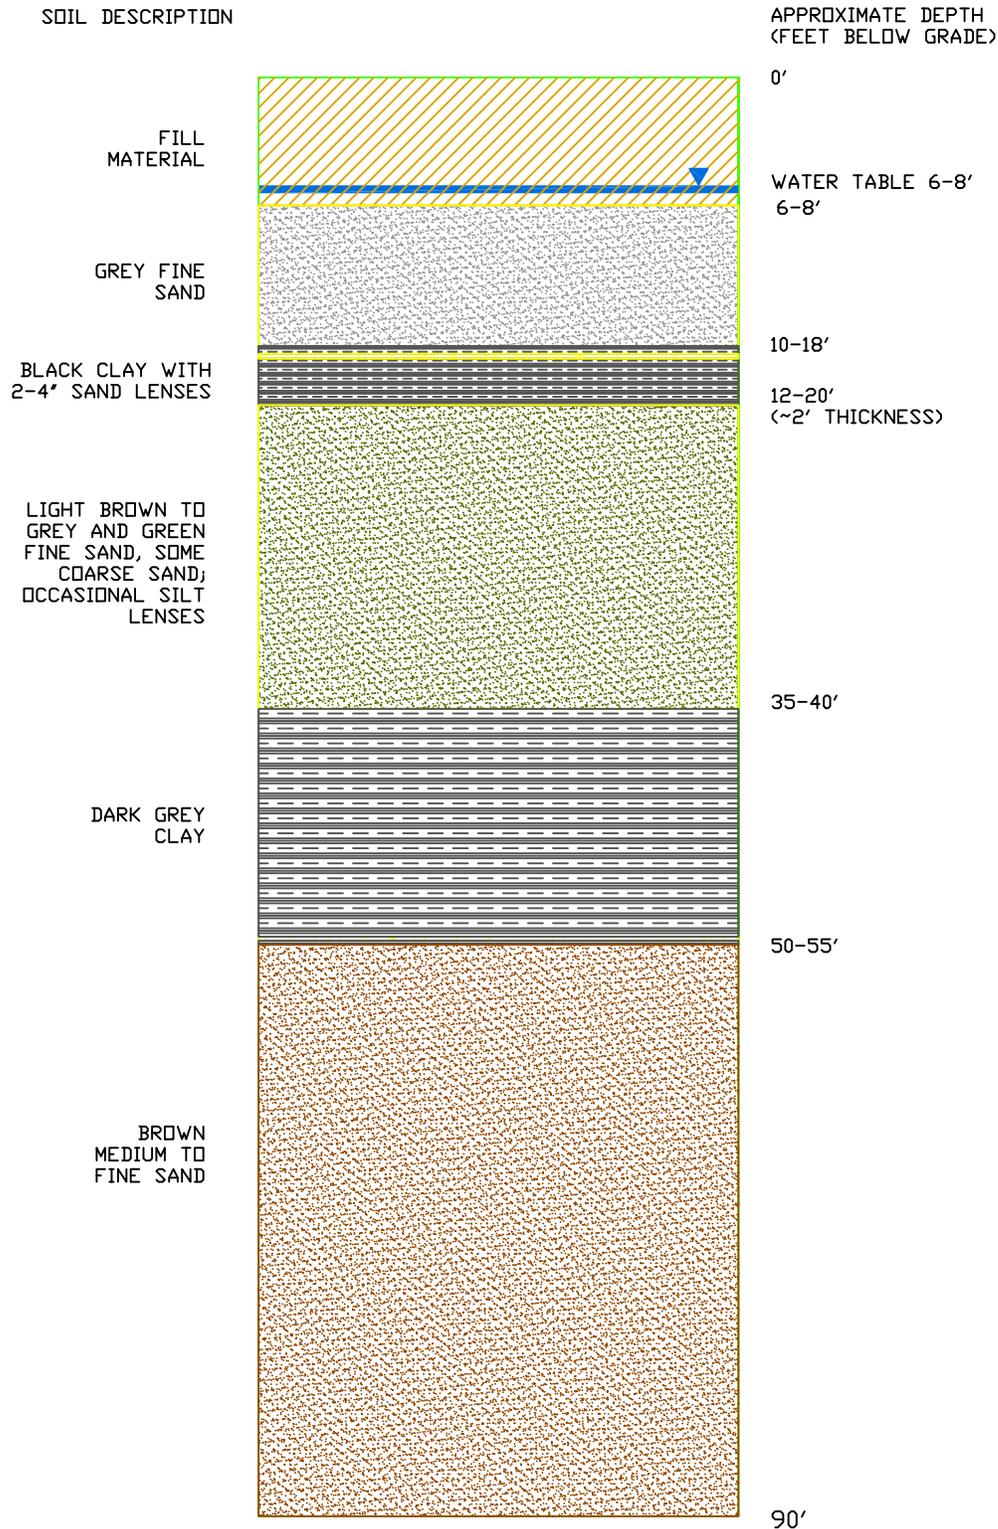
# GENERALIZED CROSS SECTION BLOCK 1599, LOT 29

The site geology has previously been characterized to a maximum depth of 90 ft. Lithologic information was collected during the advancement of soil borings conducted across the site in April 2008. Three distinct geologic units have been encountered at the site, as described below. A more complete description of the site geology is provided in the ISTT Work Plan. A generalized cross section is provided as Figure 3.

The fill material is underlain by loose fine gray sand with small amounts of coarse sand. The thickness of this layer ranges from approximately 5 to 10 ft.

Discontinuous, organic silty clay to clayey silt lenses (1 to 4 ft. thick) occur at the base of the Shallow Zone, below the fill and sand units. These clay lenses separate the Shallow and Intermediate Zones and locally act as a semi-confining unit. These silty clay lenses contain small amounts of fibrous organic material (peat) in thin laminations. Trace amounts of shell fragments are also found within these silty clay lenses. While these clay layers have been observed in all soil borings conducted at the site, the depth, composition and thickness of the individual clay lenses vary greatly across the site. The depth at which the clay lenses are encountered ranges from 11 and 20 ft. bgs.

The Deep Zone consists of a brown-gray, fine to medium sand layer with a thickness greater than 40 ft. and occurs below the second clay unit at a depth of approximately 54 ft. bgs. The sand layer was observed to be loose to medium dense.

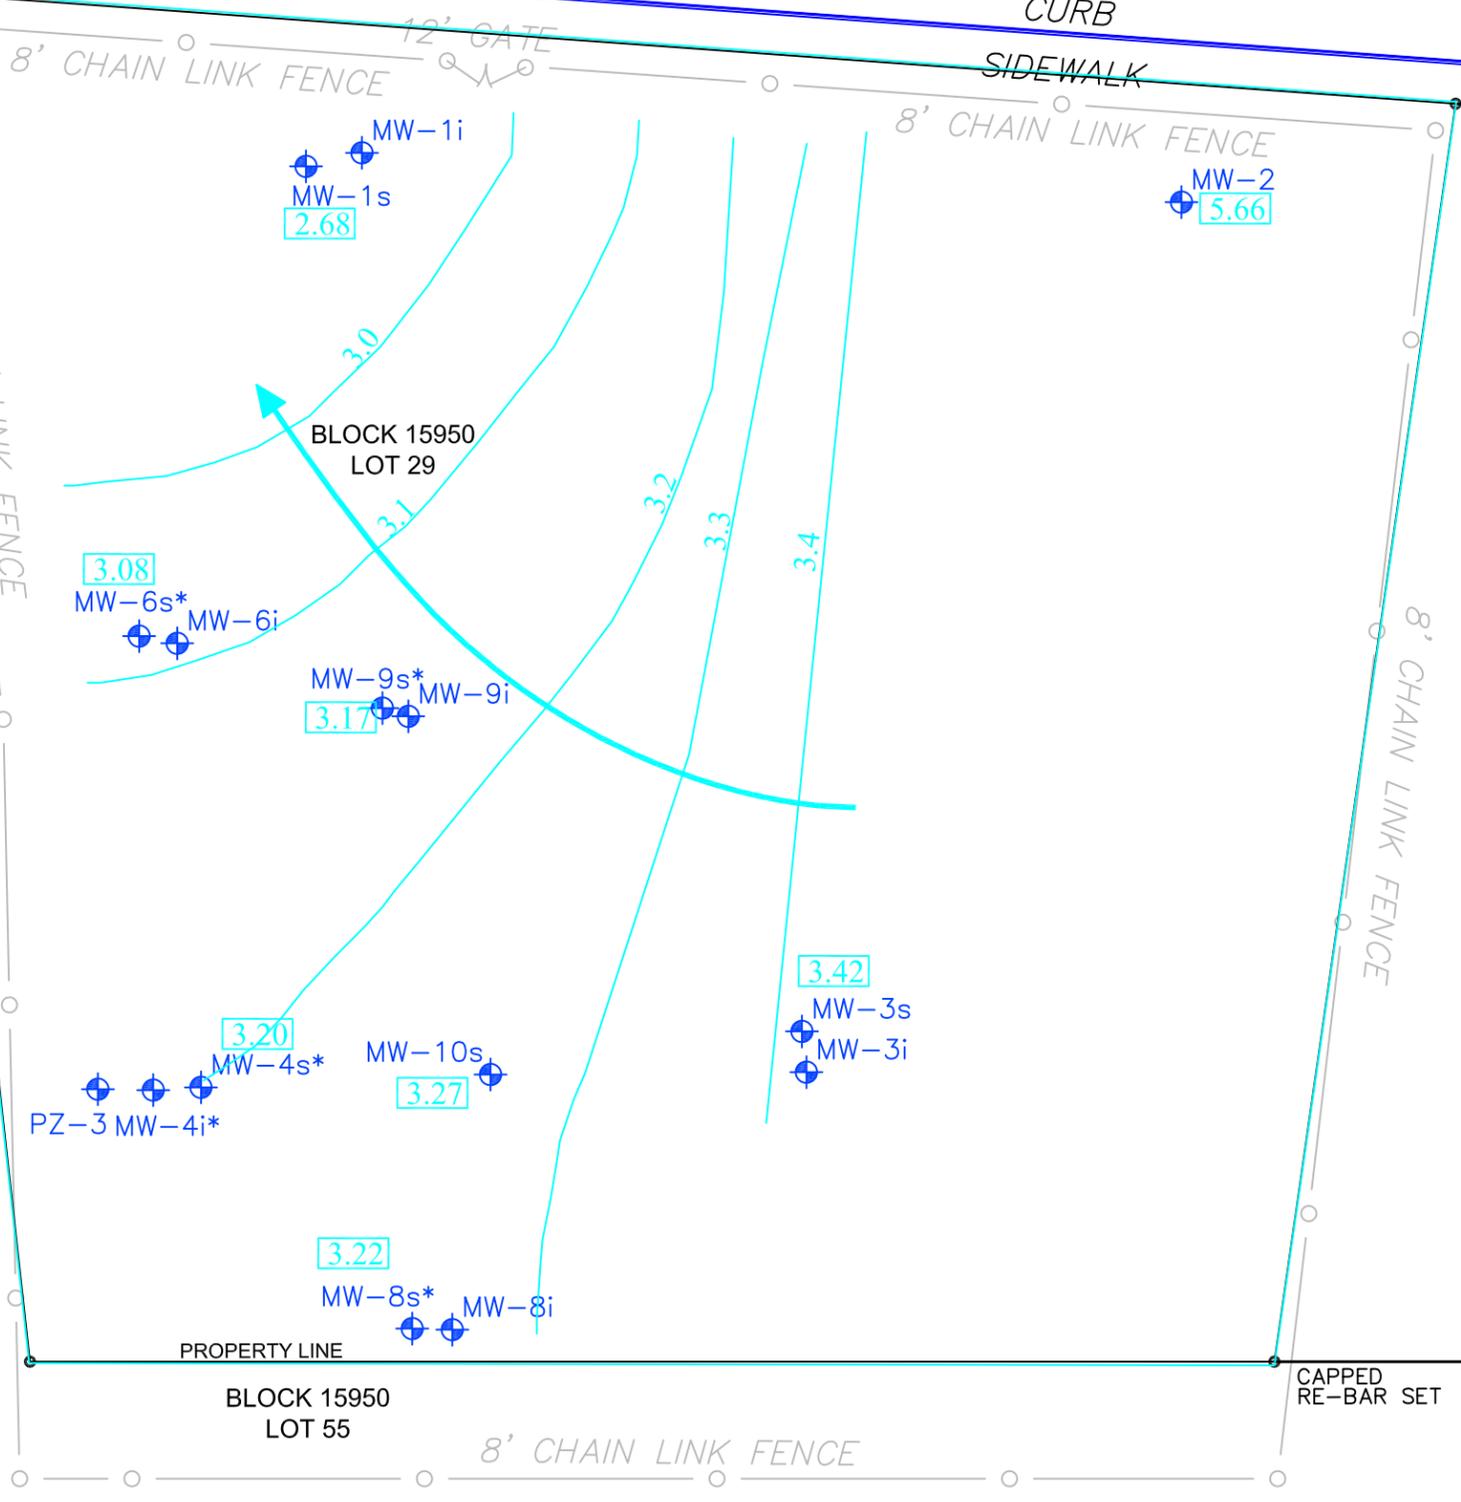
The groundwater flow direction for the Shallow Zone is generally to the west and northwest. The highest groundwater elevation was noted at monitoring well MW-3s, with an elevation of 3.42 ft. AMSL. The average hydraulic gradient is approximately 0.002 ft./ft.

The groundwater water flow direction in both the Shallow and Intermediate Zones were re-assessed during the RI. The flow direction in the Shallow Zone was observed to generally be from southeast to northwest, with a more northerly flow component towards the eastern half of the site. Intermediate Zone groundwater was observed to be to the north, with a radial component suggesting a northerly and westerly flow direction.

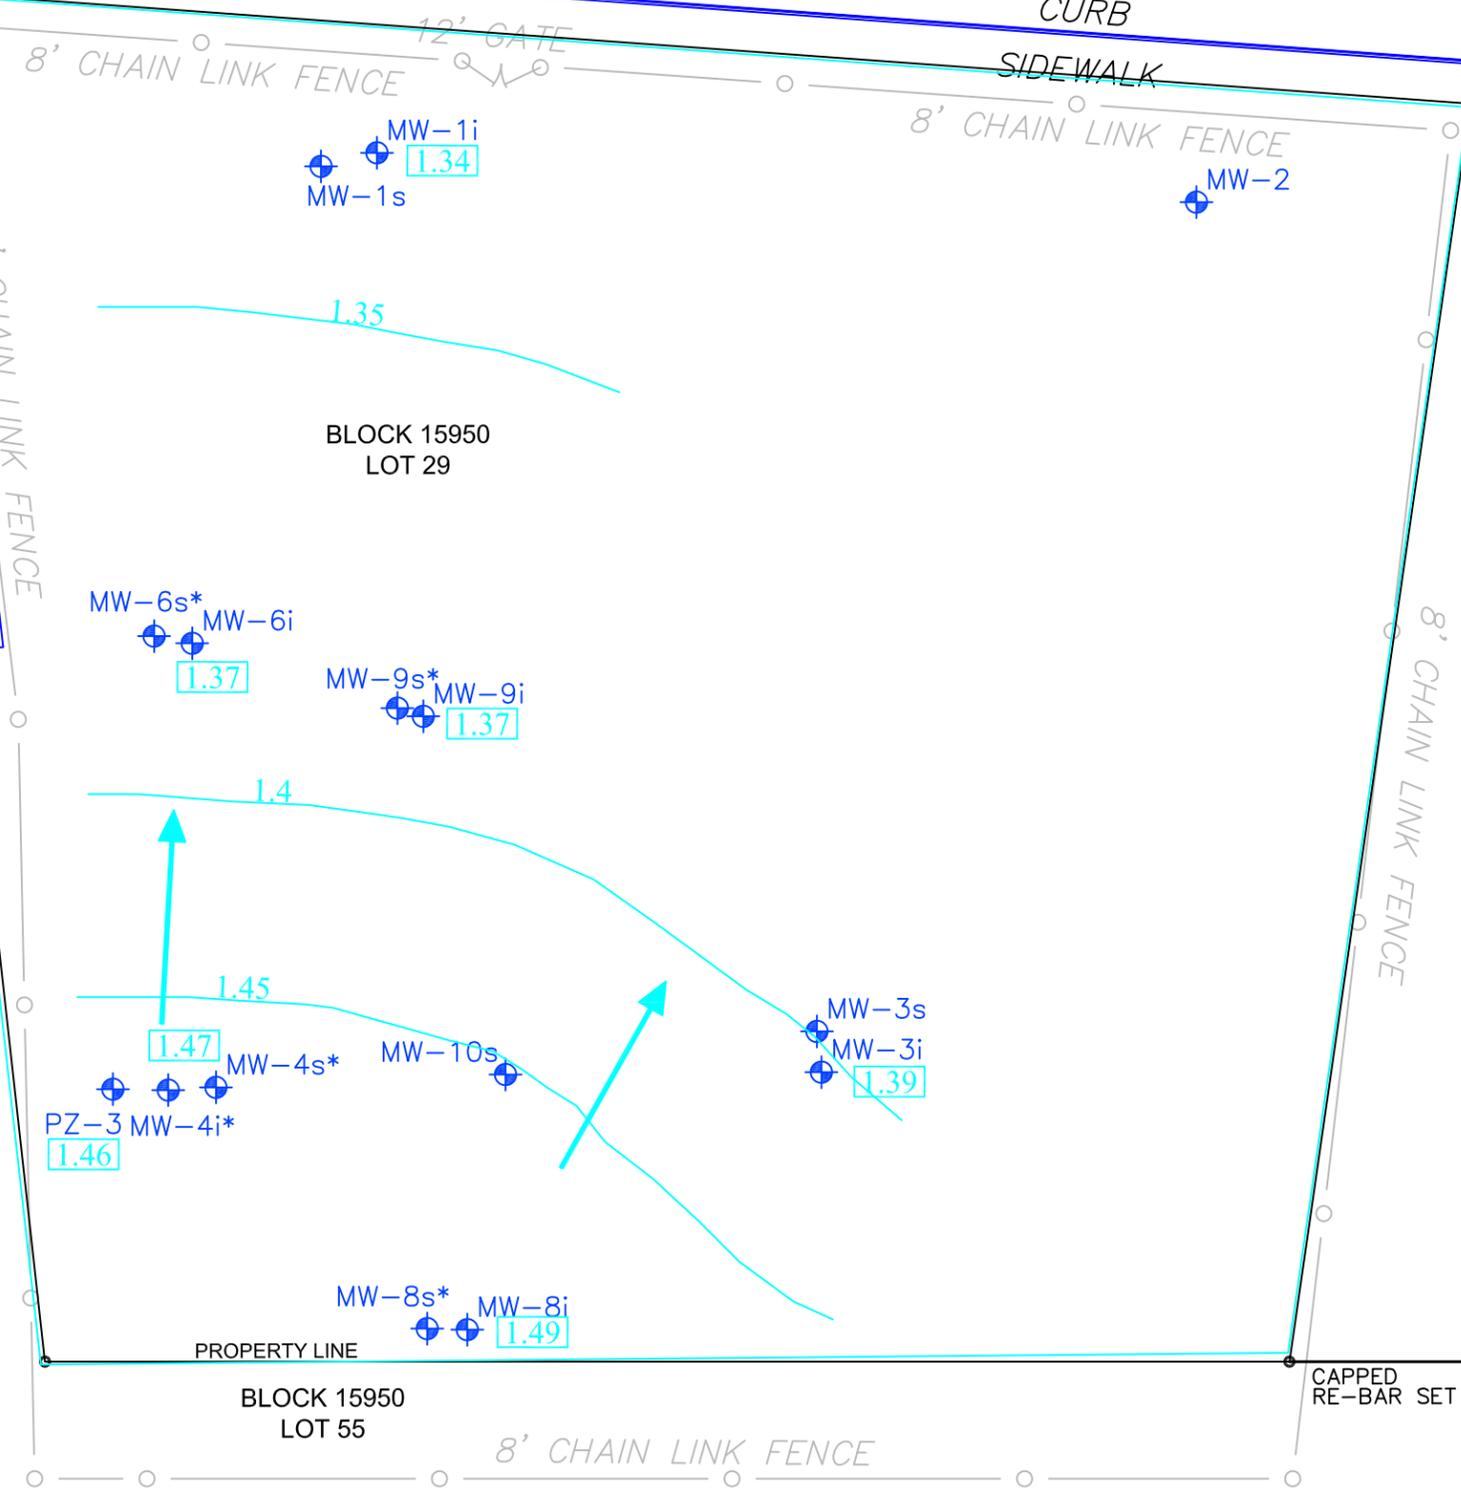
The groundwater flow direction for the Intermediate Zone is generally to the north. The highest groundwater elevation was noted at monitoring well MW-8i, with an elevation of 1.49 ft. AMSL. The average hydraulic gradient was approximately 0.00105 ft./ft.

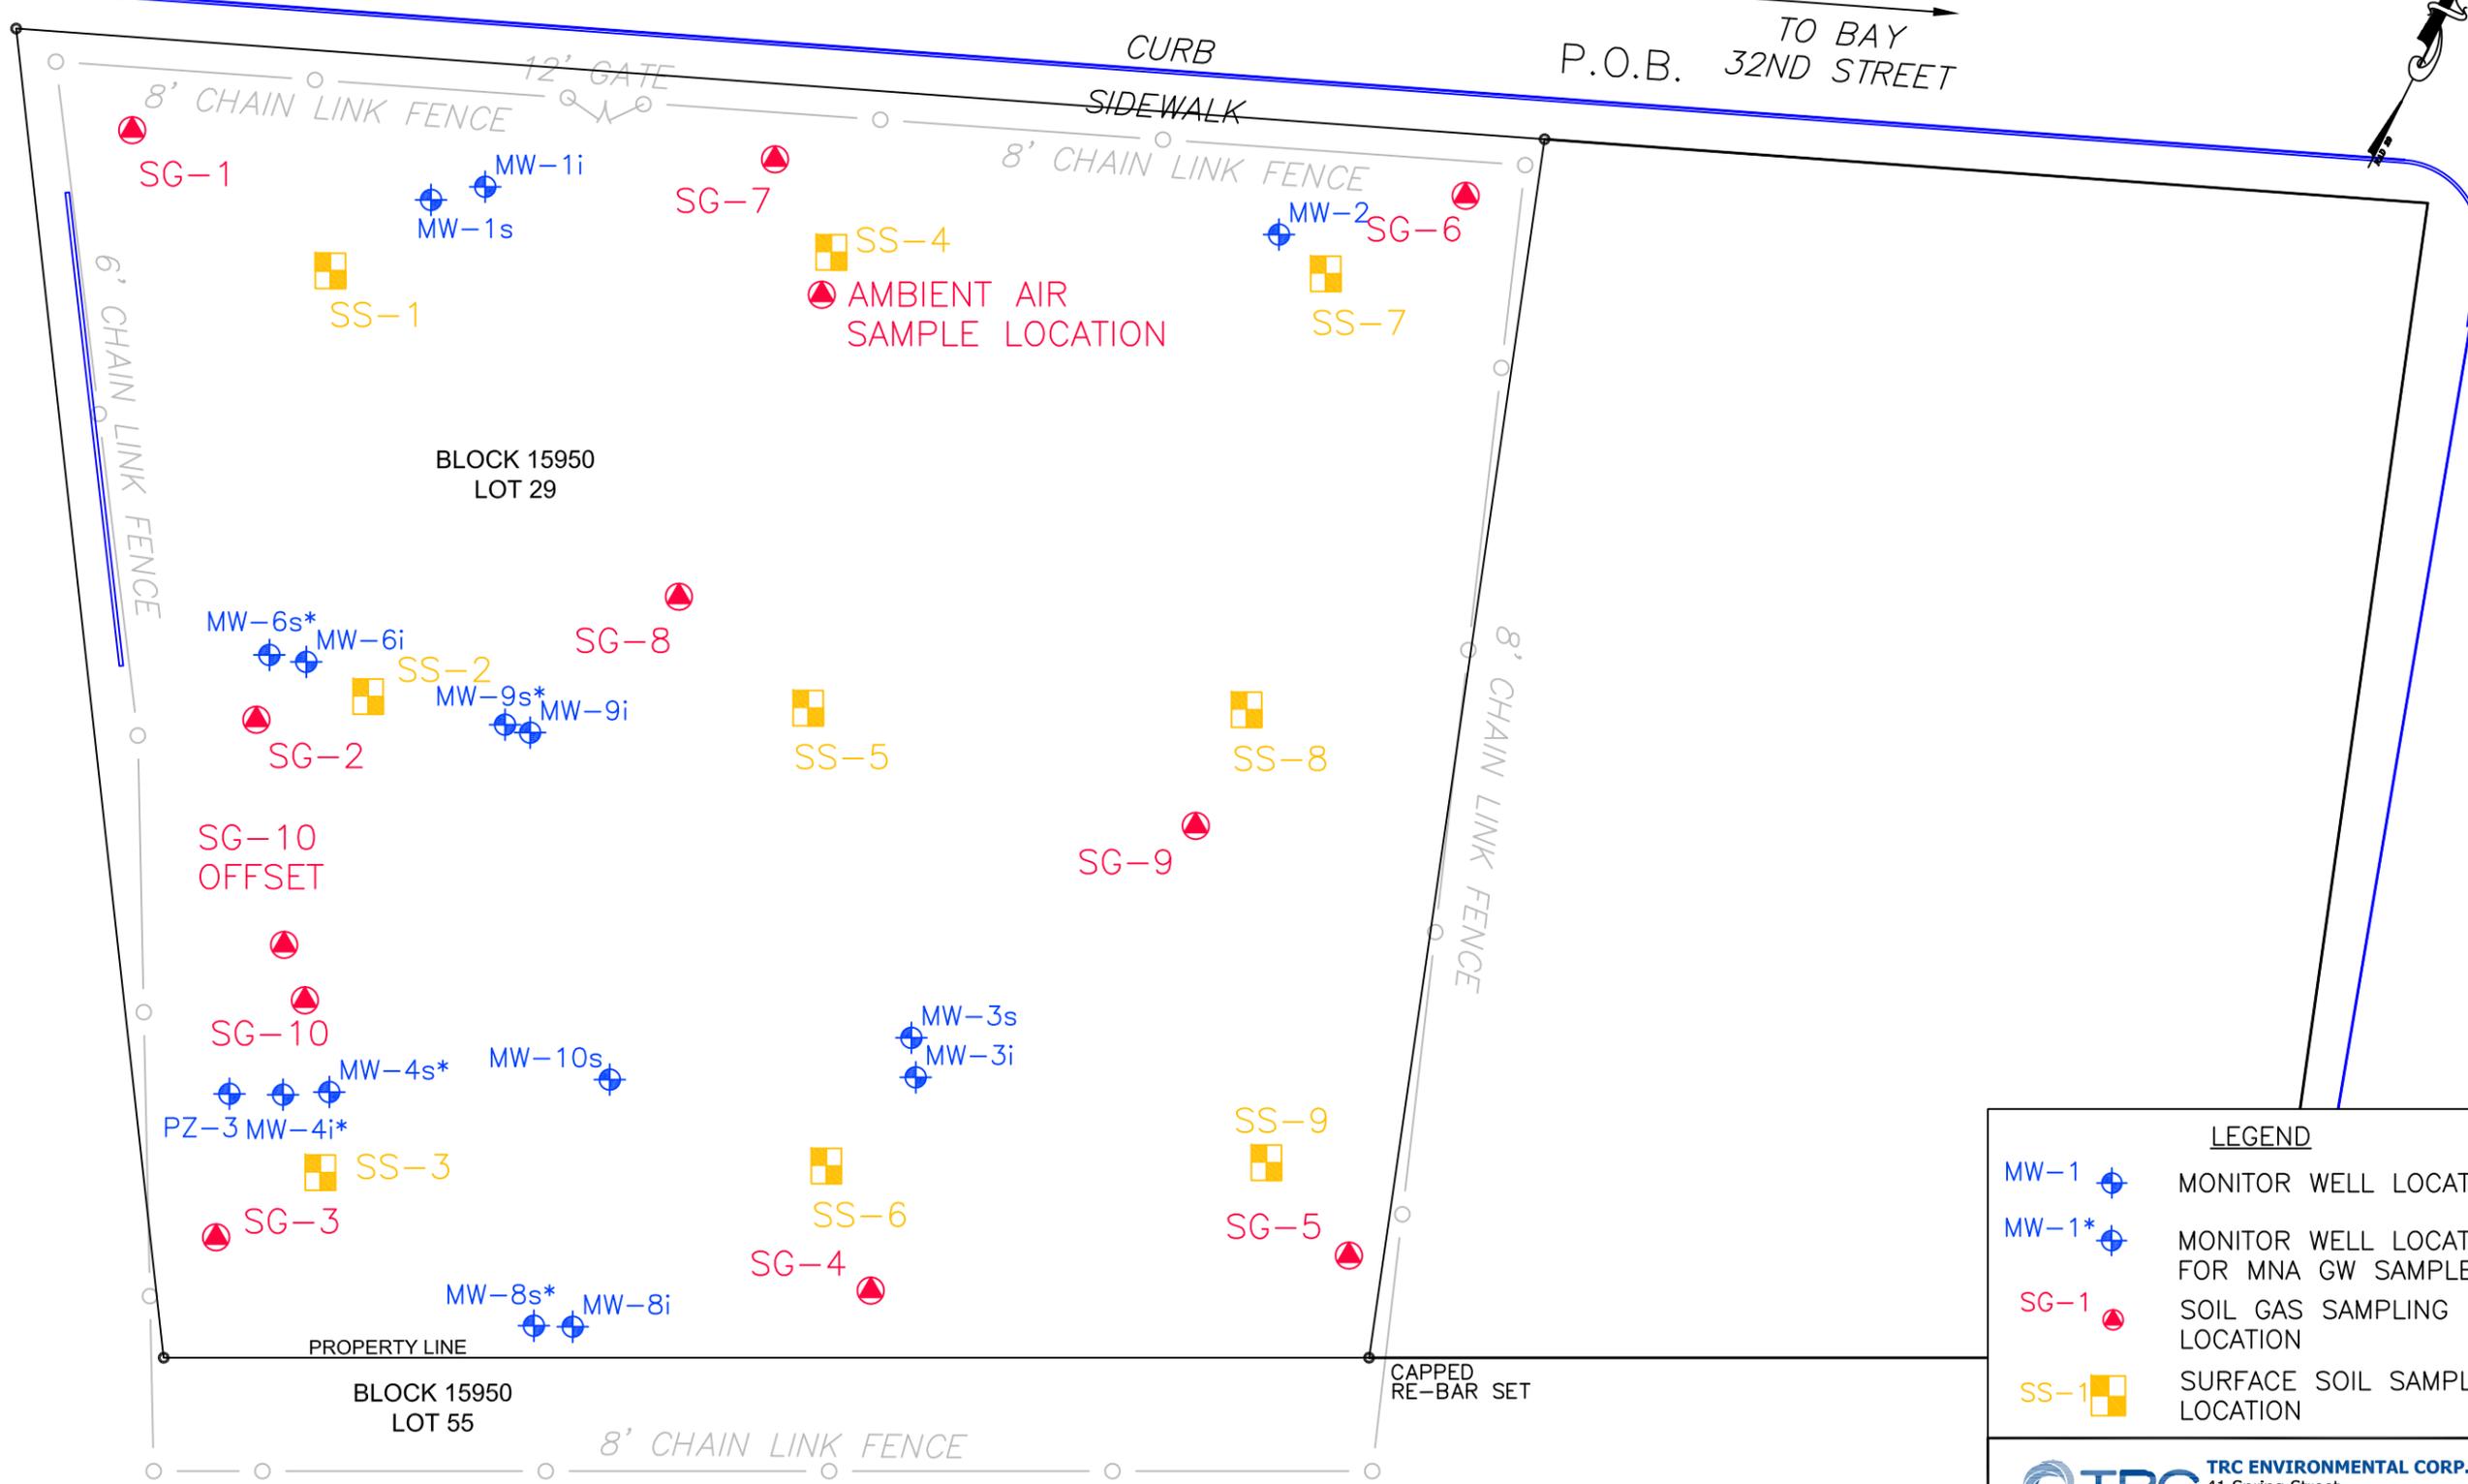
HFN	DATE: JULY 2014	FIGURE: 6
-----	-----------------	-----------

LEGEND	
MW-1	MONITOR WELL LOCATION
MW-1*	MONITOR WELL LOCATION FOR MNA GW SAMPLES
SG-1	SOIL GAS SAMPLING LOCATION
SS-1	SURFACE SOIL SAMPLING LOCATION

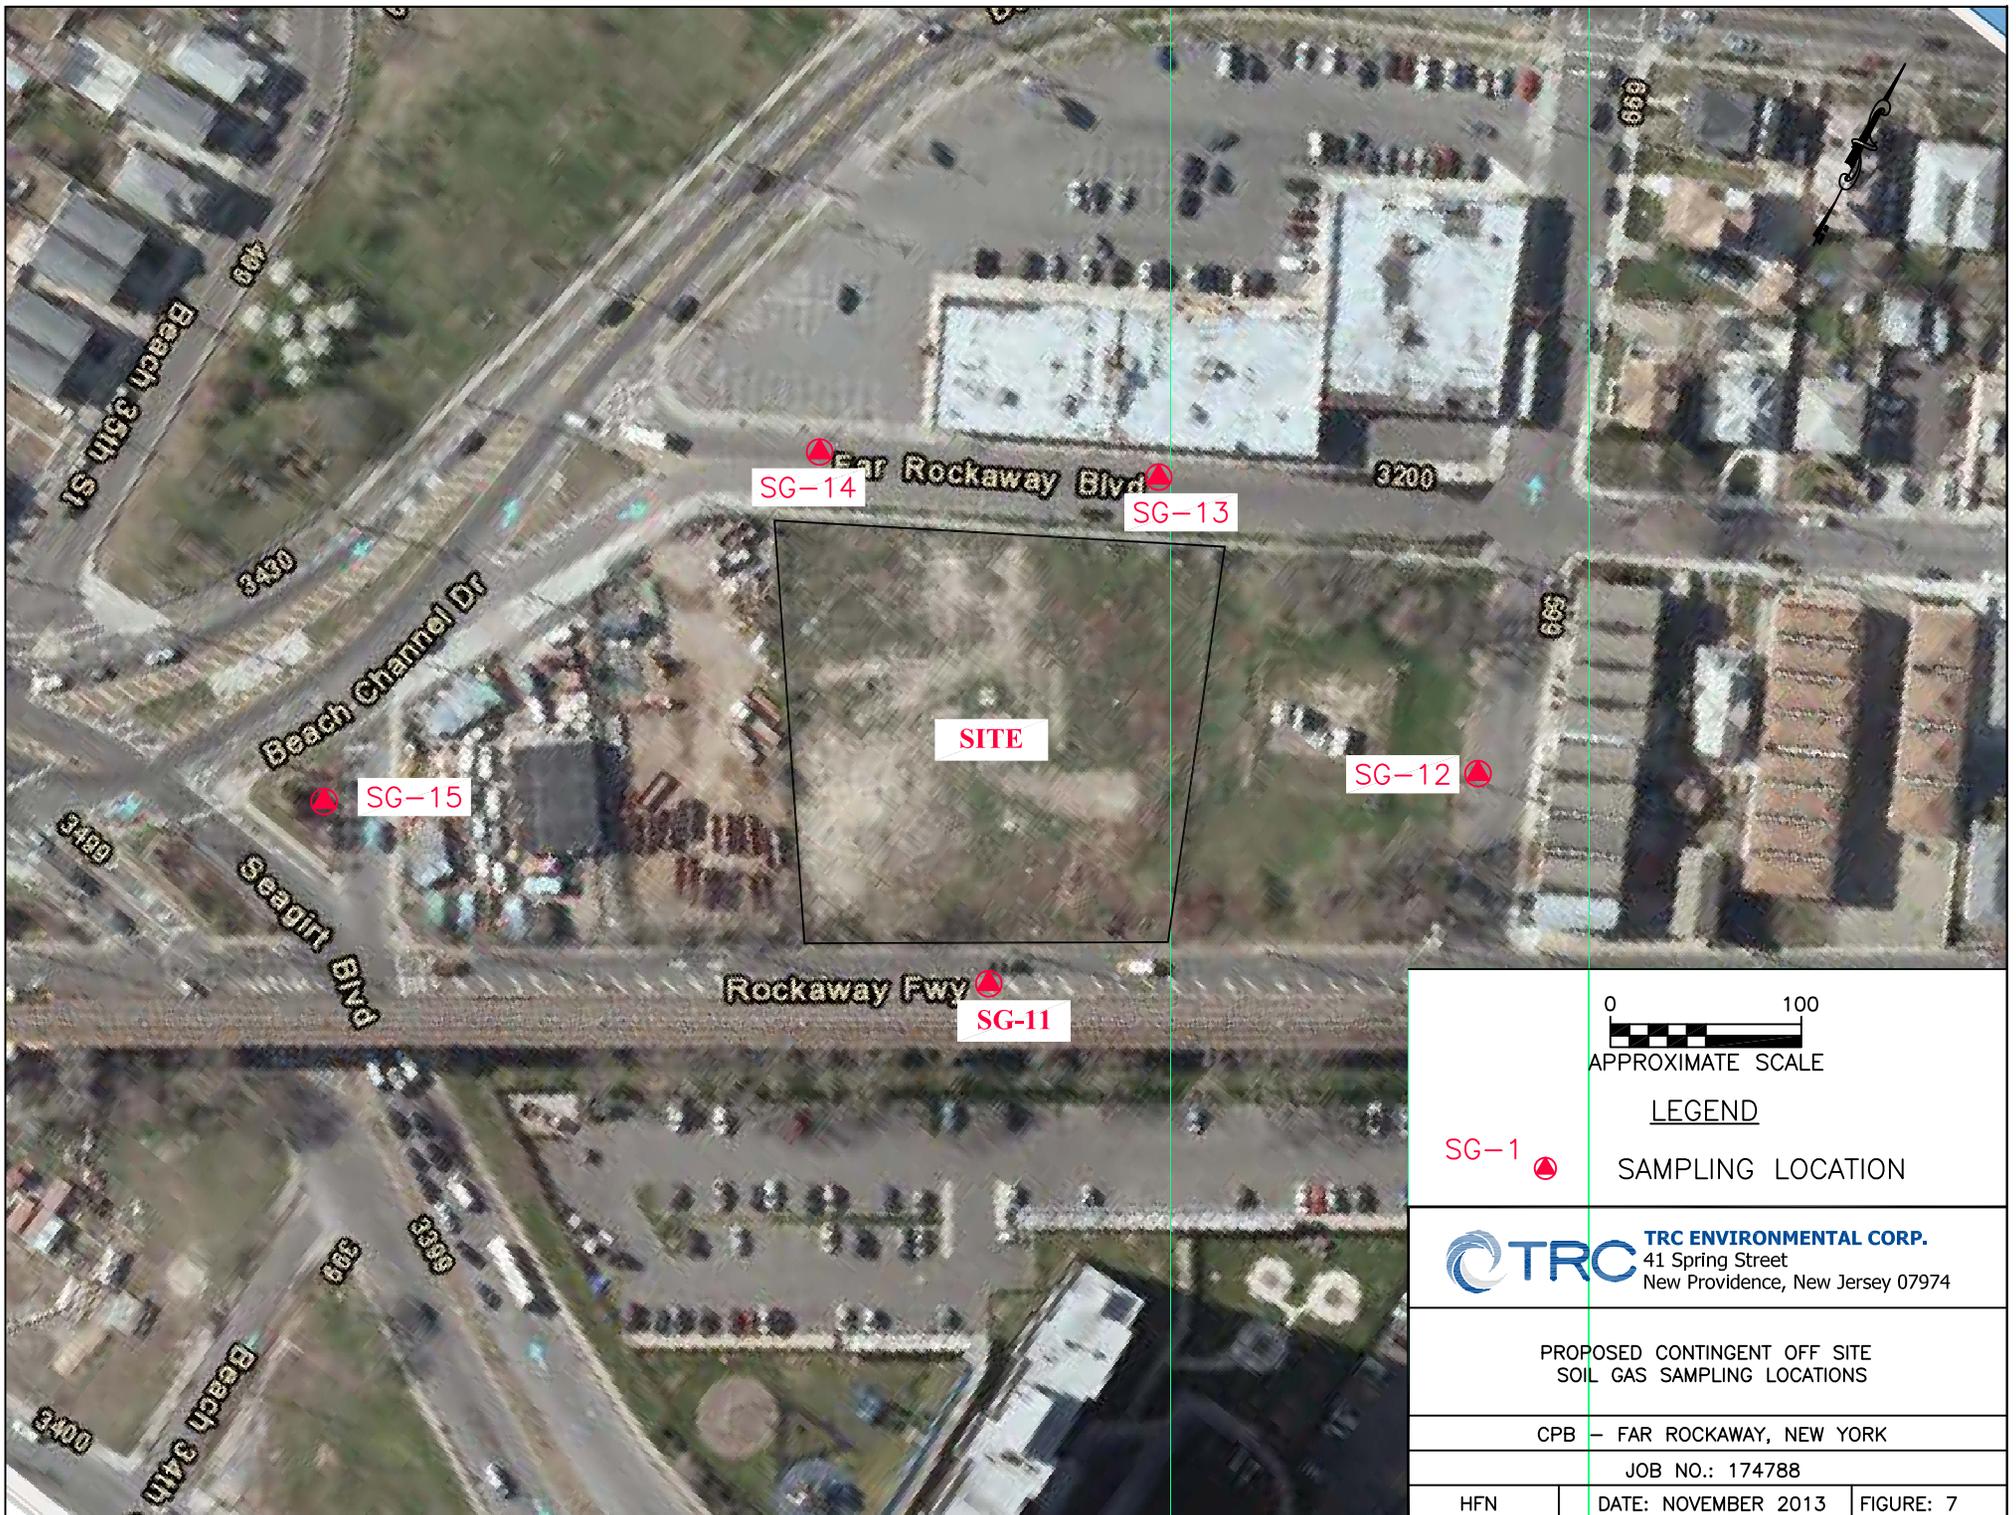
In accordance with the RIWP, a total of fifteen (15) soil gas samples were collected from on- and off-site. Summit Drilling, of Bridgewater, New Jersey conducted the drilling and obtained the necessary permits and utility clearances. Figure 6 shows the approximate on-site sampling locations, while Figure 7 shows the approximate off-site sampling locations. A description of the sampling locations is provided below.

A total of 27 soil samples were collected from nine locations. The approximate locations of the sample collection points are provided on Figure 6.

A total of ten on-site and five off-site temporary well points were installed and sampled between January 23 and January 30, 2015. A second groundwater sample was collected at an off-site location approximately 5 feet from SG-10. The off-site location was installed due to a very turbid sample from the original location. As described above in the soil gas sampling discussion, one off-site location, SG-11 was installed and sampled on March 27, 2015, due to access limitations and conflicts at the sample location. Figure 6 presents the approximate location of the temporary well point locations.

Groundwater samples were collected at five monitoring well locations, as shown in Figure 6. Samples were collected from MW-4s, MW-4i, MW-6s, MW-8s, and MW-9s. These wells were be sampled for TCL VOCs, SVOCs, TAL metals, PCBs/pesticides, natural attenuation (NA) parameters and dissolved gases (including methane, ethane and ethene).

In addition to the soil gas samples described above, groundwater and surface soil samples were collected from the locations depicted on Figure 6. A description of each sampling medium is provided below.

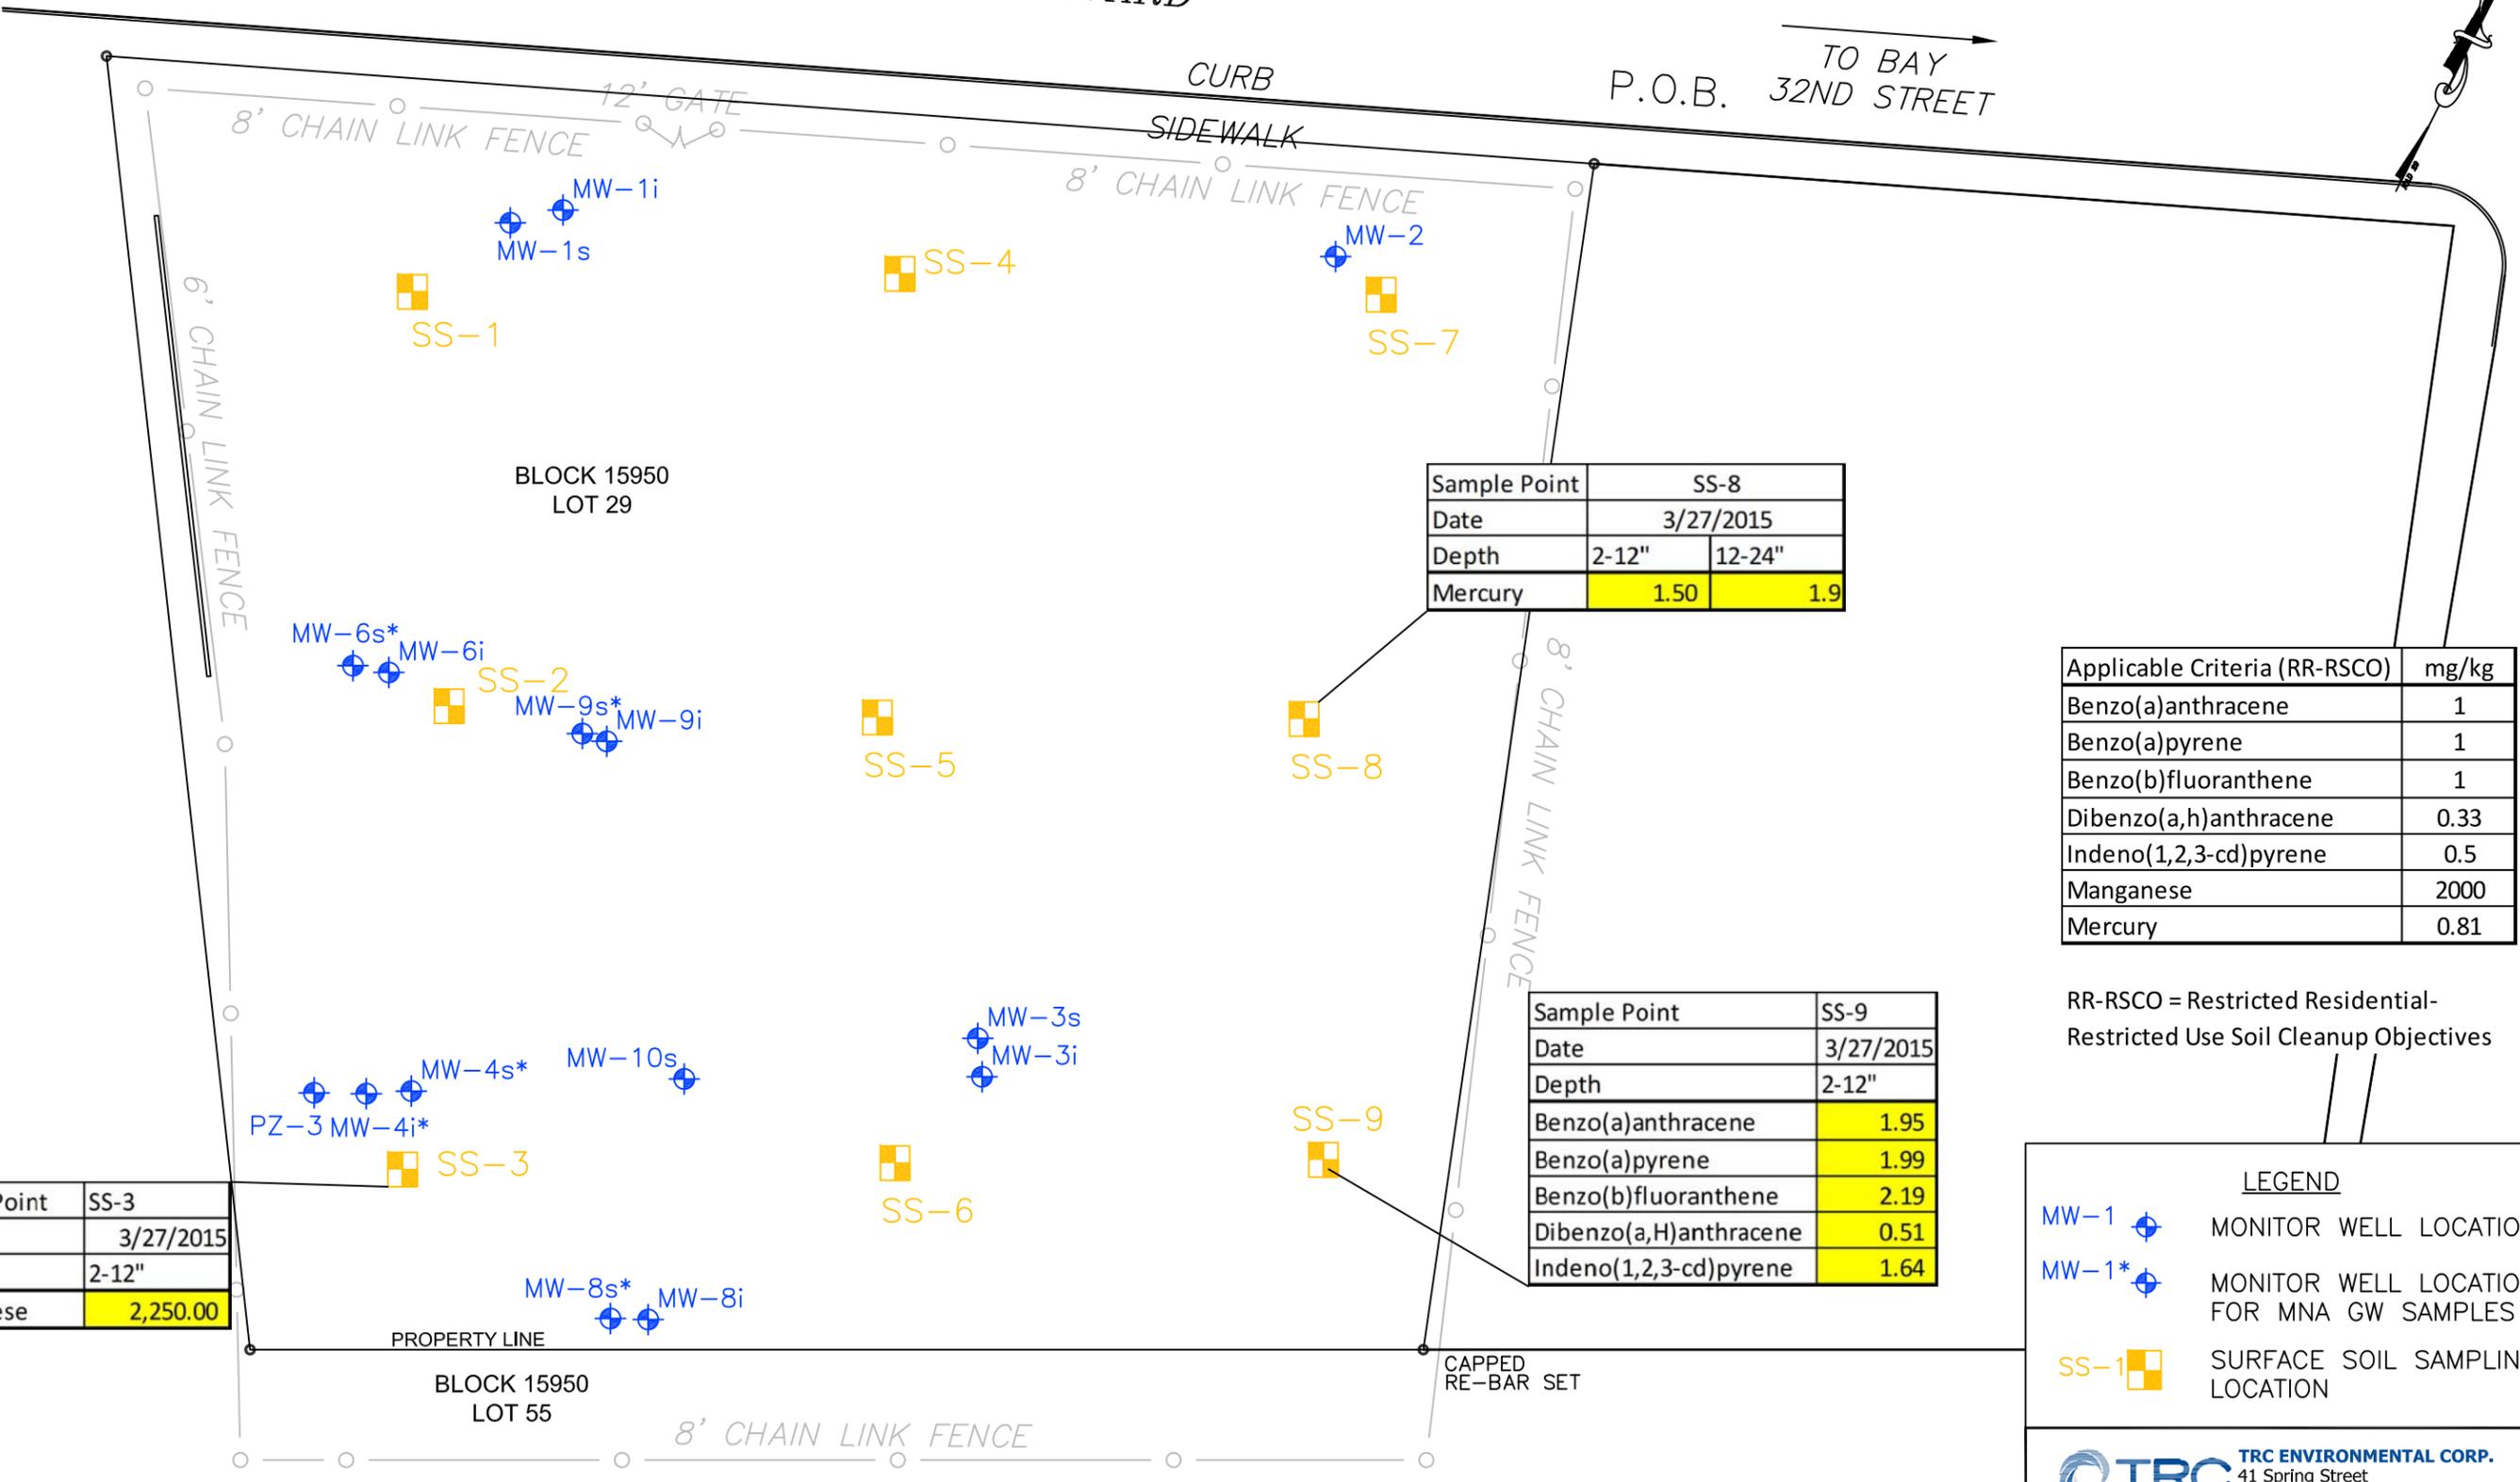
The results for all VOC, pesticide and PCB compounds were below the RSCO concentrations. Metal compounds were found to exceed the RSCOs at two sample locations, SS-3 and SS-8. Manganese was detected at location SS-3 at the 2-12” depth interval at a concentration of 2,250 mg/kg, marginally exceeding the RSCO criteria of 2,000 mg/kg. The results from the 0-2” and 12-24” depth horizon were significantly below the RSCO, at concentrations of 122 and 153 mg/kg, respectively, indicating that the manganese contamination is isolated. Mercury was detected at sample location SS-8 at the 2-12” and 12-24” depth horizon at concentrations of 1.5 and 1.9 mg/kg, respectively, exceeding the RSCO criteria of 0.81 mg/kg.

Sample Point	SS-8	
Date	3/27/2015	
Depth	2-12"	12-24"
Mercury	1.50	1.9

Sample Point	SS-9
Date	3/27/2015
Depth	2-12"
Benzo(a)anthracene	1.95
Benzo(a)pyrene	1.99
Benzo(b)fluoranthene	2.19
Dibenzo(a,h)anthracene	0.51
Indeno(1,2,3-cd)pyrene	1.64

Manganese was found at concentrations exceeding the RSCO in the 2” to 12” depth horizon at SS-3. Mercury was detected above the RSCO at SS-8 in the 2” to 12” and the 12” to 24” depth horizons. SVOCs were detected above the RSCO at SS-9, in the 12-24” depth horizon. It should be noted that if the RSCO Commercial use standards were applied, then no compounds would exceed the standards, other than benzo(a)pyrene at SS-9.

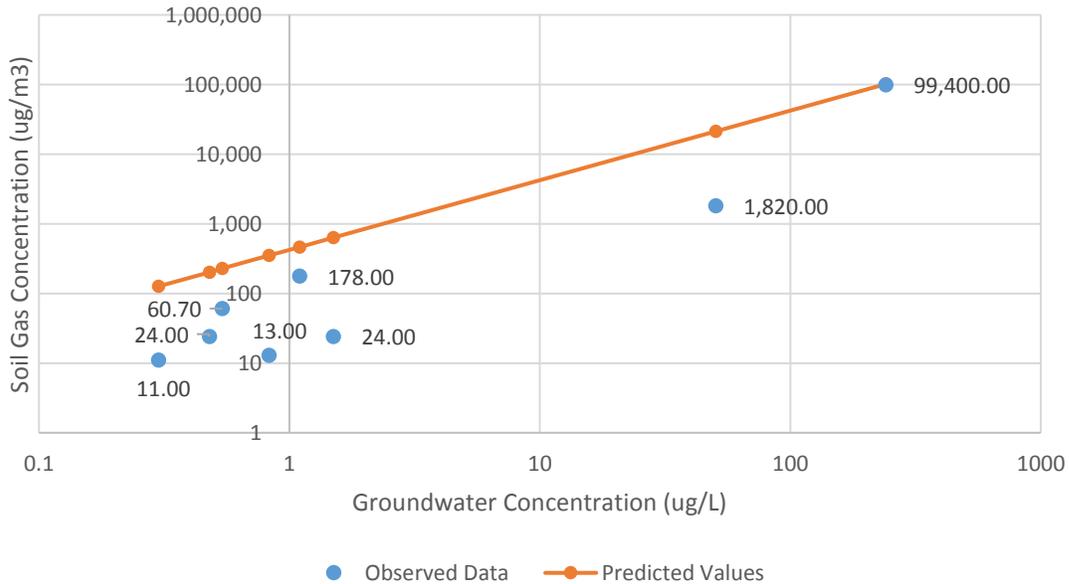
Soil Gas Concentration v. Groundwater Concentration

Location	GW Concentration (ug/L)	Observed Soil Gas (ug/m3)	Predicted Soil Gas (ug/m3)	% Difference
SG-1	0.83	13.00	350.26	96%
SG-2	50.5	1,820.00	21,311.00	91%
SG-3	0.48	24.00	202.56	88%
SG-4	0.54	60.70	227.88	73%
SG-5	0	0.81	-	
SG-6	0	-	-	
SG-7	0	1.20	-	
SG-8	0.3	11.00	126.60	91%
SG-9	1.5	24.00	633.00	96%
SG-10	1.1	178.00	464.20	62%
SG-11	241	99,400.00	101,702.00	2%
SG-12	0	-	-	--
SG-13	0	-	-	--
SG-14	0	-	-	--
SG-15	0	-	-	--
