11-28 31ST DRIVE
11-28 31ST Drive, Queens, NY 11106

PERIODIC REVIEW REPORT

NYSDEC BCP Number: C241159

APRIL 20, 2023, TO APRIL 20, 2024

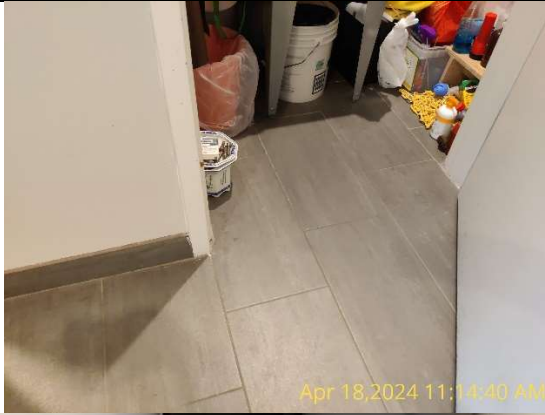
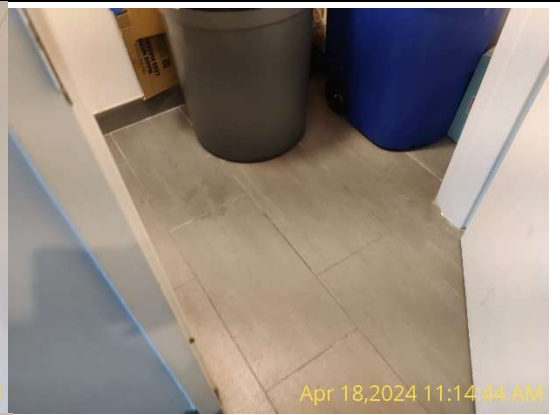
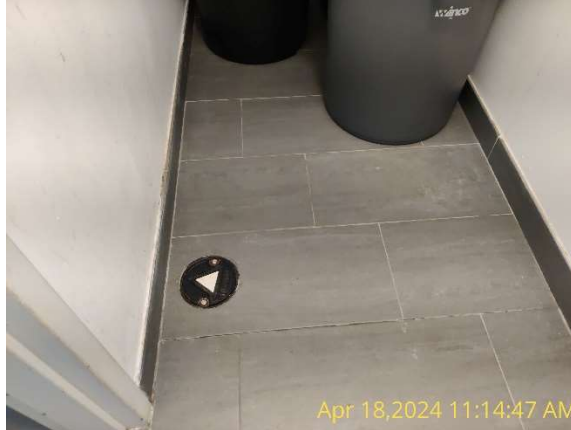
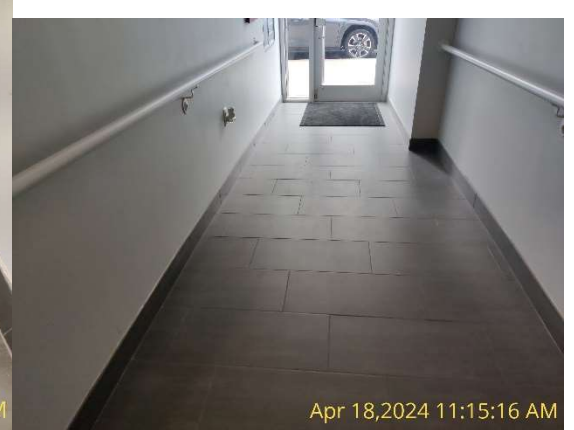
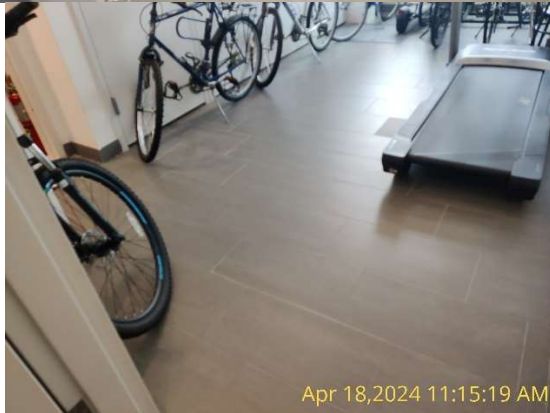
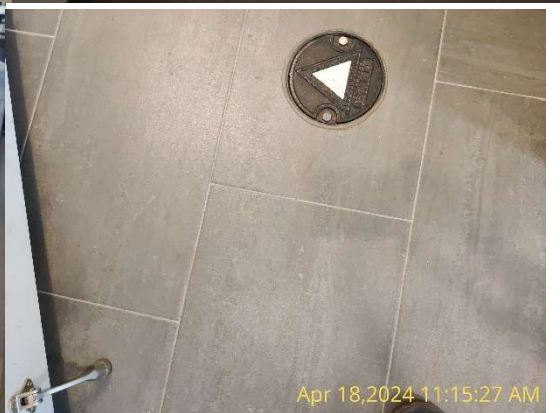
**Photo Log –
Pictures of Slab**

The slab is in good condition

No cracks or penetrations were observed at the time of inspection.
