Periodic Review Report

131-05 & 131-15 Fowler Avenue Site

Block 5076, Lot 31 Site ID: C241161

July 15, 2020

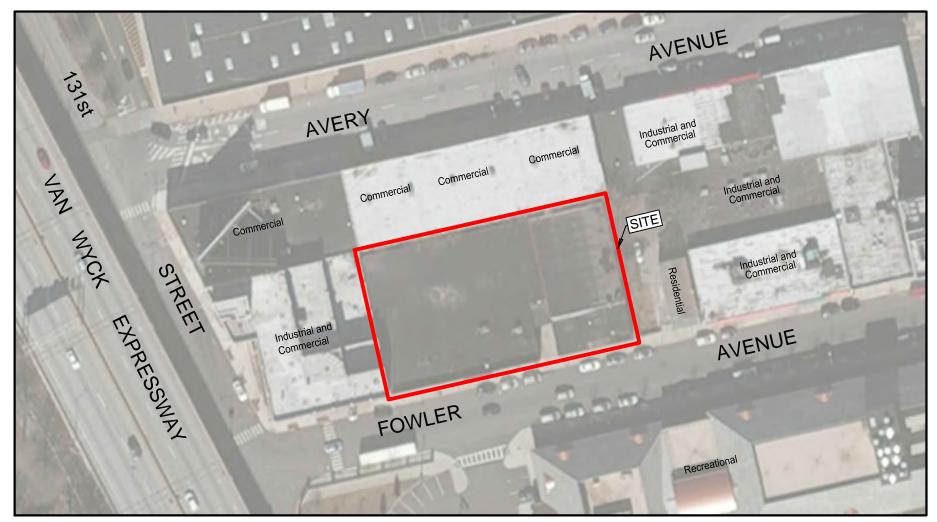
JOB NO.: 14164 SCALE: As Shown DATE: 03/03/15 FIG. 2

200 Riverfront Blvd. Elmwood Park, NJ 07407 Tel: (201) 791-0075 Fax: (201) 791-4533 SITE PLAN MAP 131-05 & 131-15 FOWLER AVENUE SITE ID: C241161 QUEENS

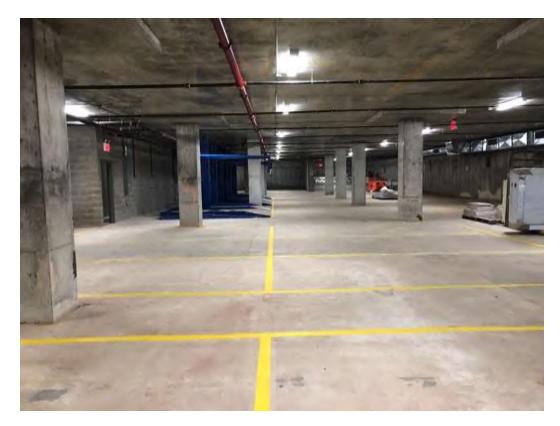
Photo 3

| Site Inspection Item | Inspection Result | Comments |
|---|---|---|
| 2. Building Capping System | Acceptable | The foundation slab remain intact |

| Date | Photo ID | Description |
|---|---|---|
| 9/27/2019 | 3 | View of the foundation slab in the basement level facing west |

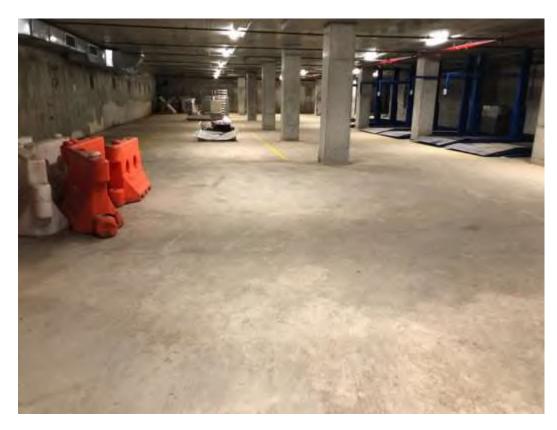
Photo 4

| Date | Photo ID | Description |
|---|---|---|
| 9/27/2019 | 4 | View of the foundation slab in the basement level facing east |

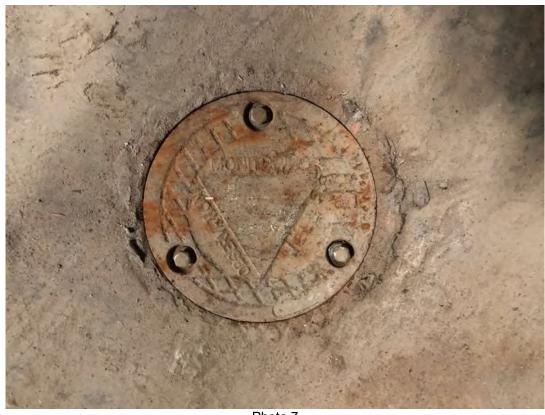
Photo 7

| Site Inspection Item | Inspection Result | Comments |
|---|---|---|
| 4. Monitoring Well | Acceptable | |

| Date | Photo ID | Description |
|---|---|---|
| 9/27/2019 | 7 | View of the outer casing of the monitoring well in the basement |

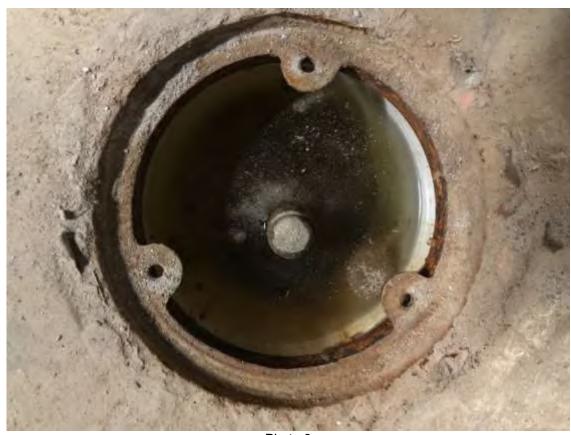
Photo 8

| Date | Photo ID | Description |
|---|---|---|
| 9/27/2019 | 8 | View of the inner casing of the monitoring well in the basement |

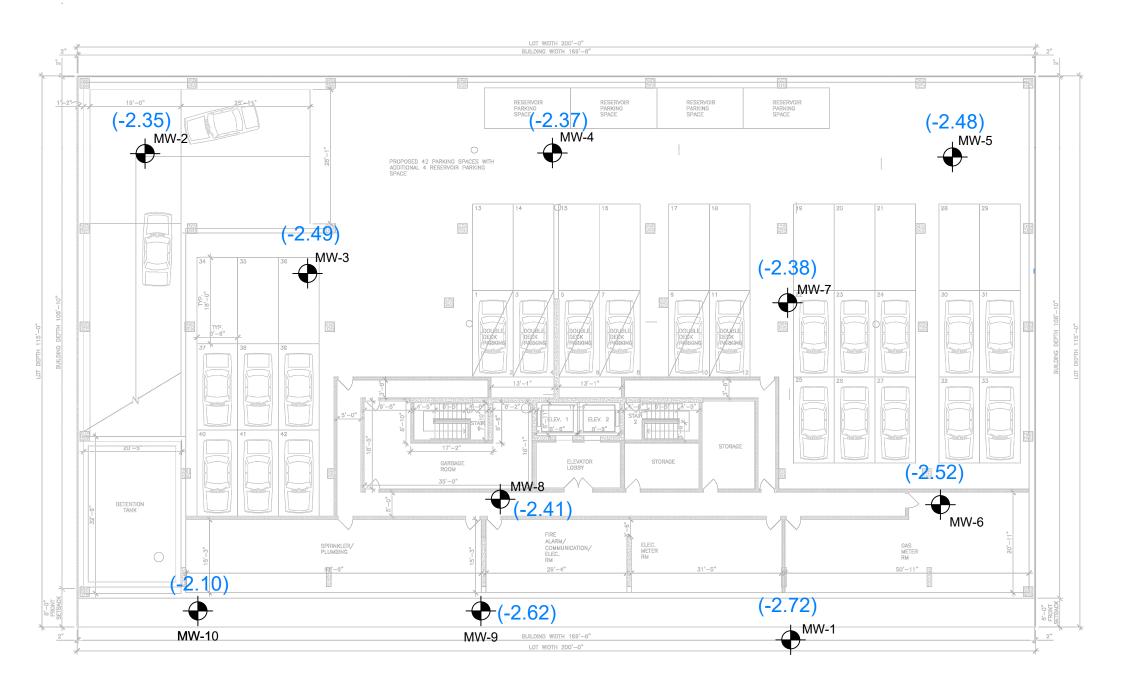
MW-X AS-BUILT MONITORING WELL LOCATIONS/GROUNDWATER INJECTION LOCATIONS

Tel: (201) 791-0075 Fax: (201) 791-4533 GROUNDWATER ELEVATION CONTOUR MAP 131-05 & 131-15 FOWLER AVENUE SITE ID: C241161 **QUEENS**
