## **PHASE II ENVIRONMENTAL ASSESSMENT LIMITED SUBSURFACE INVESTIGATION**

Rochdale Village

169-55 137th Avenue, Queens, New York

September 17, 2010  
GRS Project #: 10-07561

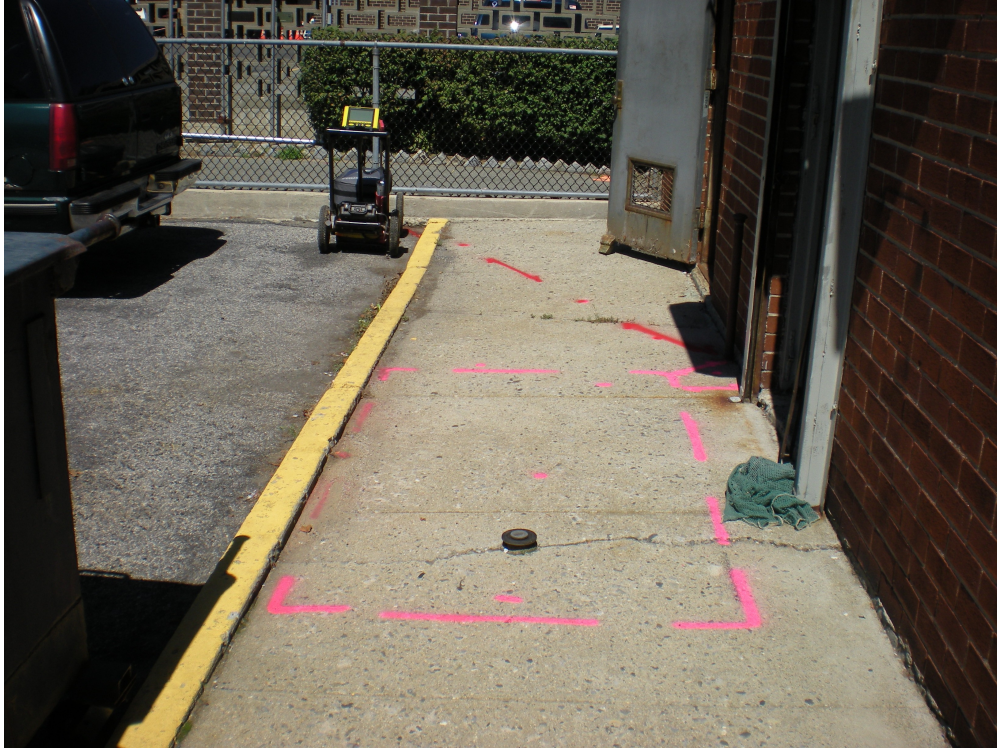
due to access limitations, this area could not be directly surveyed to confirm the presence of a UST at this location. Visual evidence of appurtenances associated with USTs (i.e., fill port and vent pipe) were additionally observed on the exteriors of both of these tenant spaces during. The geophysical survey report is attached in Appendix E.

Figure 1 – Metallic anomaly consistent with an UST and associated piping designated with pink paint. Note the electrical line nearby designated in red.

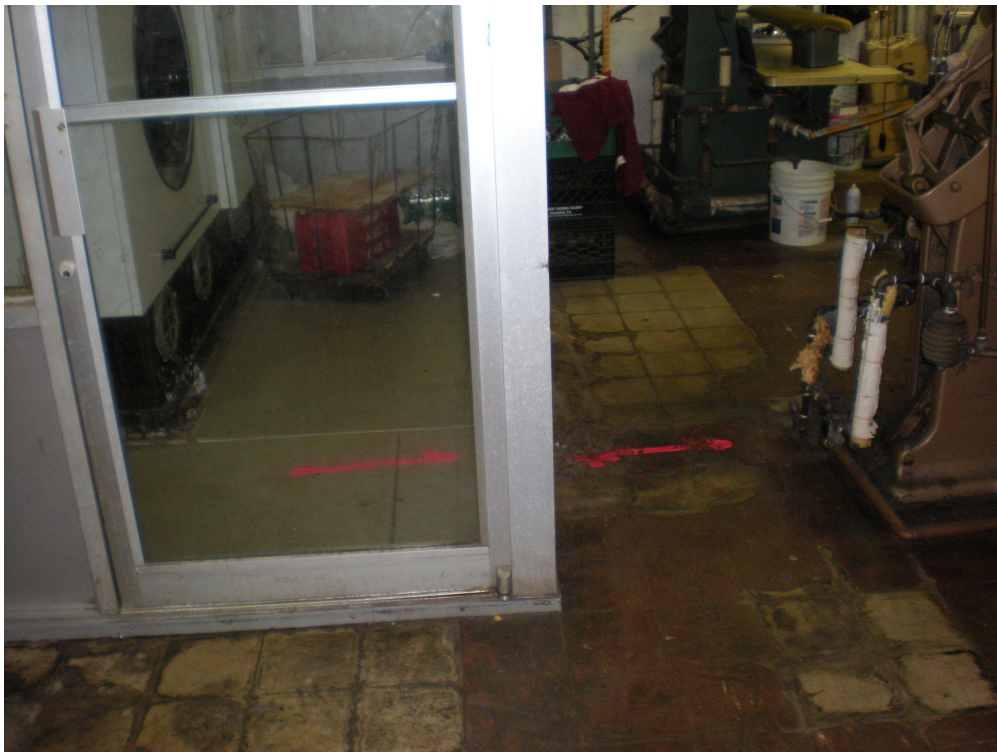
Figure 2 – Steam line designated with pink paint. Note the dry cleaning equipment and interior walls limiting the scope of the survey.
