Jackson Heights Shopping Center 75-11 31st Avenue Queens County Jackson Heights, New York 11370

SITE MANAGEMENT PLAN

NYSDEC Site Number: C241176

OCTOBER 2019

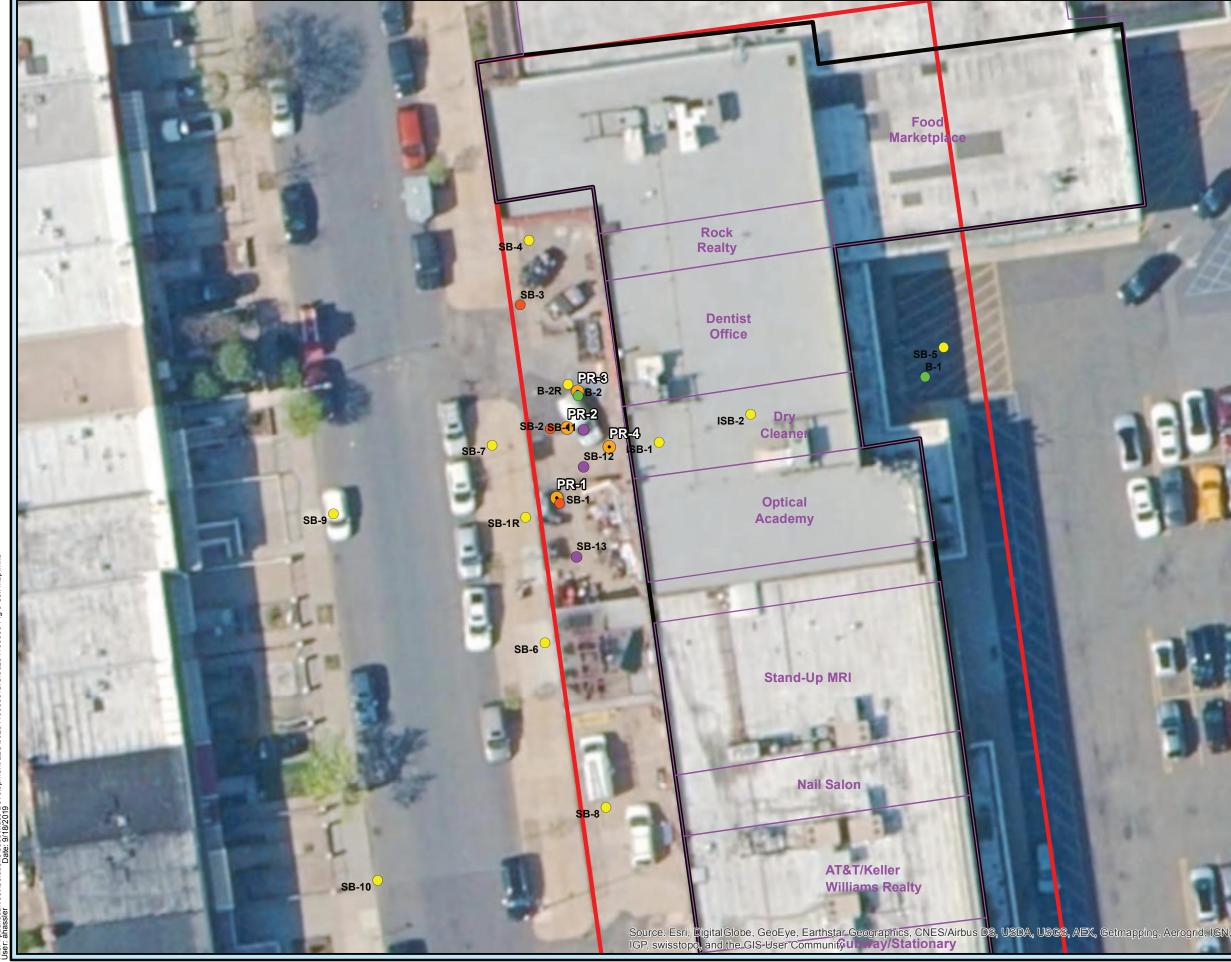
FIGURE 5 JULY 2, 2019 **GROUNDWATER CONTOUR MAP**

A groundwater contour map is shown in Figure 5. Groundwater elevation data is provided in Table 2. Groundwater monitoring well construction logs are provided in Appendix C.

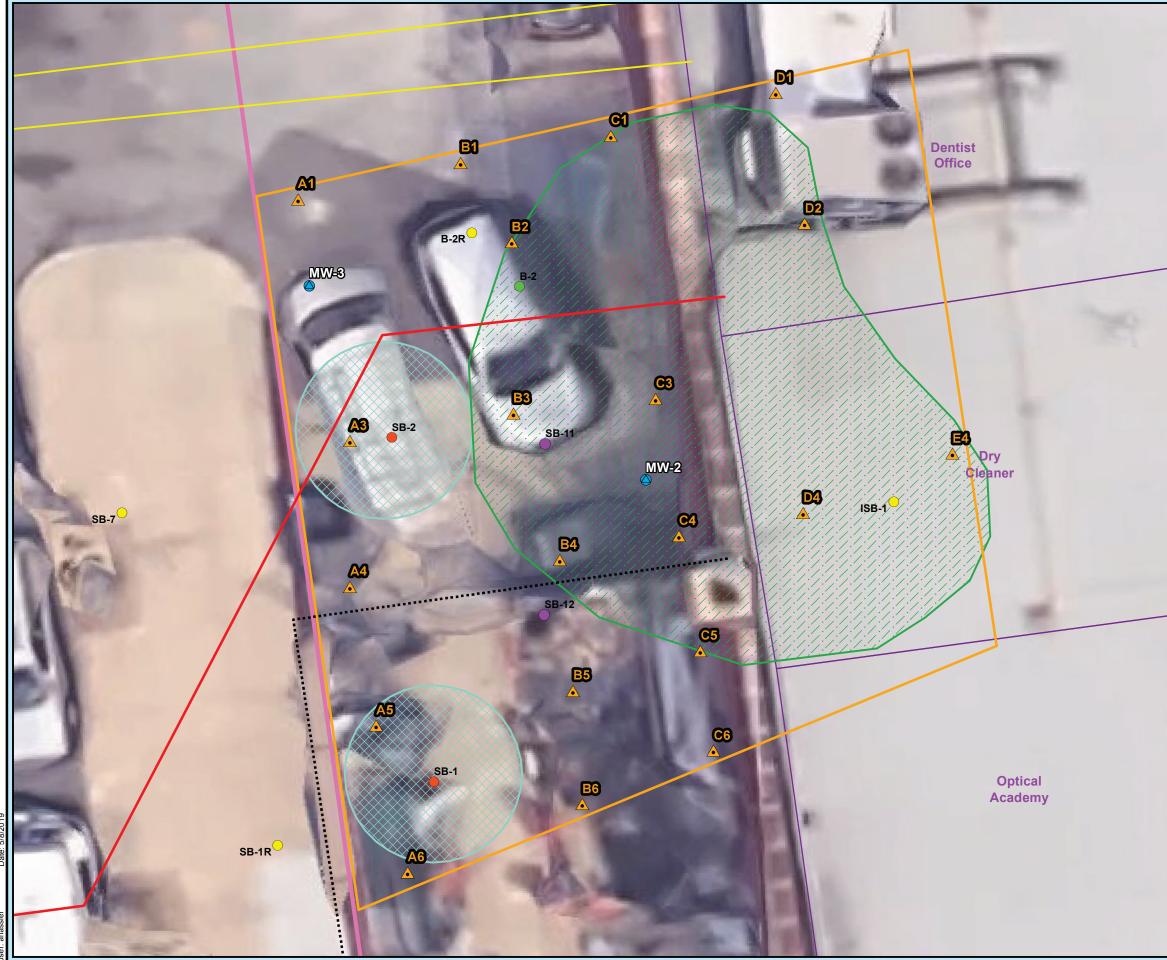
FIGURE 16 INJECTION LOCATION MAP

The potassium permanganate was delivered to the Site by a tanker truck. The injection compounds were mixed off-Site and were stored in a large tank onsite. It was batched mixed in stainless steel tanks to concentrations as high as 5%. The permanganate was injected through a progressive cavity pump where pressure, flow and total flow are continuously monitored. The preliminary design was based upon the use of 1,657 pounds of reagent. This mass was injected uniformly among the temporary 20 injection points.

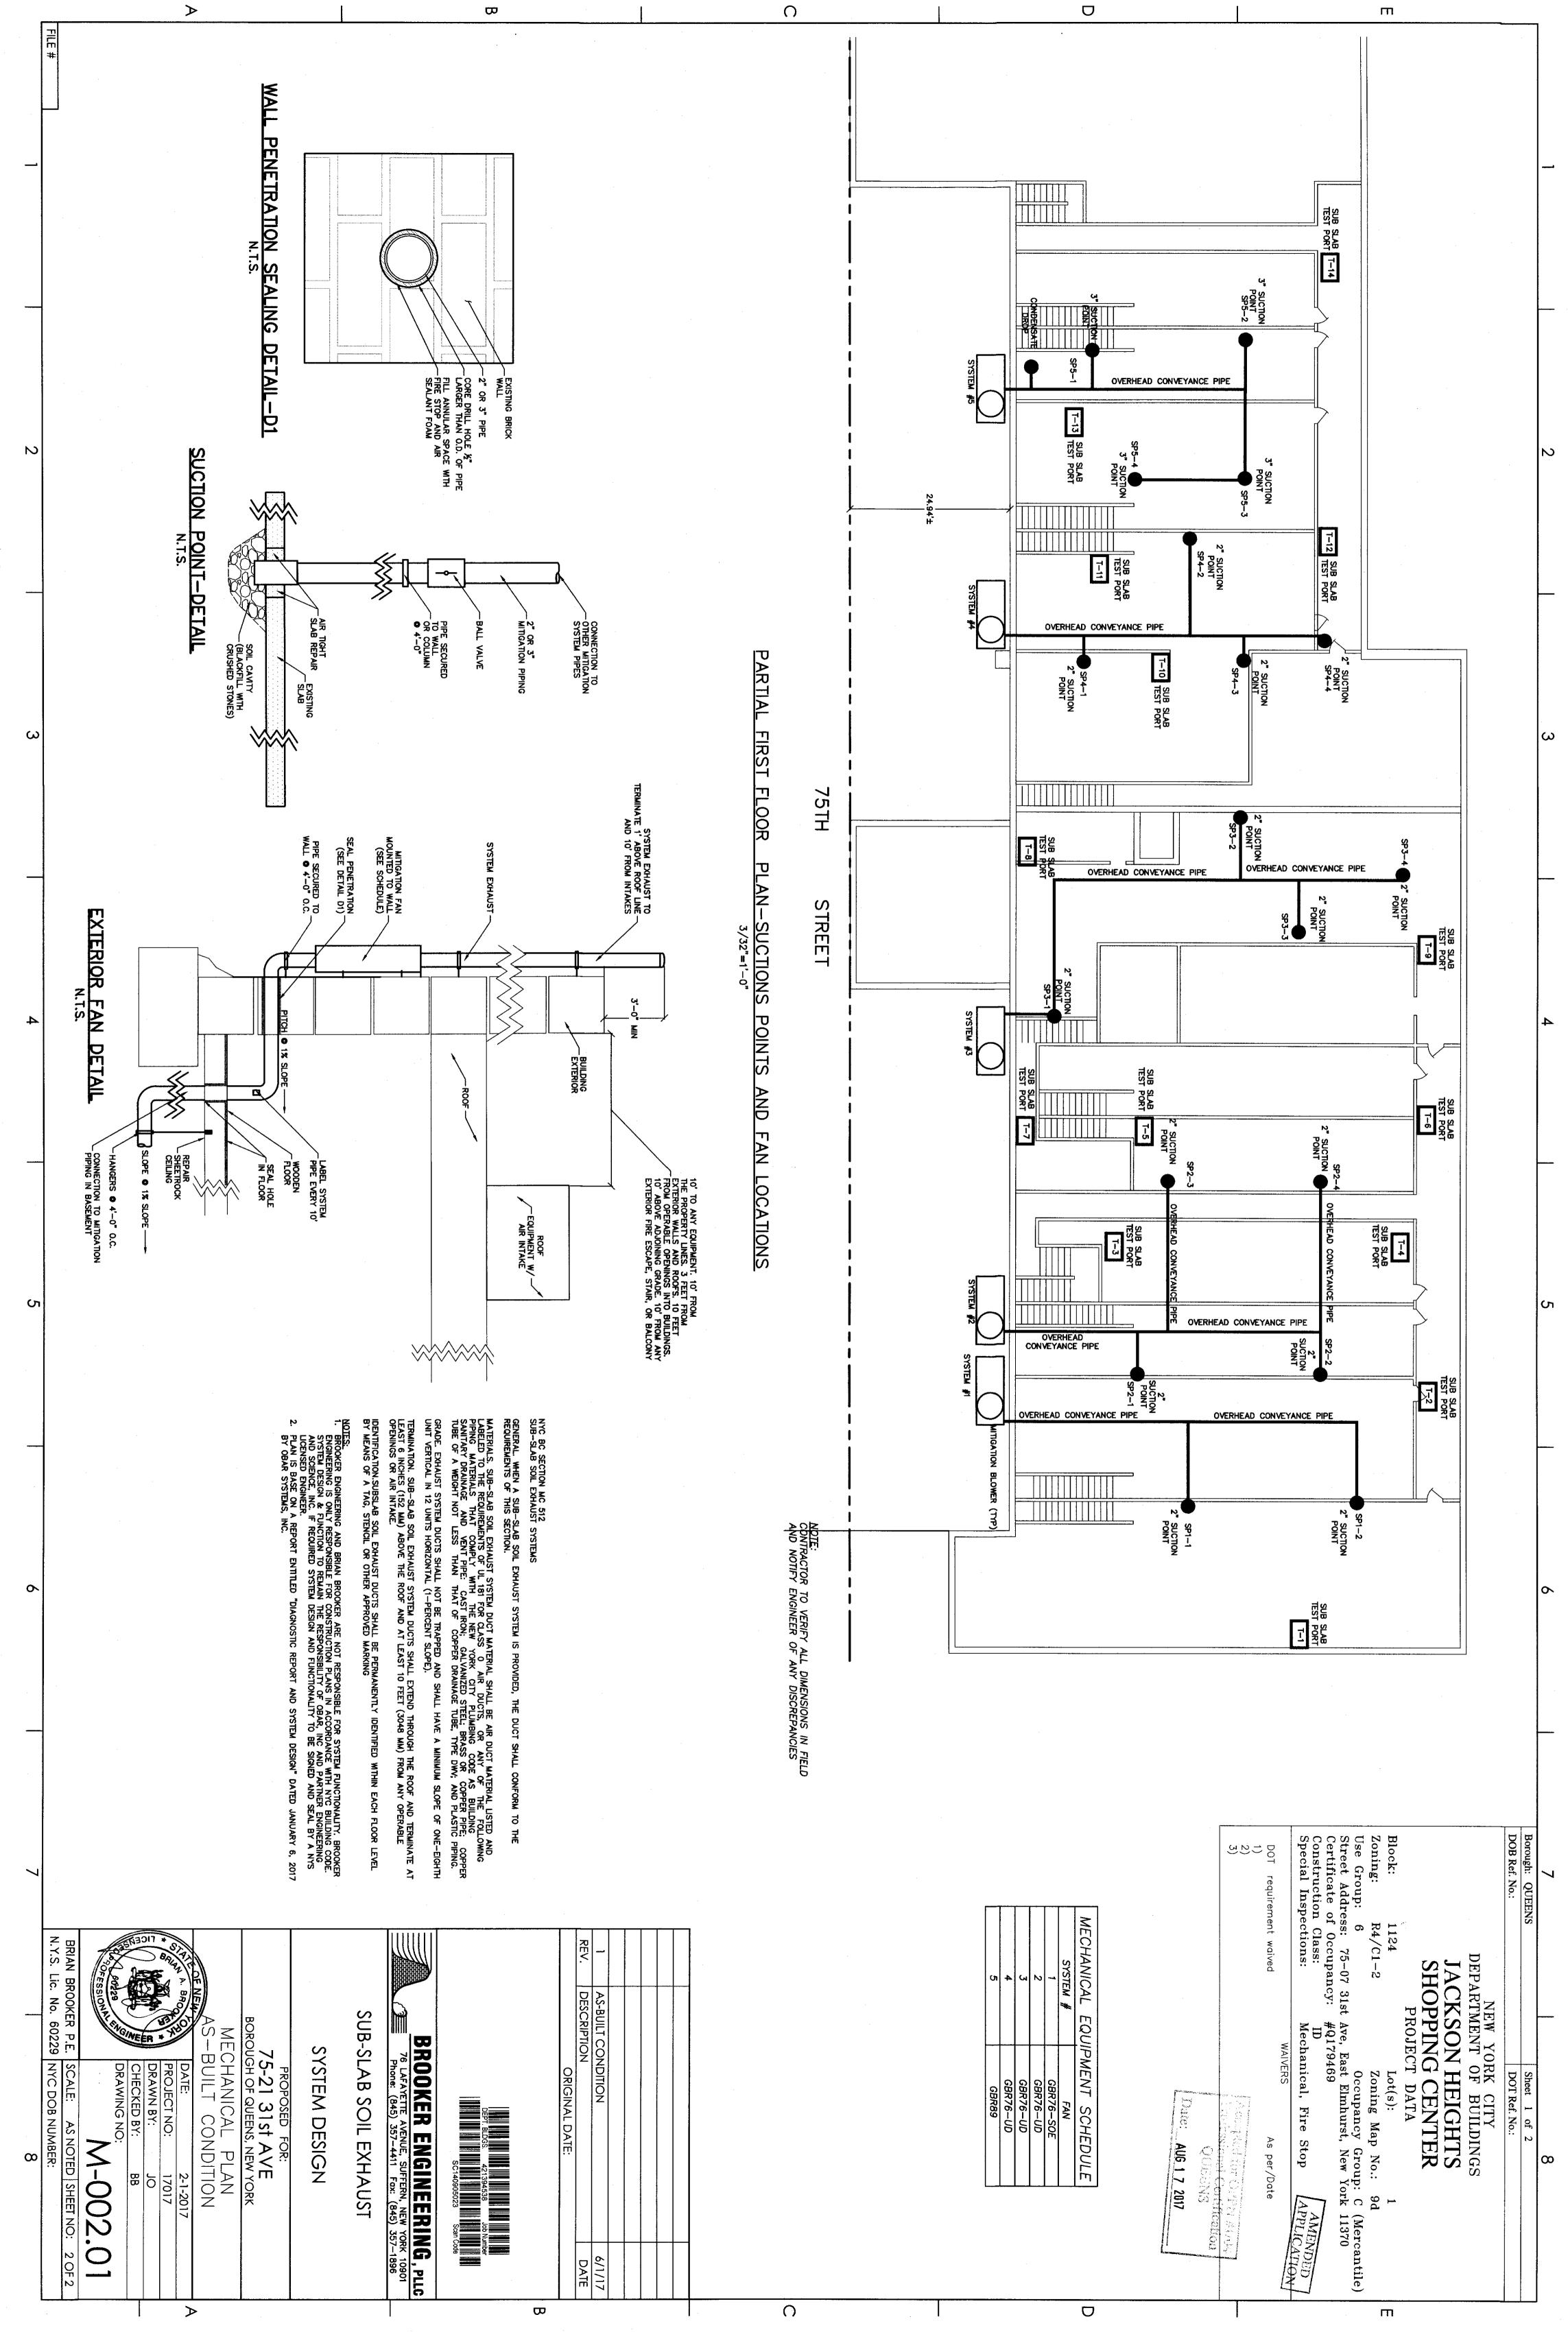
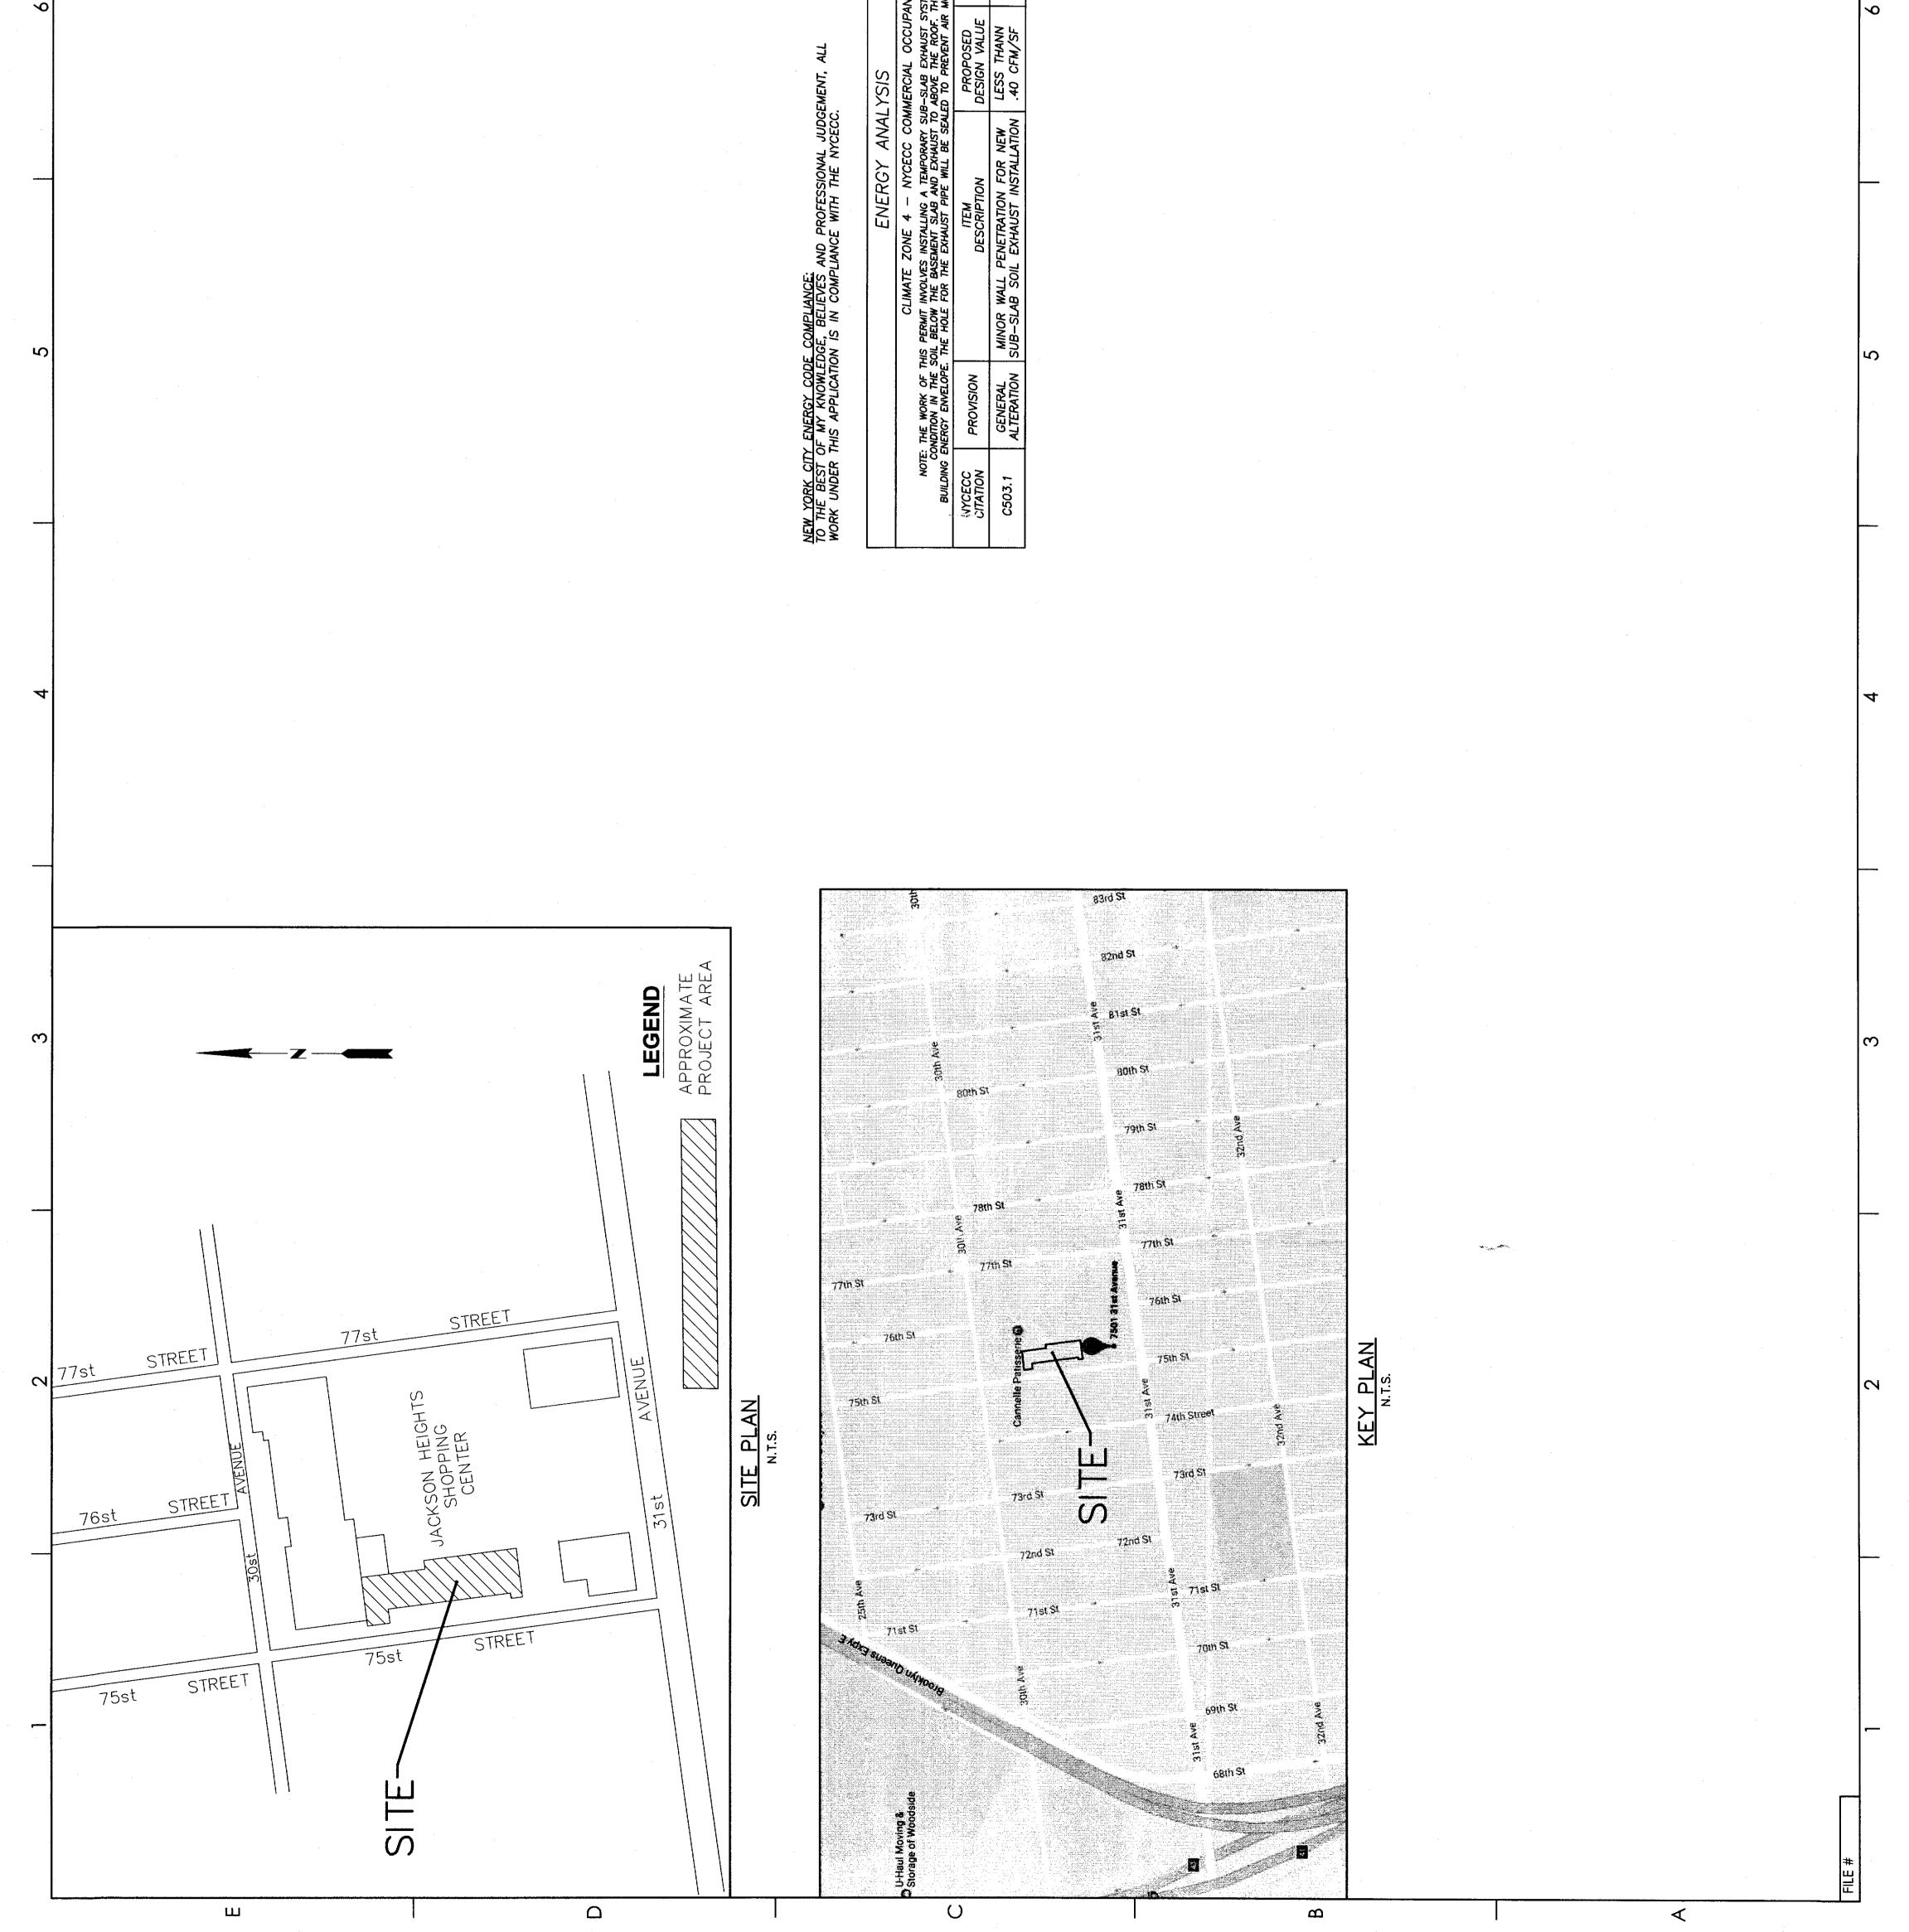
AS-BUILT DRAWING

Ш	۵		U	<u>م</u>	<
7 8	gi: QUEENS Sheet 1 of 2 Ref. No.: DOT Ref. No.: DOT Ref. No.: DOT Ref. No.: DOT Ref. No.: NEW YORK CITY DEPARTMENT OF BUILDINGS JACKSON HEIGHTS SHOPPING CENTER PROJECT DATA PROJECT DATA sk: 1124 Lot(s): 1 ref. 124 Lot(s): 1 ref. 125 Lot(s	The Norward Contraction of the Second Contra	AMENDED		Indext Indext Indext Inde	
	Borough DOB Ref Block Zonin Use G Streef Certif Specid Specid 3)					
6				PANCY SYSTEM TO REMEDIATE ENVIRONMENTAL STHERE ARE NO CHANGES TO THE R MOVEMENT INTO THE CONDITIONED SPACE CODE PRESCRIPTIVE SUPPORT VALUE VALUE DOCUMENTATION LESS THANN LESS THANN DRAWING .40 CFM/SF M-002.00		70

The SSDS has a warning device to indicate that the system is not operating properly. The system is equipped with two audible and visual alarm panels. One two-gauge panel for systems 4 and 5 is located in the gas and meter room underneath the dentist's office tenant space. A second three-gauge alarm panel is located in the contractors' workshop underneath the Stand-Up MRI and services Systems 1-3. In the event of a system failure, the red light will illuminate and the audible alarm will sound. In the event that warning device is activated, applicable maintenance and repairs will be conducted, as specified in the Operation and Maintenance Plan, and the SSDS will be restarted. Operational problems will be noted in the Periodic Review Report to be prepared for that reporting period.
