**Re: Tangible Property Tax Credit BCA Amendment Request for Eligibility Determination  
Former Liberty Brass Site BCP Site #: C241178  
38-01 Queens Blvd., Long Island City, NY**

## BROWNFIELD CLEANUP PROGRAM (BCP) APPLICATION TO AMEND BROWNFIELD CLEANUP AGREEMENT AND AMENDMENT

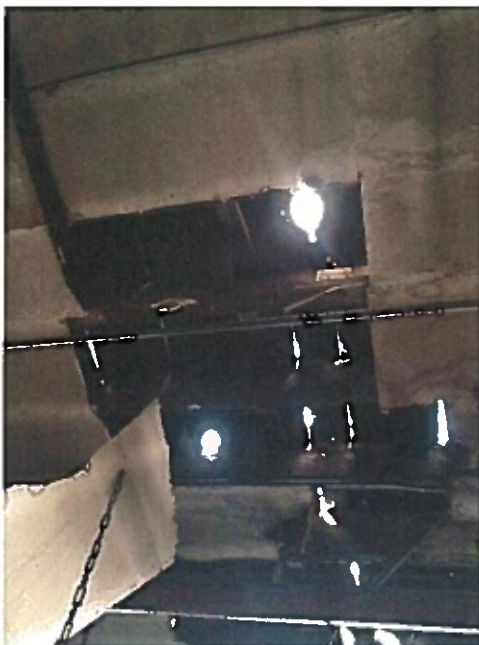
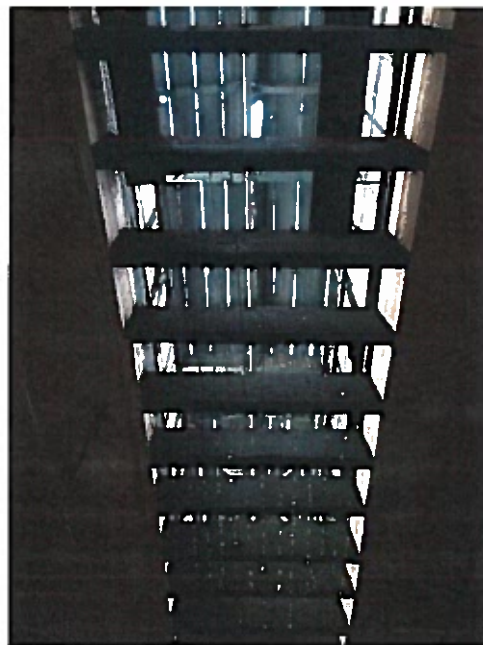
Condition of roof

Building roof is observed to be in very bad condition. At many locations throughout the building, roofing is deteriorated and roof boards are found to be either rotten or broken. Majority of the wood roof filler beams are observed to be soaked due to rainwater coming into the building through openings at the roof.

Overall building stability is questionable. Heavy damage at roof structural elements may lead to partial or full collapse of the roof. Cracks at the party wall and its' foundation along north property line creates an unstable condition for the support of the roof above.

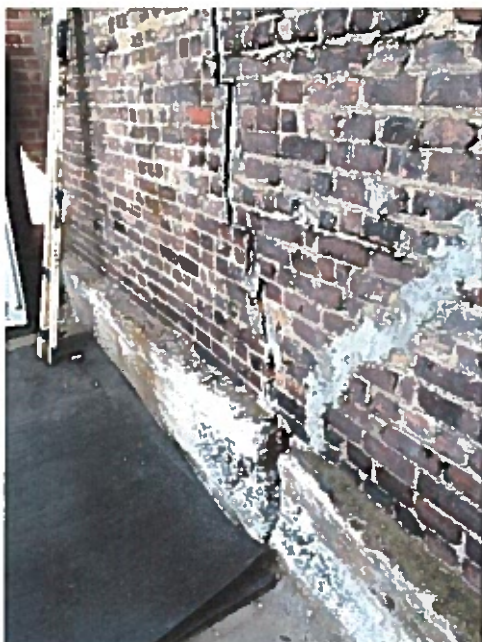
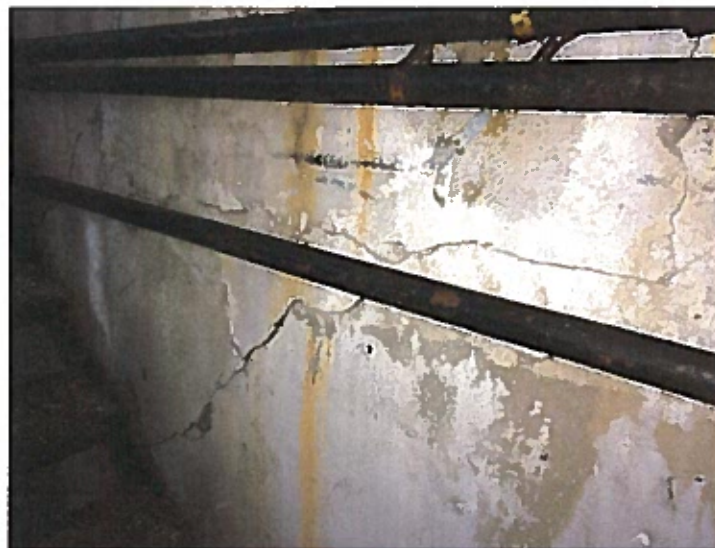
Condition of party wall, foundation and retaining wall

Party wall along north property line is observed to have a large diagonal crack continuing into the wall footing. Retaining wall along north face of the basement also had a diagonal crack.

Cracks observed at the retaining wall along north face of the basement is a concern and may lead to settlements at grade level due to surcharge loads and may result in sudden failure of the wall.

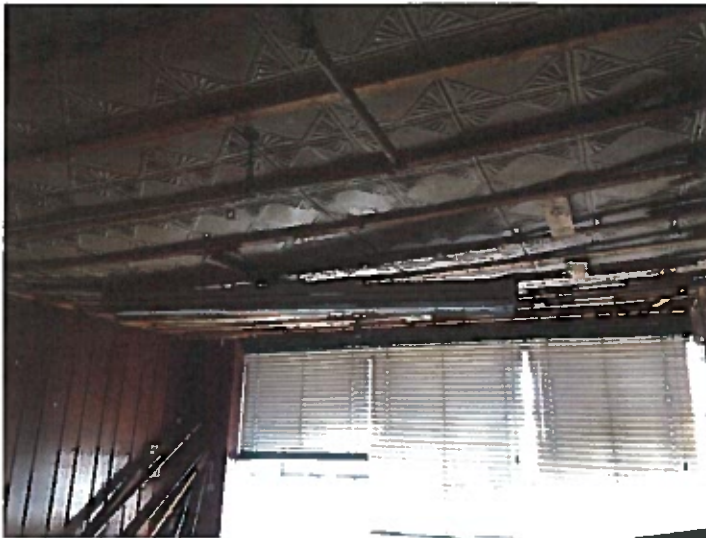
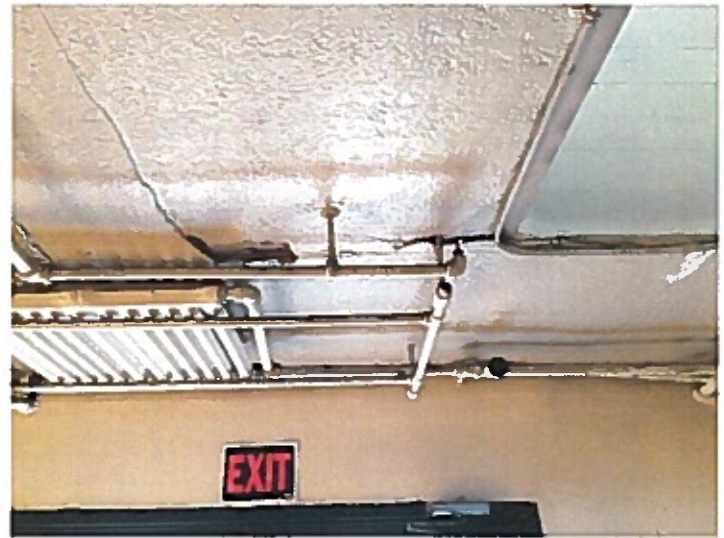
Condition of mezzanine

Mezzanine level floor framing was found to be in very poor condition. Floor is sagging and the base boards are deteriorated. Ceiling is also sagging at many locations throughout offices.
