**Brownfield Cleanup Program
Off-Site Investigation Report**

**31/32 LIC LLC
37-25 31ST STREET
LONG ISLAND CITY, NEW YORK**

BCP SITE #C241182

June 2017

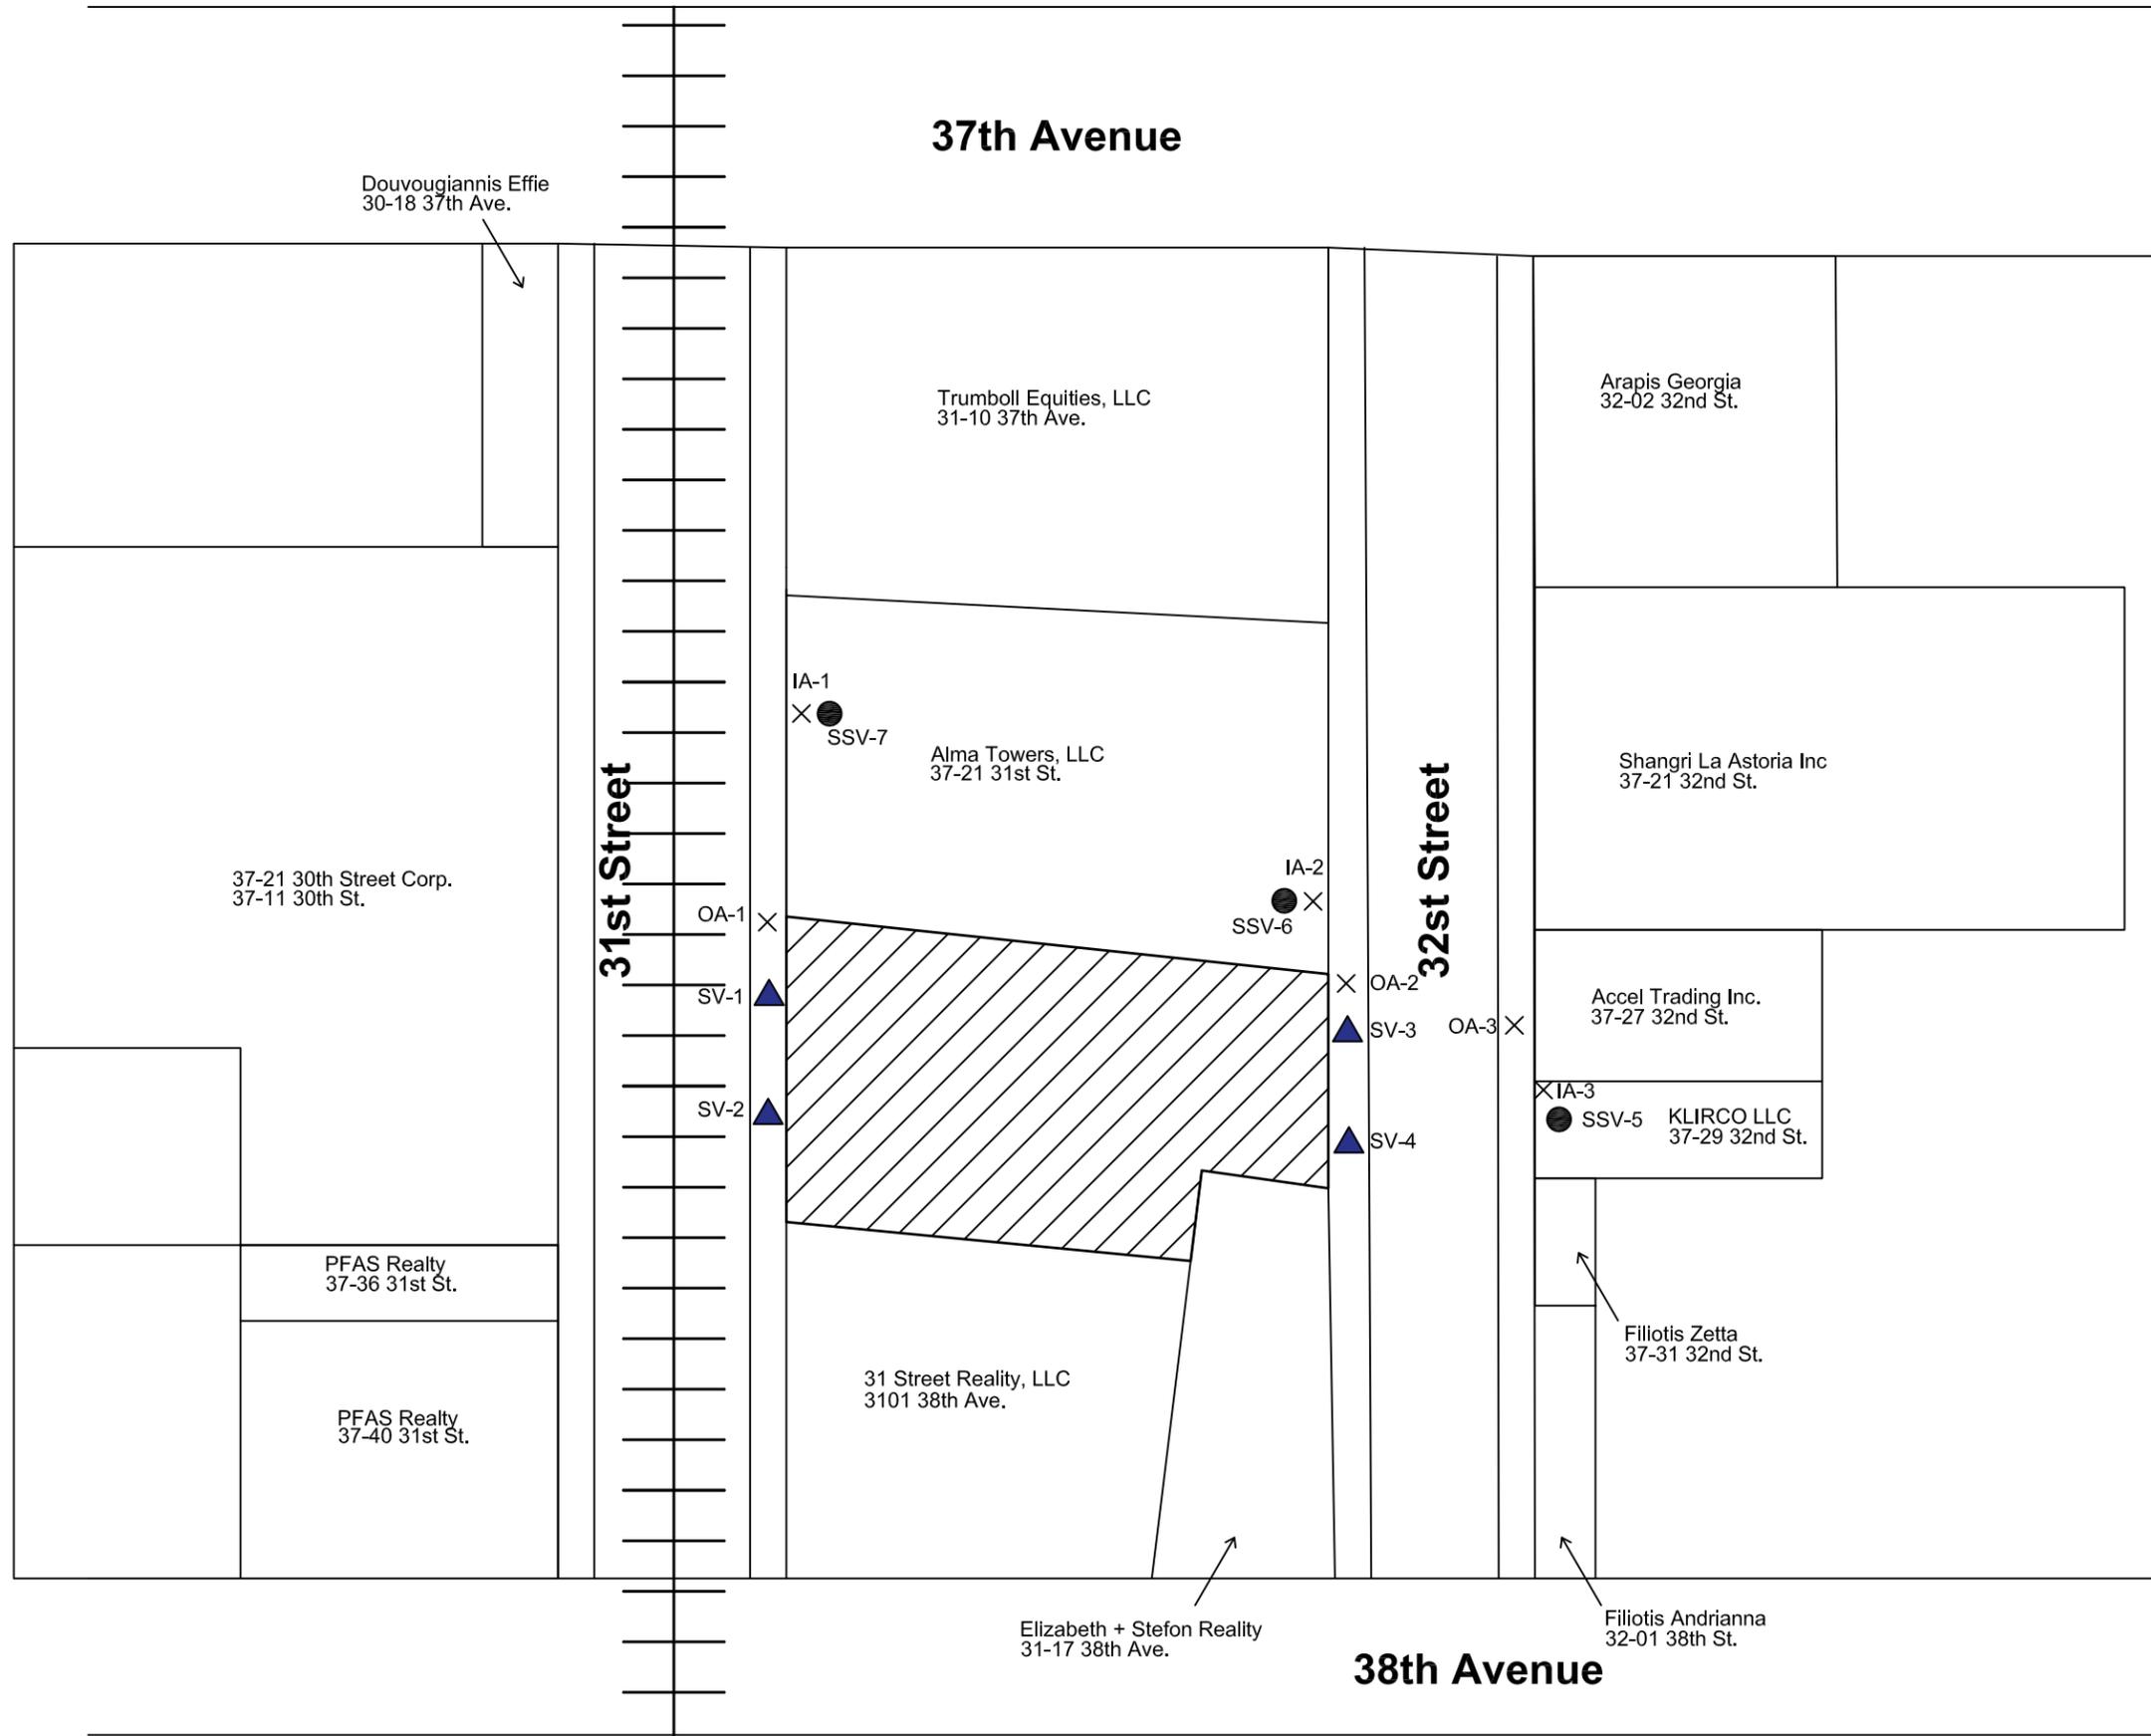
A sample soil vapor point installation log is included as Appendix C. No local condition(s) occurred during the sampling that may influence interpretation of the results (ie. weather). The sampling locations are illustrated on Figure 2.

IA-1 was collected co-located with SSV-7
IA-2 was collected co-located with SSV-6

4.1 Sidewalk: Trichloroethene (TCE) was detected at 6.29 ug/m³ in SV-2, 13.1 ug/m³ in SV-3, and 80.6 ug/m³ in SV-4. The NYSDOH Matrix parameter for TCE is 5 ug/m³. TCE was also detected in SV-1 at 2.91 ug/m³. Several other compounds were detected at low levels. The results of these samples are presented on Table 1.

4.2 37-29 32nd Street: Carbon tetrachloride was detected at 0.491 ug/m³ in the indoor air, above its NYSDOH Decision Matrix of 0.25 ug/m³. Carbon tetrachloride was not detected in sub-slab soil vapor, but was detected at 0.384 ug/m³ in the outdoor air. According to the NYSDOH Decision Matrices, reasonable and practical actions should be taken to identify source(s) and reduce exposures.

Additionally, TCE was detected at 22.3 ug/m³ in sub-slab soil vapor, and 0.349 ug/m³ in indoor air, above its NYSDOH Decision Matrices of 5 ug/m³ and 0.25 ug/m³, respectively. TCE was also detected at 0.124 ug/m³ in outdoor air. According to the NYSDOH Decision Matrices, further monitoring is recommended. The results of these samples are presented on Table 2.

4.3 37-21 31st Street: Carbon tetrachloride was detected at 0.365 ug/m³ in indoor air sample IA-1 and 0.371 ug/m³ in indoor air sample IA-2, above its' NYSDOH Decision Matrix of 0.25 ug/m³. Carbon tetrachloride was not detected in sub-slab soil vapor, but was detected at 0.371 ug/m³ in outdoor air sample OA-1 and 0.396 ug/m³ in outdoor air sample OA-2. According to the NYSDOH Decision Matrices, reasonable and practical actions should be taken to identify source(s) and reduce exposures.

Additionally, TCE was detected at 25.6 ug/m³ in sub-slab soil vapor sample SSV-6 and 16.4 ug/m³ in sub-slab soil vapor sample SSV-7, above its' NYSDOH Decision Matrix of 5 ug/m³. Additionally, TCE was detected at 0.527 ug/m³ in indoor air sample IA-1 and 0.688 ug/m³ in indoor air sample IA-2, above its' NYSDOH Decision Matrix of 0.25 ug/m³. TCE was detected at 0.113 ug/m³ in outdoor air sample OA-1 and 0.226 ug/m³ in outdoor air sample OA-2. According to the NYSDOH Decision Matrices, further monitoring is recommended. The results of these samples are presented on Table 3.

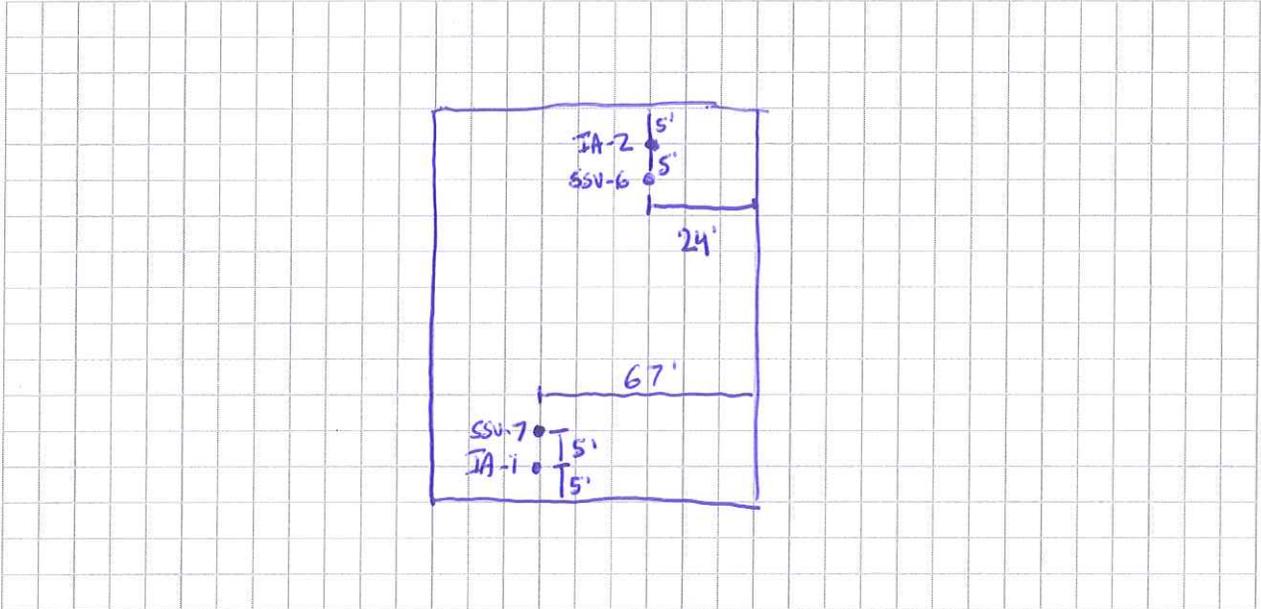
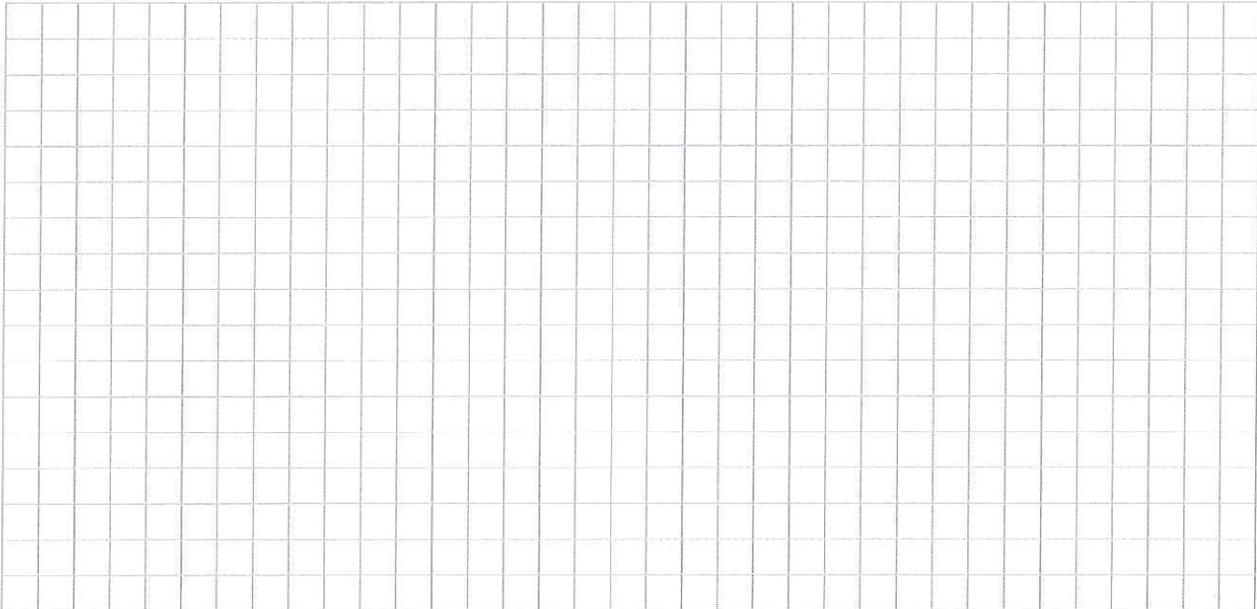
Some cracks in slab

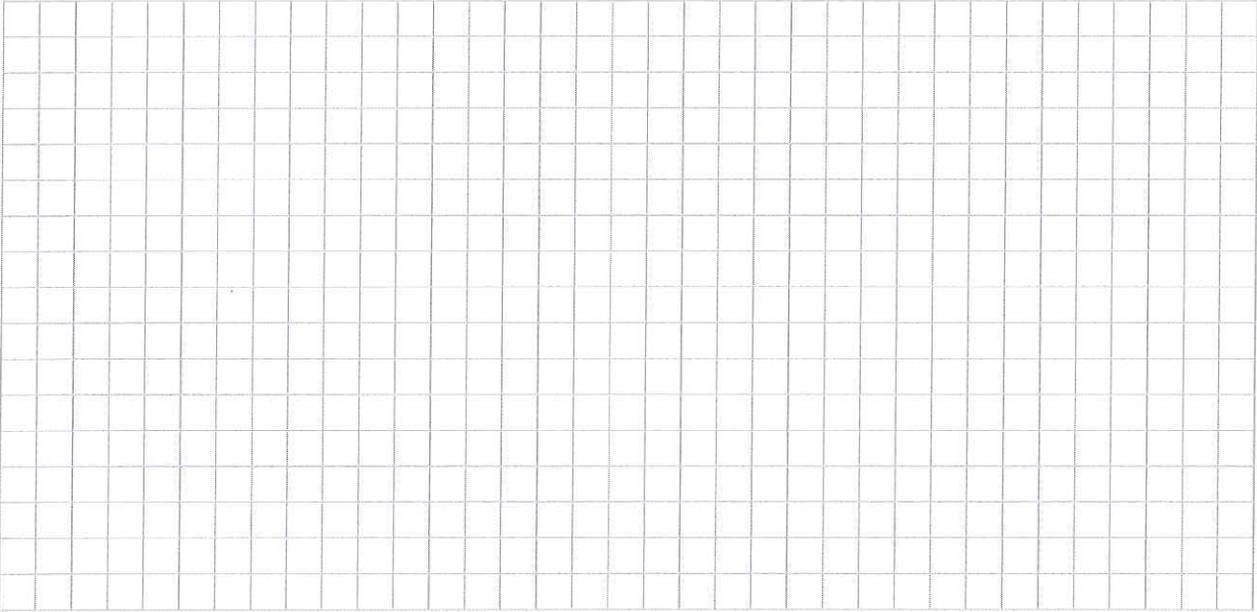
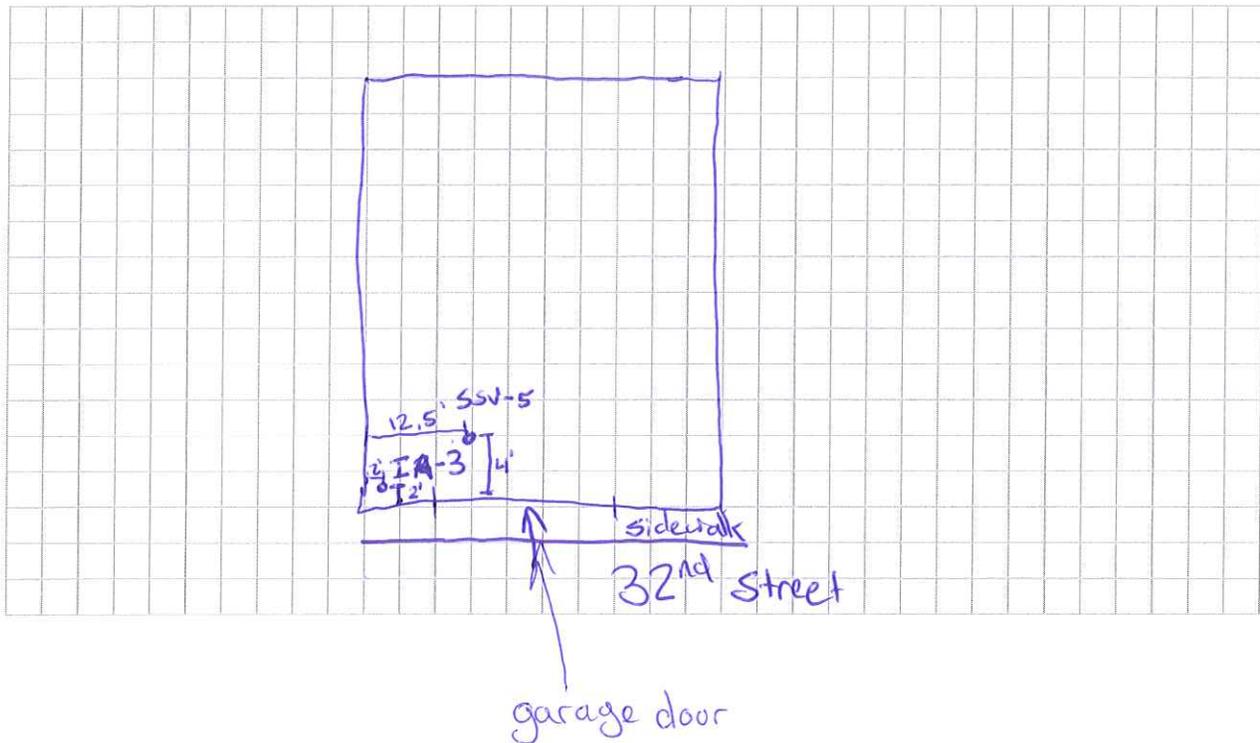
a few cracks noted in slab.

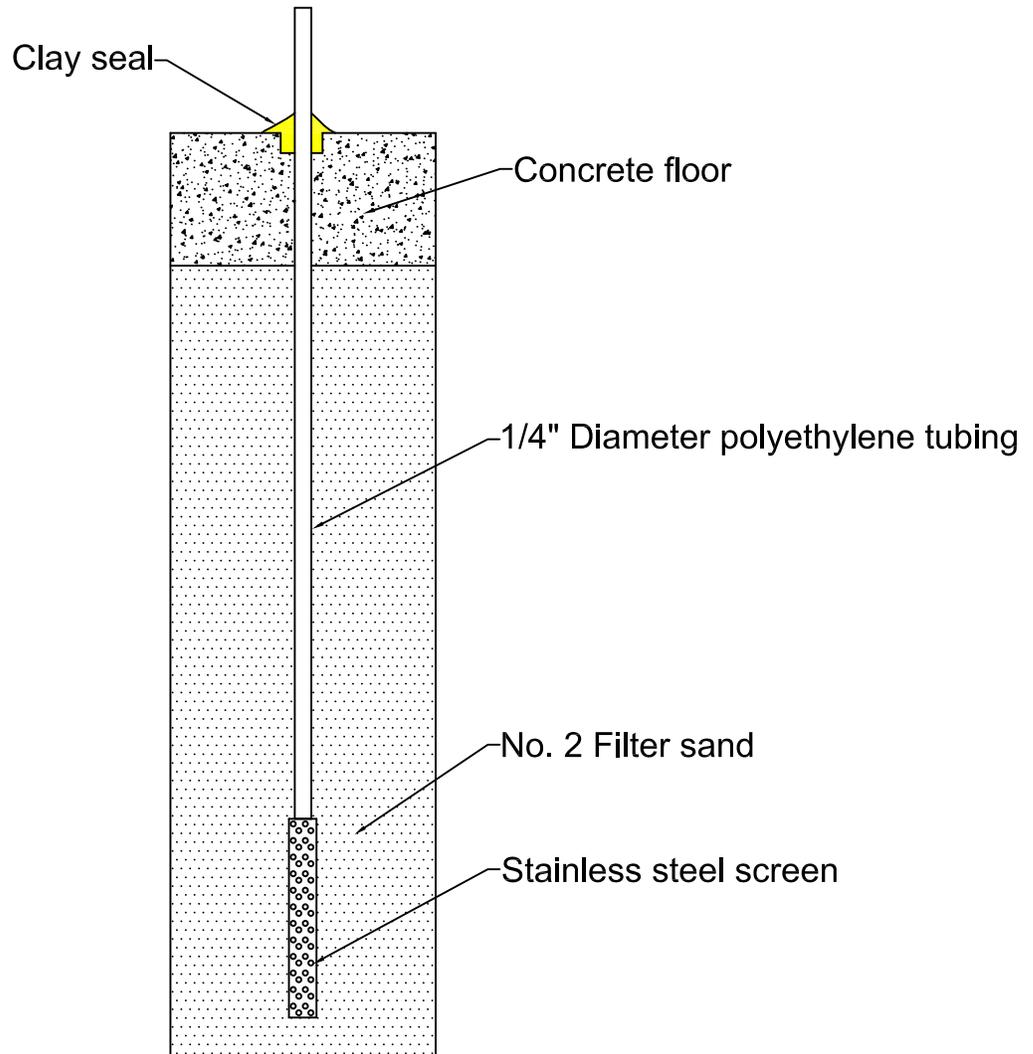
Typical Sub-Slab
Soil Vapor Point

Note:
The sub-slab soil vapor point is installed to approximately 2-inches below the bottom of the concrete slab.
