Phase II Environmental Site Assessment

18-46 Decatur Street

18-46 Decatur Street
Queens, New York

EBI Project No. 1216000109

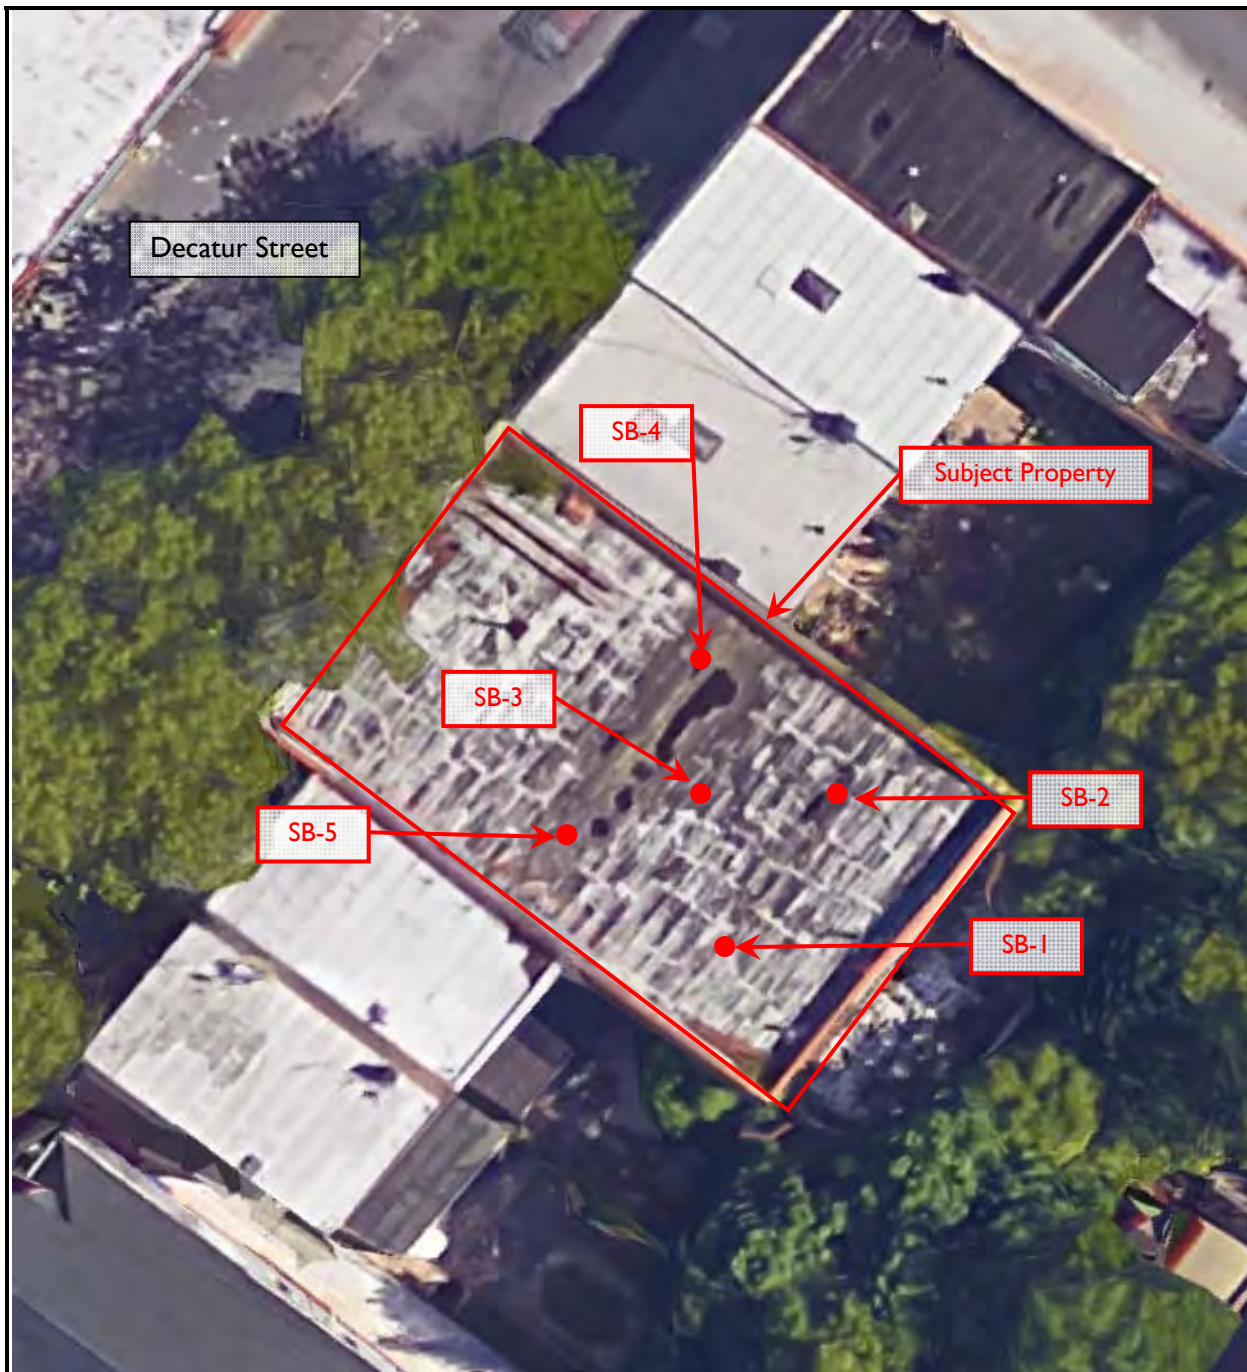
Figure 3
Boring Location Map

- Boring SB-1 was installed in on the ground floor in the southeastern portion of the Subject Property building, located approximately 20 feet from the eastern wall and 10 feet from the southern wall.
- Boring SB-2 was installed in on the ground floor in the northeastern portion of the Subject Property building, located approximately 20 feet from the eastern wall and 10 feet from the northern wall.
- Boring SB-3 was installed in on the ground floor in the central portion of the subject property building.
- Boring SB-4 was installed in on the ground floor in the central portion of the Subject Property building, located approximately 10 feet from the northern wall.
- Boring SB-5 was installed in on the ground floor in the central portion of the Subject Property building, located approximately 10 feet from the southern wall.

Boring locations are illustrated on Figure 3, Boring Location Map.
