18-46 Decatur Street Periodic Review Report

18-46 Decatur Street, Ridgewood, Queens, New York
Block 3579, Lot 45
NYSDEC BCP Site Number: C241194

May 2023

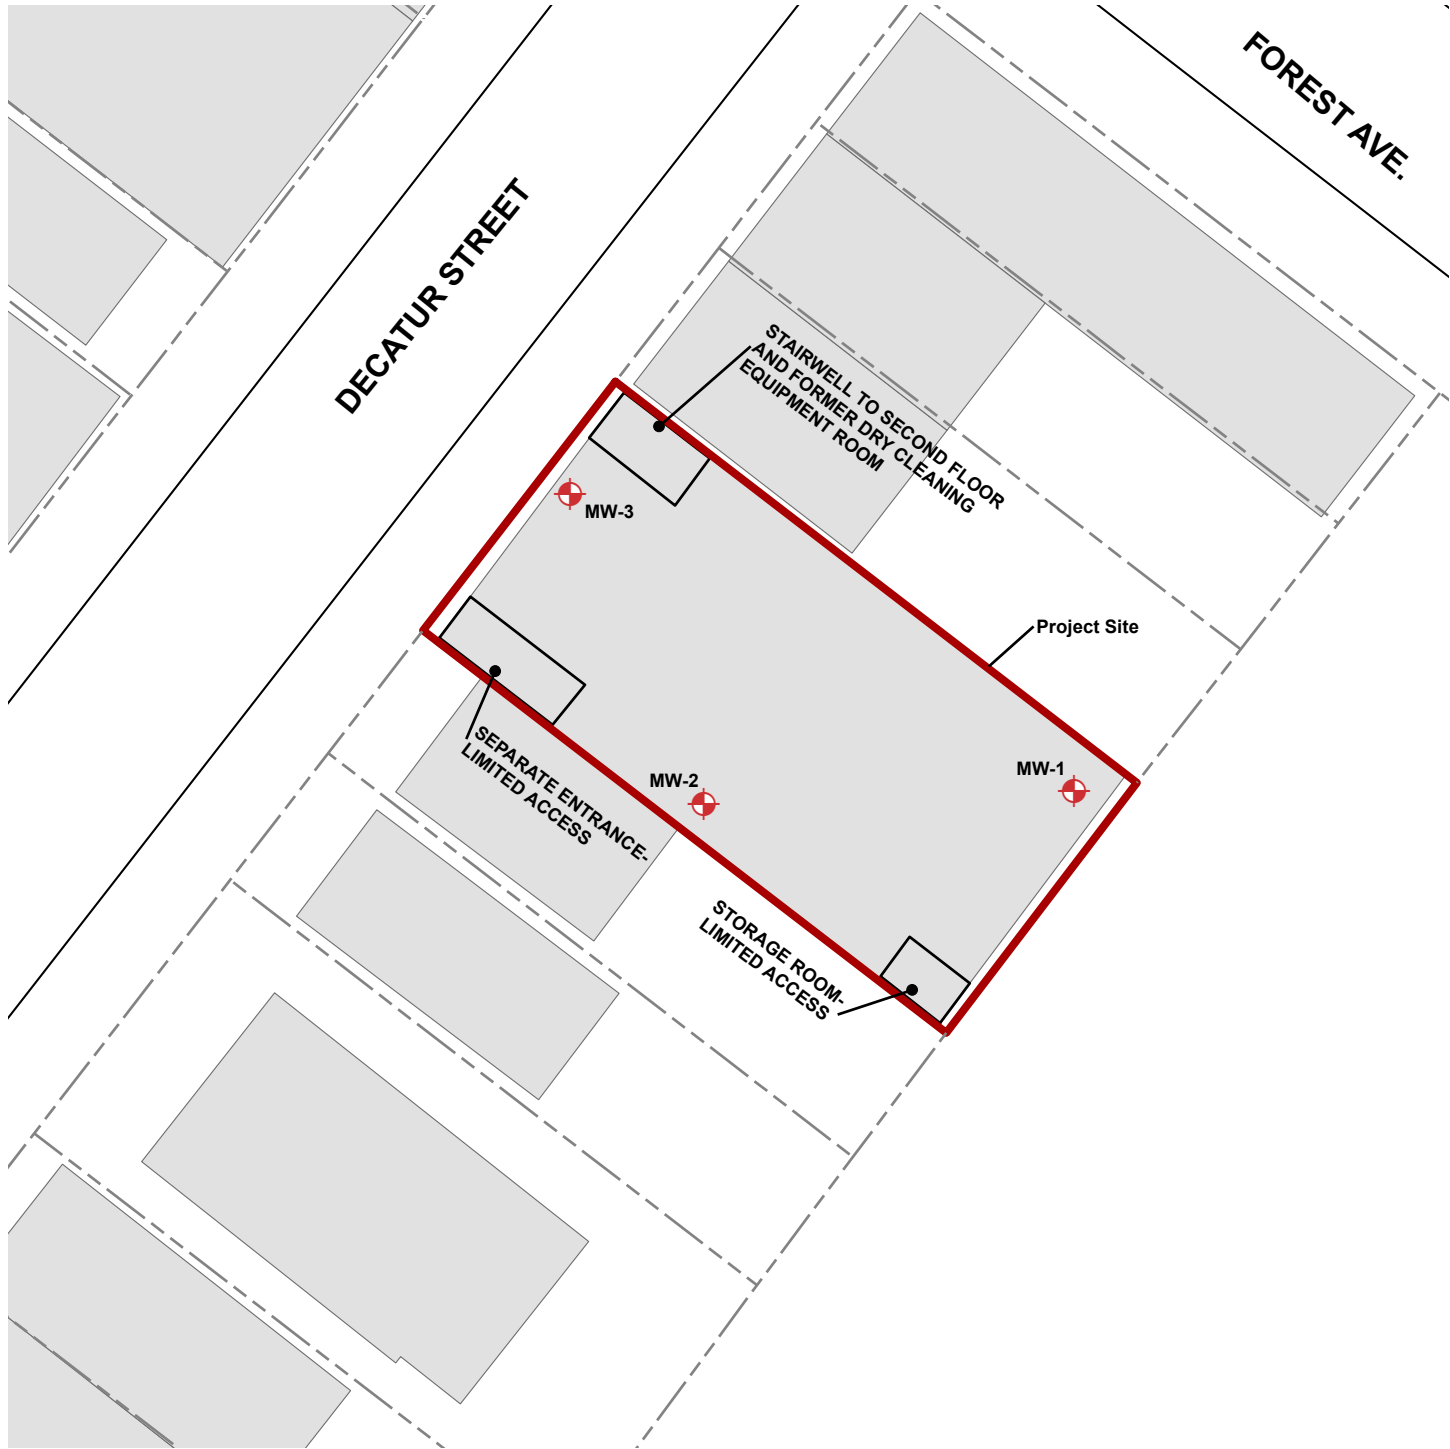
Drawing No
Figure 3

The depth to groundwater is approximately 67 feet below grade surface. Groundwater monitoring wells are shown on Figure 3. Based on the well survey, the groundwater flow is generally to the south, and is shown on Figure 4.
