18-46 Decatur Street

Remedial Investigation Work Plan

18-46 Decatur Street, Ridgewood, Queens, New York
Block 3579, Lot 45
BCP Site #C241194

February 2017

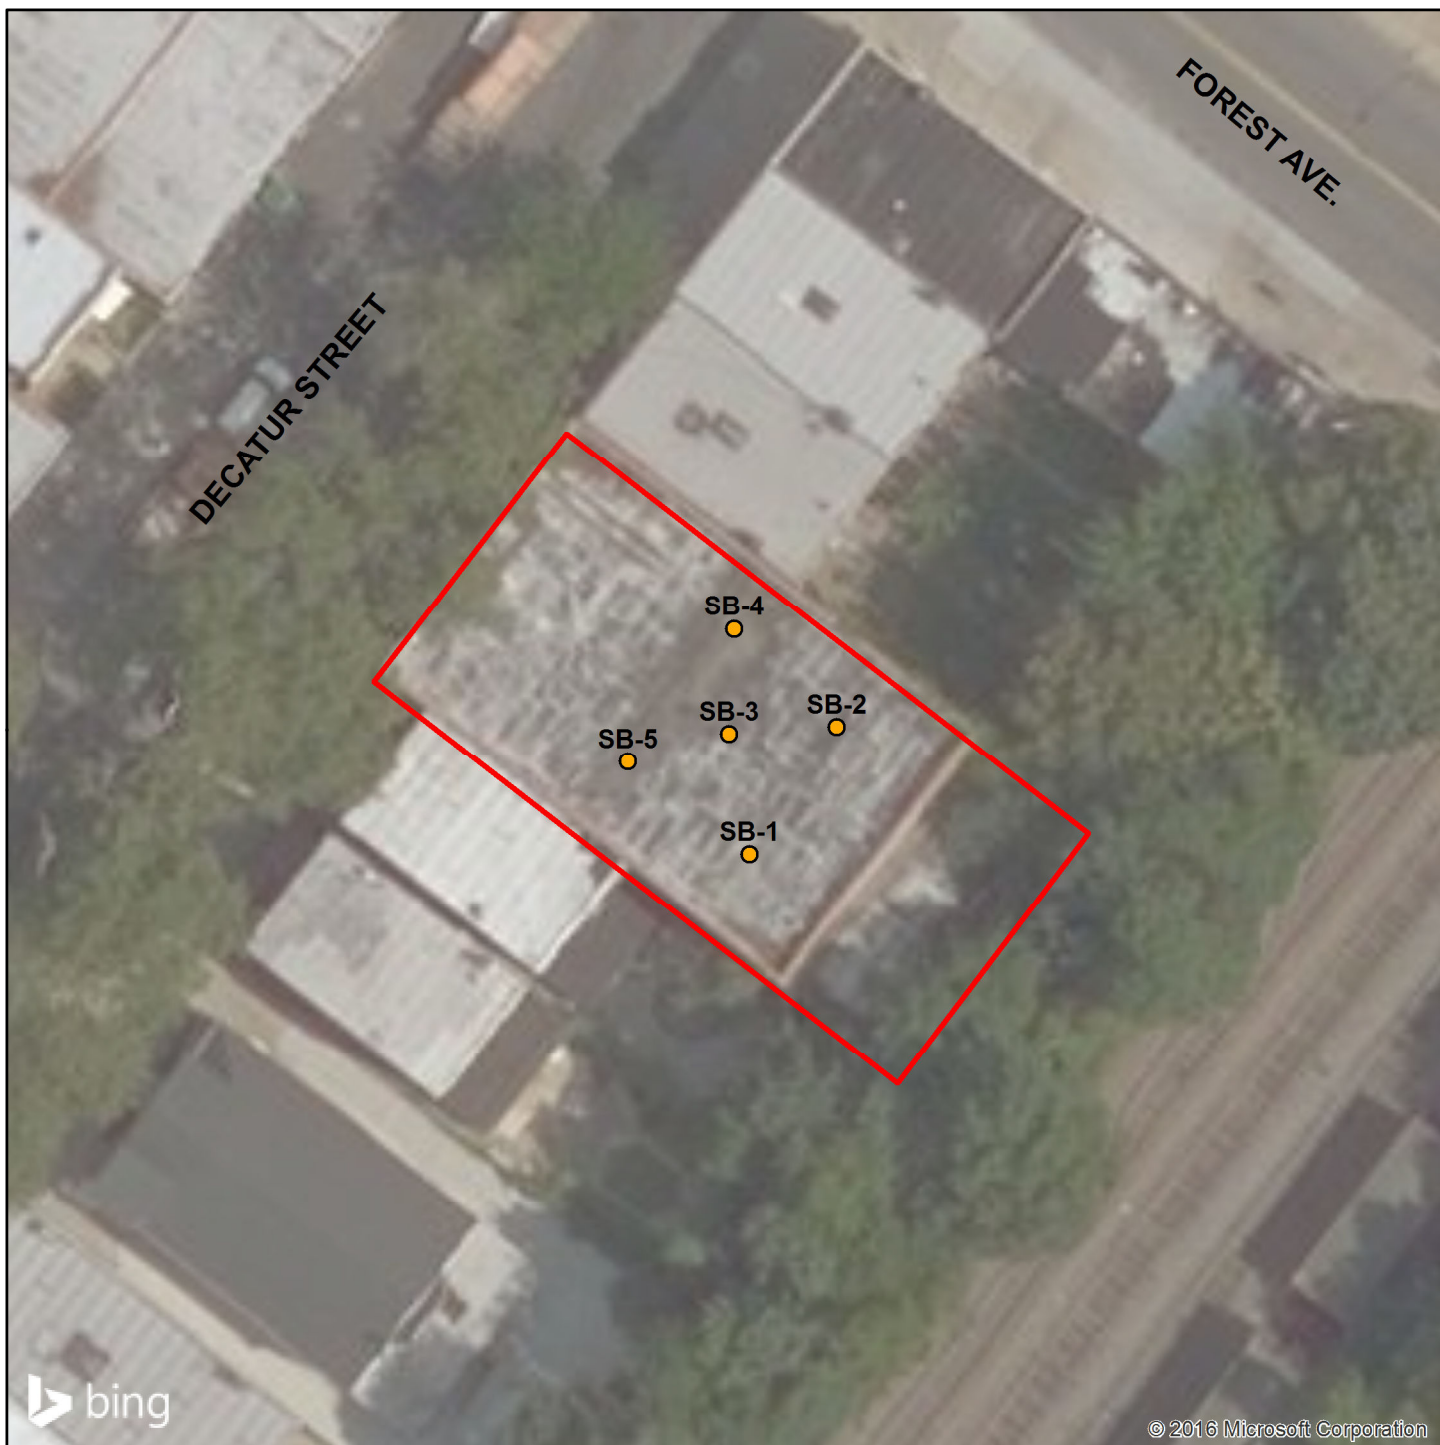
- Soil & Soil Vapor Sample Locations
- Site Boundary

Five soil borings were completed to refusal in the central area of the Site, as shown on Figure 3. Each boring was field-screened for organic vapors using a photoionization detector (PID). No visual or olfactory evidence of contamination was observed in the soil samples. PID readings ranged from 3.1 to 4.9 parts per million (ppm). Two soil samples were collected from each boring and were analyzed for volatile organic compounds (VOCs) by EPA Method 8260.

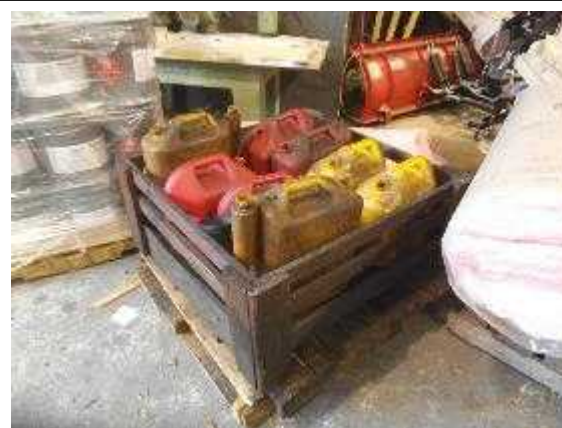
5. View of onsite minor amounts of gasoline storage.

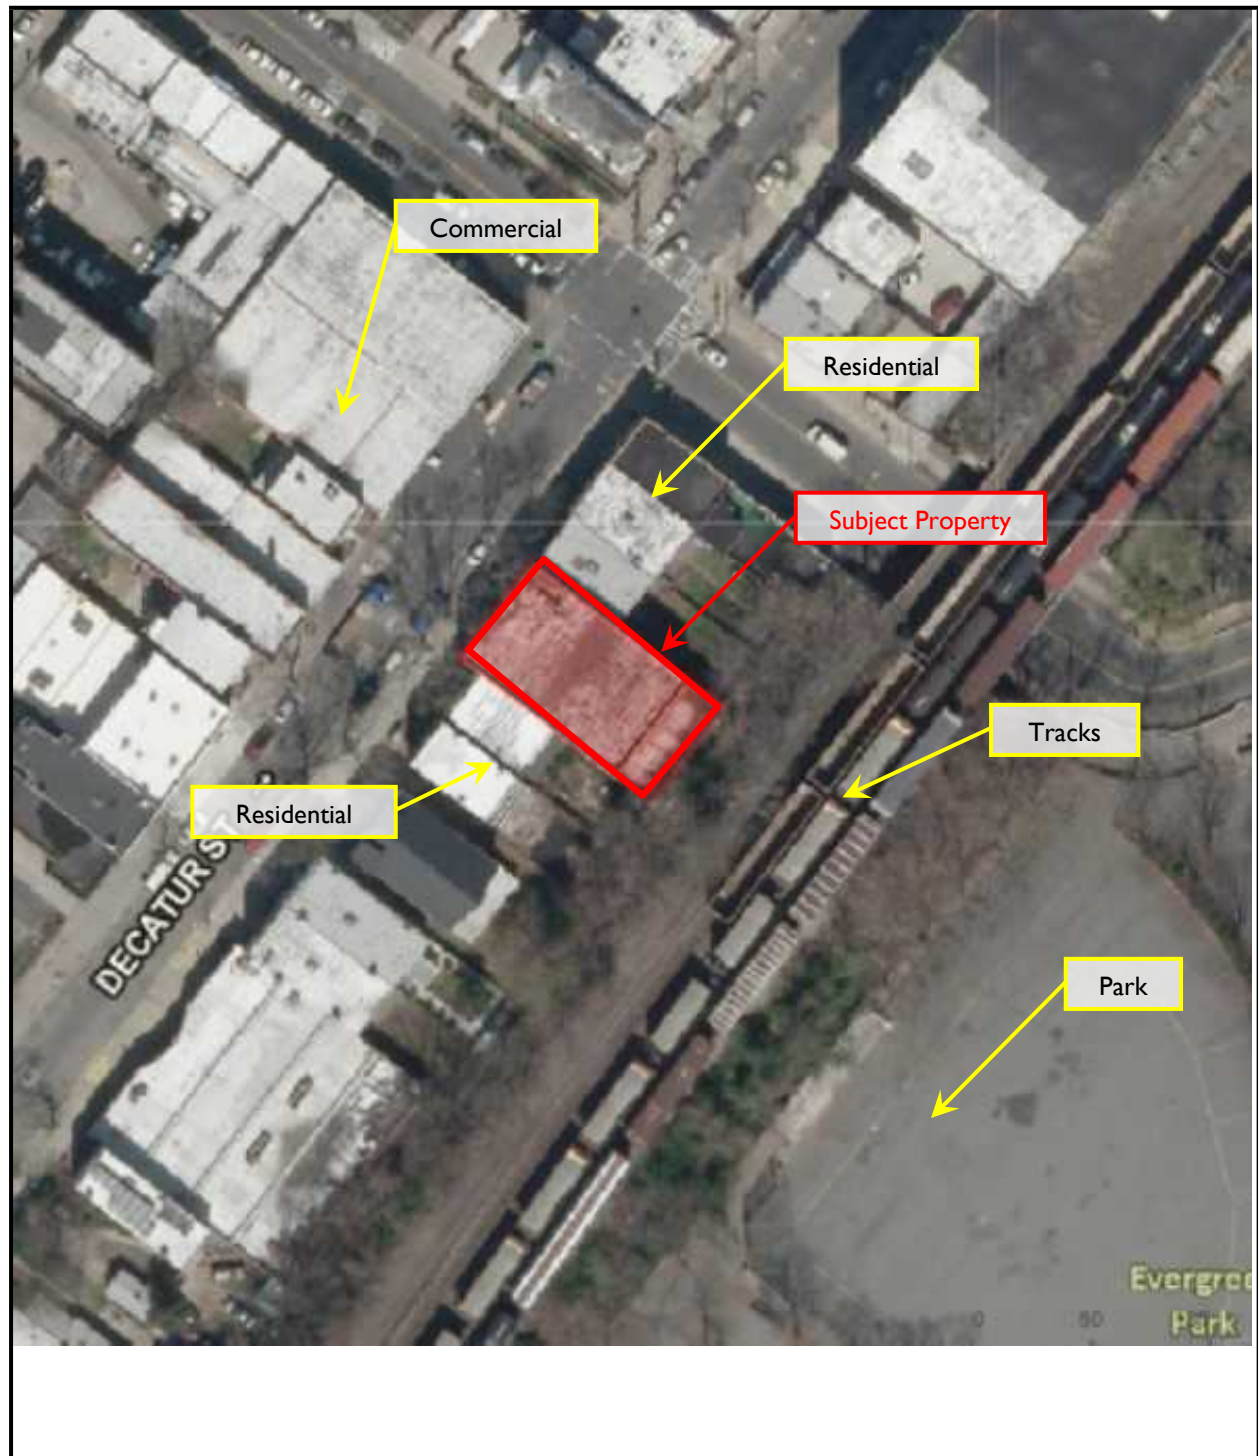
FIGURE 3 – SITE PLAN

The Subject Property is located at 1846 Decatur Street in Queens, New York. The Subject Property includes one rectangular-shaped parcel, identified by the New York City Department of Finance Office as Block 3579 Lot 45 totaling approximately 0.11 acres. The Subject Property is located approximately 100 feet south of the intersection of Decatur Street and Forest Avenue. Figure 1 - Location Map depicts the location of the Subject Property on a street map of Queens, New York. Figure 2 - Locus Map depicts the location of the Subject Property on the Brooklyn, NY United States Geological Survey (USGS) 7.5 Minute Topographic Quadrangle. Figure 3 - Site Plan depicts the configuration of the Subject Property and adjoining properties.
