DAILY STATUS REPORT

NYSDEC BCP Project No.:	C241199	NYCOER Project No.:	17CVCP044Q	Date:	6/26/2023
Project Name:	148-28 Hillside Avenue

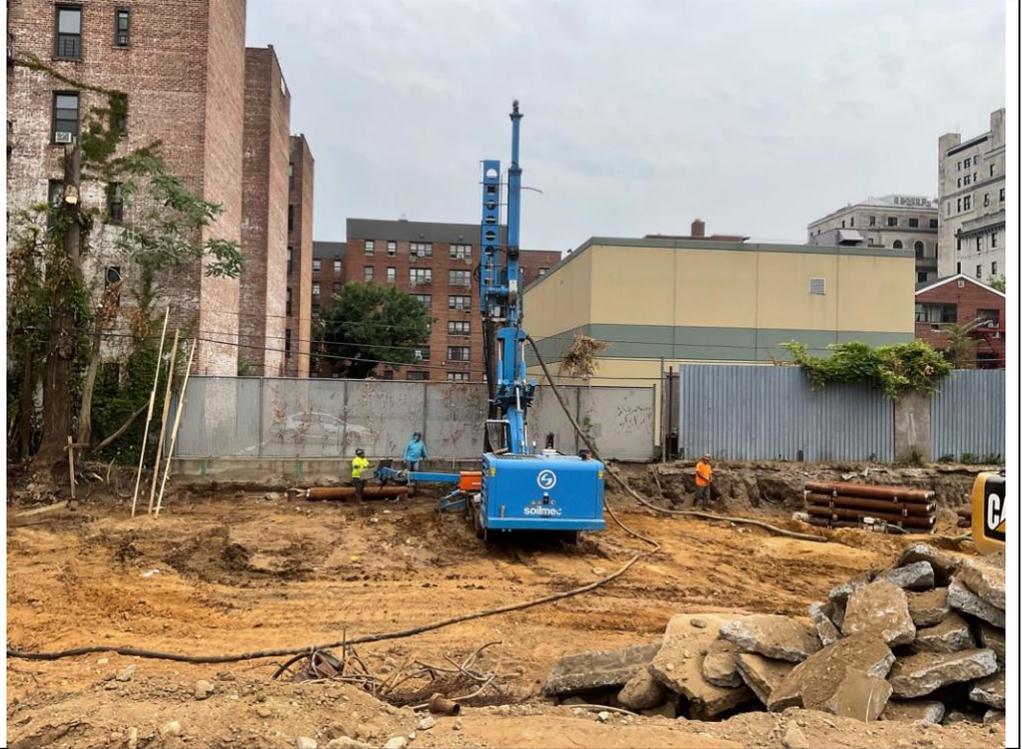
Photo 1 – Installing shoring piles along the southern perimeter, in C4 and D4.

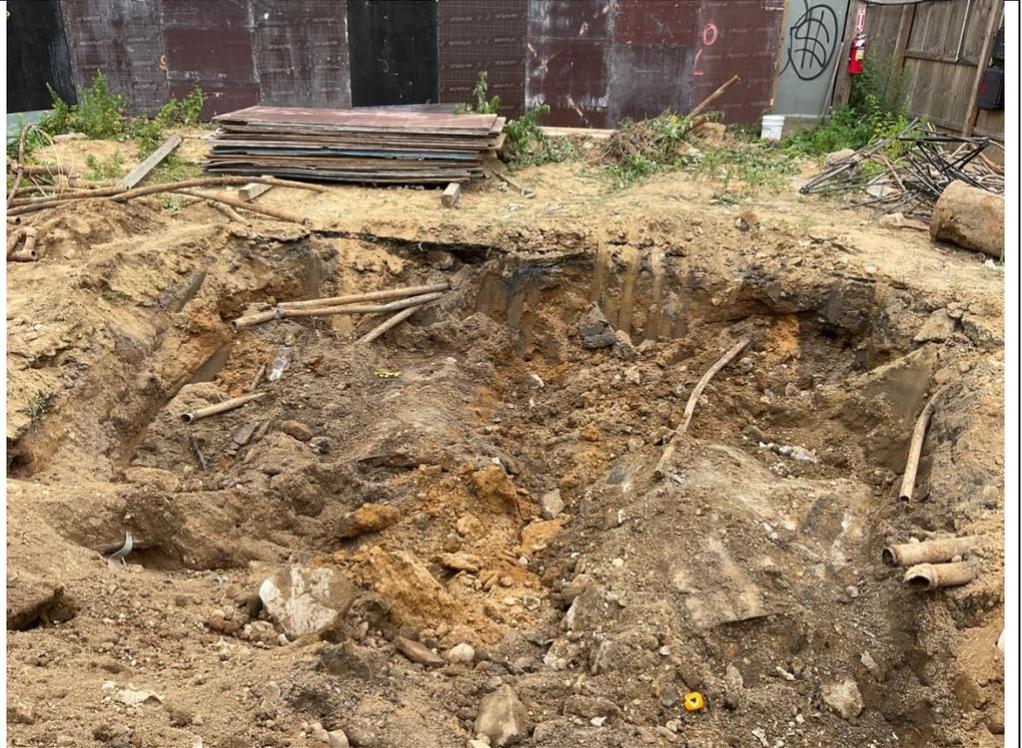
Photo 2 – Two USTs exposed in the NW portion of the site, in site grid map A1 and B1. The USTs were covered with concrete.

- A total of two USTs were exposed in the excavation area. The tanks had a concrete cover. The top of tanks is about 3ft below the ground surface. The length of the tanks is 5ft.

- A short spike and max PID reading of 11.88 ppm was noted in the UST excavation area (B1).
- No oil spill was observed in the vicinity of the tanks. The maximum PID readings in the vicinity was 11.88 ppm for a few seconds when excavating in B1. The average PID reading in the vicinity air is <1.0 ppm.

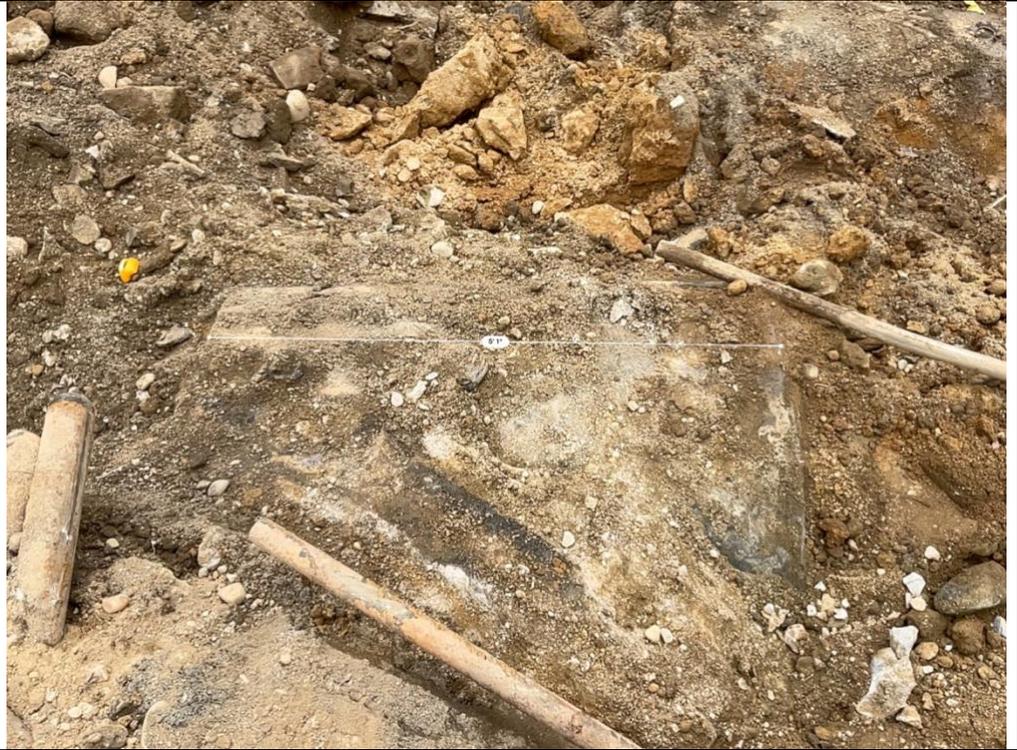
Photo 3- The length of UST 5 ft.

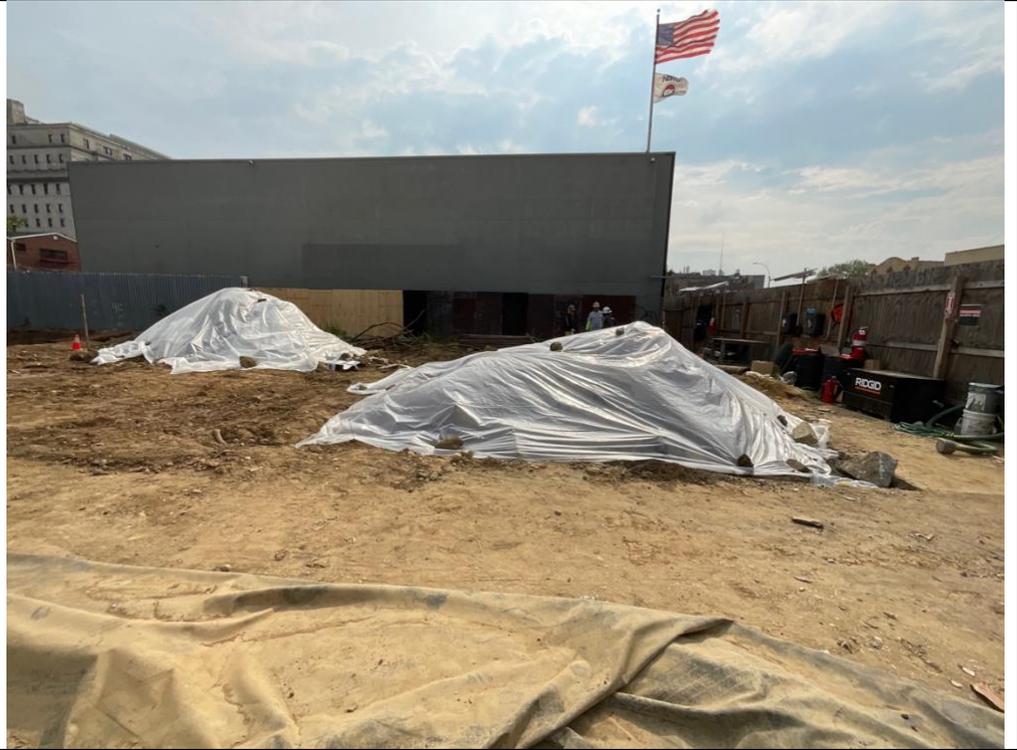
Photo 4 – Soil excavated from the UST area was stockpiled and covered with plastic sheets.

- The soil from the excavation was stockpiled and covered with a plastic sheet.
- ACT representative left the site around 4:15pm.

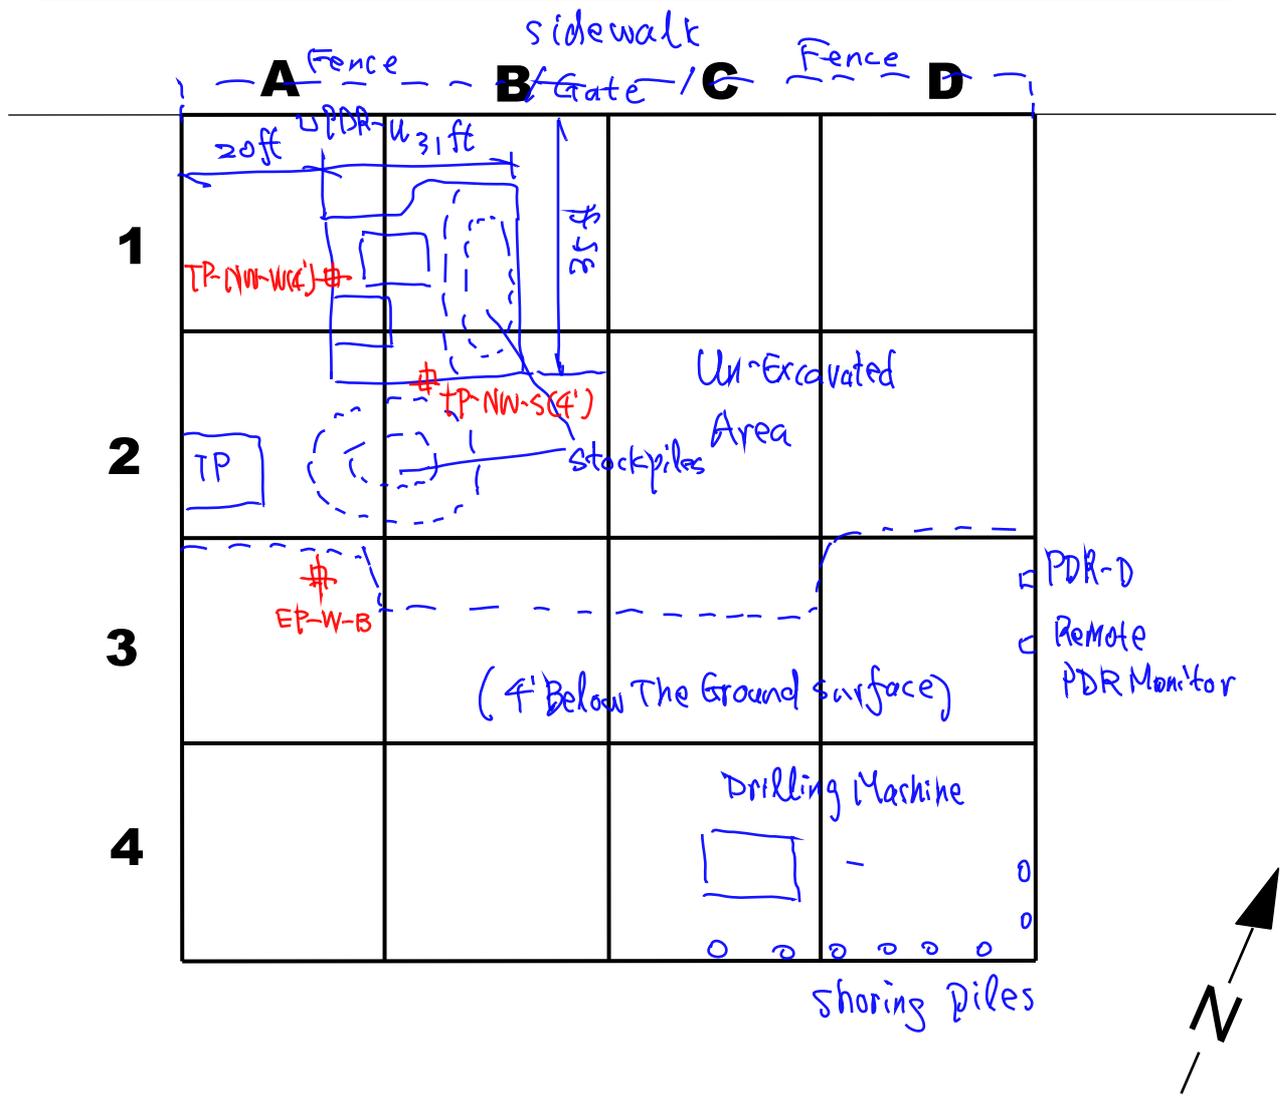
Soil sampling Location

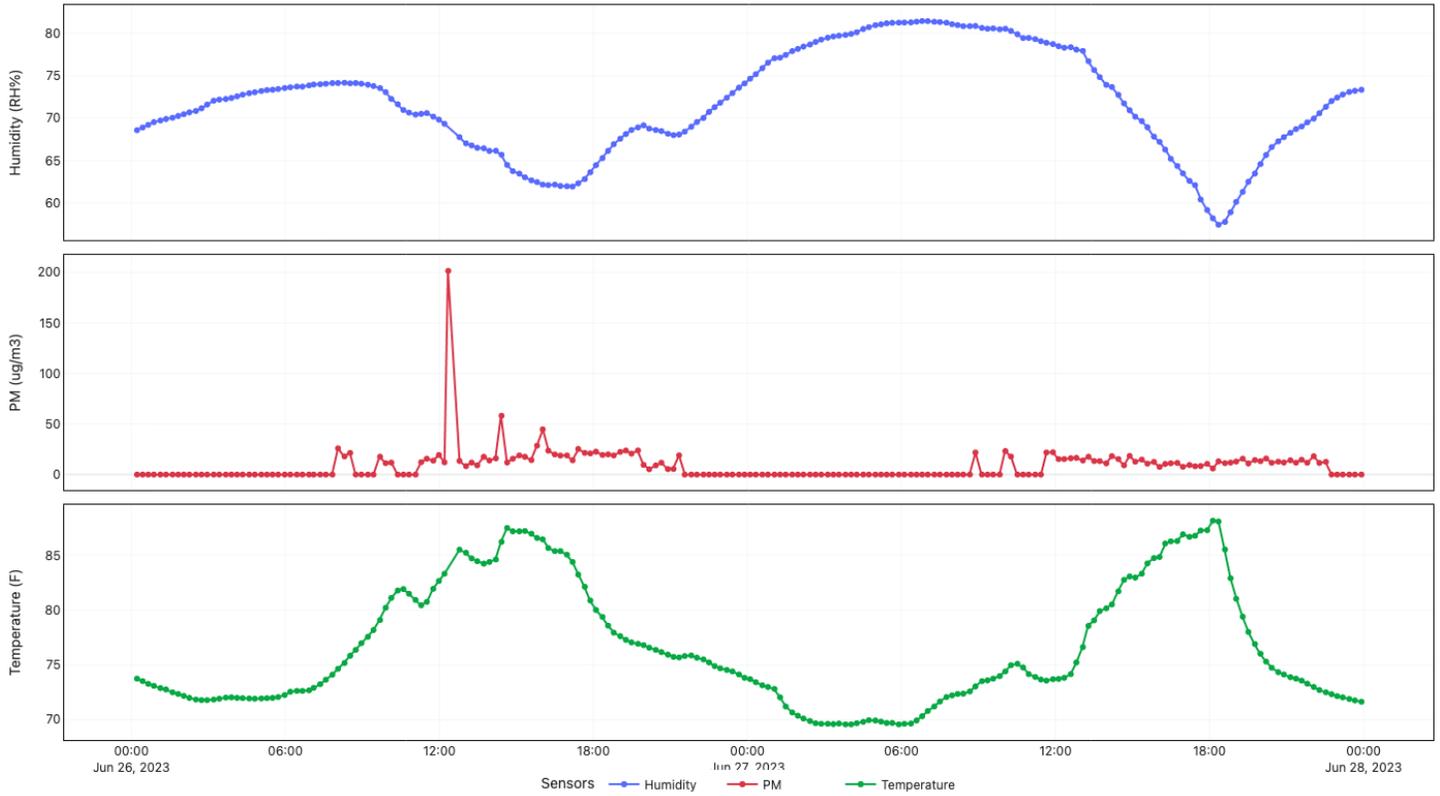
Attachment 1.

Graph of the Permanent Downwind CAMP station readings

Graph of C241199-148-28 Hillside
Between 2023-06-26 and 2023-06-27

- A short spike and max dust reading of 202 µg/m³ was noted in the permanent downwind dust monitor at 12:20 PM when the concrete cover for the USTs was removed. The dust concentration reduced to 103 µg/m³ by 12:30 and 23 ug/m³ by 12:45 pm.
