147-25 94TH AVENUE
QUEENS, NEW YORK

Remedial Action Work Plan

AKRF Project Number: 170340
NYSDEC BCP Site Number: C241206
OER Project Number: 18TMP0247Q
E-Designation: E-175

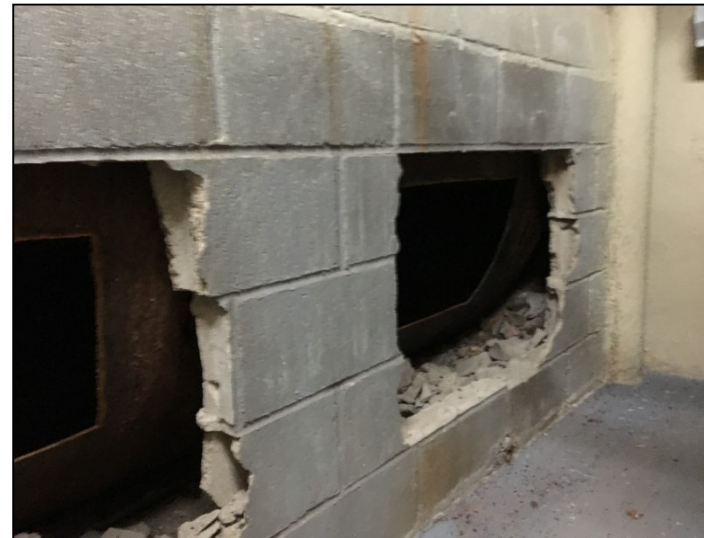
Photograph 4: View of the concrete vault for abandoned in-place AST.

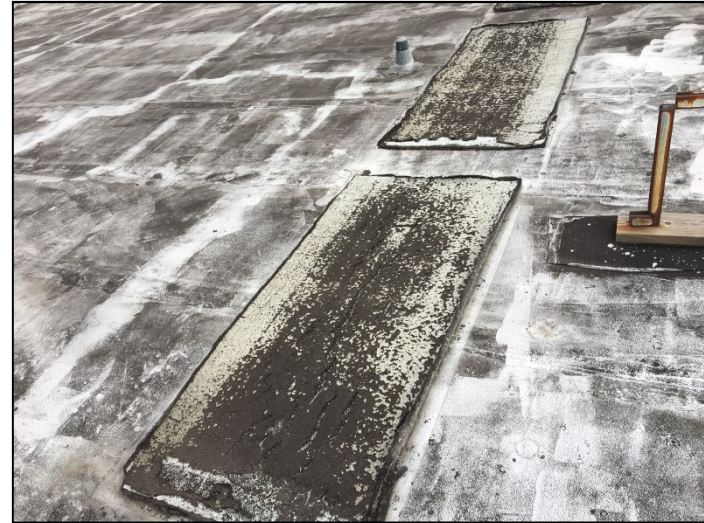
Photograph 10: Repair patches from former roof repairs.

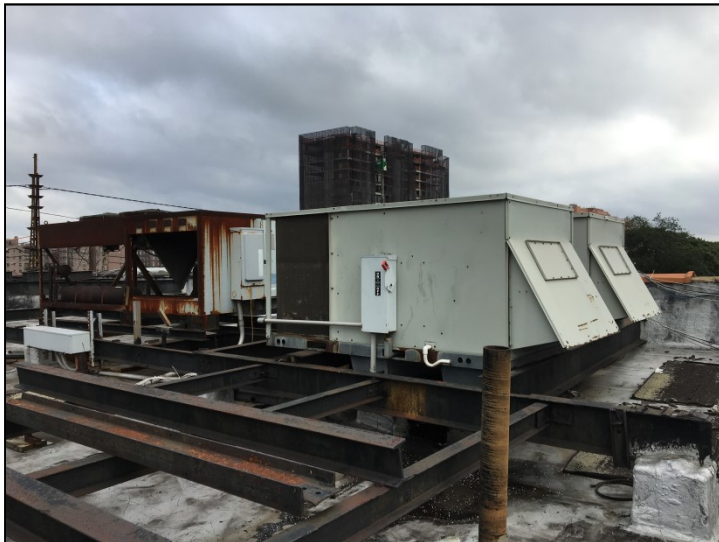
Photograph 11: Roof mounted HVAC system.

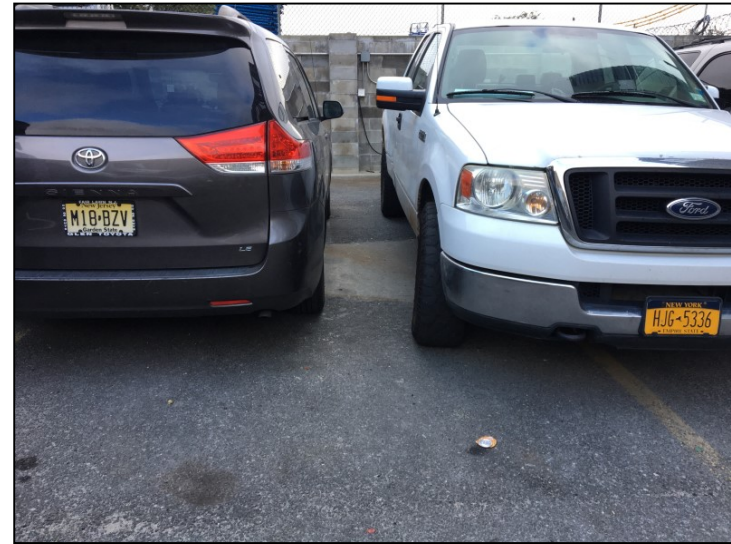
Photograph 14: Concrete patch beneath the cars in eastern parking area.
