REMEDIAL INVESTIGATION REPORT

BEACH 21ST STREET DEVELOPMENT 10-47 Beach 21st Street Far Rockaway, Queens, New York Block 15705, Lot 69

June 19, 2019

Langan Project No. 170540601

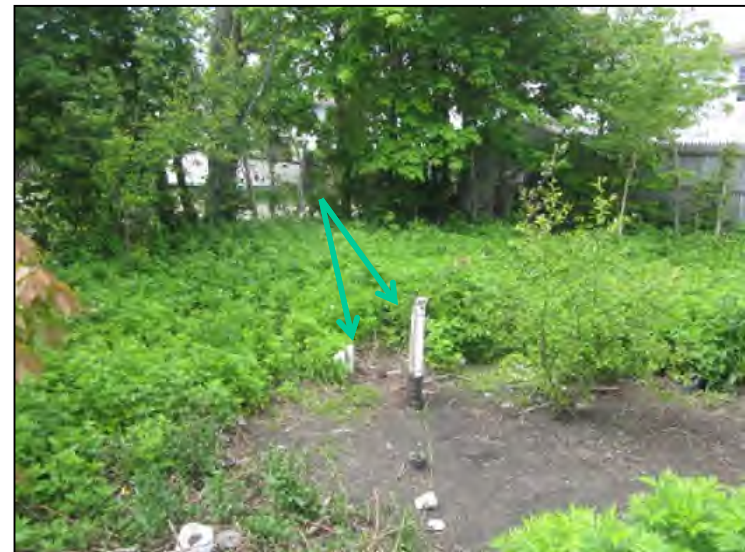
Photograph 4. A grassy patch in the southwestern corner of the Property, with monitoring wells for a permeable pavement pilot test.

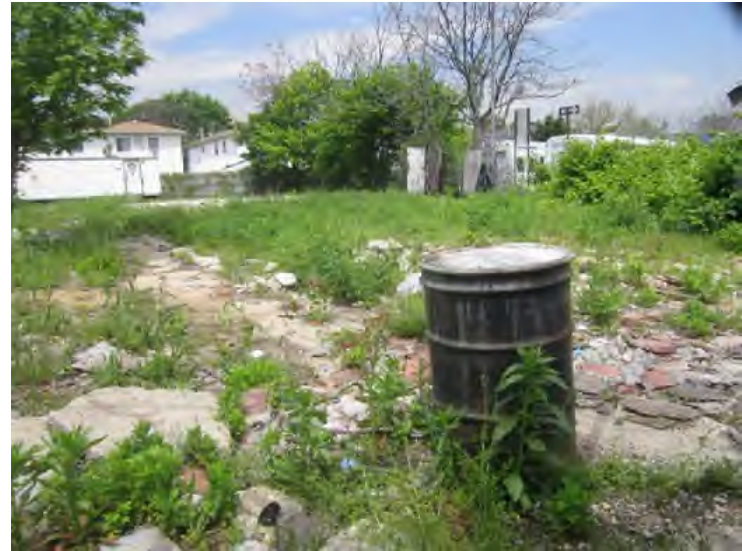
Photograph 5. A vacant lot south-adjacent to the Property, view west from Beach 21st Street.

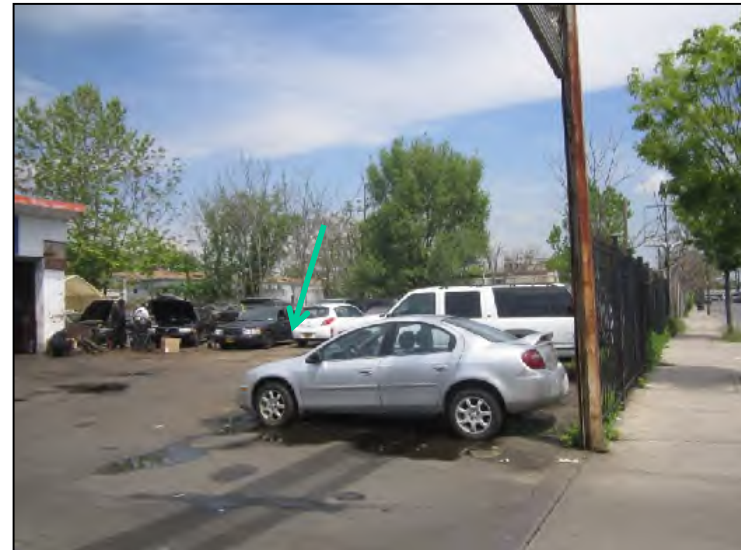
Photograph 8. A parking and repair area adjacent to the auto repair shop. Note that the northern portion (marked with an arrow) is unpaved.

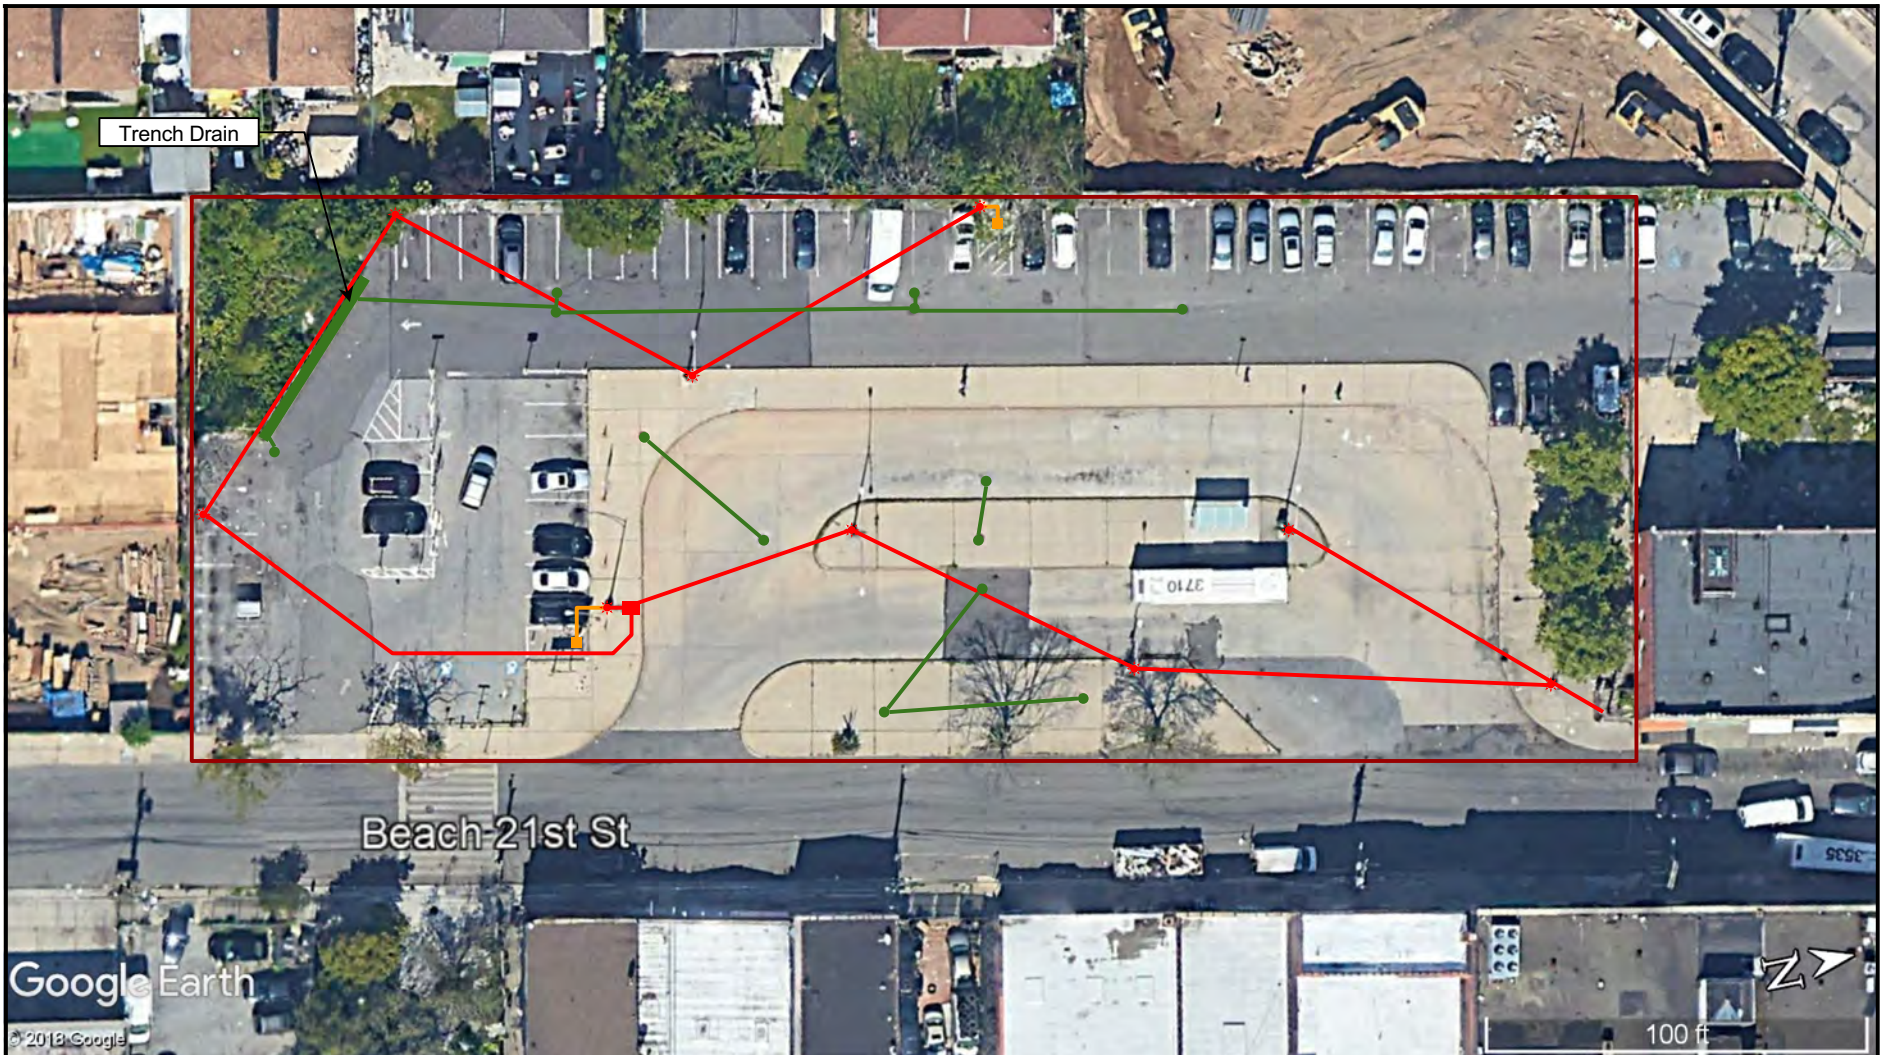
<p style="text-align: center;">NOVA Geophysical Services</p> <p style="text-align: center;">Subsurface Mapping Solutions 56-01 Marathon Parkway, # 765 Douglaston, New York 11362 Phone (347) 556-7787 * Fax (718) 261-1527 www.nova-gsi.com</p>	SURVEY PLAN	LEGEND	
	<p>SITE: OER Jump Start Site 10-73 Beach 21st Street, Far Rockaway, New York 11691</p> <p>CLIENT: Langan</p> <p>DATE: December 12th, 2018</p> <p>AUTH: Chris Steinley</p>	<p> Survey Area</p> <p>—●— Drainage</p> <p>— Electric</p> <p>— Communications</p>	<p>★ Overhead Light</p> <p>■ Parking Meter</p>
