**FOCUSED SUBSURFACE SITE INVESTIGATION (FSSI)**

**161-01/11 29TH AVENUE  
AKA 161-01/11 BAYSIDE LANE  
FLUSHING, QUEENS, NEW YORK 11358**

**MECC PROJECT NO. M18982A**

**MERRITT ENVIRONMENTAL CONSULTING CORP.**

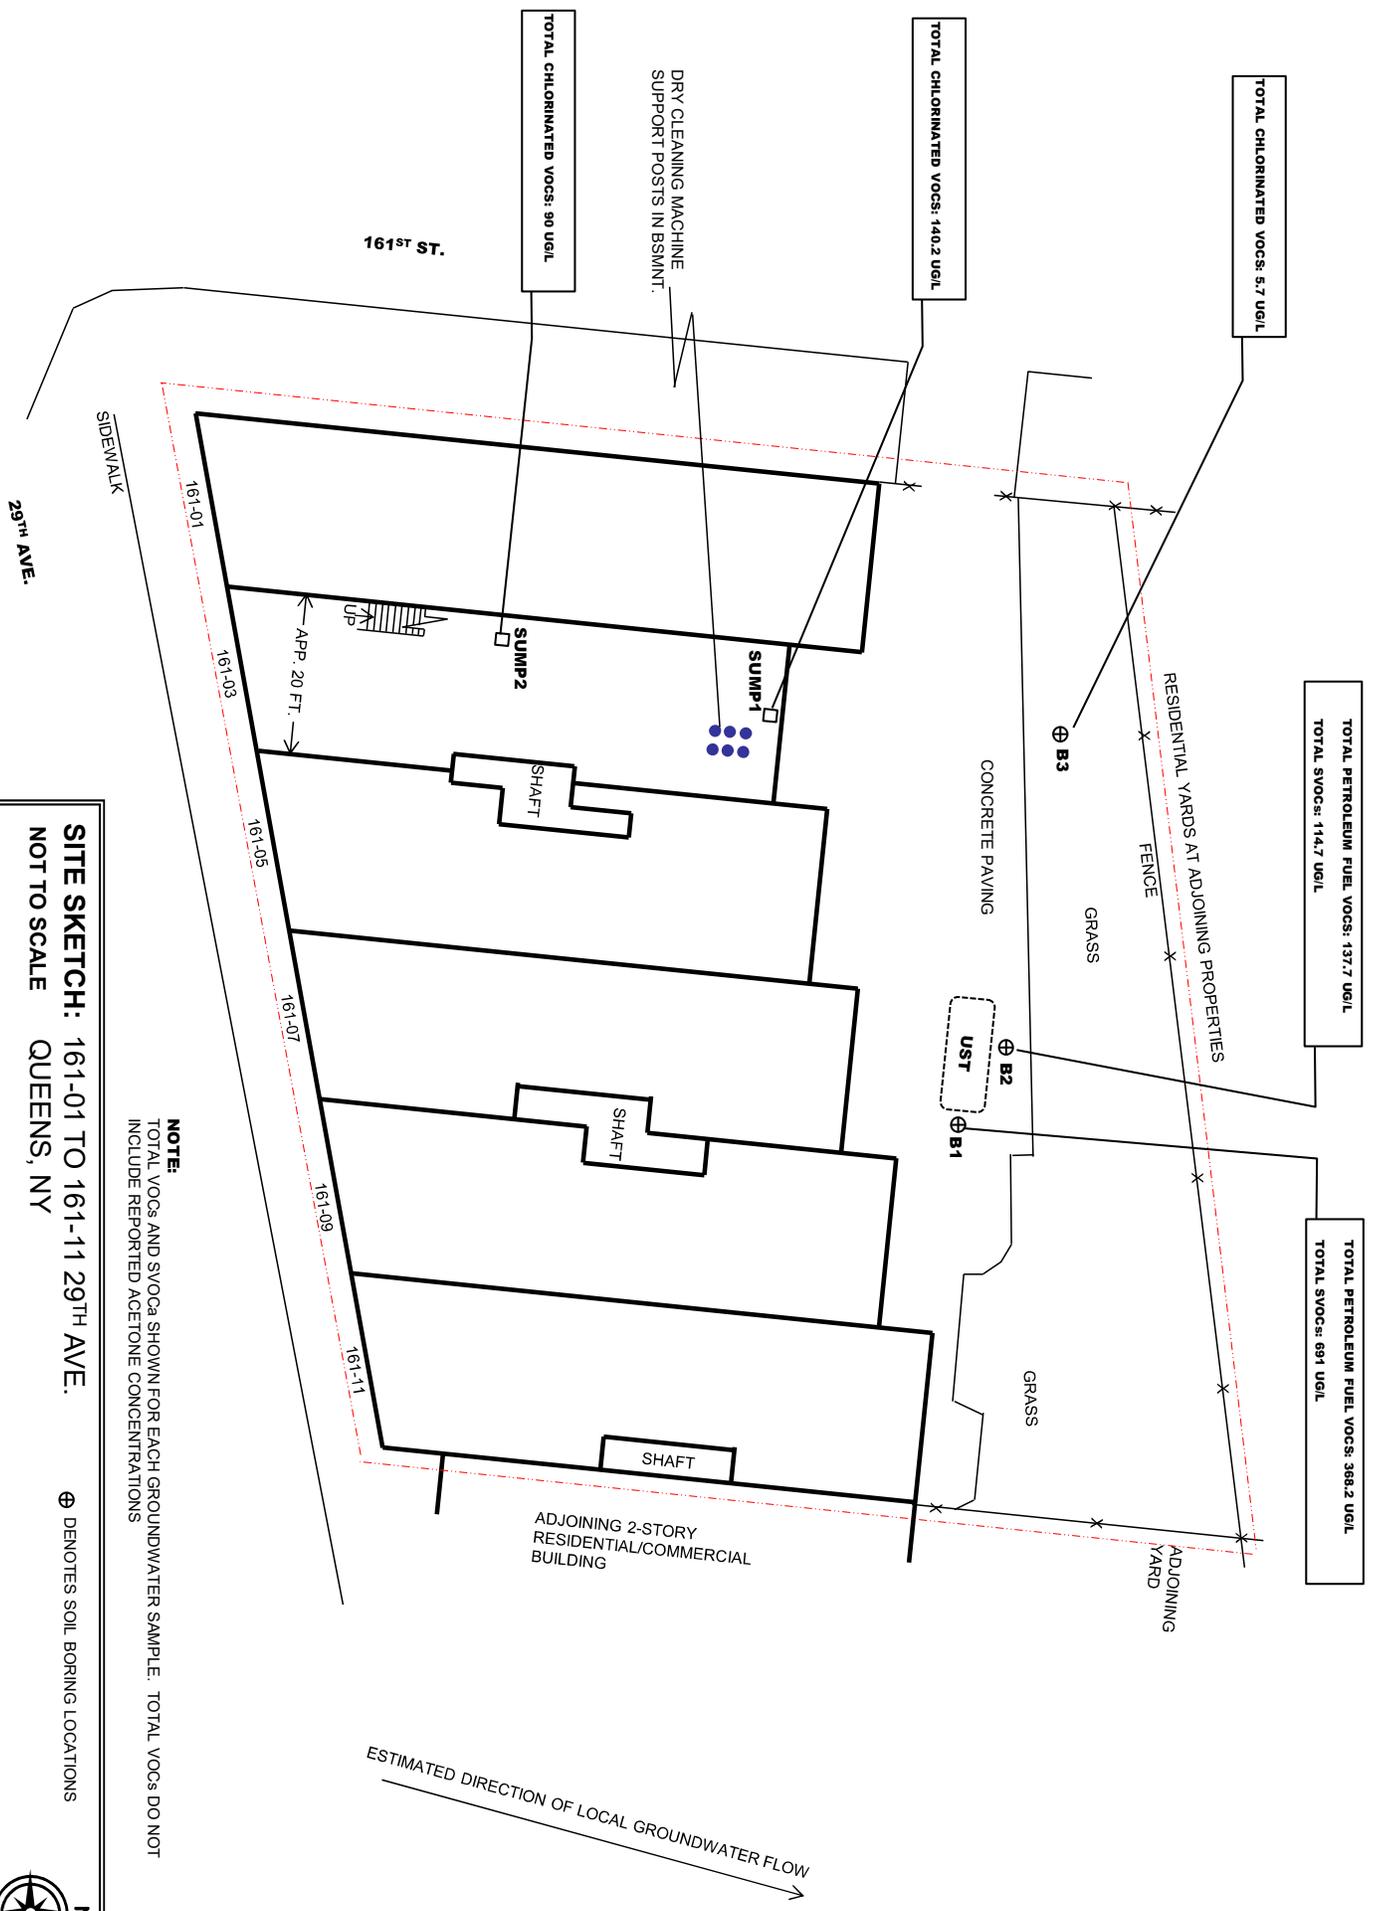
**SITE SKETCH: 161-01 TO 161-11 29<sup>TH</sup> AVE.**

**NOTE:**  
 TOTAL VOCs AND SVOCs SHOWN FOR EACH GROUNDWATER SAMPLE. TOTAL VOCs DO NOT  
 INCLUDE REPORTED ACETONE CONCENTRATIONS

⊕ DENOTES SOIL BORING LOCATIONS

PATTERNED LINES ENCLOSE THE SITE

INTERIOR DETAILS ARE APPROXIMATE AND BASED ON OBSERVATIONS ONLY

All field activities were conducted on December 12, 2019. A qualified contractor was retained to first conduct a ground-penetrating radar (GPR) survey of the rear yard at the Site. The GPR survey confirmed the location of the closed in-place heating oil UST. Please refer to the attached Site Sketch for the locations of the historical UST location. Based on the reported dimensions of the subsurface anomaly, MECC believes that the volume of the UST may be as great as 2,000 gallons.

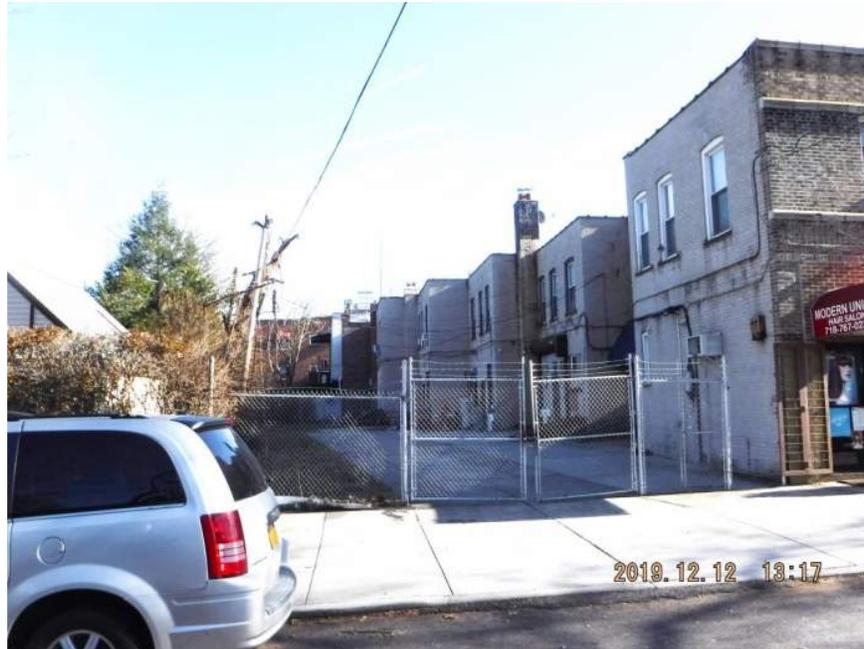
**Photograph 1:** General view of the rear Site yard looking east from 161<sup>st</sup> Street. Site buildings at right.

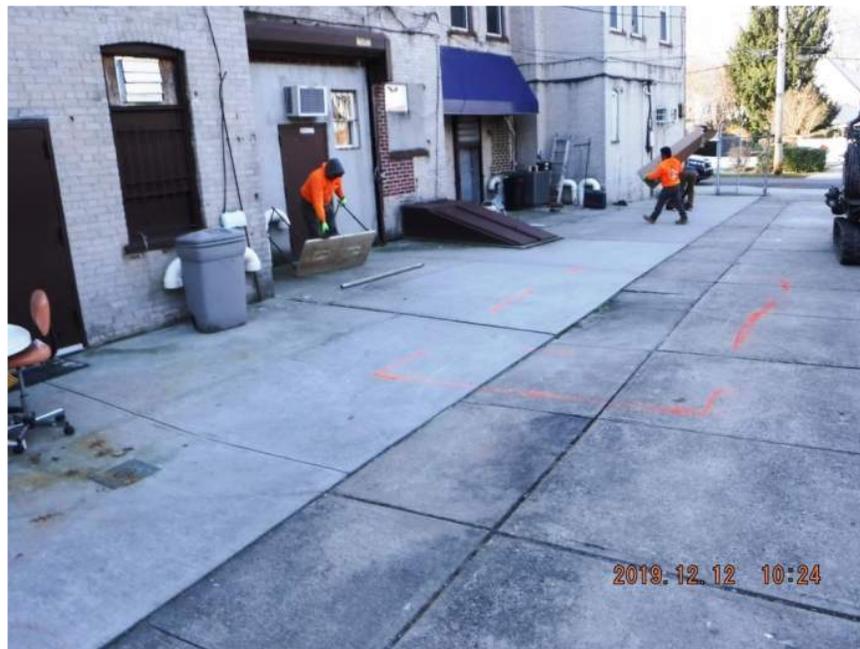
**Photograph 2:** Outline of the UST in red spray paint as established by the GPR survey. Photographer facing west.

Laboratory analysis of the two groundwater samples collected from B1 and B2 show that an actionable petroleum release has occurred at the Site heating oil UST. Although MECC concludes that the extent and severity of this release is likely limited to the immediate vicinity of the UST, this finding requires regulatory reporting and corrective action. It is recommended that the UST be removed along with any soil containing petroleum contamination which is the presumed source of the discovered groundwater contamination.

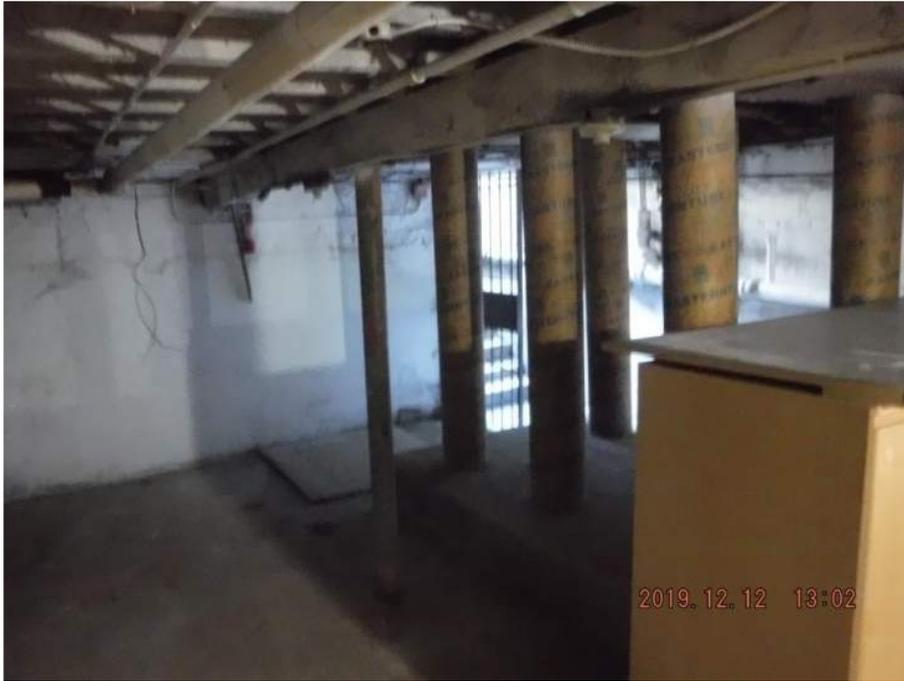
**Photograph 3:** View of Sump1 in the basement of 161-03 29<sup>th</sup> Avenue (sump is under plywood cover at background). Support posts for former dry cleaning machine visible at right.

Laboratory analysis of the groundwater samples identifies PCE at elevated concentrations in both of the interior sump samples. Trichloroethene (TCE) and cis-1,2-dichloroethene (cis-1,2-DCE) were also detected in both sump samples at concentrations exceeding the applicable regulatory limit (TCE and cis-1,2-DCE are PCE degradation products).

Based on the data gathered by this study, MECC believes that the lateral extent of chlorinated VOC contamination caused by the former dry cleaner is limited and moderate in severity. However, the contaminant concentrations are great enough to warrant a recommendation to notify regulators and to conduct further investigation to better establish the horizontal and vertical extent of groundwater impact, and to determine if a vapor intrusion condition exists inside the building.

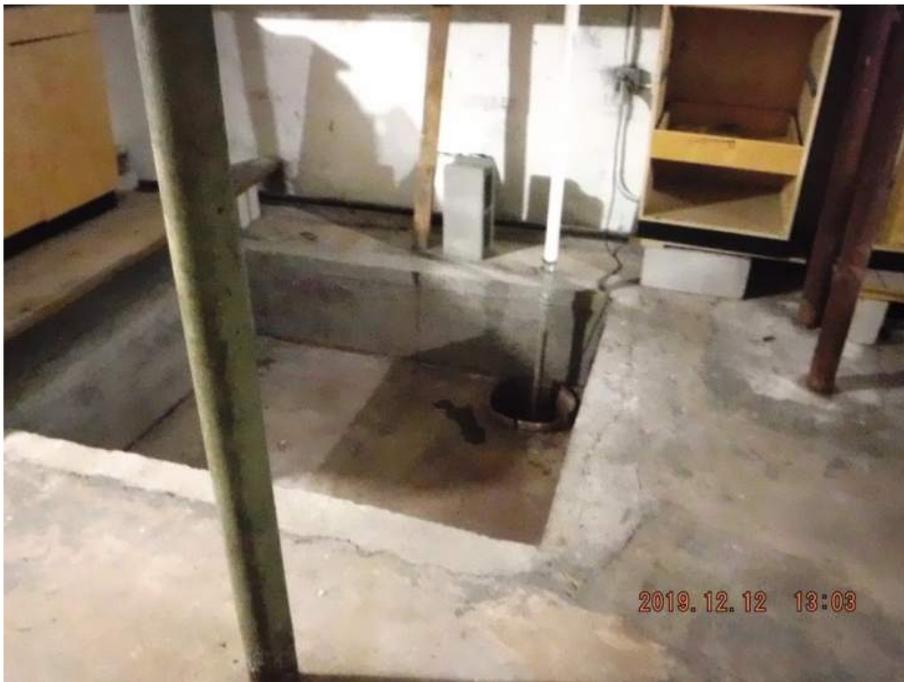
**Photograph 4:** Sump2 in the basement of 161-03 29<sup>th</sup> Avenue.

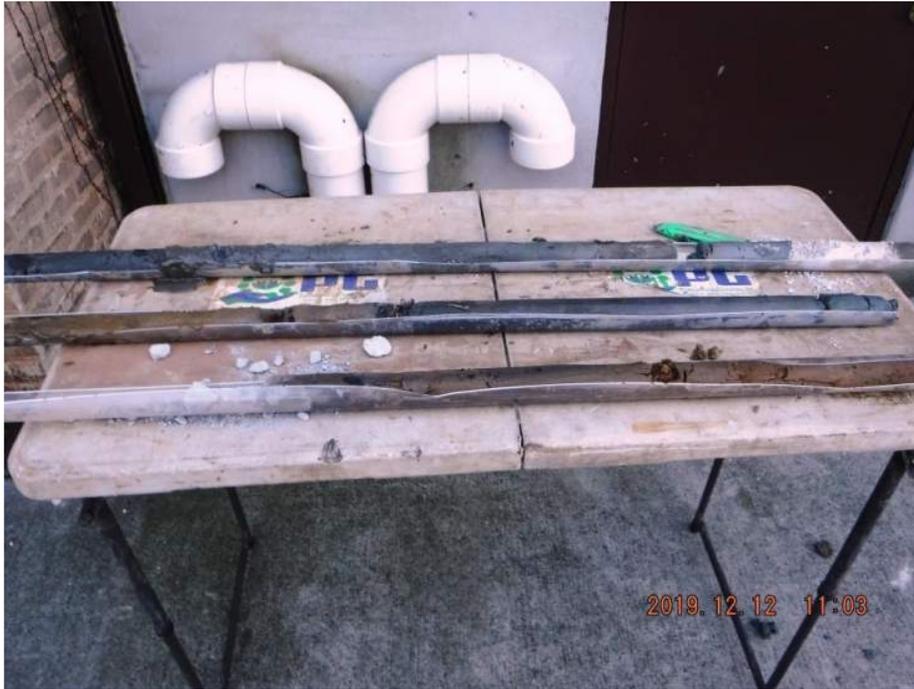
**Photograph 5:** Soil samples collected from B1. Discoloration by petroleum is evident (grey-colored material).

Soil samples were continuously subjected to field screening techniques as B1 through B3 were drilled. The field screening techniques consisted of using a portable photoionization detector (PID) for measuring volatile organic vapors and assessing each soil sample for physical evidence of contamination. Field screening activities were conducted to boring termination at 15 feet bgs. PID readings in soil ranged from undetect to up to 100 parts per million (ppm) in B1 in clay and sand below the first water-bearing deposit at five feet to seven feet bgs. In addition, physical evidence of petroleum contamination was observed in soil and groundwater at both B1 and B2. No free-phase product was observed on water extracted from B1 and B2, although a heavy petroleum sheen and strong petroleum odors were identified. B3 was installed north of the dry cleaner tenant space, at some distance from the UST. No field evidence of soil or groundwater contamination as identified in this boring.

Aside from acetone, all detected VOCs in B1GW and B2GW are constituents of petroleum-related fuels. Naphthalene, which was detected in both B1GW and B2GW, is a common constituent of heavier petroleum fuels such as heating oil.
