Daily Activity Report

Magnolia Gardens
39-03 College Point Boulevard, Queens, NY
BCP Site No. C241273

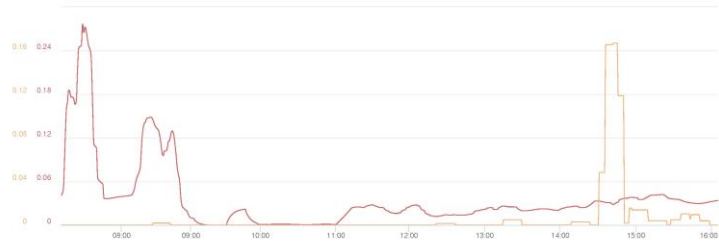
Downwind CAMP Station Data

CAMP Response Actions: Elevated particulate readings were recorded at the Downwind CAMP station between approximately 7:31 AM and 8:23 AM. The elevated readings were caused by welding work being conducted in close vicinity to the CAMP station. The station was moved away from the welding work and the levels went back to normal. The exceedance was not related to site soil/intrusive work and no other corrective measures were required.

Tue, 9th of Apr 2024, 0:00:00 – 17:42:44
(GMT-05:00) Eastern Time (US & Canada)

Mass Conc. Total mg/m³ AVG 15m
mg/m³
DustTrak-8530
85301015

MIN	AVG	MAX
0	0.036	0.2765

VOC ppm AVG 15m ppm
minRAE 3000
85301015

MIN	AVG	MAX
0	0	0.1669

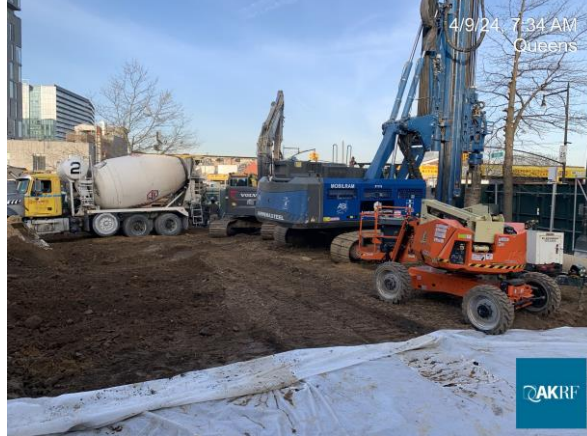
Photograph 1 -
Grouting soldier piles
in Grid WC-6, view
facing west.

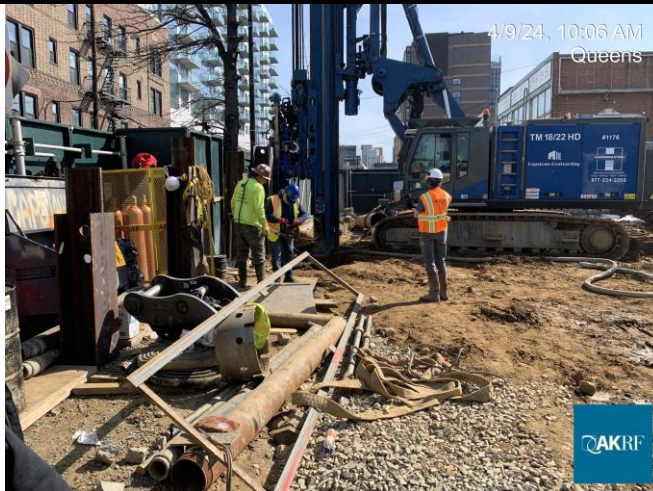
Photograph 2-
Drilling soldier piles in
Grid WC-6, view
facing east.

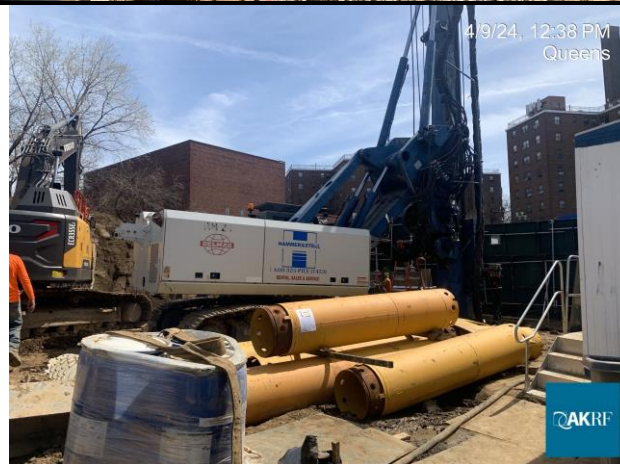
Photograph 3-
Drill assembly in Grid
WC-4, view facing
southeast.
