Daily Activity Report

Magnolia Gardens
39-03 College Point Boulevard, Queens, NY
BCP Site No. C241273

Date:	Tuesday, May 21, 2024
Weather:	55-75°F, Sunny
Wind Direction/Speed (towards):	SW @ 5 mph
AKRF Personnel on Site:	Madelyn Fleming
AKRF Equipment on Site:	Mini RAE 3000 Photoionization Detectors [(PID) x3] and DustTrak Aerosol Monitors (x3)
Visitors:	None

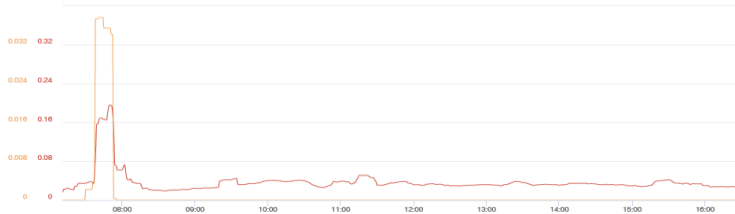
Downwind CAMP Station Data

Mass Conc. Total mg/m³ AVG 15m
mg/m³
DustTrak-8530
#823203

MIN	AVG	MAX
0.017	0.0371	0.1957

VOC ppm AVG 15m ppm
miniRAE 3000
#823204

MIN	AVG	MAX
0	0	0.0376

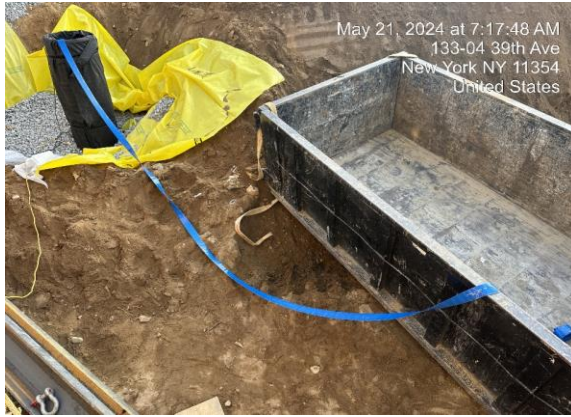
Photograph 1 - Completed wash water collection system prior to trucking in Grid WC-2.

Prior to trucking, a collection/weir tank was imported to the site and installed in the northwestern portion of the Site to complete the trucking pad installation. Trucking commenced following the weir tank installation. Most of the trucks remained on the trucking pad and tires did not come in contact with site soil. A couple of truck tires needed to be washed and the wash water was collected in the collection pit.

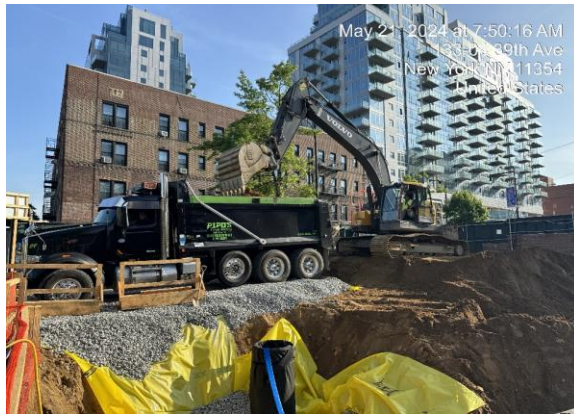
Photograph 2 - Non-hazardous soil being loaded on to trucks for export to Bayshore.

Approximately 940 cubic yards of non-hazardous soil from Grids WC-4, WC-7, and WC-8 (8-16') were exported to the Bayshore Soil Management facility located in New Jersey.

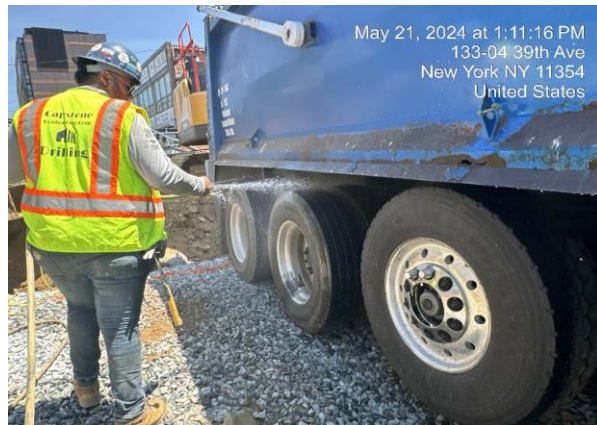
Photograph 3 - Truck tires being washed upon exiting Site in Grid WC-2. Wash water was collected in the collection pit.
