Daily Activity Report

Magnolia Gardens
39-03 College Point Boulevard, Queens, NY
BCP Site No. C241273

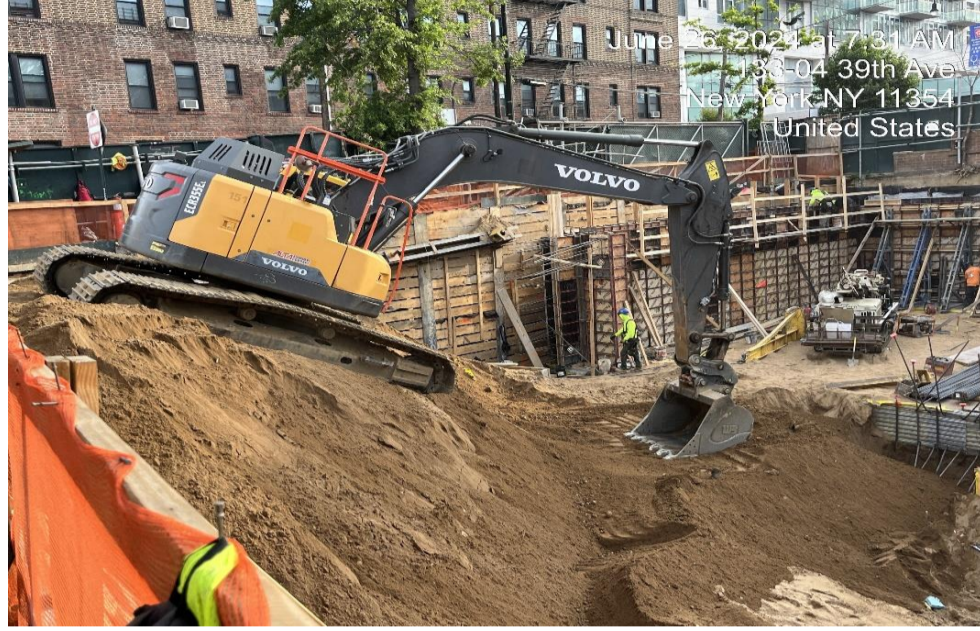
Photograph 1 -
Grading in WC-1 for site
work. View facing
northeast.

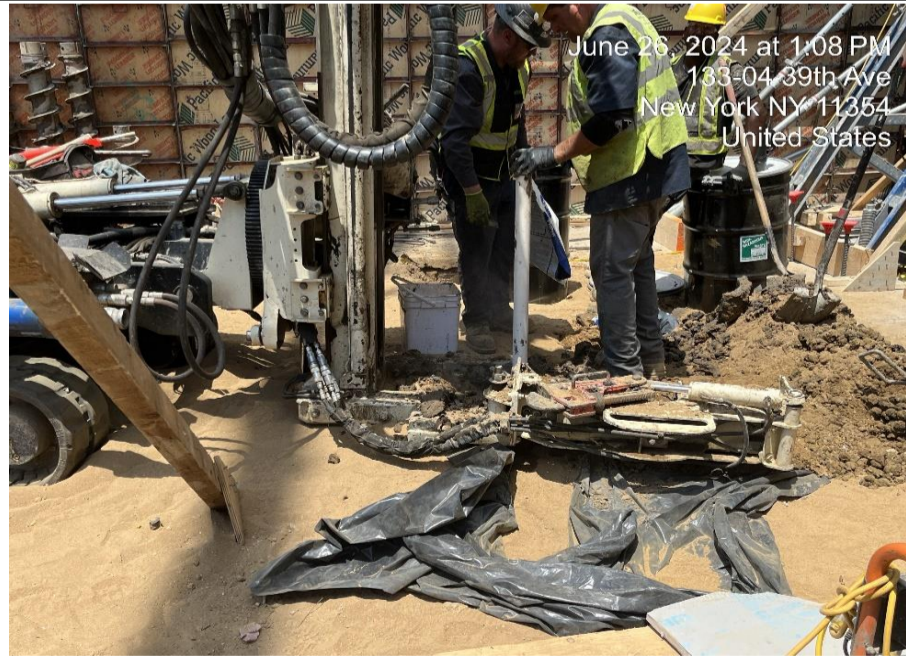
Eastern installed injection wells IW-01, IW-02, and IW-05 in Grid WC-5. AKRF developed IW-02 and IW-05. The IDWs were drummed and staged for off-site disposal at a later date. No signs of gross contamination (odor, PID, sheen etc.) were noted during the drilling.

Photograph 3 -
Eastern Environmental
installing injection well
(IW-05) in Grid WC-5, view
facing north.
