Daily Activity Report					
	Magnolia Gardens					
	39-03 College Point Boulevard, Queens, NY					
	BCP Site No. C241273					
General Site Information						
Date:	Friday, July 5, 2024					
Weather:	72-87°F, Mostly Cloudy					
Wind Direction/Speed (towards):	S @ 4-9 mph					
AKRF Personnel on Site:	Isabella Legovich and Samantha Fagundez					
AKRF Equipment on Site:	Mini RAE 3000 Photoionization Detectors [(PID) x3] and DustTrak Aerosol Monitors (x3)					
Visitors:	None					
Contractor Information						
Subcontractor						
Archstone Builders LLC				General Contractor (GC)		
Capstone Contracting Corp.				Foundation Contractor		
Description and Location of Work Activities Performed						
Excavation and grading related to SOE work occurred in Grids WC-2 and 6. The site access ramp was reconstructed in WC-2 after completion of work.						
Contractor installed sub-slab pipes for the SSDS- geotextile fabric and slotted PVC piping.

Soil Waste Classification Grid Plan

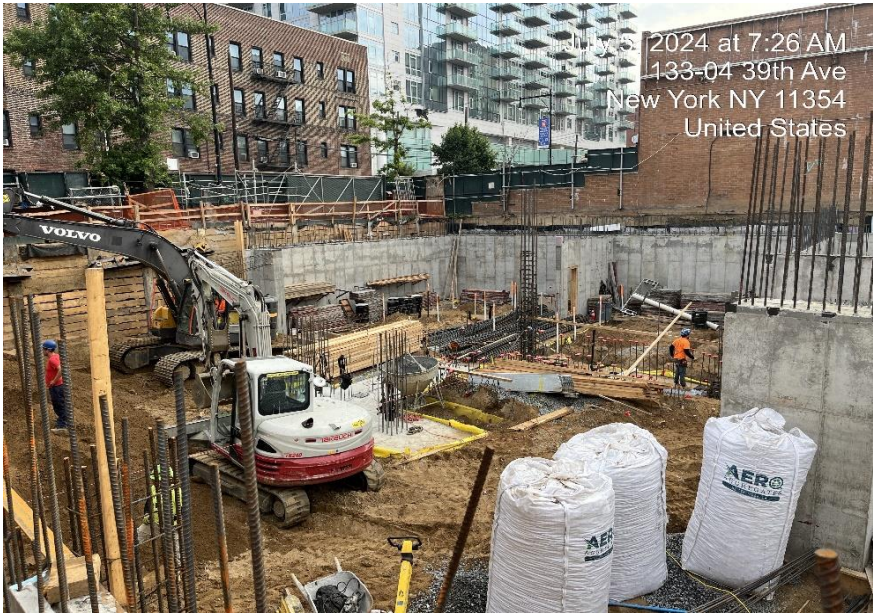
Site Photographs	
Photograph 1 - General site view, facing northeast.

<p>July 5, 2024 at 7:26 AM 133-04 39th Ave New York NY 11354 United States</p> <p>This photograph shows a general view of the construction site from the northeast. In the foreground, there are several large white bags of AER® material. A white Volvo excavator is positioned in the middle ground. The background features a multi-story brick building and a modern glass-fronted building. The site is enclosed by a concrete wall with rebar visible.</p>
Photograph 2 - Excavation and grading for SOE work in WC-02, facing southwest.

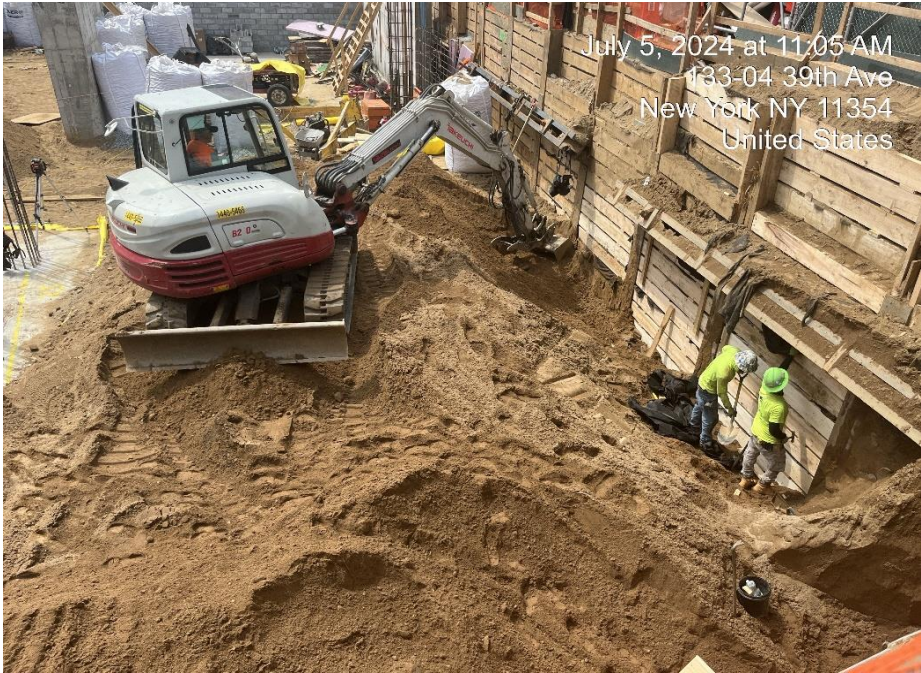
<p>July 5, 2024 at 11:05 AM 133-04 39th Ave New York NY 11354 United States</p> <p>This photograph shows an excavator working on a large pile of dirt. Two workers in yellow safety gear are standing near the excavator. The site is bordered by a wooden retaining wall on the right. The ground is uneven and appears to be in the process of being graded.</p>

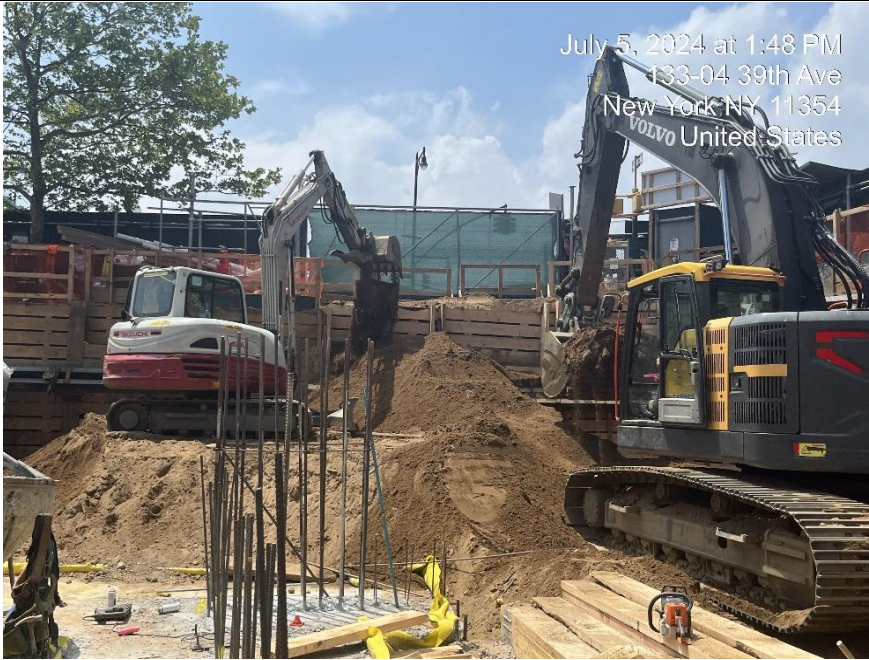
Photograph 3 - Reconstruction of soil ramp in WC-2 for equipment removal, facing west.

<p>July 5, 2024 at 1:48 PM 133-04 39th Ave New York NY 11354 United States</p> <p>This photograph shows two excavators working on a soil ramp. One excavator is white and the other is yellow. They are positioned on a pile of dirt. In the foreground, there are some wooden planks and a yellow safety barrier. The background shows a green safety fence and trees.</p>
