# PHASE I ENVIRONMENTAL SITE ASSESSMENT

AMSTER NOVELTY 101-21 101ST STREET QUEENS, NEW YORK AT99-PA-90999

ISSUE DATE: OCTOBER 28, 1999

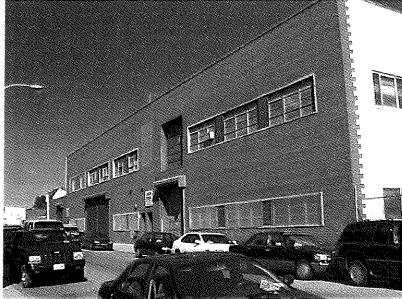
Picture #1: View of the building located on the subject property.

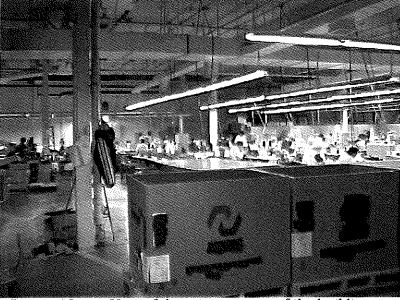
with 9"x9" and 12"x12" vinyl floor tiles, concrete block, sheetrock, wood, and wood-paneled walls, and concrete and steel beam ceilings partially covered with 2'x4' and 1'x1' ceiling tiles (see Pictures #2

Picture #2: View of the interior space of the building onsite.

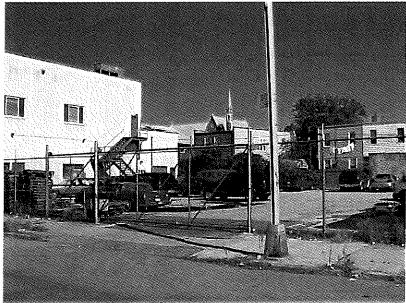
1959-1968 (three phases) Paved parking area (see Picture #4)

Picture #4: View of the paved parking area located on the southern portion of the subject property.

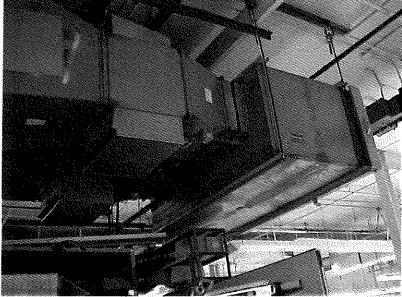
Picture #5: View of a typical gas-fired heater located in the building.

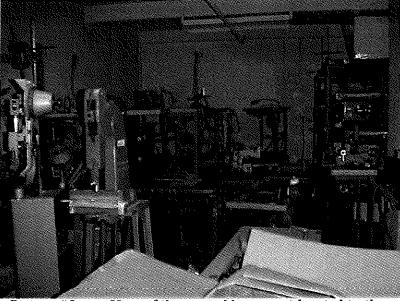
Picture #6: View of the partial basement located in the middle of the building on-site.

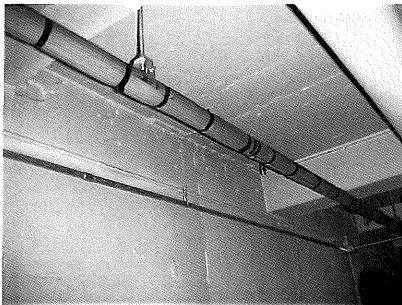
AquaTerra identified approximately 45 linear feet of friable suspect asbestos-containing pipe insulation in the sewing areas of the first floor (see Picture #11). Two bulk samples of this pipe insulation were collected, analyzed, and found to contain no asbestos. No other suspect friable asbestos-containing thermal system insulation was identified on-site. All of the exposed ducts were bare. No spray-on fireproofing was identified in the building. A copy of the asbestos analytical report is provided in Appendix E.

Picture #11: View of the pipe insulation located on the first floor which was found to contain no asbestos.

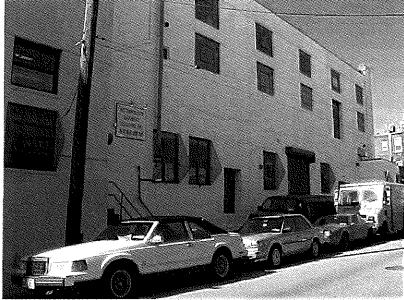
**WEST:** Properties west of the subject property consist of a multiplestory commercial/light industrial building (see Picture #10). Long Island Railroad tracks and residential homes are located further west.

Picture #10: View of properties to the west of the subject property.

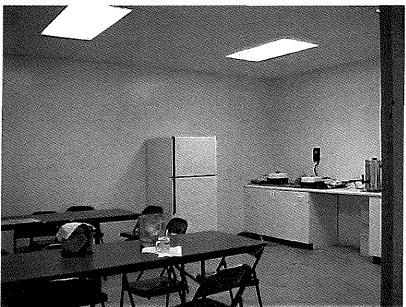
Non-friable potential asbestos-containing (PAC) 12"x12" vinyl floor tiles and friable PAC 2'x4' ceiling tiles are located throughout the building (see Picture #12). The PAC materials were in good condition and were not sampled. Mr. Picano stated that the ceiling tiles located in the second floor office area were installed approximately 15 years ago. Therefore, it is unlikely that these ceiling tiles contain asbestos.

Picture #12: View of the typical PAC ceiling tiles and floor tiles located on-site.

AquaTerra identified potential asbestos-containing (PAC) friable 2'x4' ceiling tiles and non-friable 12"x12" vinyl floor tiles throughout the building on-site. According to Mr. Picano, the ceiling tiles located in the office area were installed approximately 15 years ago and therefore, would most likely not contain asbestos. The remainder of the PAC ceiling and floor tiles are in good condition, are located in occupied areas, and were not sampled to avoid needlessly damaging them. In their present condition, even if the PAC ceiling and floor tiles contain asbestos, they present no significant environmental or health hazard. However, it is best to assume that the PAC ceiling and floor tiles contain asbestos and take certain precautions when handling them.

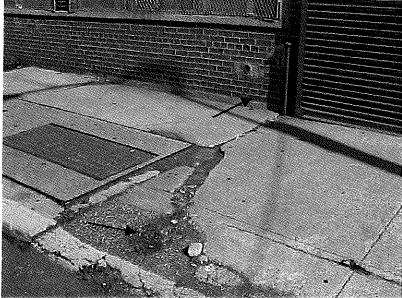
AquaTerra identified evidence of underground storage tanks (USTs) on the subject property. A fill cap, a remote fill cap, and a vent pipe were identified towards the northwest front of the building indicative of a fuel oil UST (see Picture #13). An additional fill cap and vent pipe were observed towards the southwest front of the building (see Picture #14). According to a previous Phase I ESA conducted in November 1995 by Energy & environmental Analysts, Inc. (EEA), three USTs were previously used on-site. The first fill cap and vent pipe identified by AquaTerra correspond to a former 2,500-gallon fuel oil UST which was closed in-place in 1987. The second fill cap and vent pipe correspond to a former 1,080-gallon trichloroethylene UST which was also closed in-place in 1987. According to Mr. Picano and the EEA report, another 2,500-gallon fuel oil UST was previously located in the southeast corner of the building. This UST was also closed in-place in 1987. However, this UST was removed in the early 1990s to facilitate the installation of machinery in the area of this UST. Therefore, two closed in-place USTs remain on-site; one UST formerly contained fuel oil and one UST formerly contained trichloroethylene. EEA's Phase I ESA report recommended subsurface testing to determine if these USTs were properly closed in-place.

Picture #13: View of the fill caps and vent pipe associated with a former fuel oil tank closed in-place on the subject property.

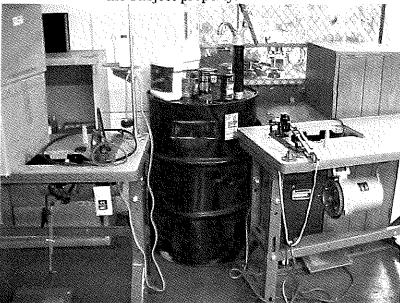
A small quantity of chemicals was identified on-site. A 55-gallon drum of lubricating oil was identified in the sewing area on the first floor (see Picture #15). Small containers of oil were located in the vicinity of this drum. Another 55-gallon drum of lubricating oil was identified in the partial basement in the middle of the building (see Picture #16). A 55-gallon drum of hydraulic oil was identified in the hydraulic elevator motor room (see Picture #17). All of the chemicals identified by AquaTerra are in good condition, with no evidence of staining or spillage. Minor oil staining was identified in the hydraulic elevator motor room. However, this staining was on a concrete floor in good condition and no floor drains were identified near this staining (see Picture #18).

Picture #15: View of a 55-gallon drum of lubricating oil located in the first floor sewing area

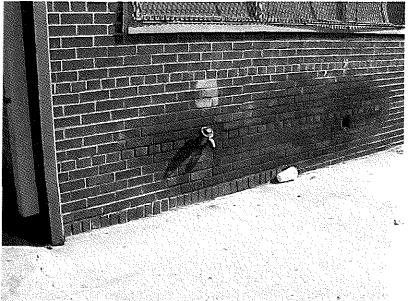
Picture #14: View of the fill cap and vent pipe associated with a former trichloroethylene UST which was closed in-place on-site.

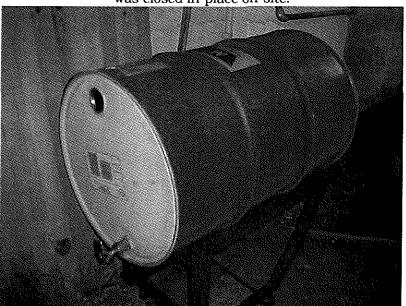
Picture #16: View of a 55-gallon drum of lubricating oil located in the partial basement in the middle of the building.

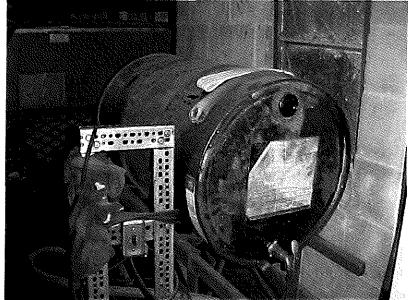
Picture #17: View of a 55-gallon drum of hydraulic oil located in the elevator motor room.

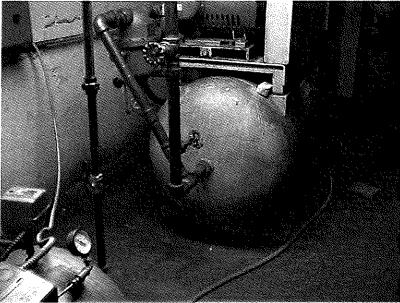
Picture #19: View of the oil staining located in the basement near an old compressor.

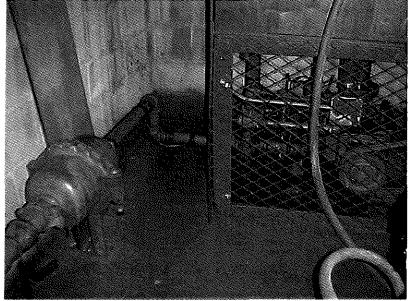
AquaTerra identified minor oil staining in the elevator motor room (see Picture #18). The oil staining was on a concrete floor in good condition with no floor drains in the vicinity of the staining. Oil staining was also identified on the floor in the partial basement in the middle of the building, which is associated with an old air compressor (see Picture #19). The concrete floor was in good condition. However, a sump pit was identified in the floor of the basement (see Picture #20). According to Mr. Picano, a 55-gallon drum is located in the pit to collect bleed water from the compressors. Mr. Picano stated that the drum is periodically pumped out and emptied into the municipal sewer system.

Picture #18: View of the oil staining located in the hydraulic elevator room.

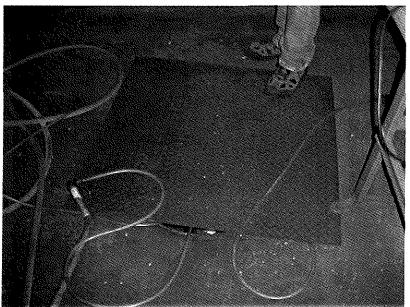
Picture #20: View of the sump pit located in the partial basement in the middle of the building.

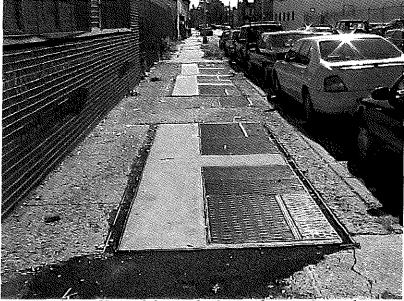
Electricity is supplied to the subject property by Con Ed. Several vaulted transformers are located along the sidewalk in front of the building (see Picture #21). The transformers are owned and maintained by Con Ed. Utility-owned transformers are generally categorized as PCB-contaminated (50 to 499 parts per million PCB). Transformers with 50 to 499 parts per million PCB are within federal regulatory compliance requirements. Typically, any maintenance, leaks or spills from the transformers are the responsibility of the utility.

Picture #21: View of the vaulted transformers located on the sidewalk in front of the subject property.

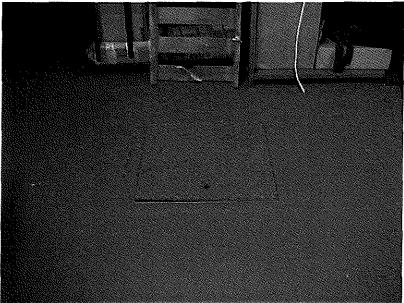
In addition, AquaTerra identified several floor drains and wasteline access panels in the building, some of which were capped (see Picture #23). No staining was identified in the vicinity of any of these floor drains. According to the previous Phase I ESA conducted by EEA in 1995, a trap cover for a floor vault was identified in the southwest corner of the building. In addition, a drywell and a drainage trench were identified adjacent to the southwestern exterior of the building. AquaTerra identified this drywell and trench area during the site inspection (see Picture #24). As part of a Phase II subsurface investigation at the subject property, a soil sample was collected from the base of the vault and a soil sample was collected in the vicinity of the exterior drywell and trench. The sample collected from the interior vault was found to contain 18,000 ppm of TPHC, which is indicative of a petroleum release. The soil sample collected from the exterior drywell and trench area was analyzed for TPHC, VOCs, and metals. EEA recommended that the sediments in the vault be cleaned out. According to Mr. Tepper, the contamination identified was cleaned out prior to Amster Novelties occupancy of the building.

Picture #23: View of the typical wasteline access panels located throughout the building.

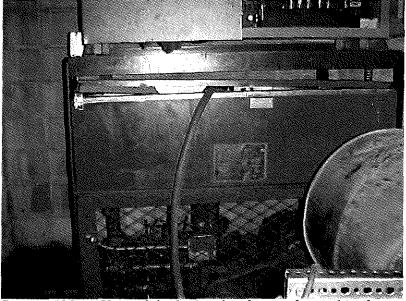
A hydraulic elevator is located on-site (see Picture #22). Minor spills of hydraulic oil were observed in the elevator mechanical room during the inspection. Mr. Tepper stated that this elevator is serviced by American Elevators. According to Mr. John Kane, technician with American Elevators, no records of leaks from this elevator were onfile. Mr. Kane stated that the elevator is pressure tested every three years. Mr. Kane was unaware of the PCB content of the hydraulic oil currently located in the hydraulic oil reservoir. Mr. Picano stated that small amounts of hydraulic oil are periodically added to the hydraulic oil reservoir associated with the elevator, but there have been no significant leaks from the reservoir.

Picture #22: View of the hydraulic elevator located in the building on-site.

A hydraulic elevator is located on-site. Minor spills of hydraulic oil were observed in the elevator mechanical room during the

inspection. This elevator is serviced by American Elevators. According to a technician with American Elevators, no records of leaks from this elevator were on-file. However, it is possible that the hydraulic oil located in the elevator motor reservoir contains PCBs.

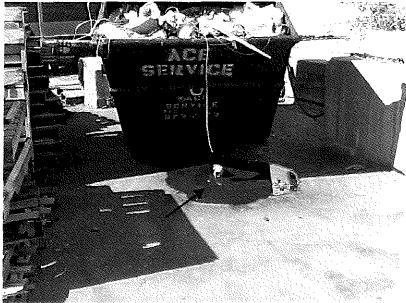
Picture #24: View of the on-site drywell (arrow) and former trench area (in background) in the parking area on-site.

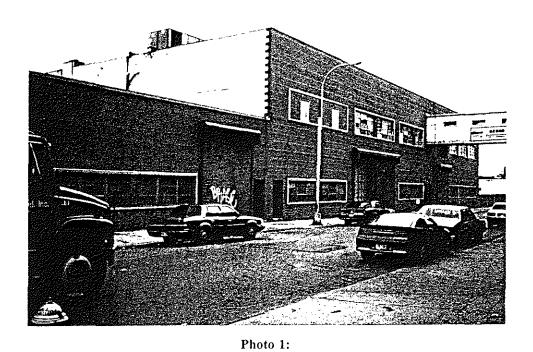
The subject property is approximately 46,000 square feet in area. The site is occupied by two 2-story and one 1-story concrete, cinderblock and steel frame structures, with approximately 36,000 square feet of gross floor space. A south paved and fenced parking lot contains the remaining 10,000 square feet of property (see Figure 2 and Photo 1).

Subject property Buildings 6, 5, and 9 (left to right), as seen from across 101st Street.

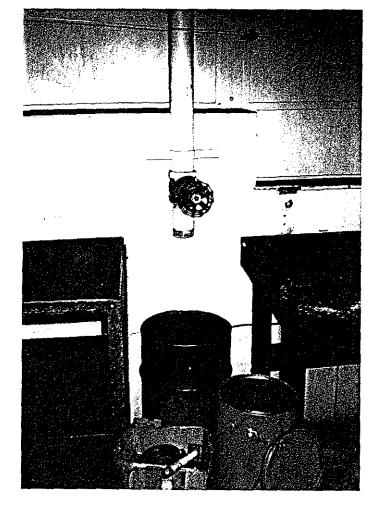
Photo 3:

Piping from interior floor drain, that discharged any leaking oil to a 55-gallon drum.

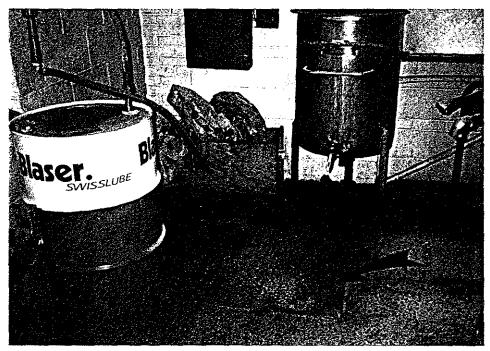
Photo 4:

Trap cover for a possible drainage structure, located in the former chemical storage/process area.

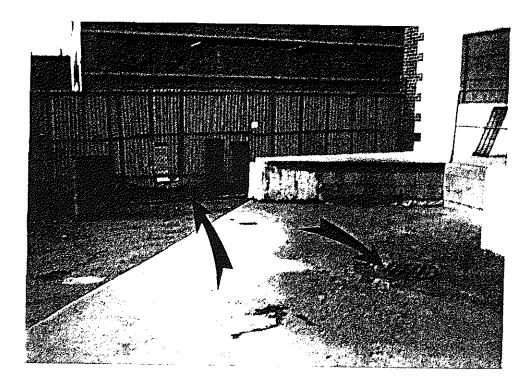
Photo 5:

Exterior drainage structure, with drainage trench to rear, along the west side of the south parking lot.

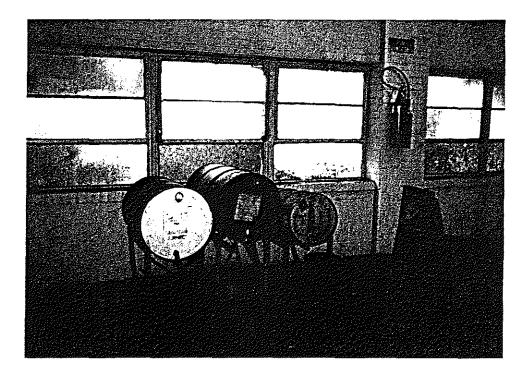
Photo 6:

Two 55-gallon drums of kerosene and lubricating oil, and one 30-gallon drum of lubricating oil, stored in the first floor of Building 5.

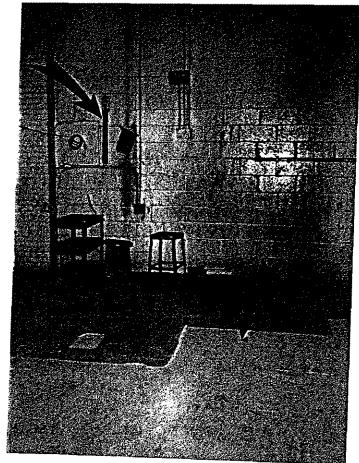
Photo 7:

Concrete area formerly used as foundation for a machine, to the rear of Building 9. Reportedly the sealed fuel oil tank (Tank No. 3) was removed from this area. Note former tank petrometer along wall.

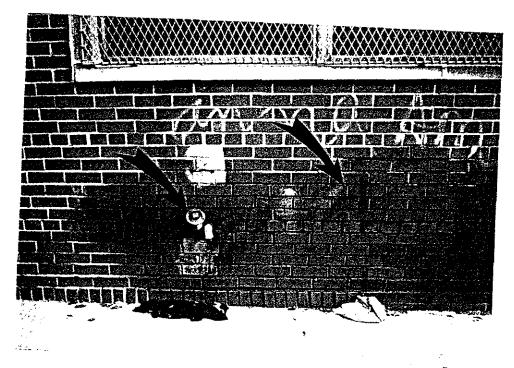
Photo 8:

Fillport and vent for sealed trichloroethylene tank (Tank No. 9), in Building 9.

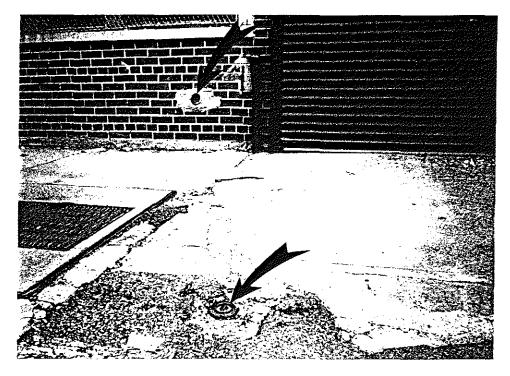
Photo 9:

Fillport and ventline for sealed fuel oil tank (Tank No. 2) in Building 6. Note the second fillport, possibly indicating a previous line leak and replacement.

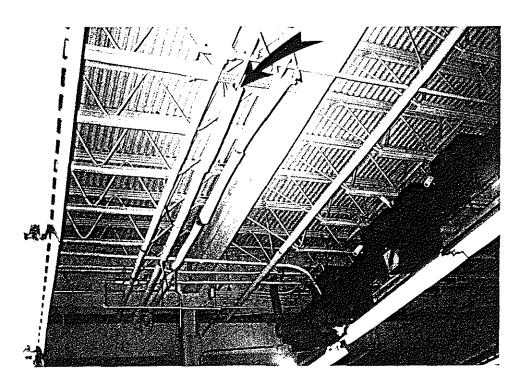
Photo 10:

Suspected asbestos-containing pipe wrap in first floor manufacturing area of Building 9.
