## ASTM PHASE I ENVIRONMENTAL SITE ASSESSMENT

**Project:** 3,960 SF Grocery Store and Laundromat on 0.22-Acres/Cruz Brothers Realty,  
LLC/Loan# 69356

1322-1326 Central Avenue and 1325-1327 Augustina Avenue

Federated Environmental Project #145812

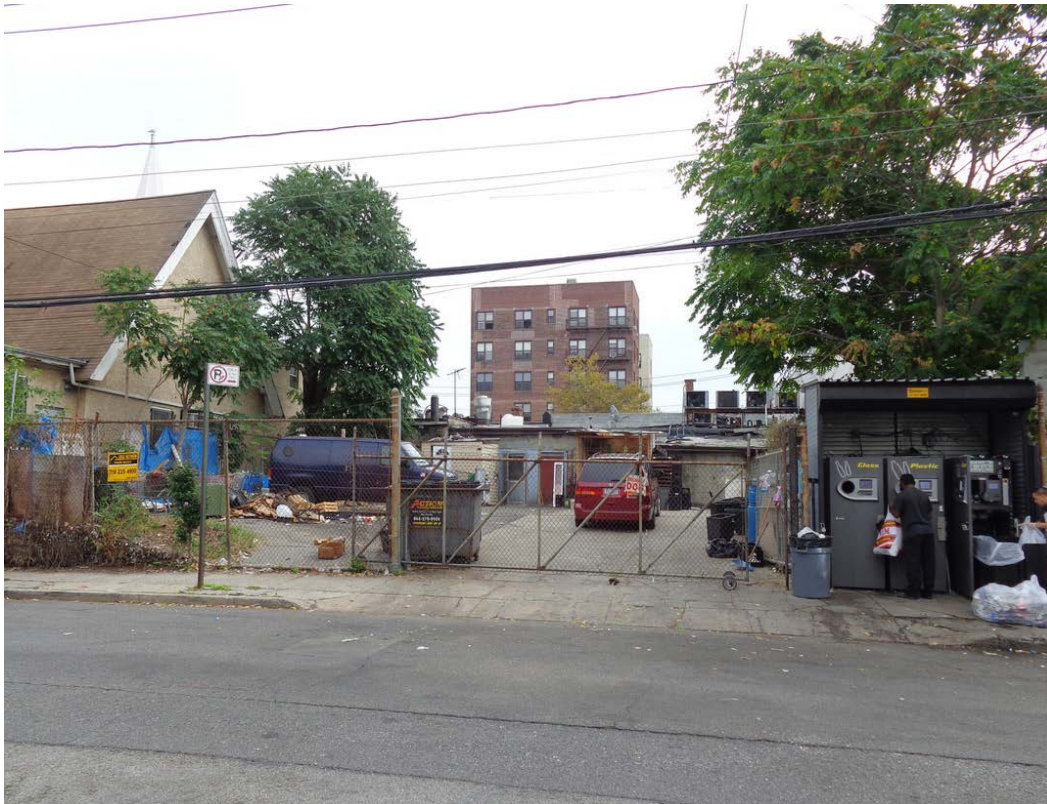
Figure 2: View of the subject property from the northwest along Augustina Avenue. Federated personnel carefully inspected the subject property for USTs, including a walk around the property for fills, vents, etc. No evidence of current USTs including fills or vent pipes were observed.

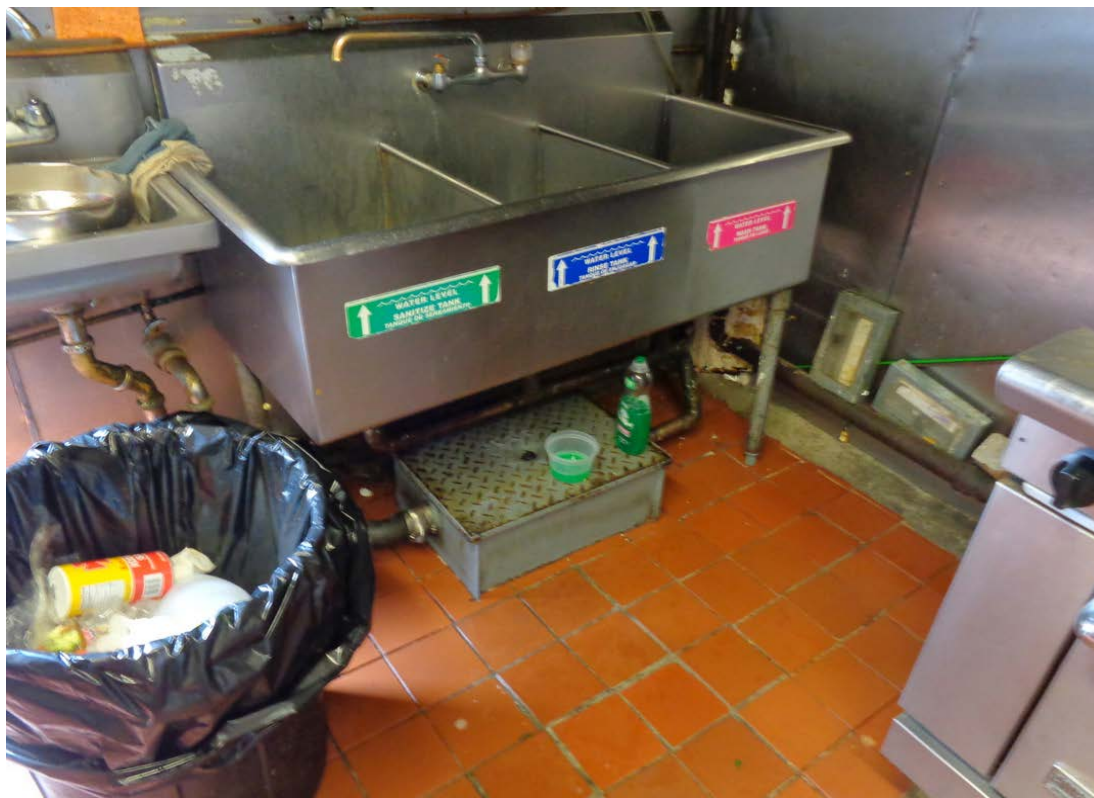
Figure 4: The grocery/supermarket includes three grease traps to collect waste cooking grease.

Federated Environmental is of the opinion the property is acceptable for hazardous chemical storage, use, and disposal concerns. The site includes limited quantities of waste cooking grease stored in 55-gallon steel drums located in the rear parking lot that is retrieved from the grease traps associated with the site kitchens within the grocery store, and removed by Tri-State Biodiesel (TSB) on an as needed basis which is usually monthly or bimonthly. Normal everyday general purpose cleaners are stored and utilized on-site. No obvious visual evidence of improper chemical storage, use, or disposal was identified during the physical site inspection.

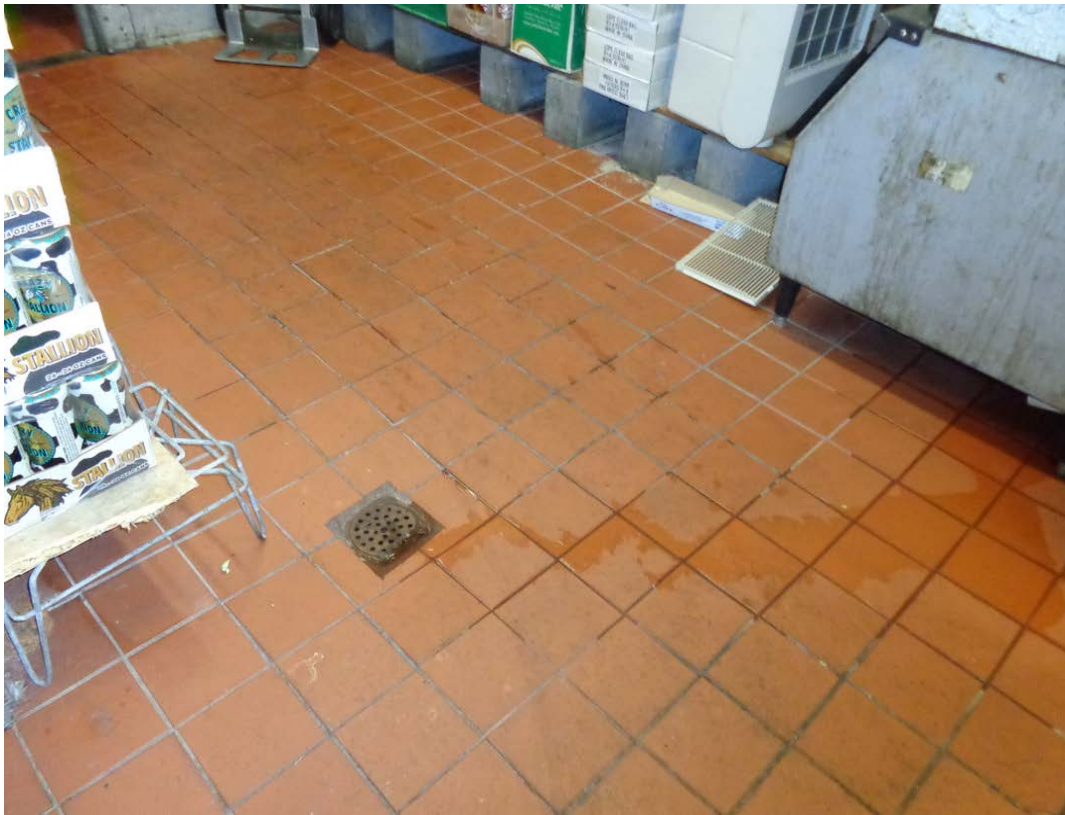
Figure 5: The grocery/supermarket on-site includes interior floor drains. No hazardous materials were observed entering into these interior floor drains.

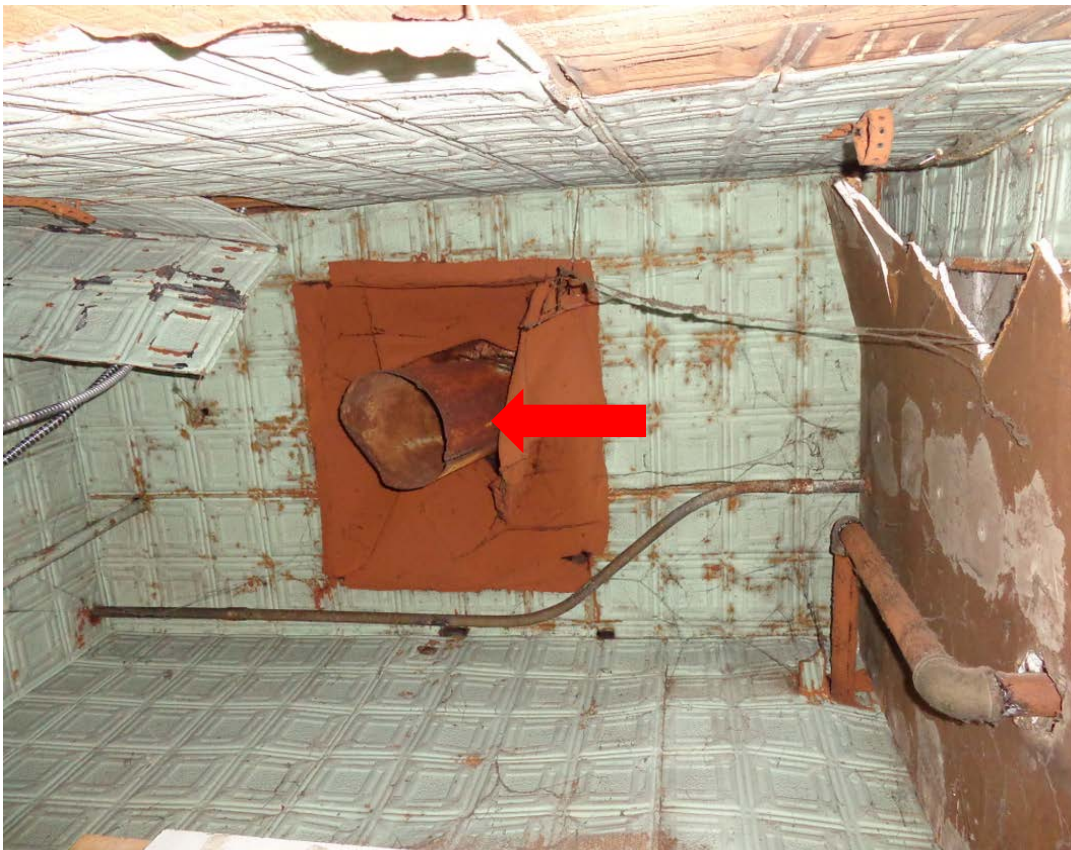
Figure 10: View of the suspected ceiling vent within the current Laundromat for either a boiler or dry cleaning equipment that was determined to have operated on-site.

Federated Environmental inspection personnel completed a telephone [(516) 343-1485] interview with current owner and landlord, Mr. Pedro Ortiz, who has owned the property since 2005. Mr. Ortiz was not sure whether any prior environmental reports were completed on the subject property, but did not have any to provide to Federated Environmental inspection personnel. Mr. Ortiz stated that an auto repair may have operated on-site at the 1325 Augustine Avenue address (northwest rear of site). Mr. Ortiz stated that the open drain in the asphalt-paved parking area was associated with an illegal garage and storage improvement bathroom that he demolished upon purchasing the property as instructed by the City. Mr. Ortiz noted that the vent leading out of the Laundromat ceiling/roof may have been associated with a boiler that he removed during his ownership, but was not certain.

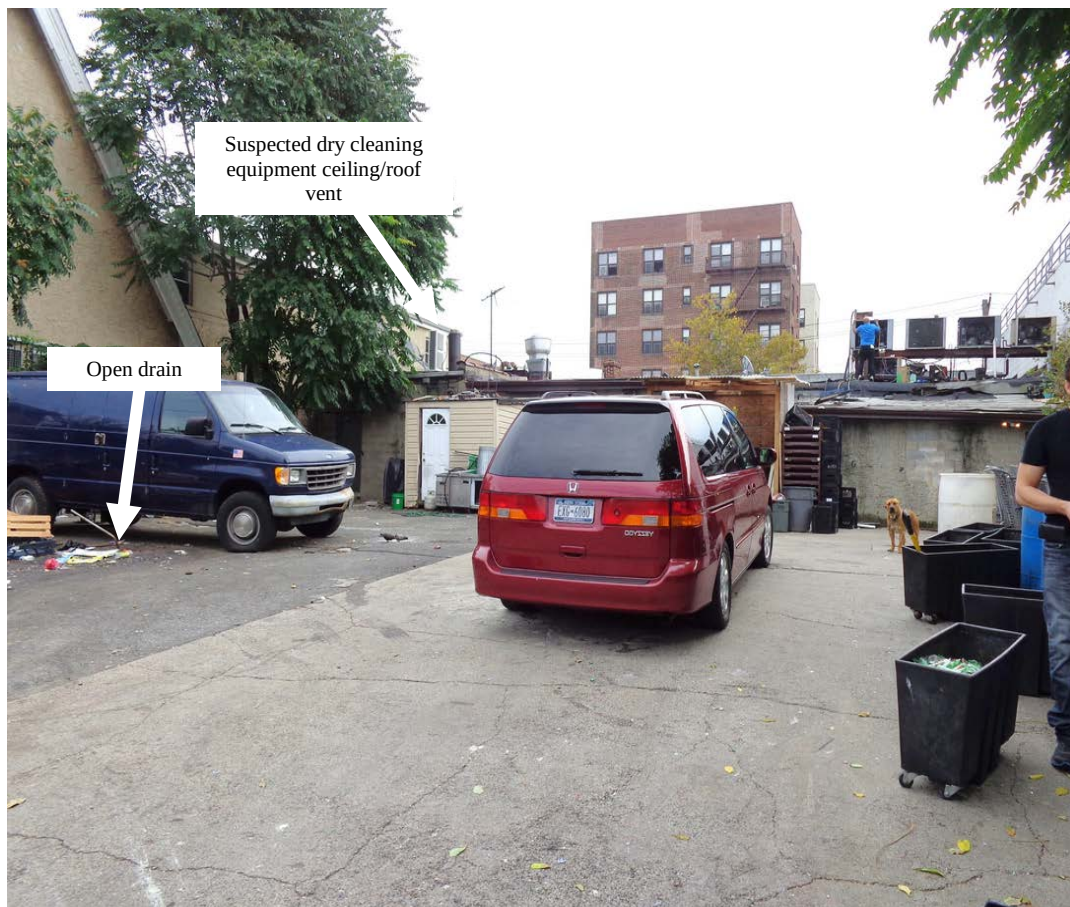
Figure 13: Representative view of the rear parking lot area of the site. The rear parking lot area includes an open exterior floor drain.

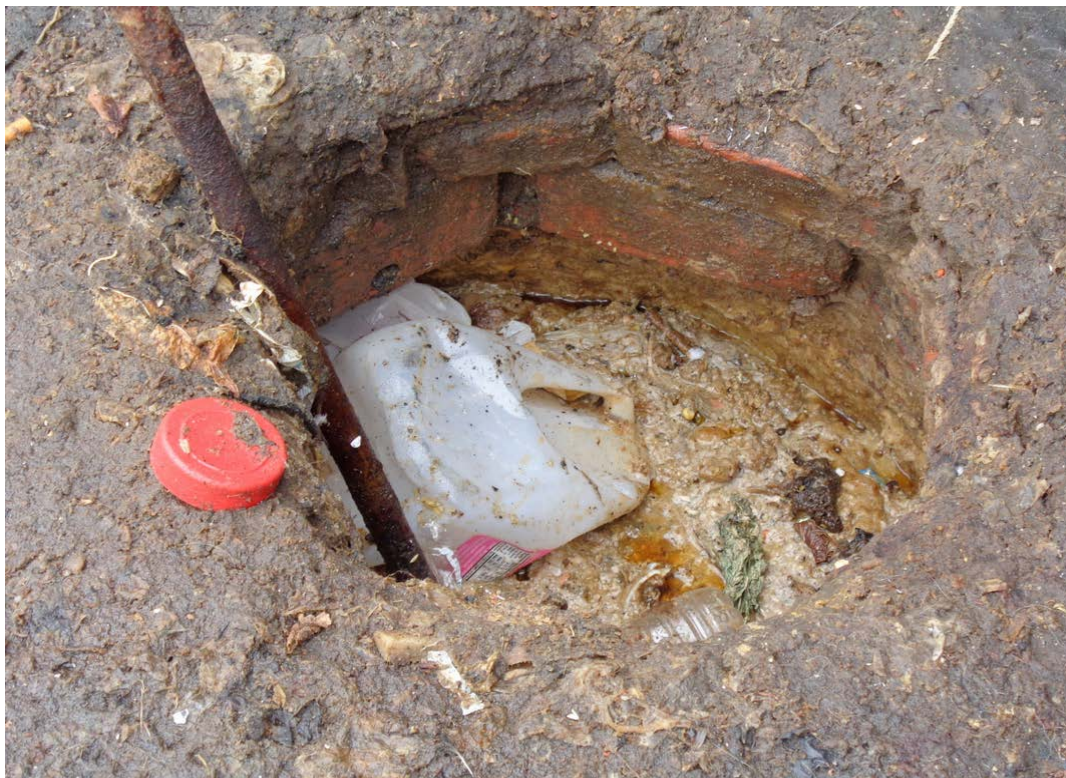
Figure 14: Close up view of the open drain within the parking lot on-site.

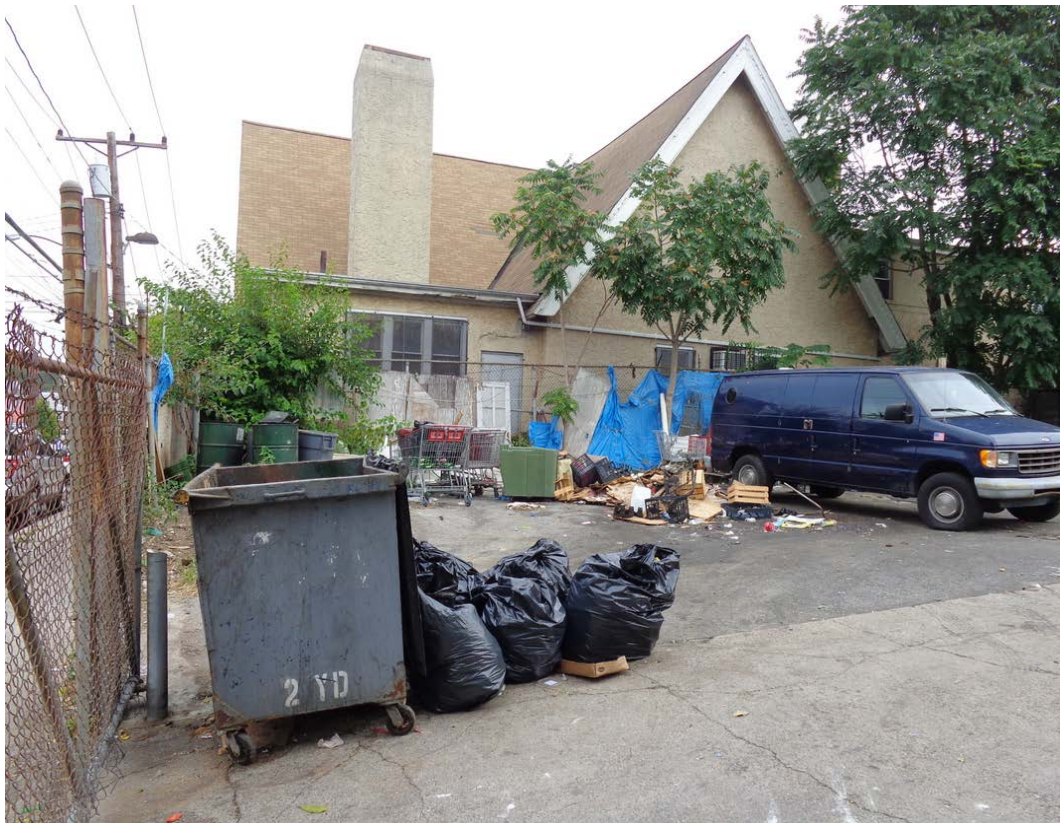
Figure 15: View along the rear of the parking lot area of the site including the non-hazardous waste (trash) dumpster container, several 55-gallon waste cooking oil drums, and miscellaneous debris.

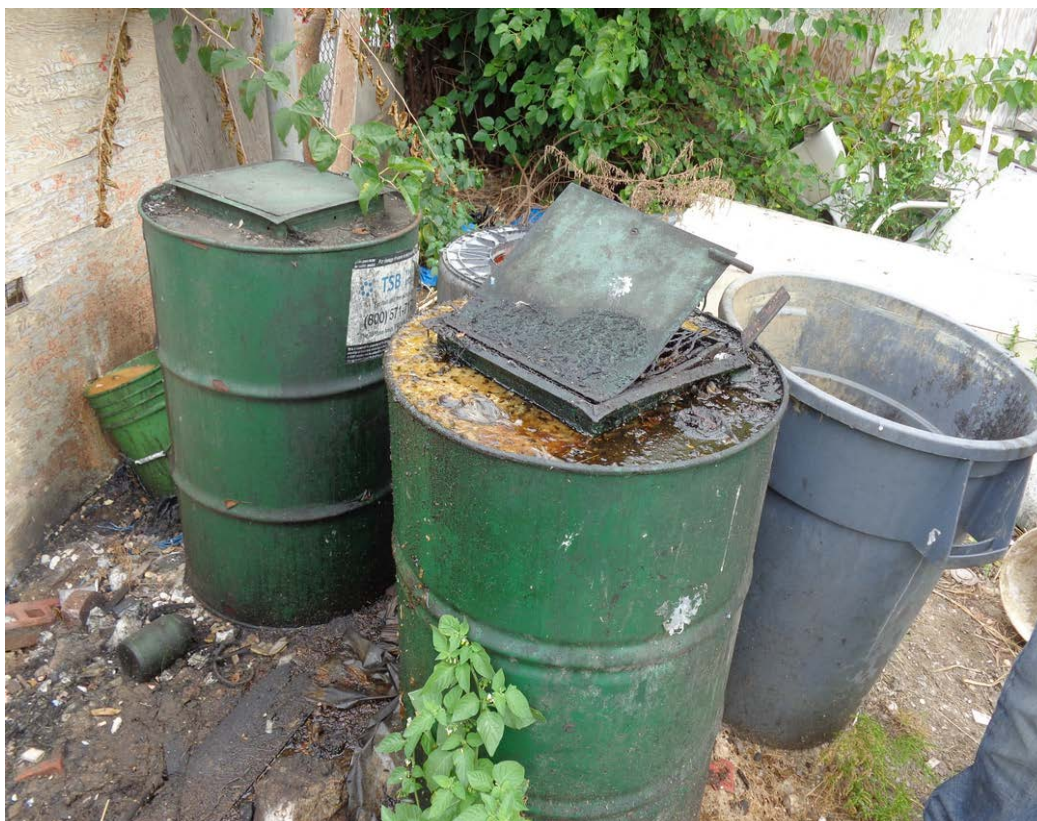
Figure 16: Close up view of the 55-gallon waste cooking grease drums located on-site.

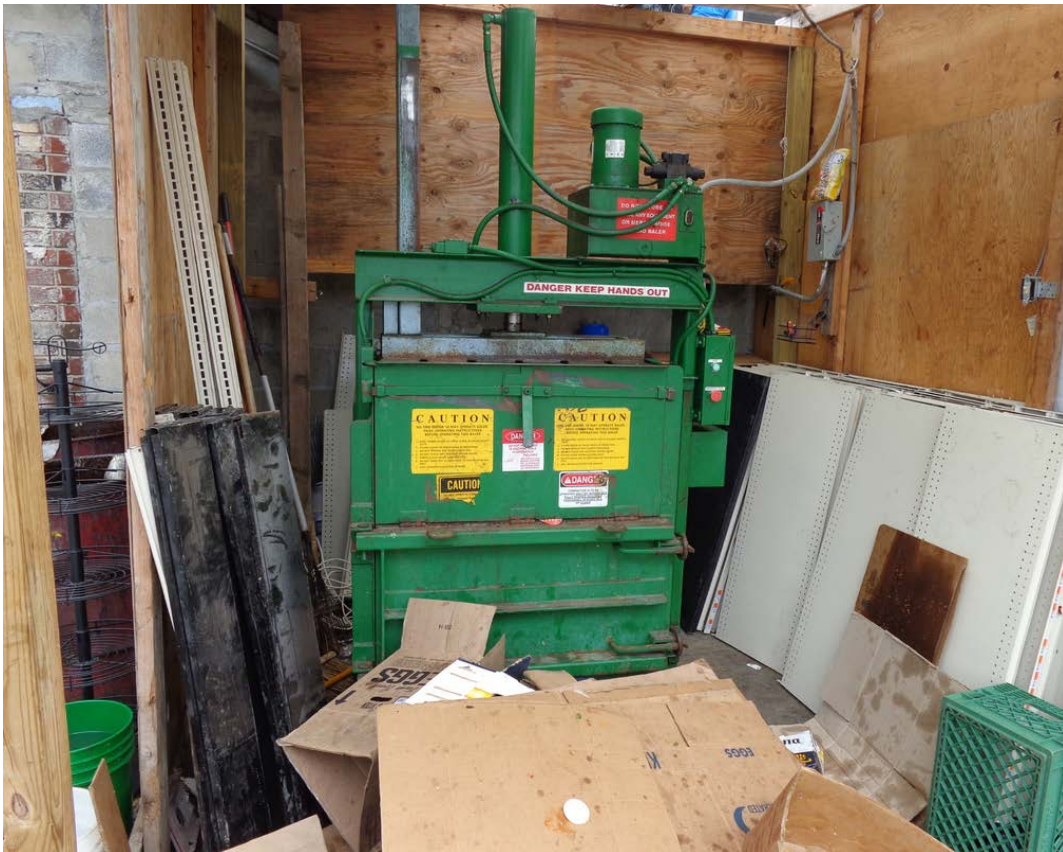
Figure 18: The subject property utilizes a cardboard box compactor on-site.
