FINAL ENGINEERING REPORT

**Coral Island Shopping Center
1650 Richmond Avenue
Staten Island, Richmond County, New York**

NYSDEC BCP Number: C243033

Remedial Engineering, P.C.
Environmental Engineers

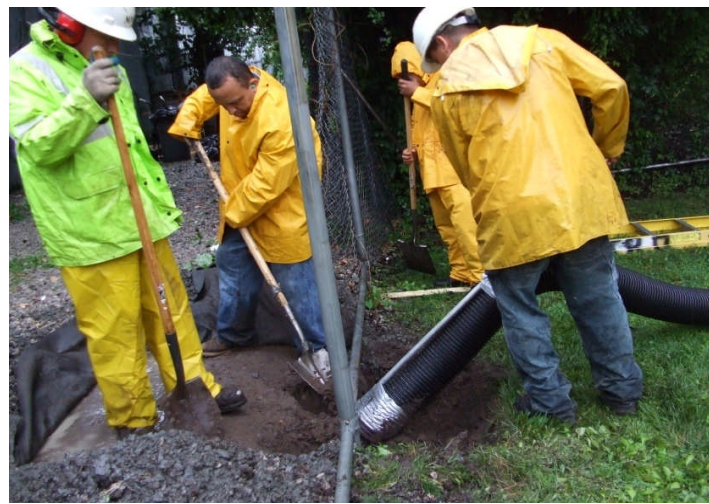
Photo 1: Soil excavation at Area 1.

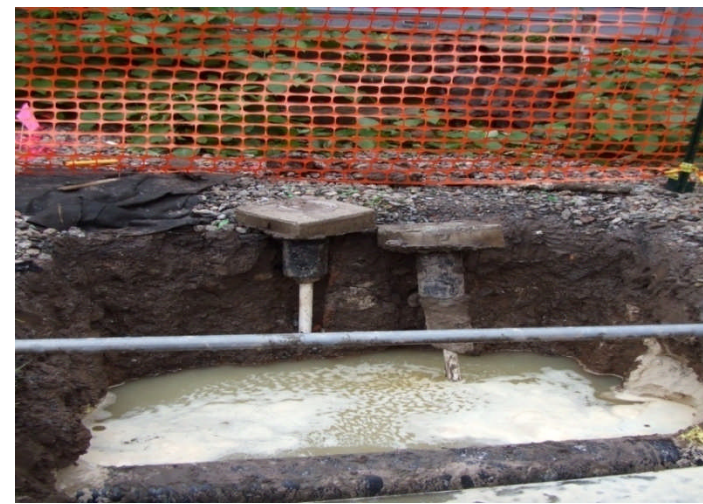
Photo 2: Gas pipeline and monitoring wells MW-102S and MW-102D exposed in open excavation of Area 2.

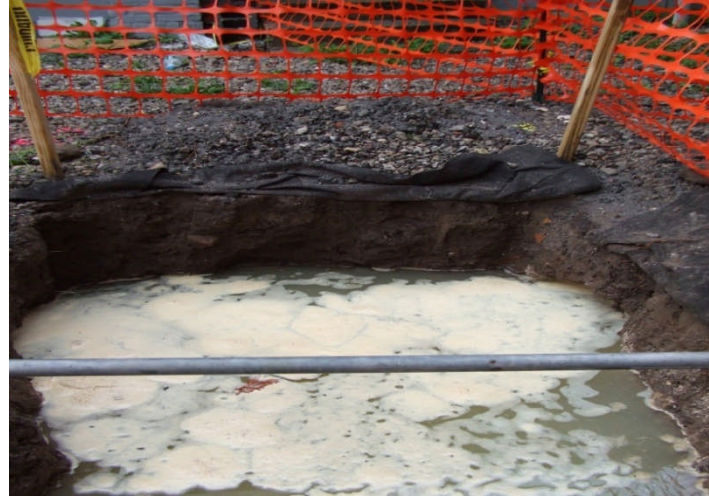
Photo 3: Groundwater in open excavation of Area 1.

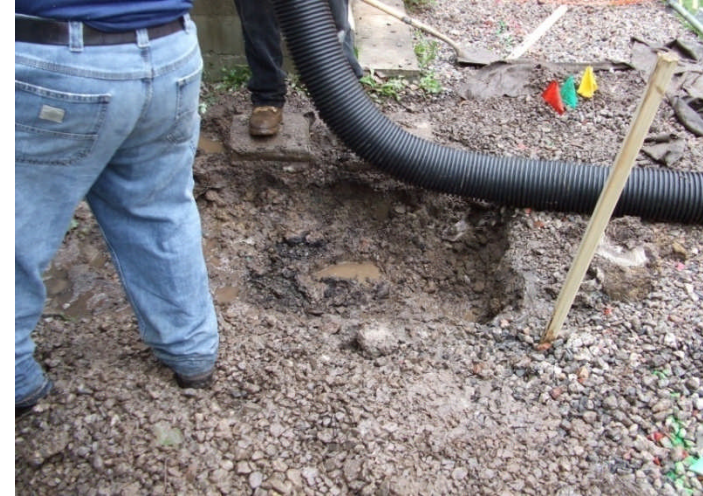
Photo 4: Soil excavation at Area 4.

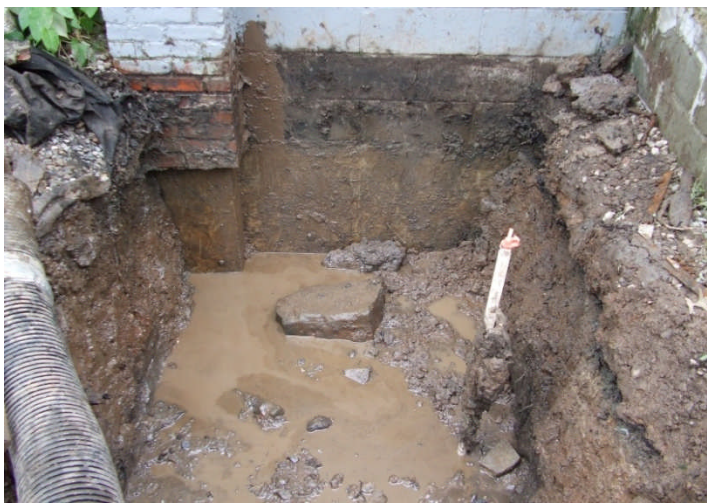
Monitoring well MW-101S was not damaged during the performance of the Remedial Action. However, monitoring well MW-101D was damaged during the performance of the Remedial Action. The monitoring well was abandoned by backfilling the remaining well casing with cement. Monitoring well MW-101DR (Plate 7) was installed on October 17, 2007 to replace monitoring well MW-101D. Monitoring well MW-101DR was constructed in a manner similar to MW-101D (i.e., one-inch diameter Schedule 40 PVC well casing, Geoprobe pre-packed screen, well screen from 13 to 18 feet bls).

Photo 5: Exposed monitoring well MW-101S in Area 4; MW-101D was destroyed during excavation.

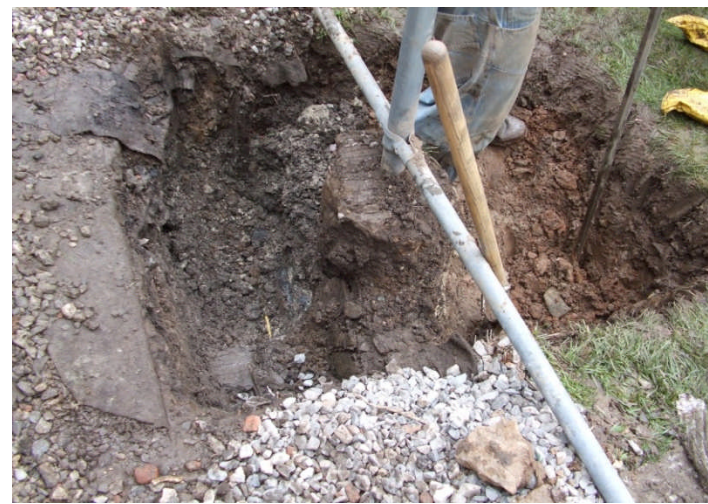
Photo 6: Soil excavation at Area 3.

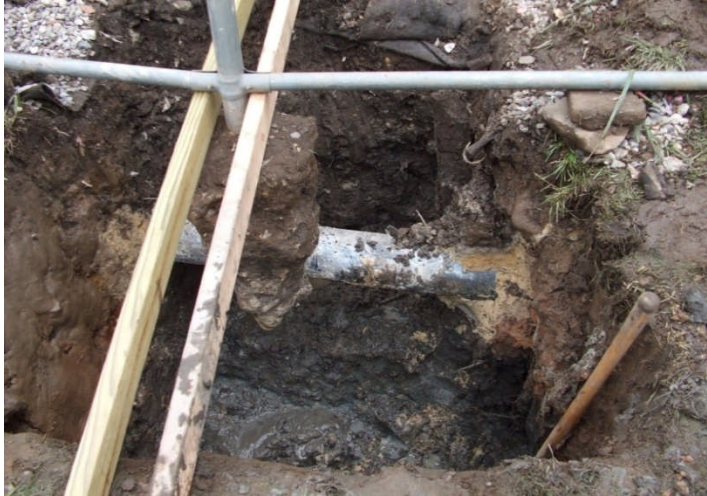
Photo 7: Exposed gas pipeline in open excavation of Area 3.

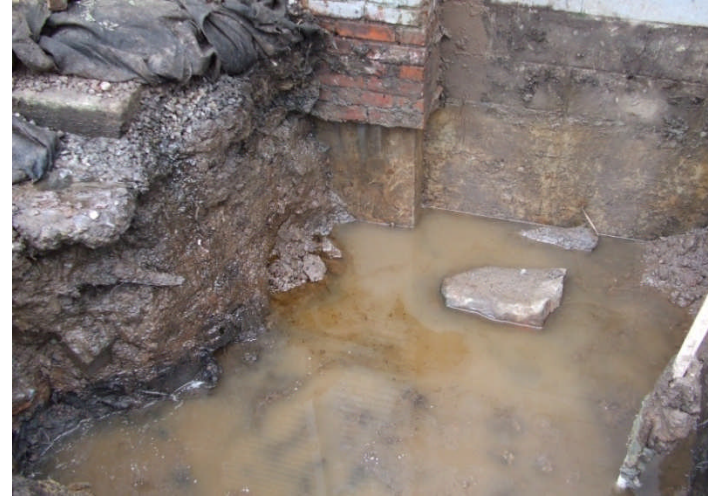
Brownish-stained material was uncovered during the excavation of the southern sidewall and the southeast corner of Area 4. The contaminant created a sheen upon contact with water. All visually stained material was removed and disposed of offsite with the other soils excavated from Area 4. All water demonstrating a sheen was also removed and disposed of offsite.

Photo 8: Sheen observed in Area 4.

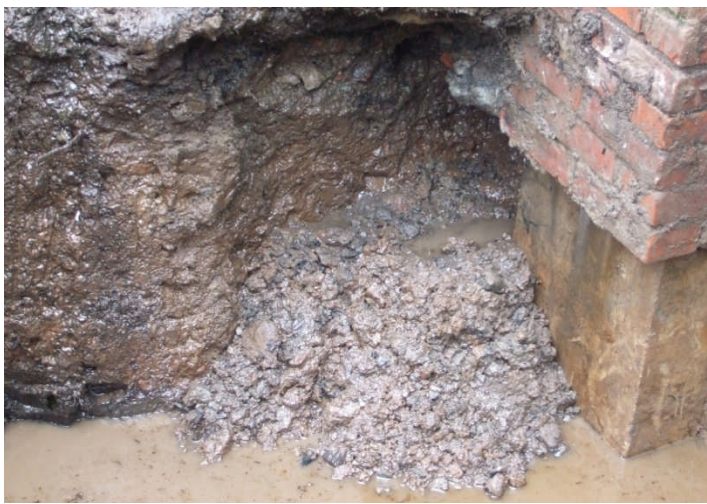
As indicated on Plate 10, VOC-impacted materials were found underneath the rear steps of the Dry Cleaner (i.e., southeast corner of Area 4). The VOC-impacted materials were able to be removed while protecting the overlying steps.

Photo 9: Soil with high PID readings from the southeast corner of Area 4.

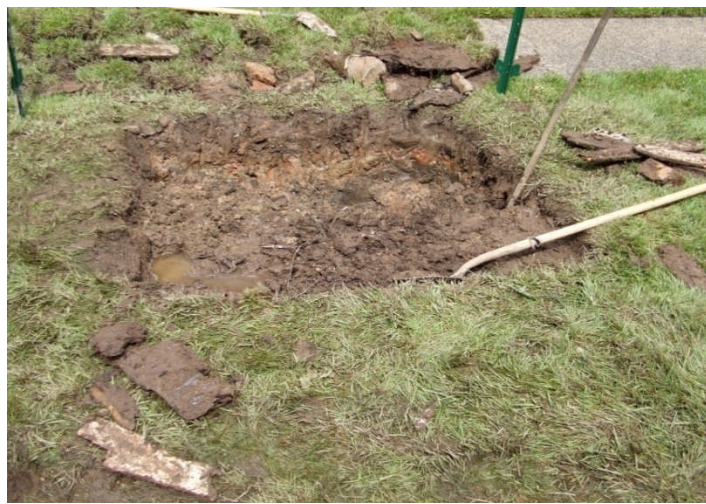
Photo 10: Preparation of Area 5 for soil excavation.

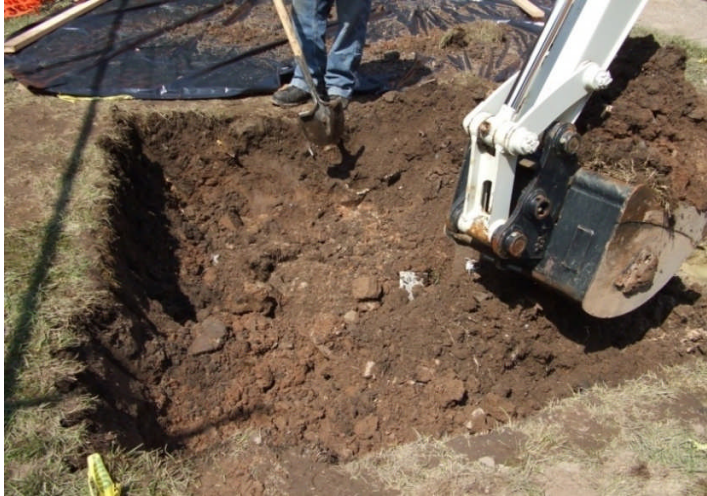
Photo 11: Soil excavation at Area 5.

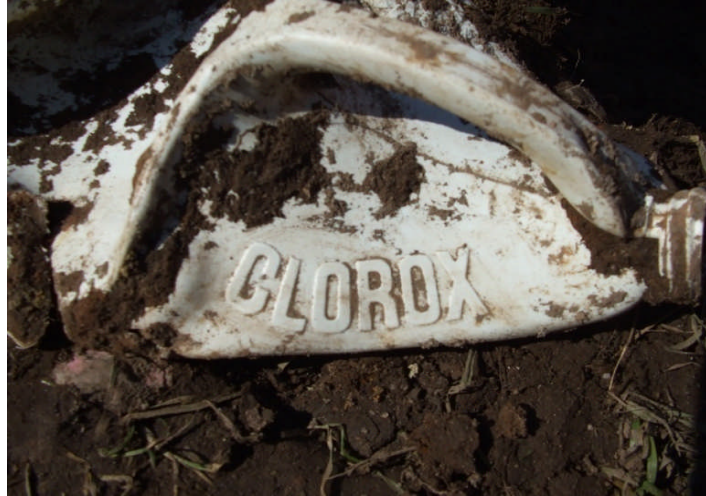
During the excavation of Area 5, miscellaneous debris (i.e., wooden planks, empty Clorox bottle) and small quantities of grayish-stained soil were uncovered. PID readings of the grayish-stained soil were greater than 500 ppm. These materials were removed and disposed of offsite. In addition to the above, a broken 2-inch diameter clay pipe was discovered at approximately 2.5 feet bls. Based on discussions with Church personnel and tracing the pipe approximately 30 feet to the east, it was concluded that the pipe was a former storm water pipe leading from the exterior corner of the Multi-Use building and was not in use. This pipe was sealed with concrete on both ends of the broken section.

Photo 12: Clorox bottle uncovered in soil removed from Area 5.

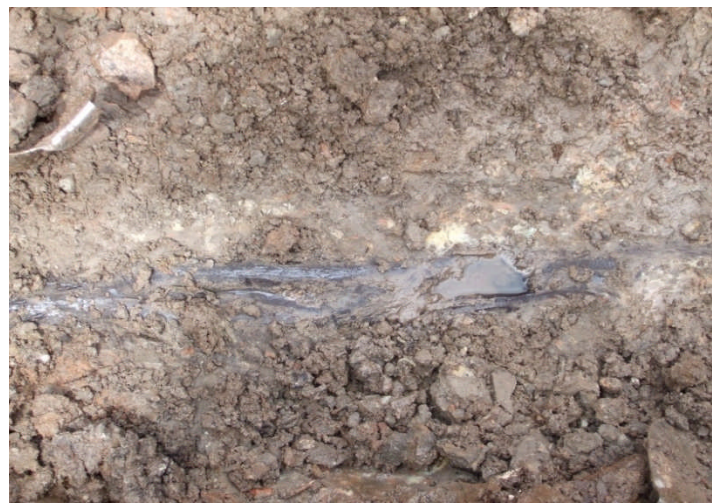
Photo 13: Broken 2-inch pipe in Area-5.

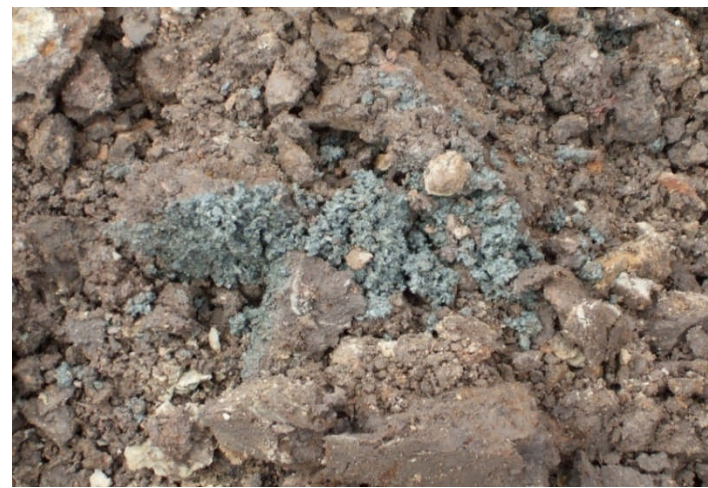
Photo 14: Grayish-stained soil with high PID readings from Area 5.

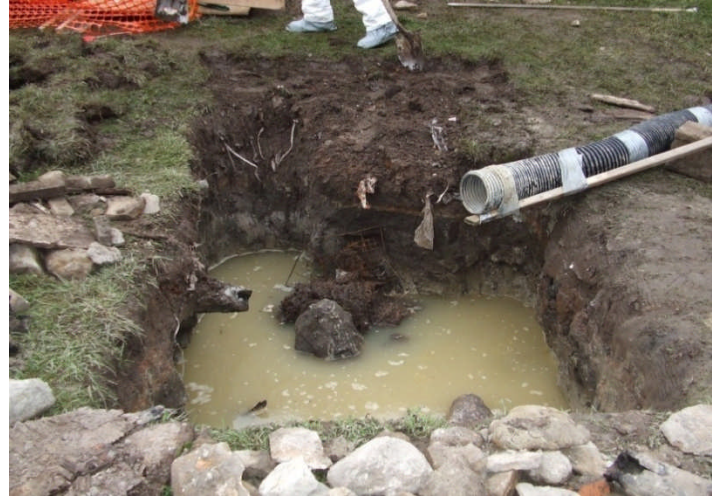
Photo 15: Preparing to dewater Area 5 at start of work day.

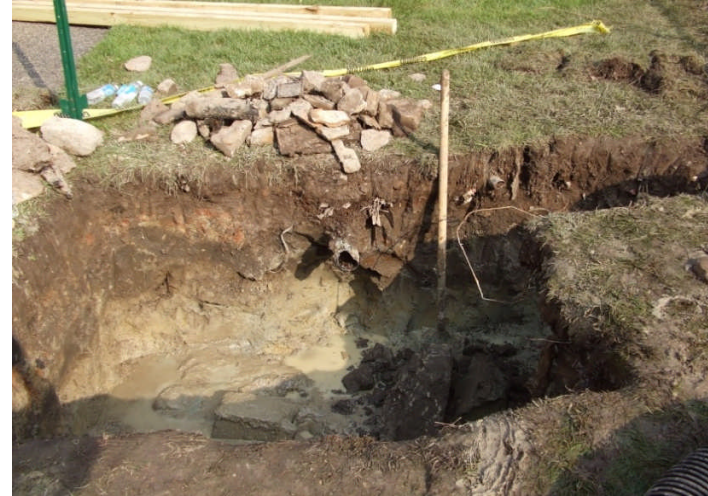
Photo 16: Initial extent of Area 5.

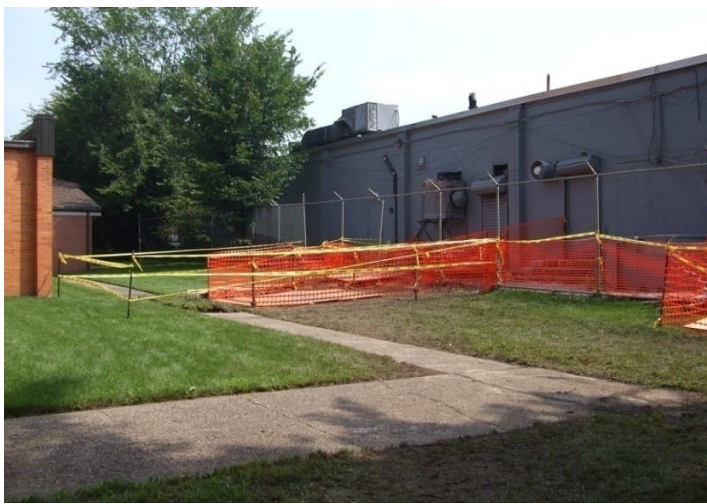
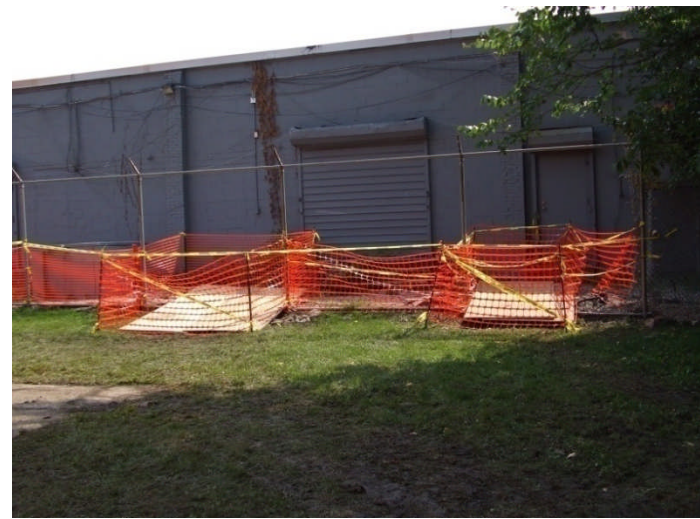
Photo 17: Typical secured site at end of work day.

Photo 18: Typical secured site at end of work day.

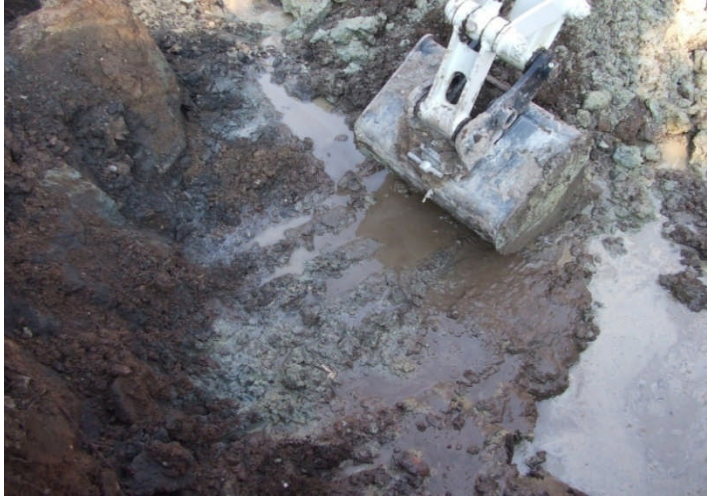
Photo 19: Additional grayish-stained soil uncovered at Area 5.

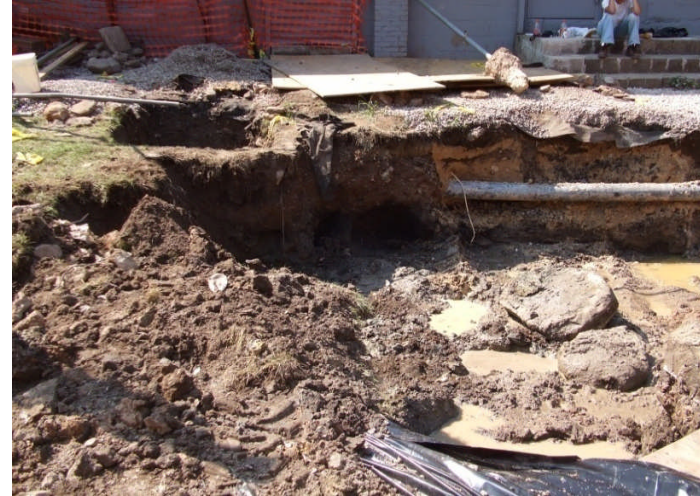
Photo 20: Southeast corner of Area 5 prior to Area 5 and Area 3 merging into one excavation area.

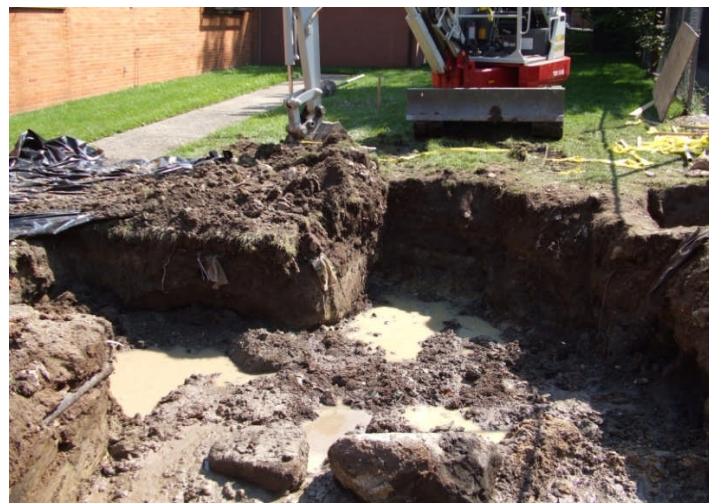
Photo 21: Additional excavation of eastern sidewall of Area 5.

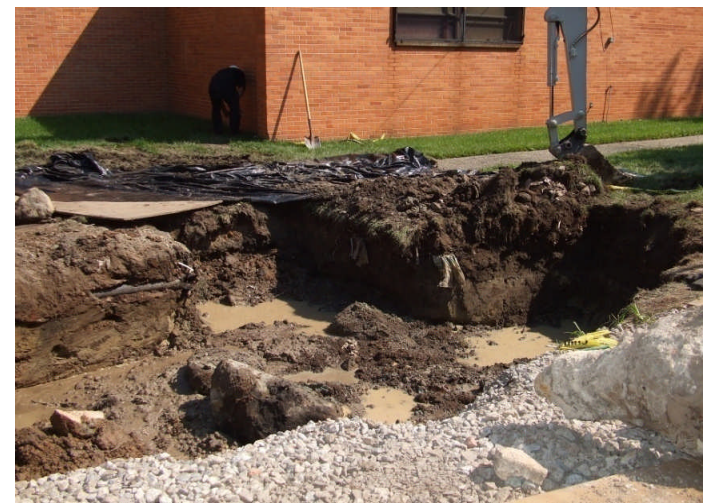
Photo 22: Approximate final extents of northern and eastern sidewalls of Area 5.

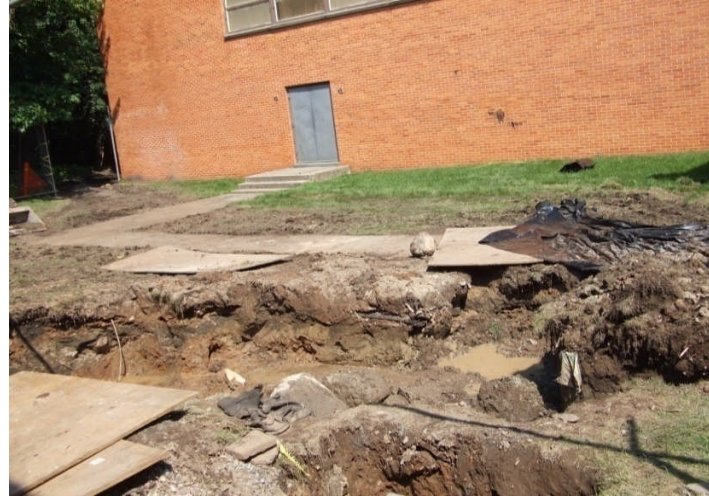
Photo 23: Approximate final extent of northwestern corner of Area 5.

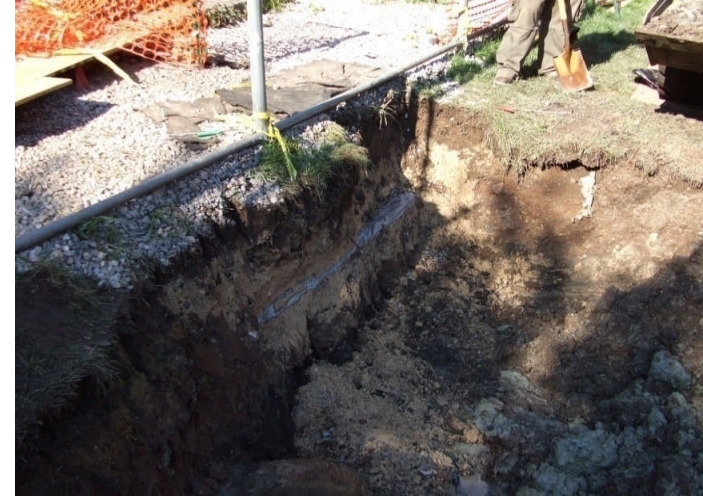
Photo 24: Approximate final extent of southwestern corner of Area 5.

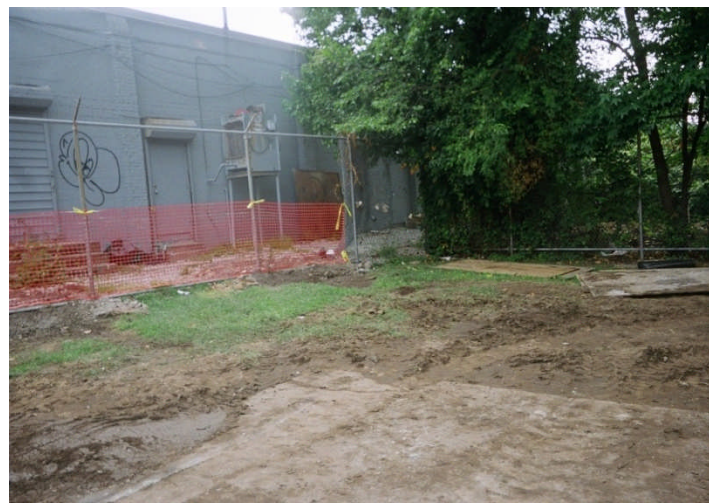
Photo 25: Area 1 and Area 2 backfilled.

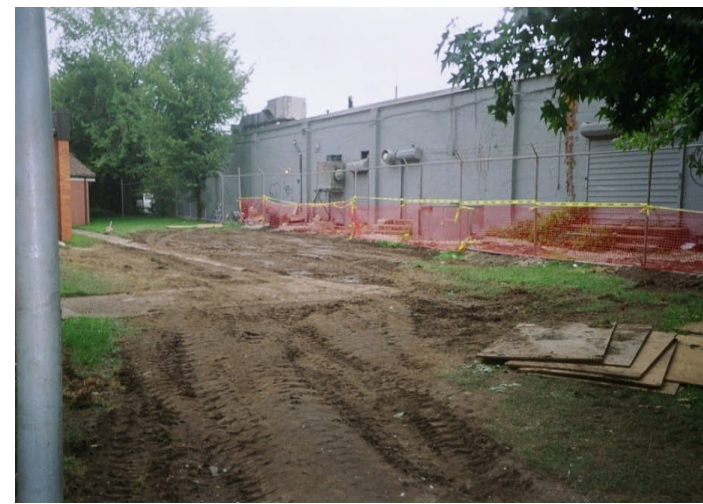
Photo 26: Site restoration.
