DAILY STATUS REPORT

Langan Project No:	100849501	Project:	990 Rossville Ave	Date:	9/9/2021
NYSDEC BCP Site No:	C243043			Time:	5:45 – 15:45

Langan Engineering, Environmental, Surveying,
Landscape Architecture and Geology, D.P.C.

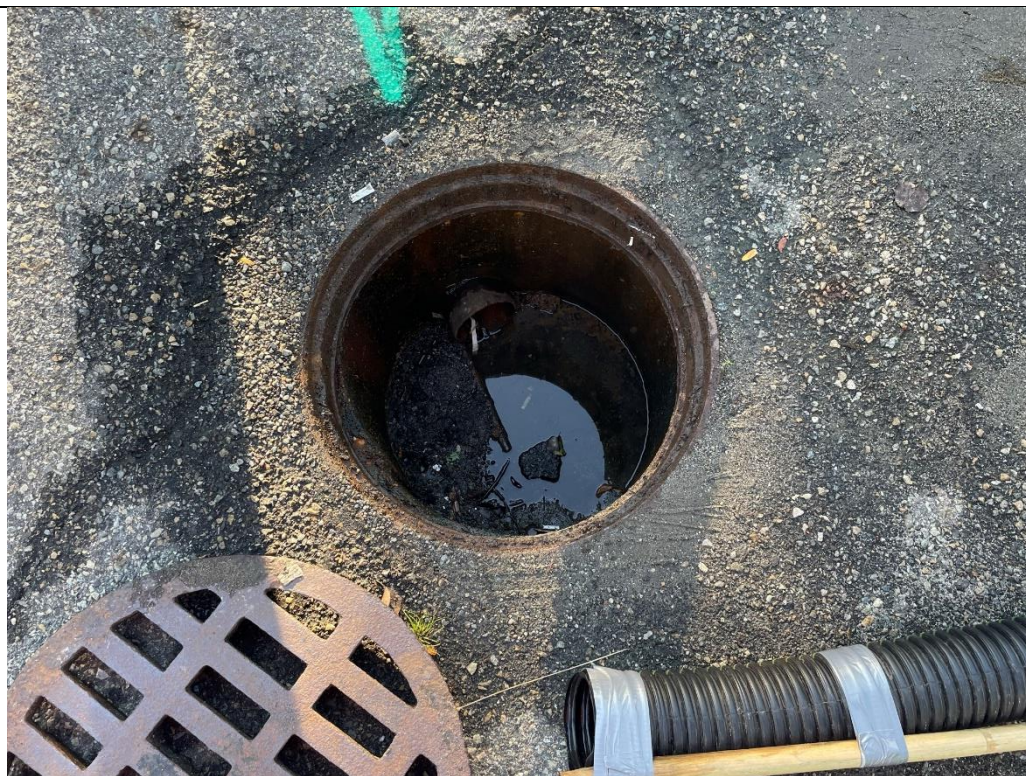
Photo 2 – View of the southern catch basin within the vicinity of the drywell prior to cleaning and video inspection, facing southwest.

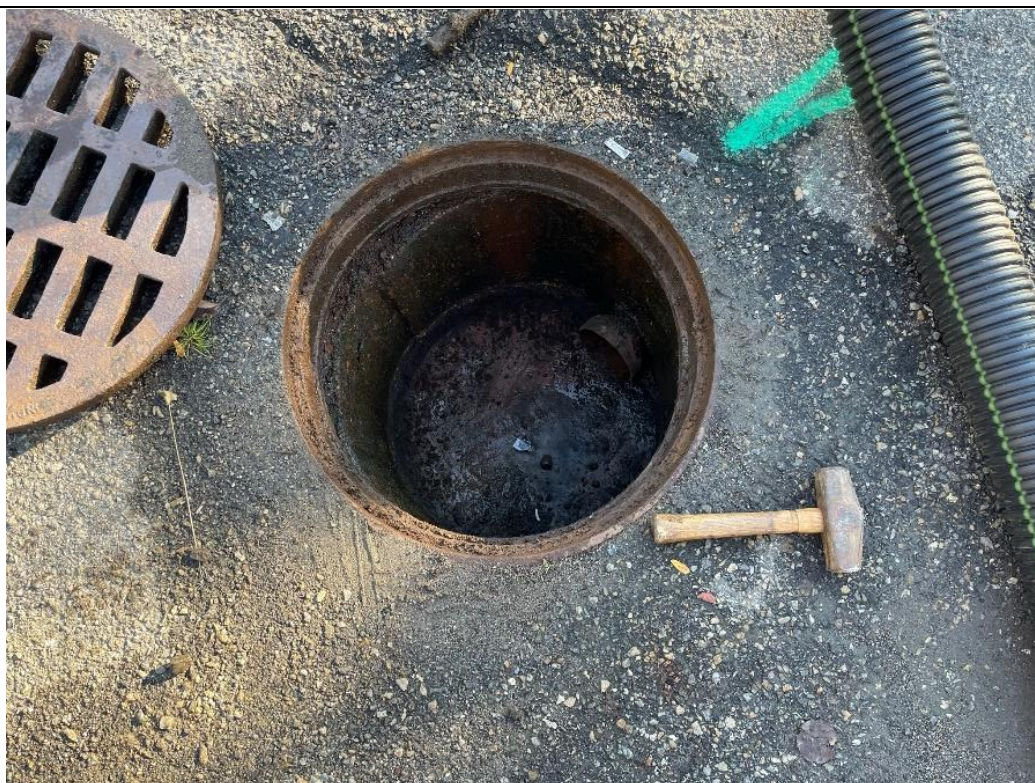
Photo 3 – View of the southern catch basin within the vicinity of the drywell after cleaning by EISCO, facing southwest.

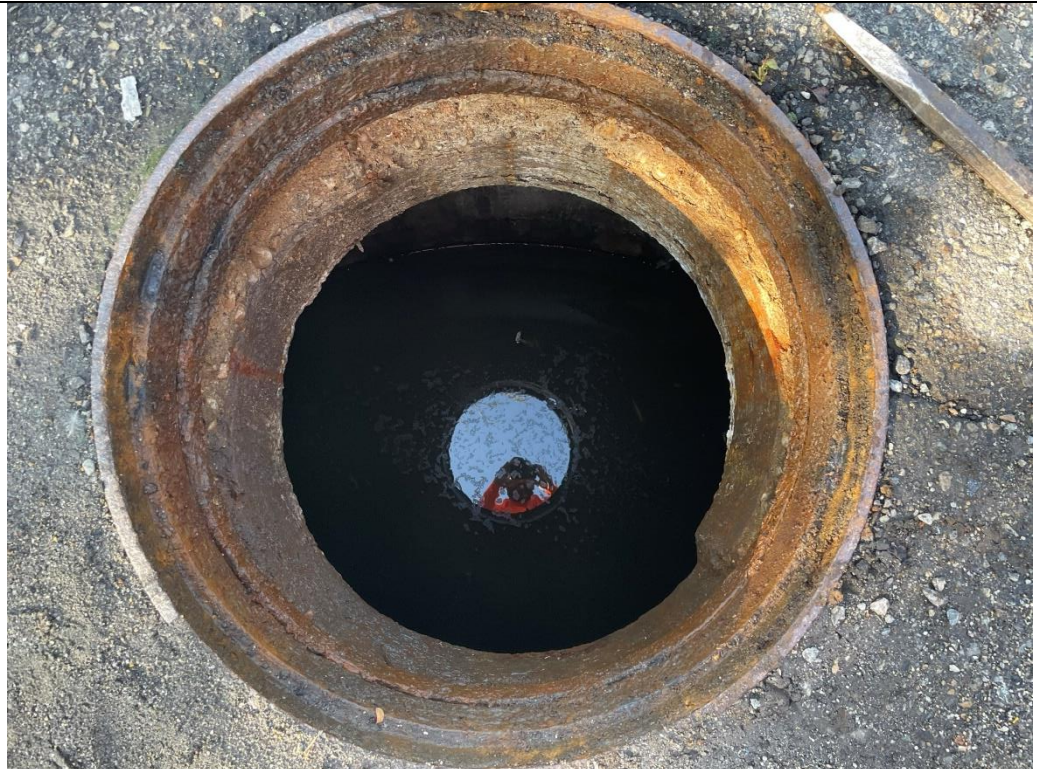
- The invert of the 12-inch diameter pipe leading into the dry well was identified at approximately 5-feet bgs. Due to limited accessibility and health and safety concerns, the piping could not be video inspected, however based on its orientation within the well it appears to run towards the southeast corner of the shopping center building, towards the building's rooftop drainage system.

Photo 6 - View of the drywell located within the southern portion of the site prior to cleaning by EISCO, facing south.

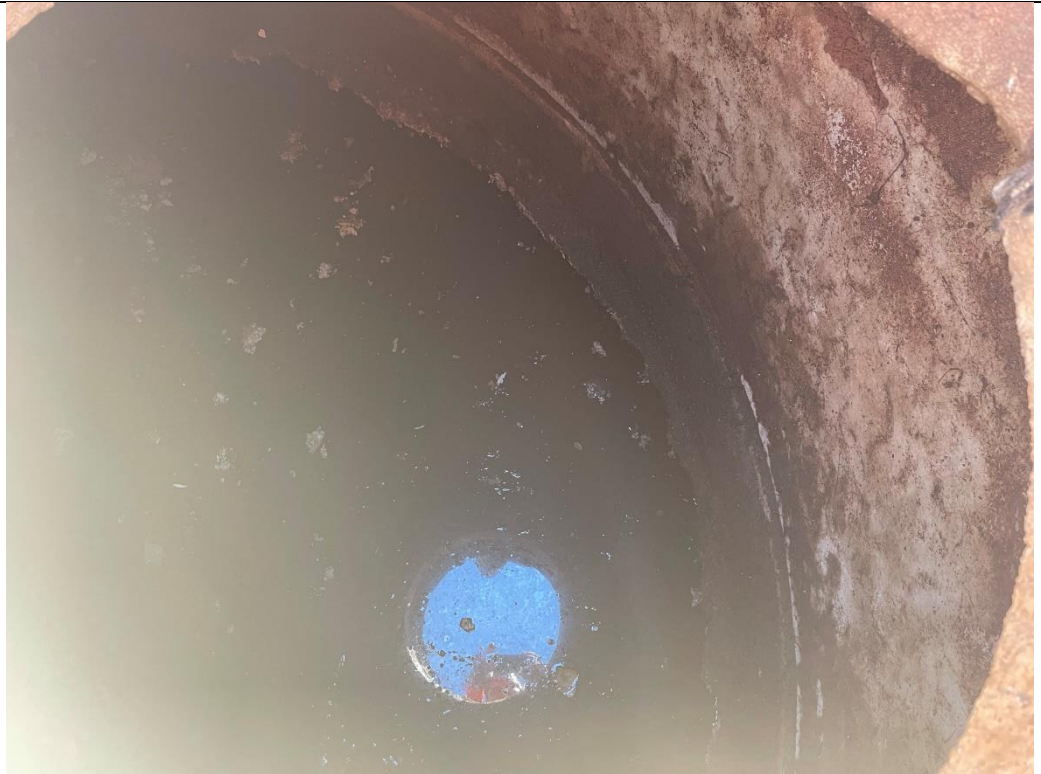
Photo 7 – View of the drywell after cleaning by EISCO. The walls of the drywell appear to be in good condition with no visible cracking, facing northeast.

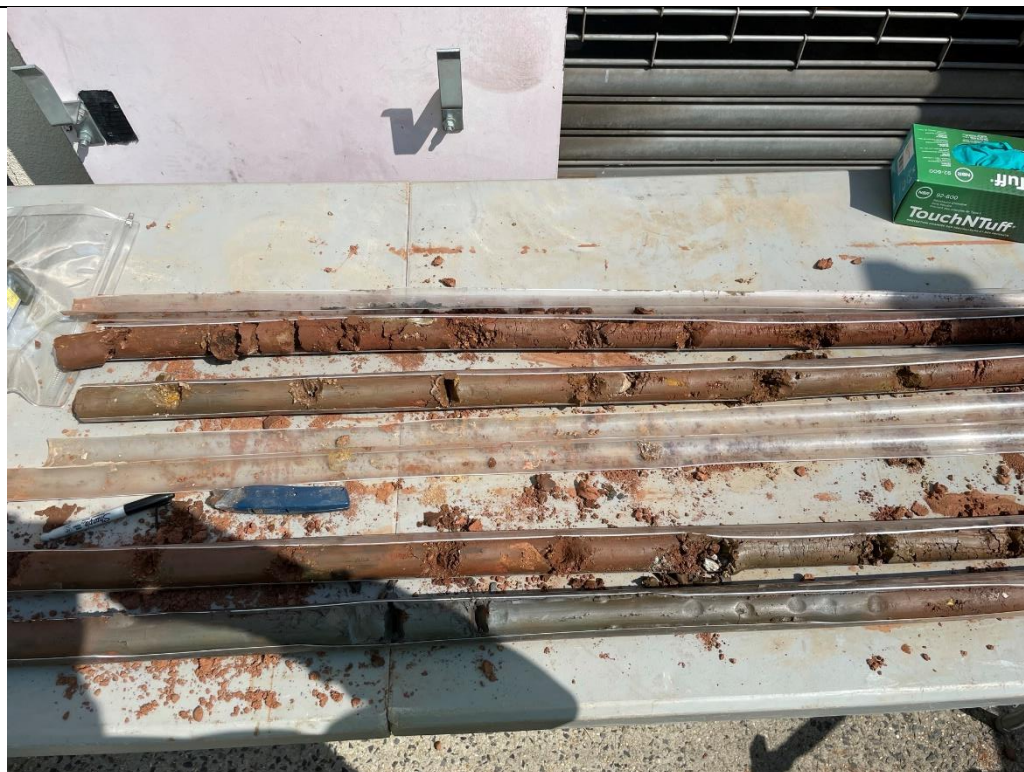
Photo 2 – View of material from LSB-13 within the western portion of the site, facing east.

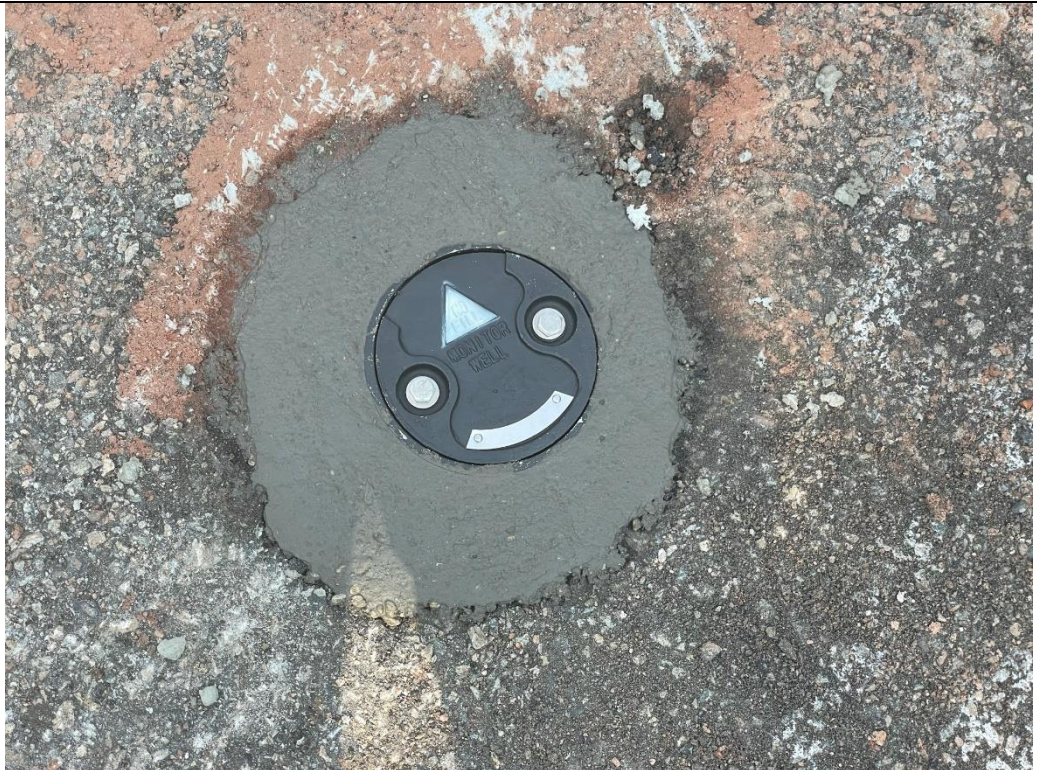
Photo 4 – View of completed installation of LMW-11A within the southern portion of the site, facing north.

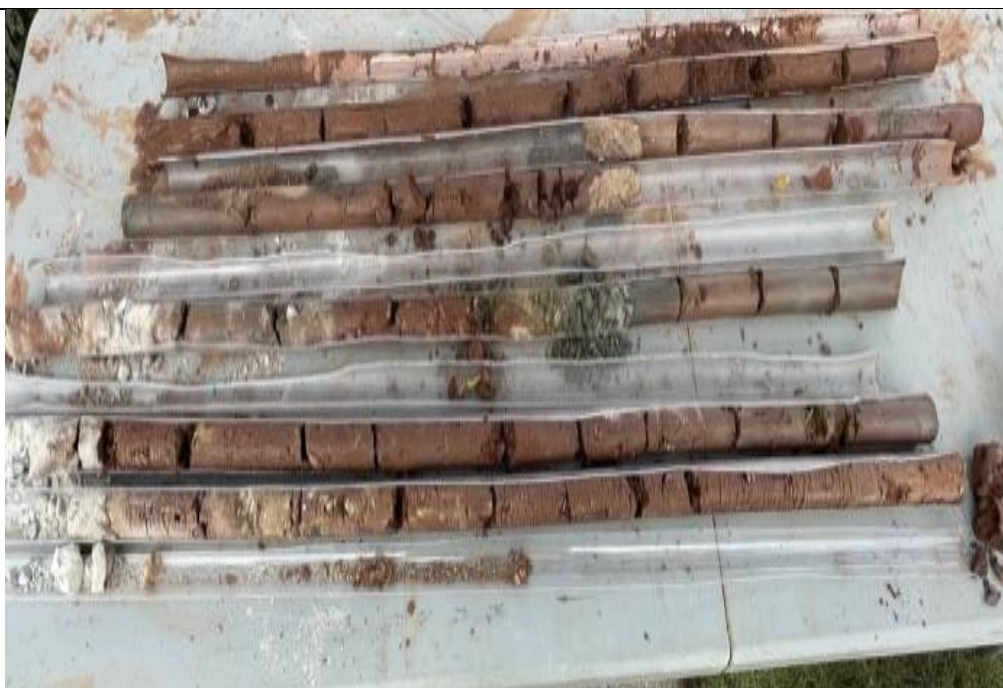
Photo 3 – View of material from LSB-11, facing north.

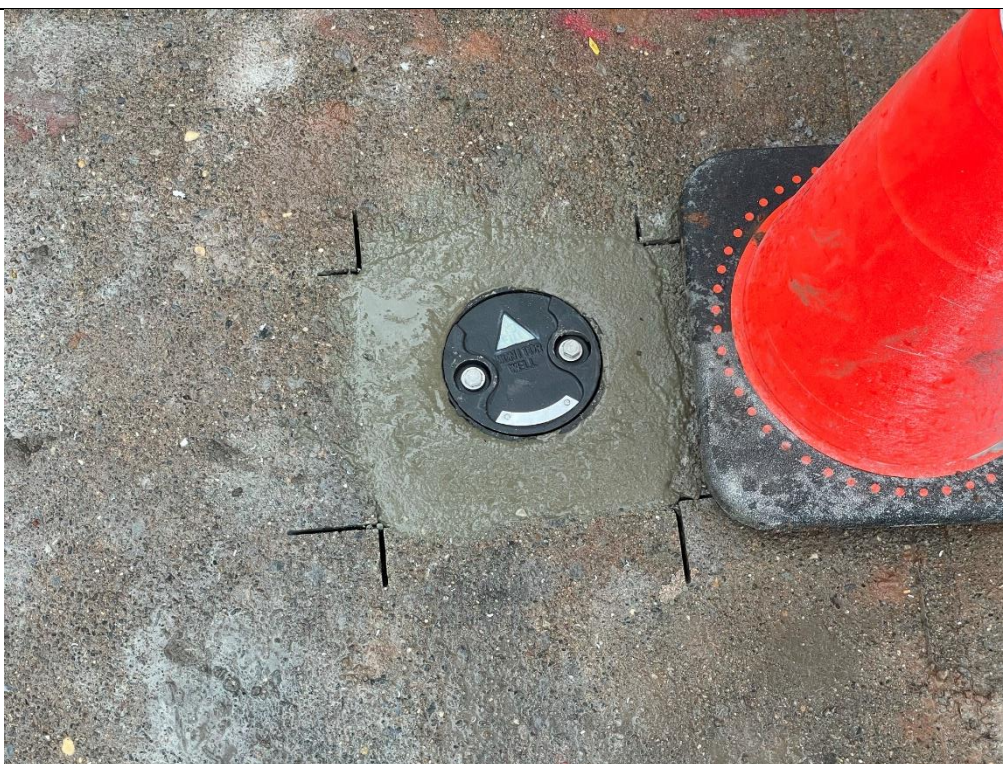
Photo 4 – View of fully installed monitoring well LMW-8, facing north.

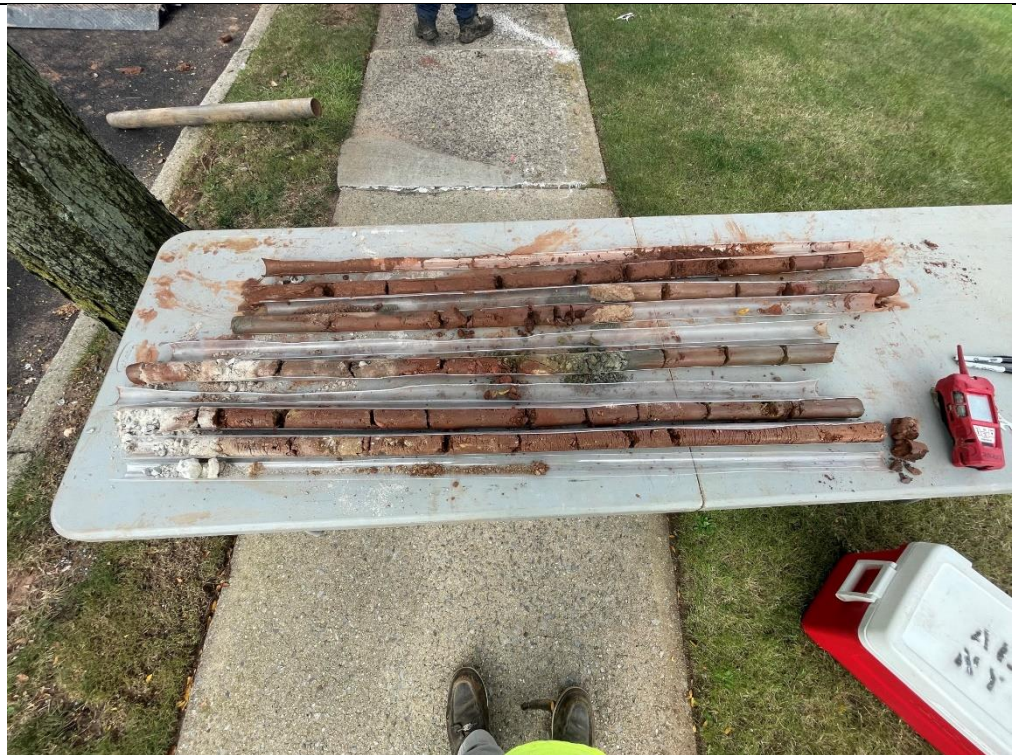
Photo 4 – View of material from LSB-21, facing west.

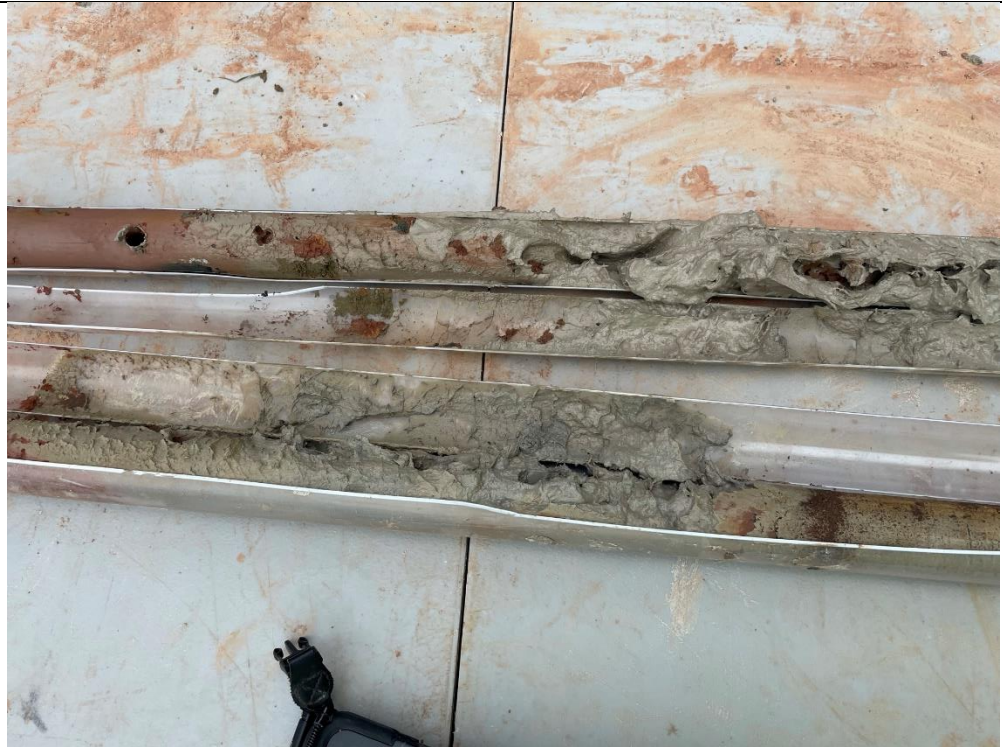
Photo 3 – View of material collected from LSB-21, facing west.

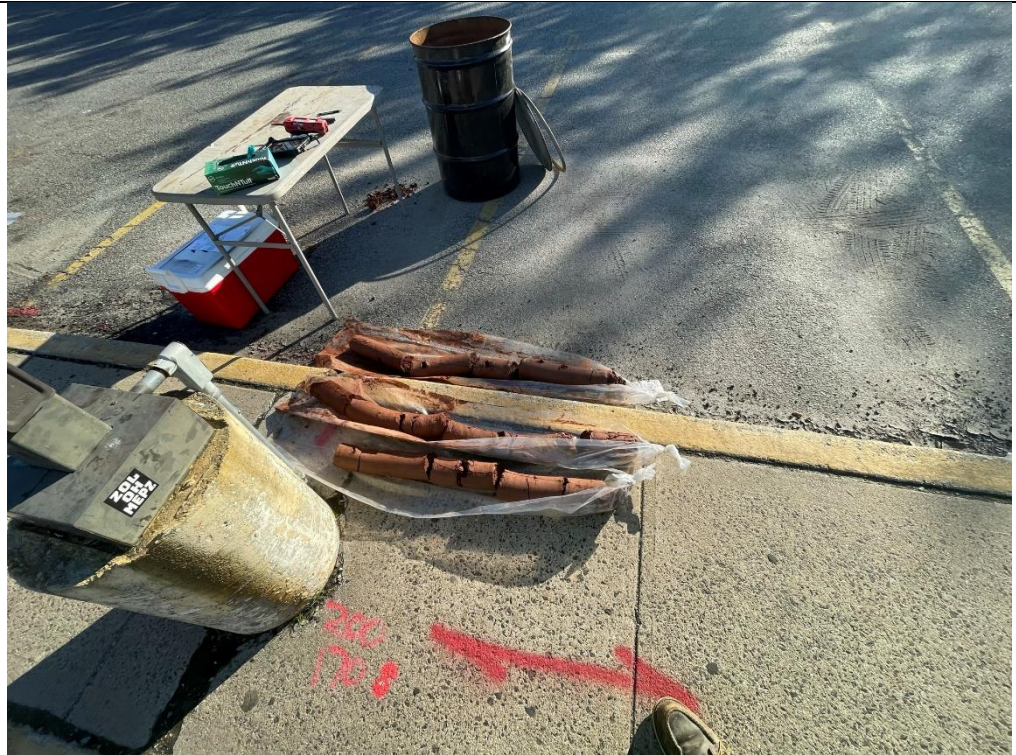
Photo 3 – View of material from LSB-17, facing east.

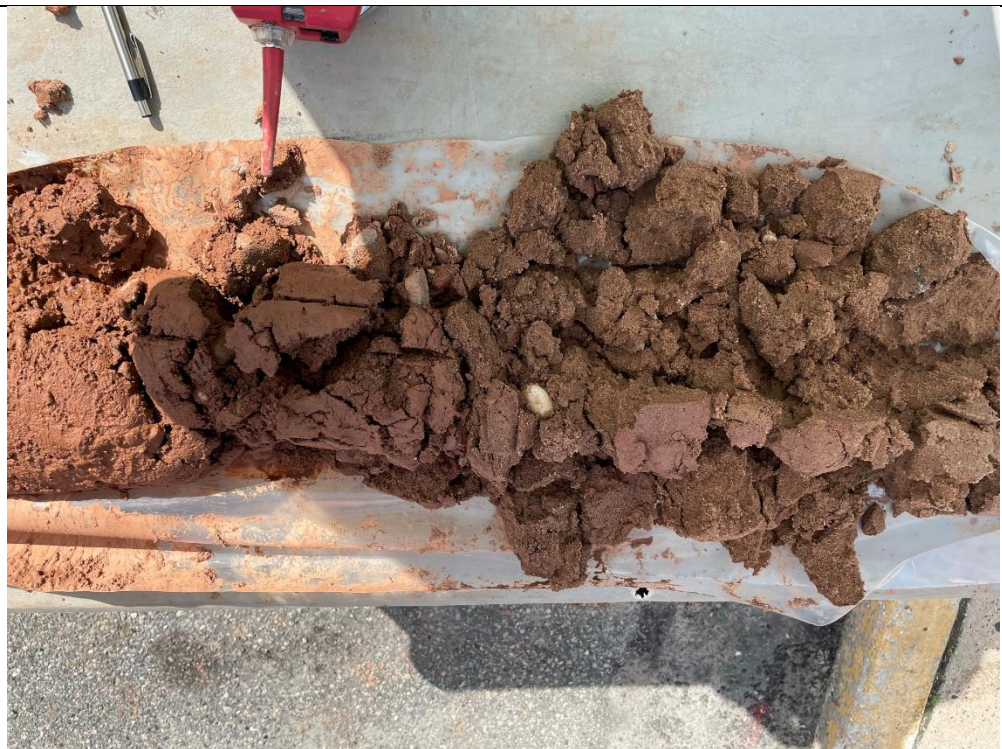
Photo 4 – View of sand encountered within LSB-17 at 37-foot bgs, facing west.

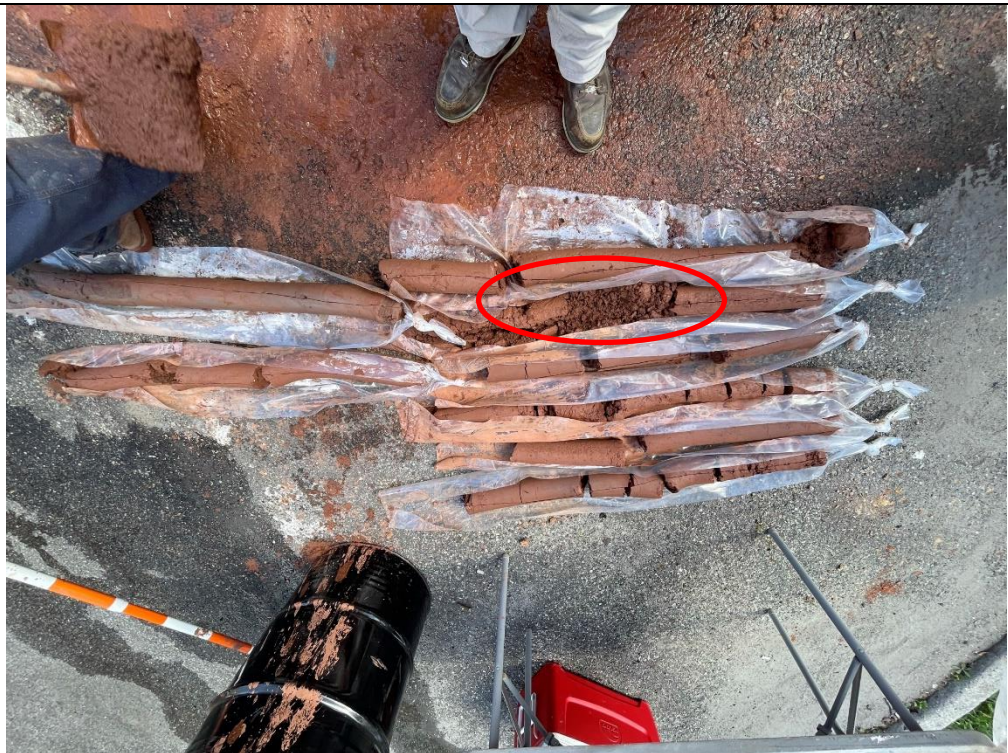
Photo 2 – View of material from LSB-16 with circled area showing the undifferentiated sand encountered at 31 feet bgs, facing southwest.

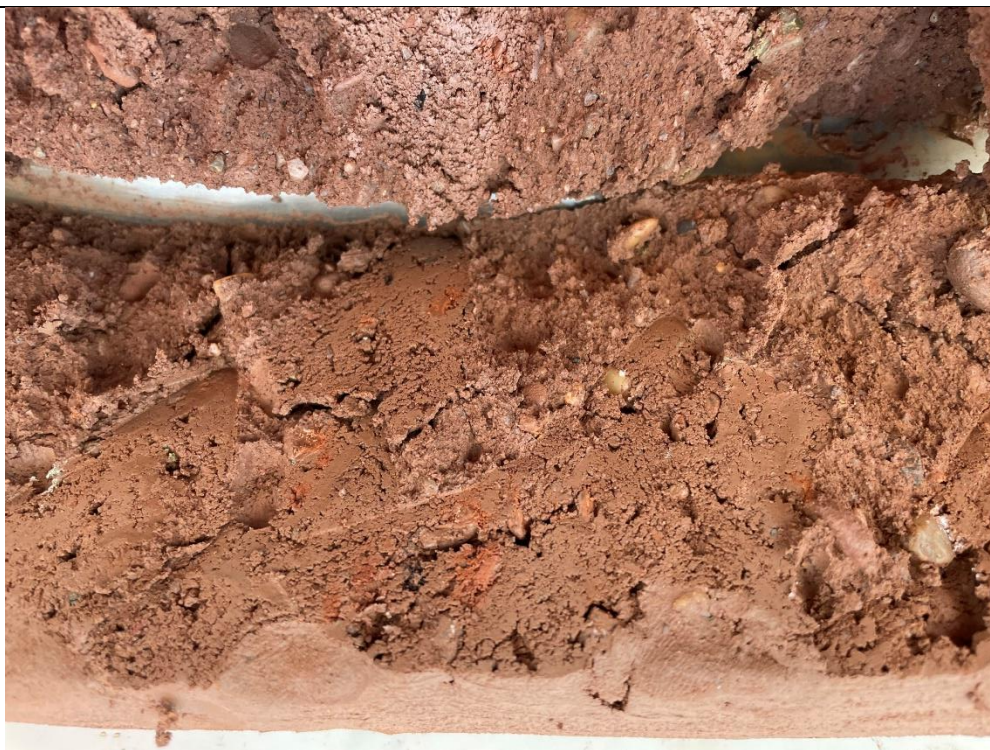
Photo 3 – View of a second confining clay layer at 65 feet bgs identified below the undifferentiated sand within LSB-17, facing east.

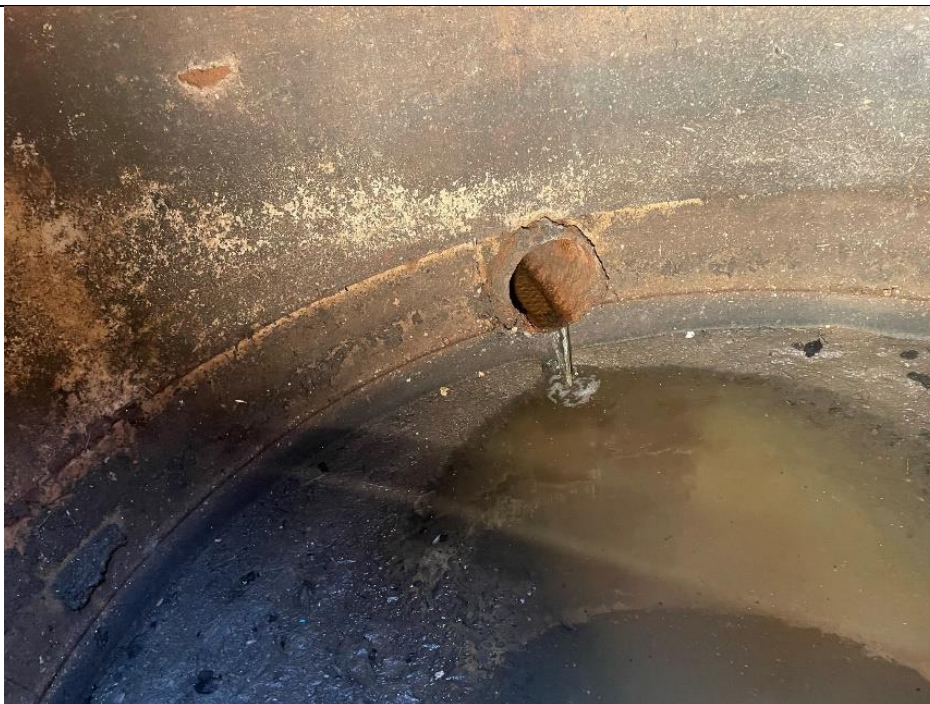
Photo 2 – View of dye test conducted tracing the roof drains to the dry well, facing northwest.

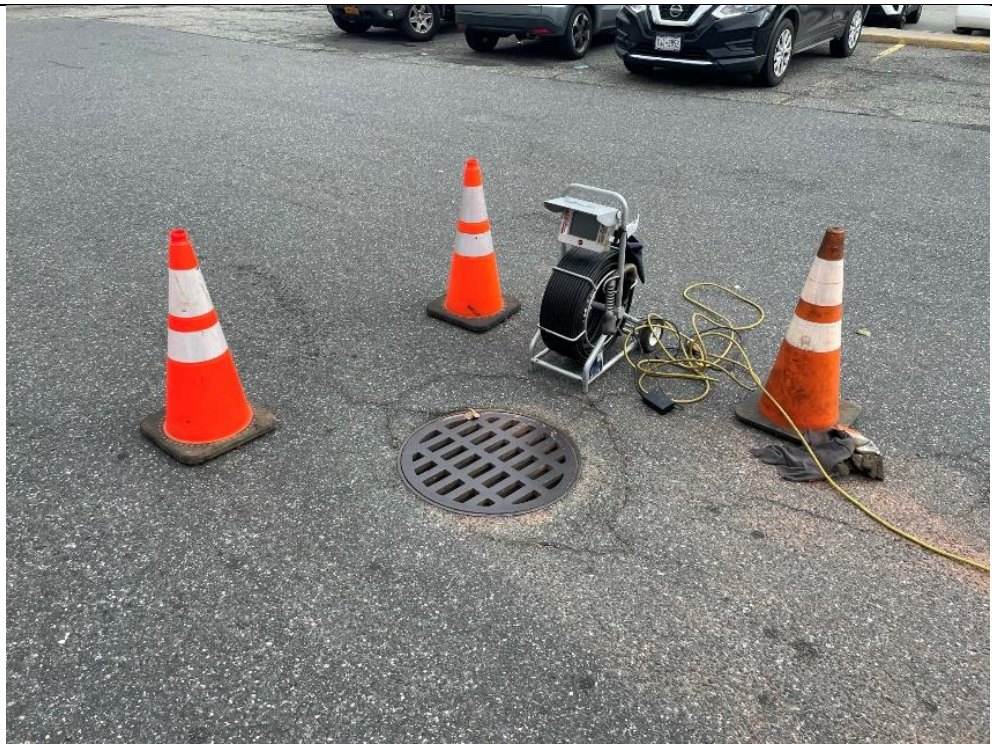
Photo 3 – View of the catch basin located in front of the hair salon with video inspection equipment visible, facing northeast.

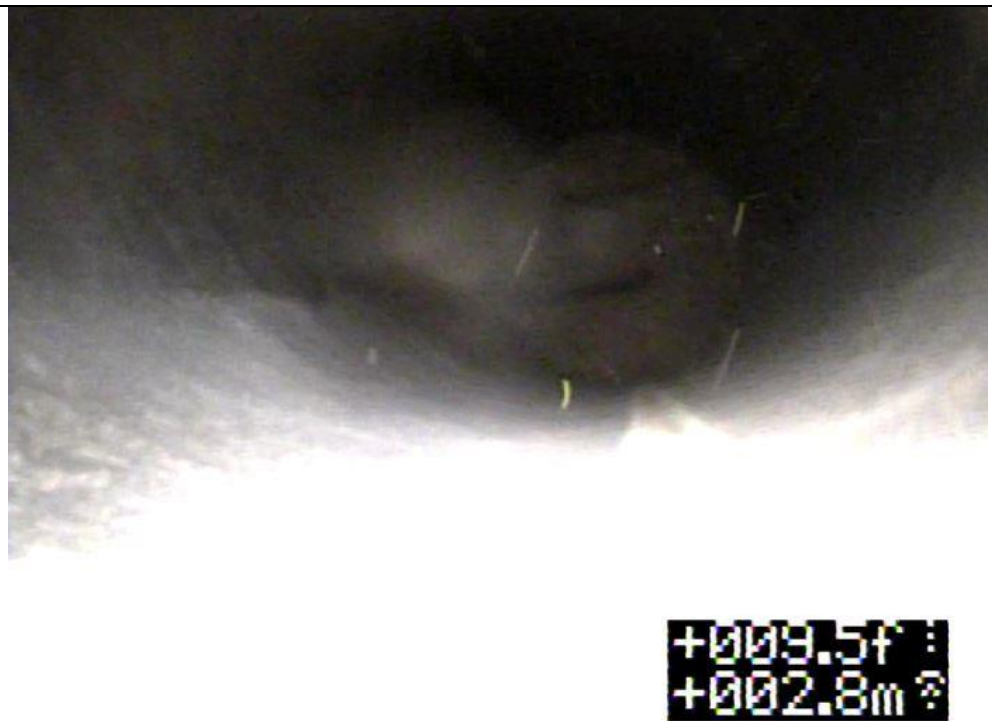
- A sewer connection from the southernmost catch basin was identified crossing the southern site boundary and leading to both a main sewer connection and overflow basin below Grafe Street. The piping connection to the main sewer and overflow basin were video inspected and observed to be in good condition. Cracks in the piping were not observed.

Photo 4 – View of the drainage pipe leading to the sewer connection from the southern drainage basin, facing south.

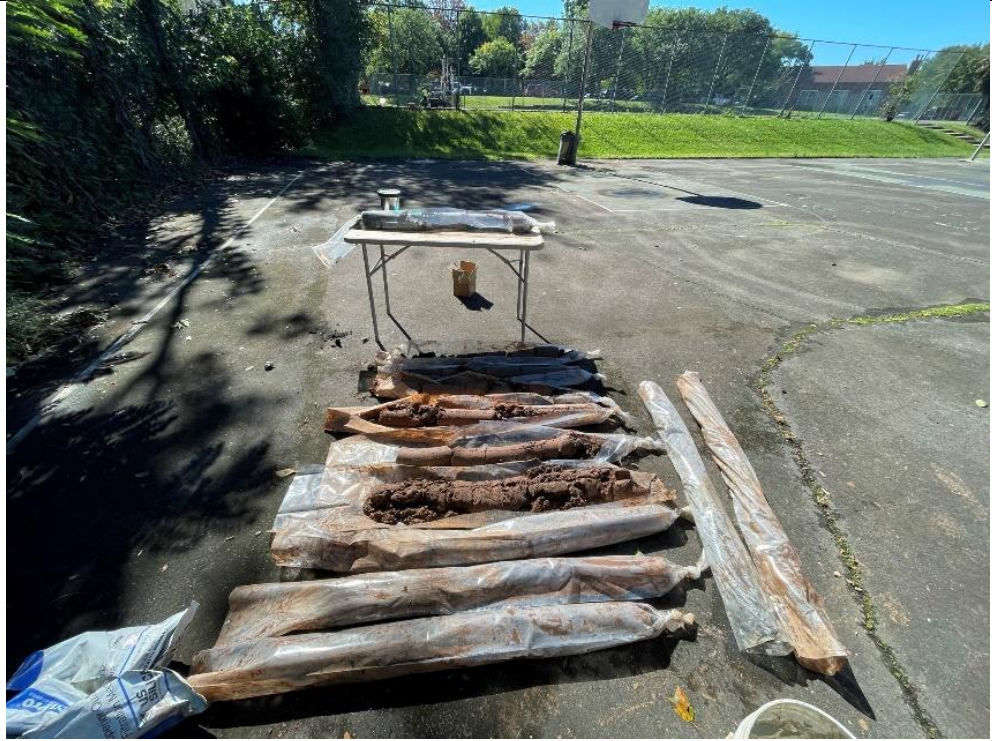
Photo 3 – View of material from LSB-19, facing south.
