**Phase I Environmental Assessment
for
475 Bay Street, AKA Block 488 Lot 9
Staten Island, New York 10304
Inspection 20011005**

**AVT ENTERPRISES
PO Box 280-291
Brooklyn, New York 11228
(718) 921-0430**

Executive Summary

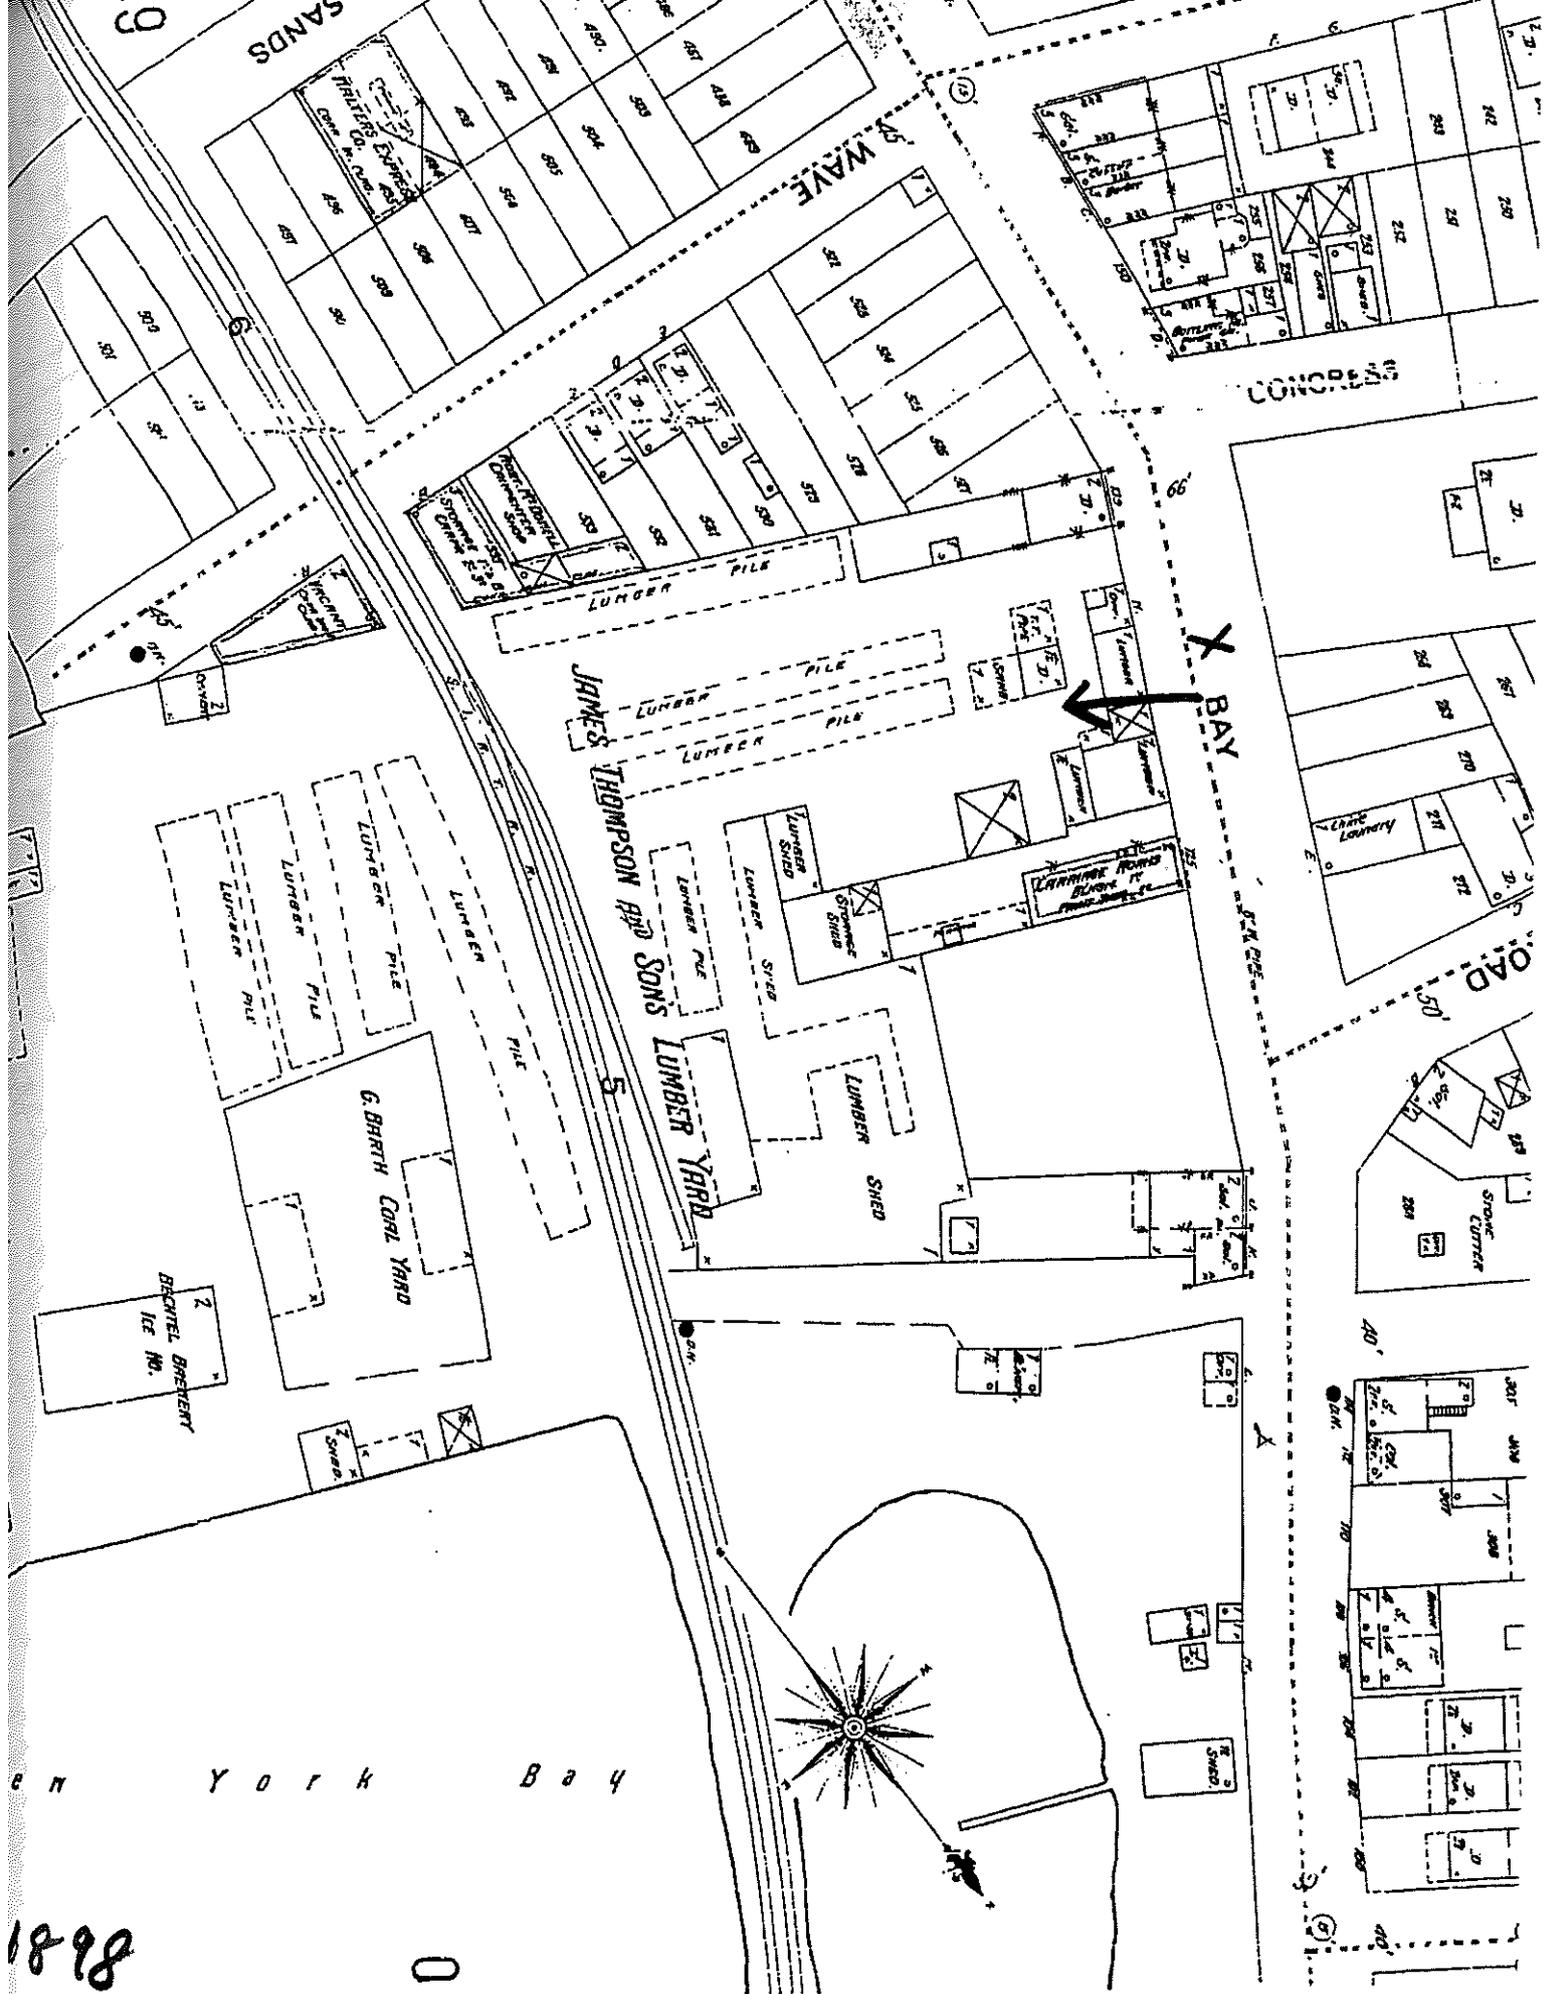
The 1898 map shows the subject property as the James Thompson and Sons Lumber Yard. Surrounding properties are primarily commercial and industrial properties. The G. Barth Coal Yard is adjoining the subject property to the East.

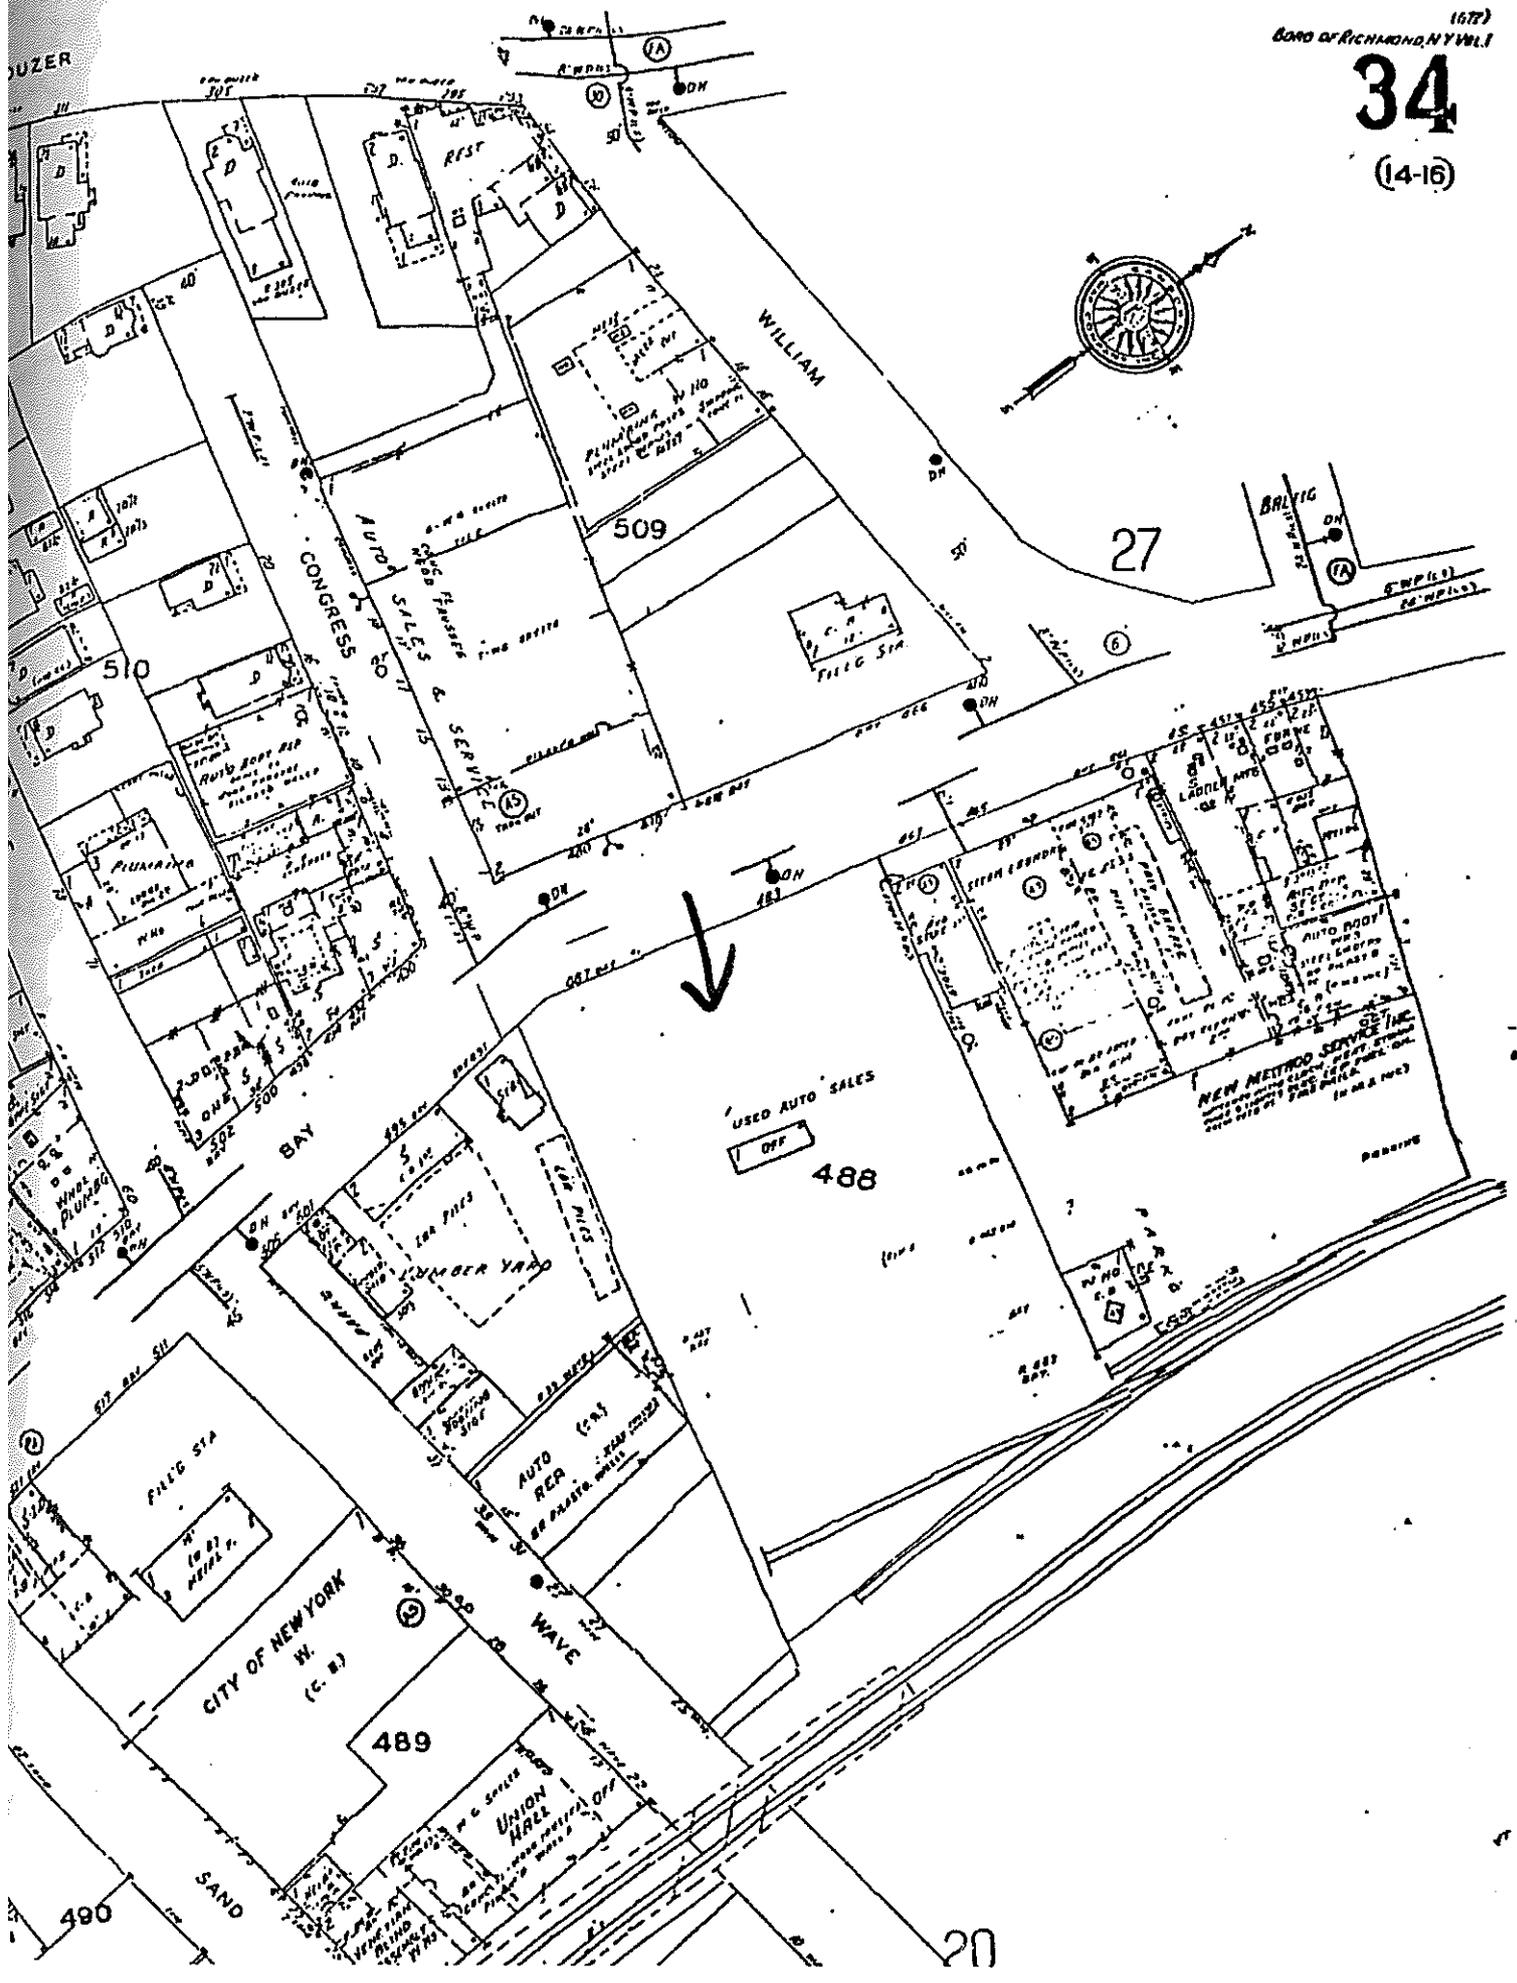
1981

The maps from 1977 and on show the subject property as it is today, vacant. There are indications that a local car dealer was storing cars on the property. Surrounding properties are still a mix of commercial and industrial uses.
