**2022 PERIODIC REVIEW REPORT**

**FORMER A.C. DUTTON LUMBER YARD  
DUTCHESS COUNTY, NEW YORK**

**NYSDEC Site # C314081**

**REPORTING PERIOD April 1, 2021 – April 1, 2022**

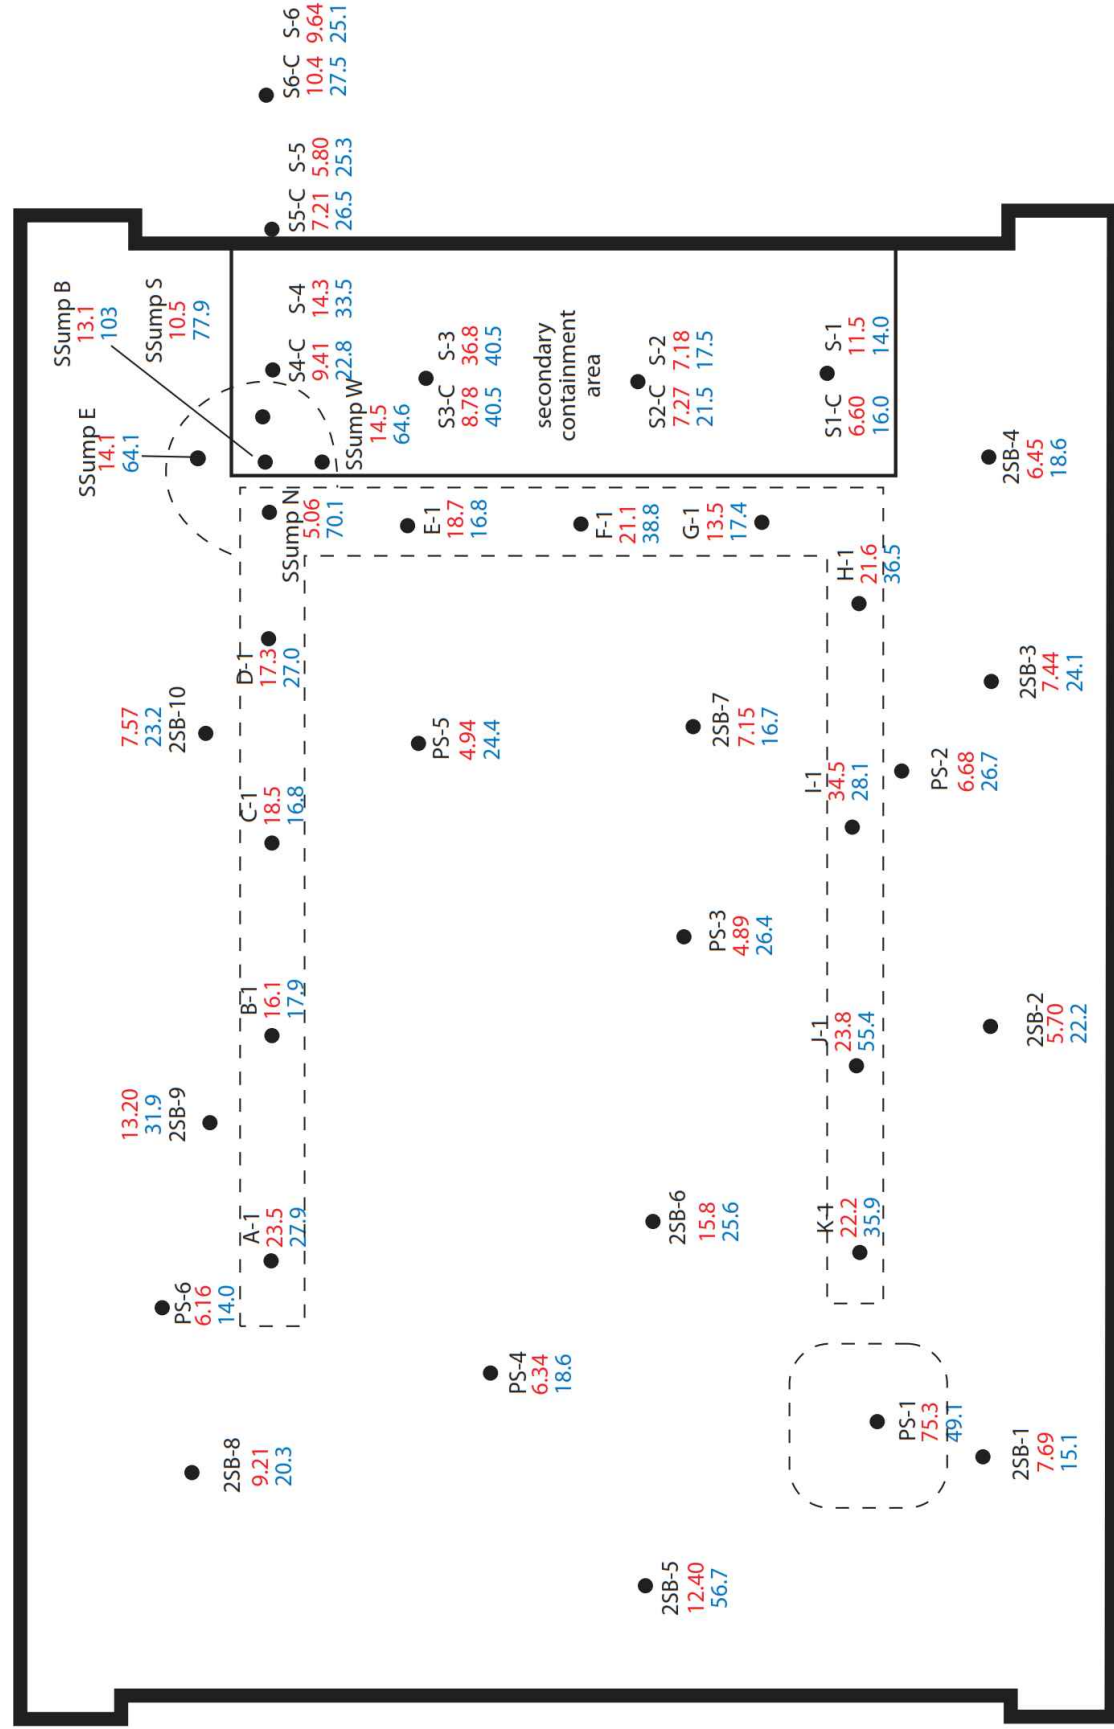
**FIG. 1.7C**

2SB = subslab soil sample 9/24/2012  
 PS = post scarification concrete sample 9/04/2012  
 B and B# = post excavation end point soil sample 10/11/2012 and 10/17/2012  
 S#-C = secondary containment concrete sample 11/19/2012  
 S# = secondary containment subconcrete soil sample 11/19/2012  
 SSump# = sump endpoint sample 11/19/2012
