# **PERIODIC REVIEW REPORT**

**Former Drive & Park, Inc. Site  
Brownfield Cleanup Program #C314111  
28 IBM Road  
Poughkeepsie, New York**

December 3, 2012

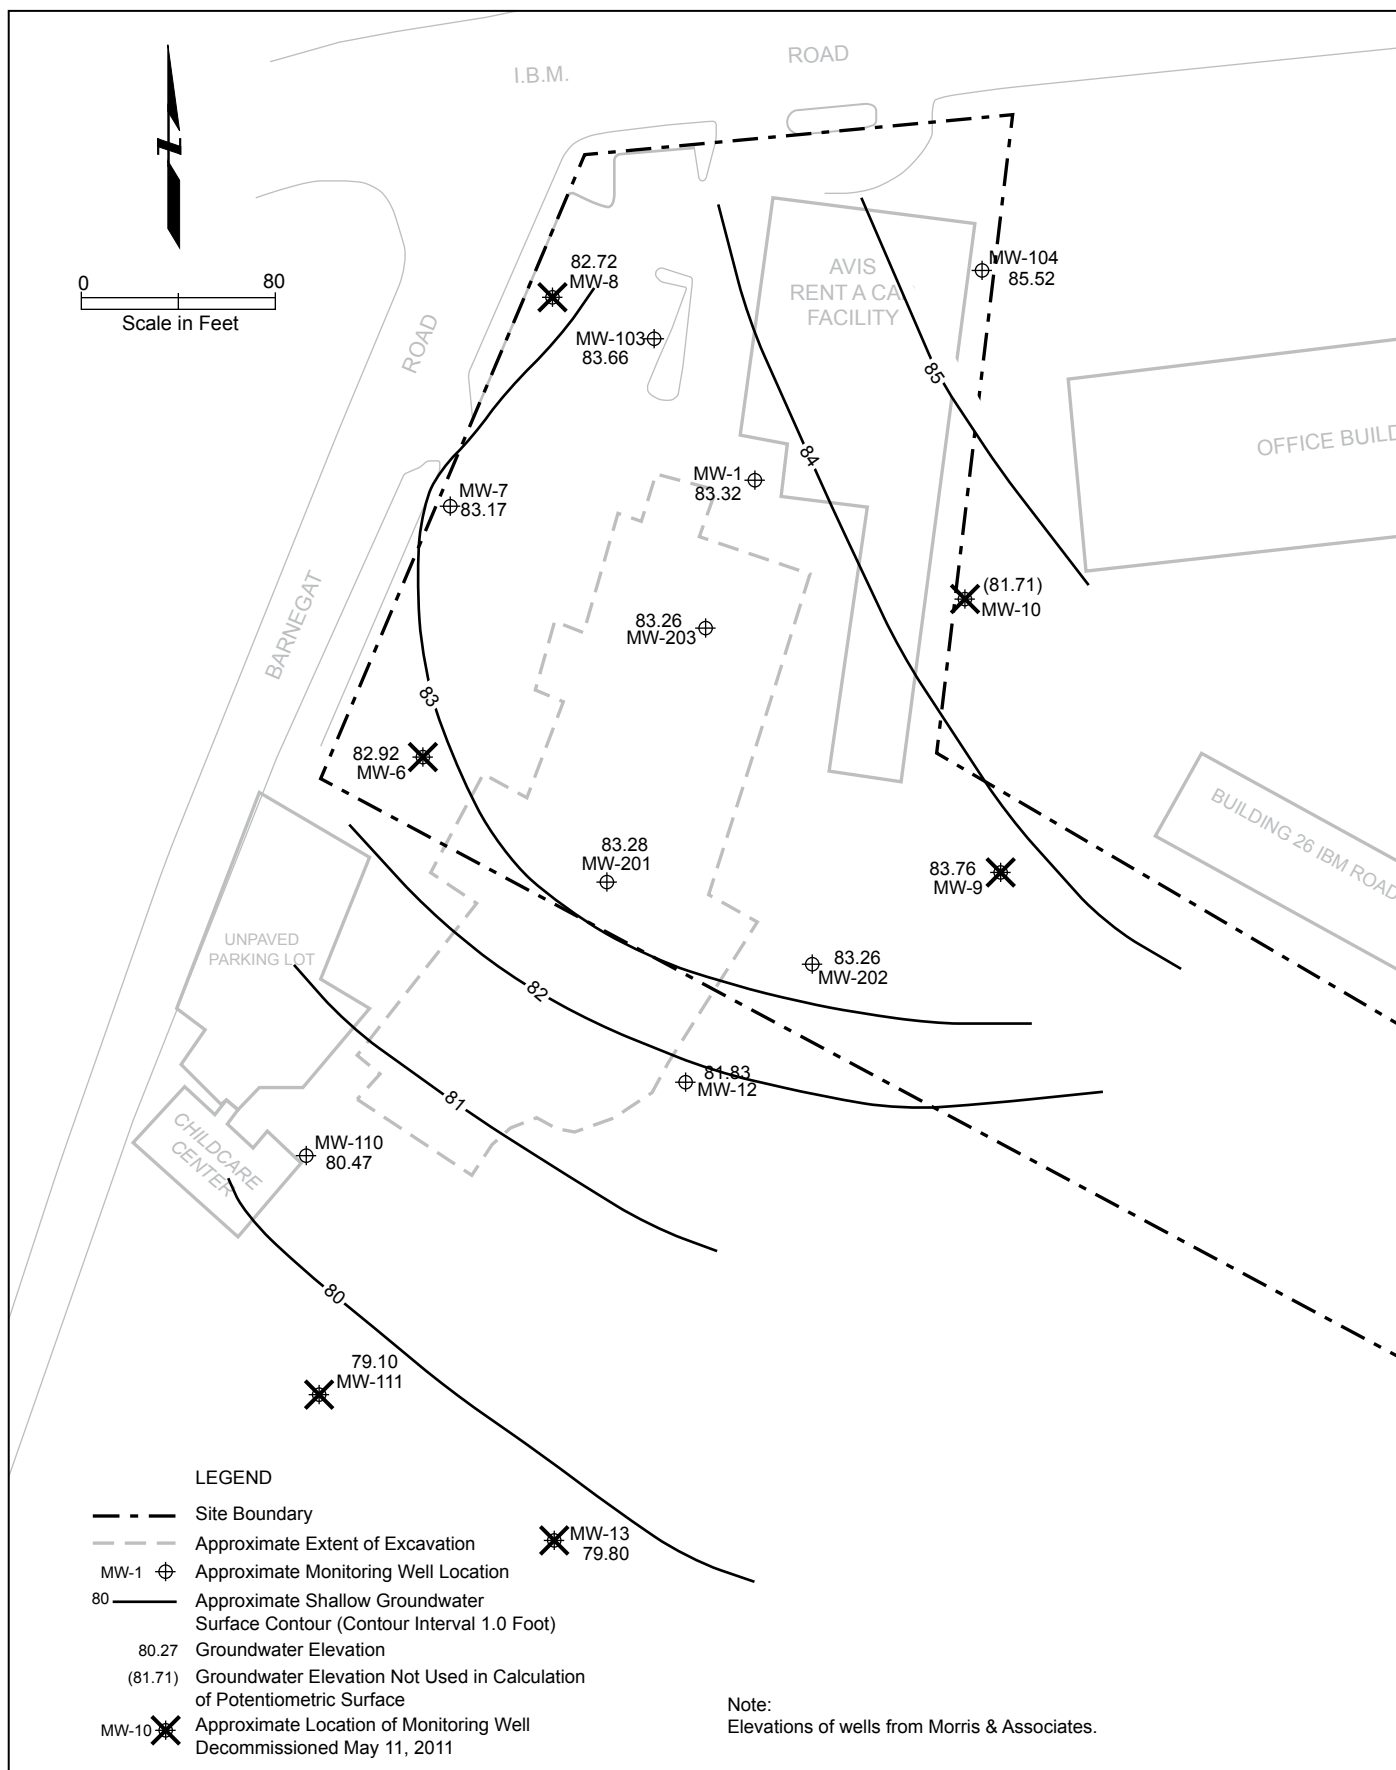
A potentiometric surface map is presented in Figure 2. Similar to previous monitoring events, the interpreted direction of the lateral hydraulic gradient was generally to the southwest, with a magnitude of approximately 0.01 ft/ft.

Groundwater samples were collected from onsite monitoring wells MW-1, MW-201, and MW-203, and offsite monitoring wells MW-12 and MW-110. Monitoring well locations are shown in Figure 2. Groundwater samples were collected from the monitoring wells on May 11 and 12, 2011.
