# **REMEDIAL INVESTIGATION WORKPLAN**

**“LONG DOCK BEACON”  
RED FLYNN DRIVE, CITY OF BEACON  
DUTCHESS COUNTY, NEW YORK**

**NYSDEC Brownfields Program Site: C314112**

**Date of Preparation: March 2005  
Revised August 2006**

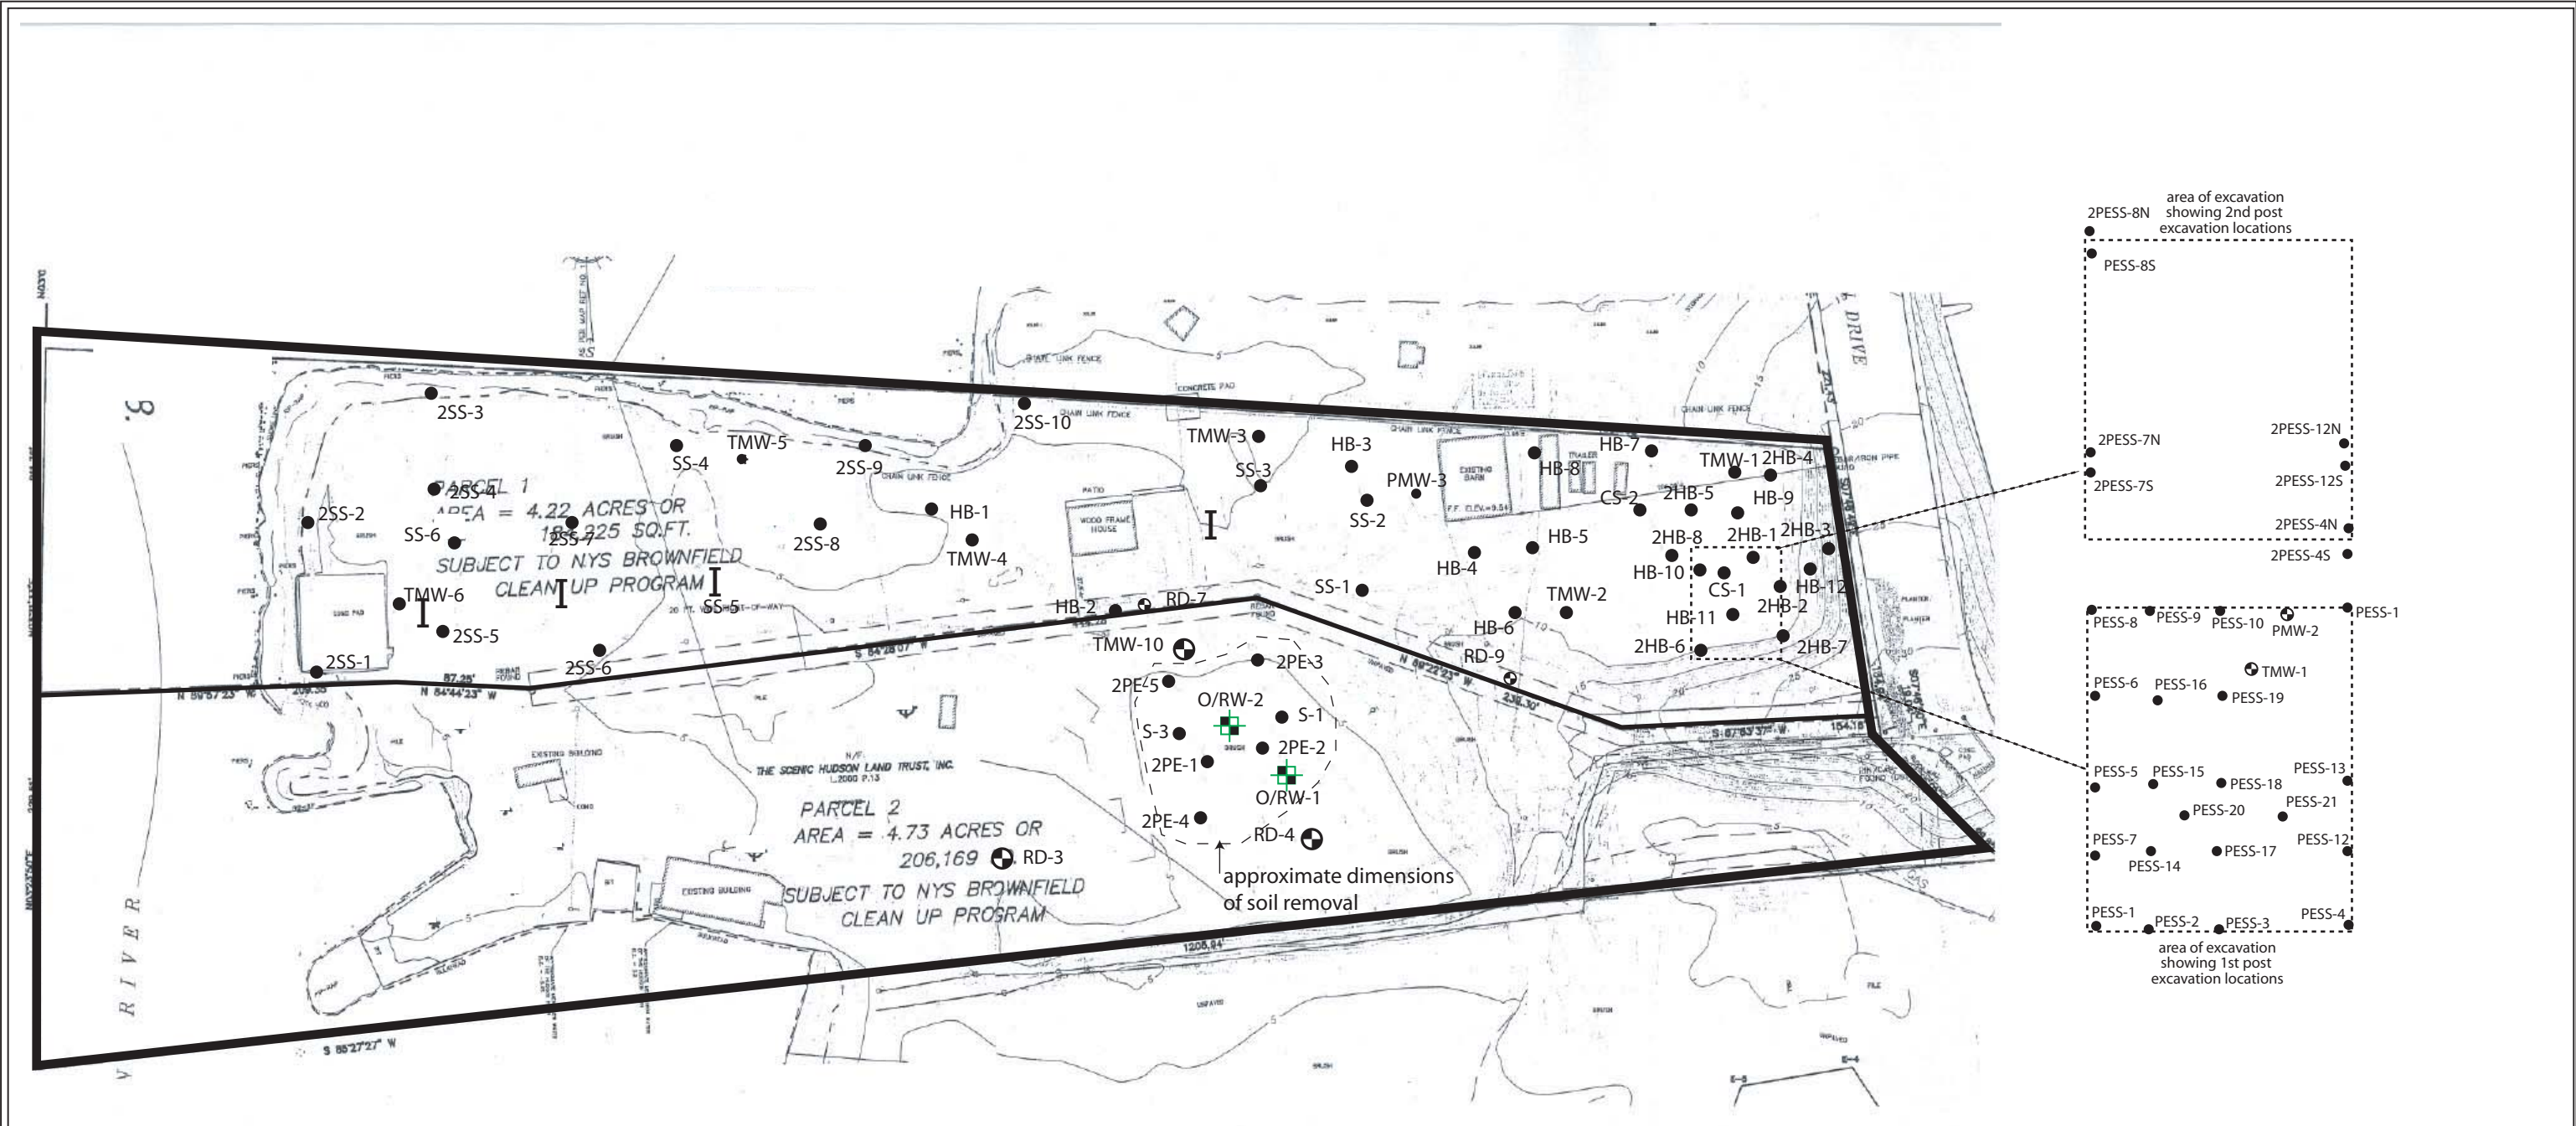
FIGURE 2

I Archaeological Test Pits (December 2004)

Four trenches were extended at locations between the western concrete pad and the barn in December 2004 as part of an archeological investigation. The NYSDEC Program Manager was present during the fieldwork. Soil samples were collected for VOCs, SVOCs, PCBs/Pesticides and metals. Evidence of low-level petroleum impacts was observed at each trench and pieces of copper fuel lines were discovered at the westernmost trench. Low-grade PAH and metal contamination was detected throughout the study area. Low concentrations of PCBs (below guidance levels) were detected near the western end of the barn. No VOCs or pesticides were detected in any sample.

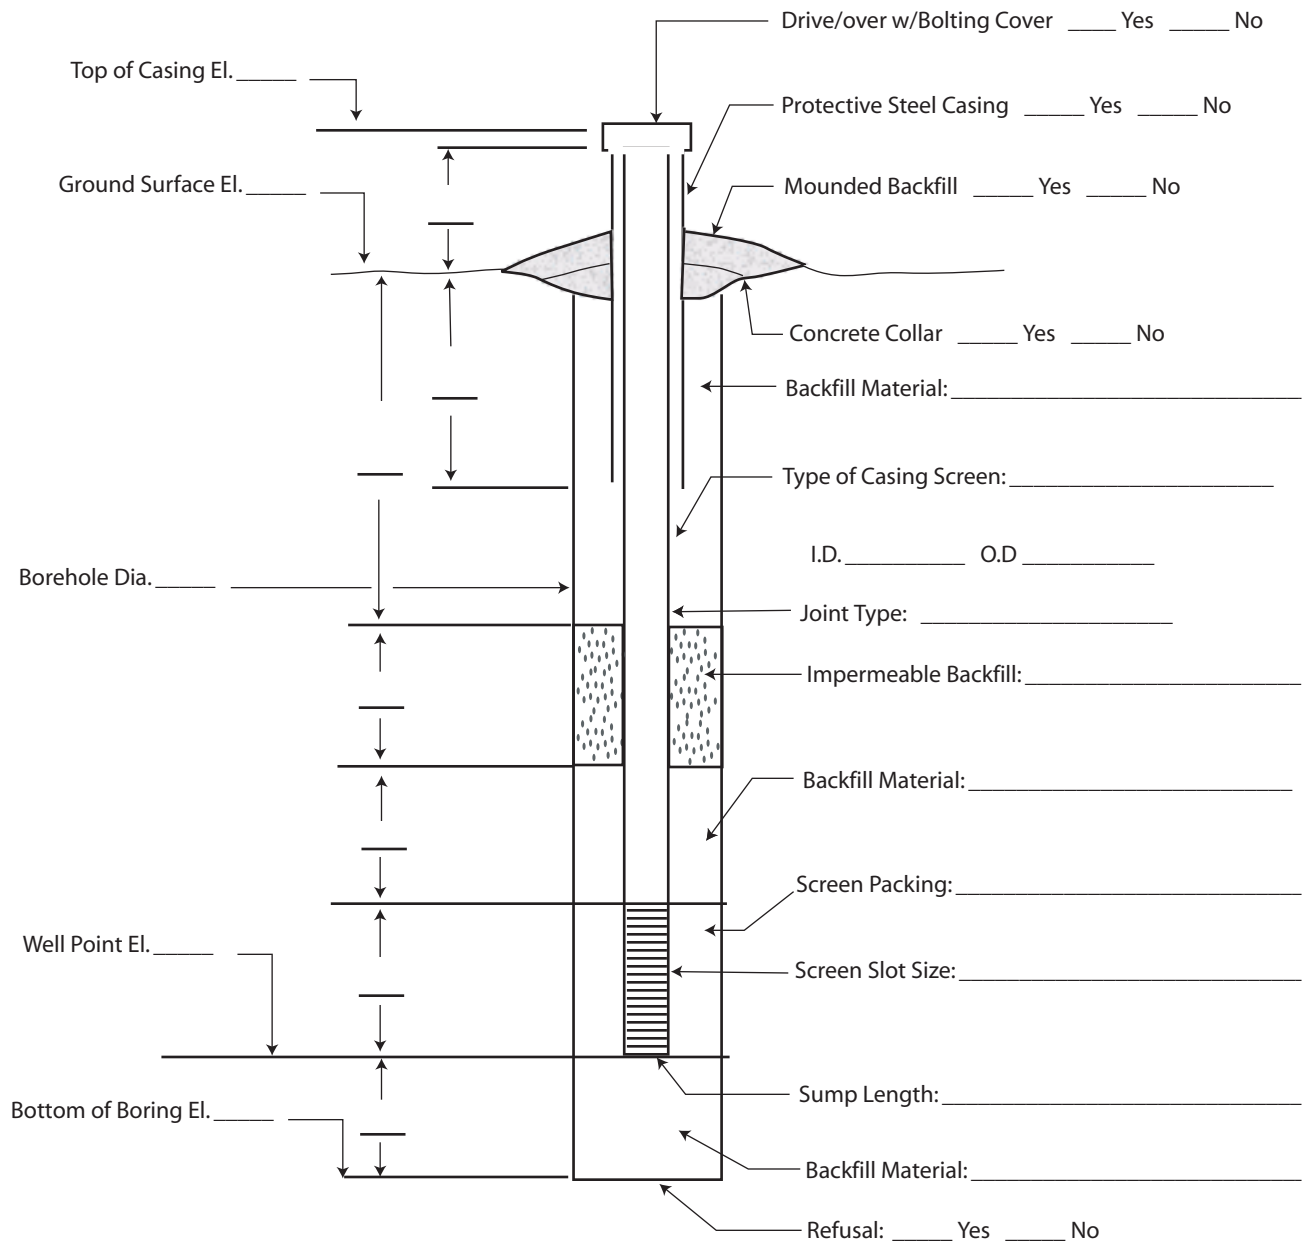
## Materials Used:

Screen (PVC)  
 Riser (PVC)  
 Plug (PVC)  
 Slip Cap (PVC)  
 Silica Sand  
 Powdered Bentonite
