2017 PERIODIC REVIEW REPORT

**AC DUTTON GREENWAY CITY SITE
DUTCHESS COUNTY, NEW YORK**

NYSDEC Site # C314123

REPORTING PERIOD (March 30, 2017 - March 30, 2018)

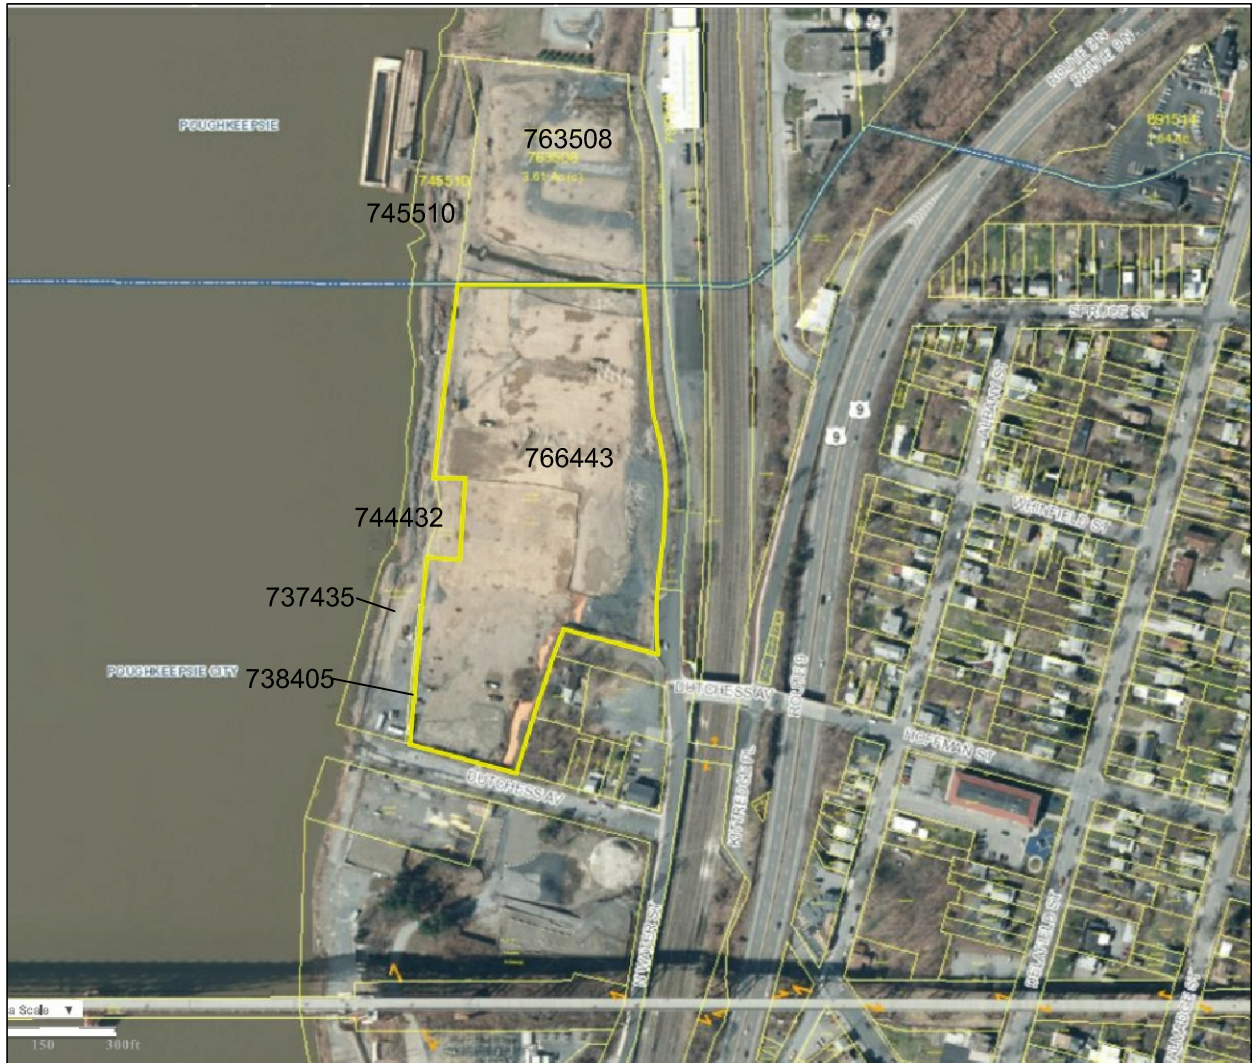
FIGURE 2.1

PROPERTY LOCATION MAP
DUTCHESS AVE. RIVER WALK SOUTH
1 DUTCHESS AVENUE AND 2 HOFFMAN STREET
POUGHKEEPSIE, NEW YORK

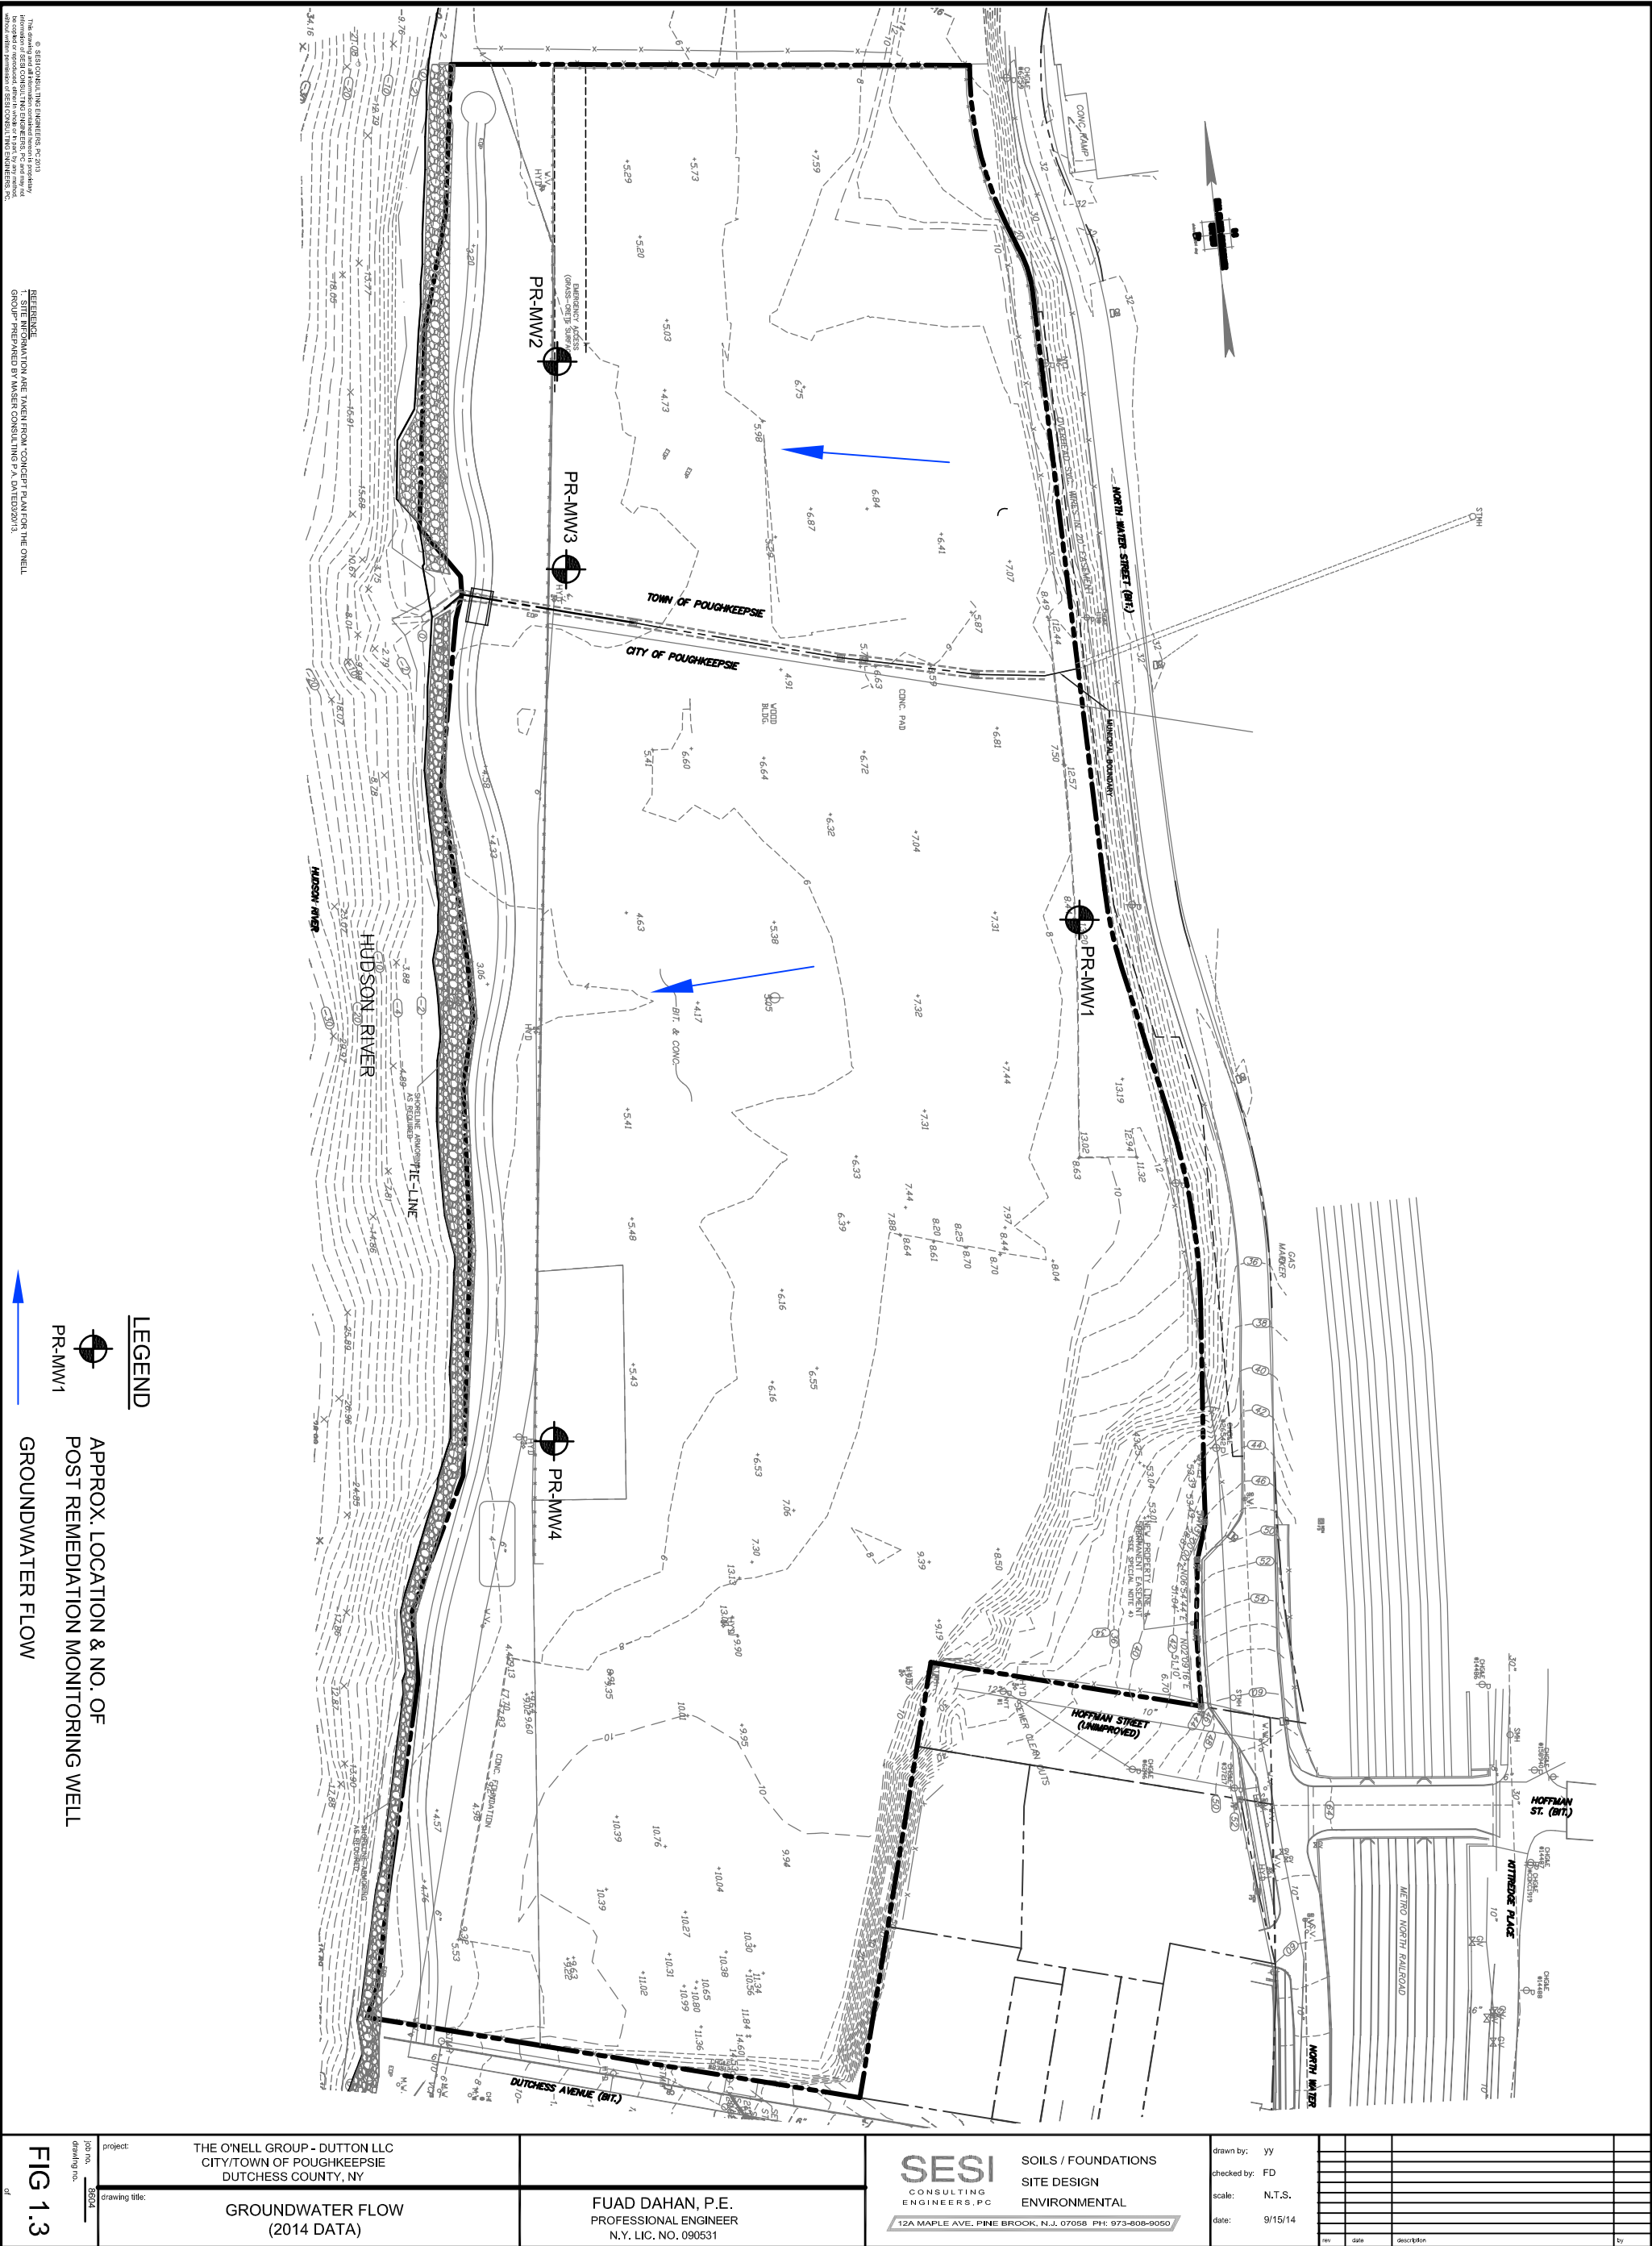
FIG 1.3	drawing no. 86004	project:	THE O'NEILL GROUP - DUTTON LLC CITY/TOWN OF POUGHKEEPSIE DUTCHESS COUNTY, NY		drawing title:	GROUNDWATER FLOW (2014 DATA)	FIG 1.3
			</
