2019 PERIODIC REVIEW REPORT

**AC DUTTON GREENWAY NORTH TOWN SITE
DUTCHESS COUNTY, NEW YORK**

NYSDEC Site # C314124

REPORTING PERIOD (April 1, 2019 - March 30, 2020)

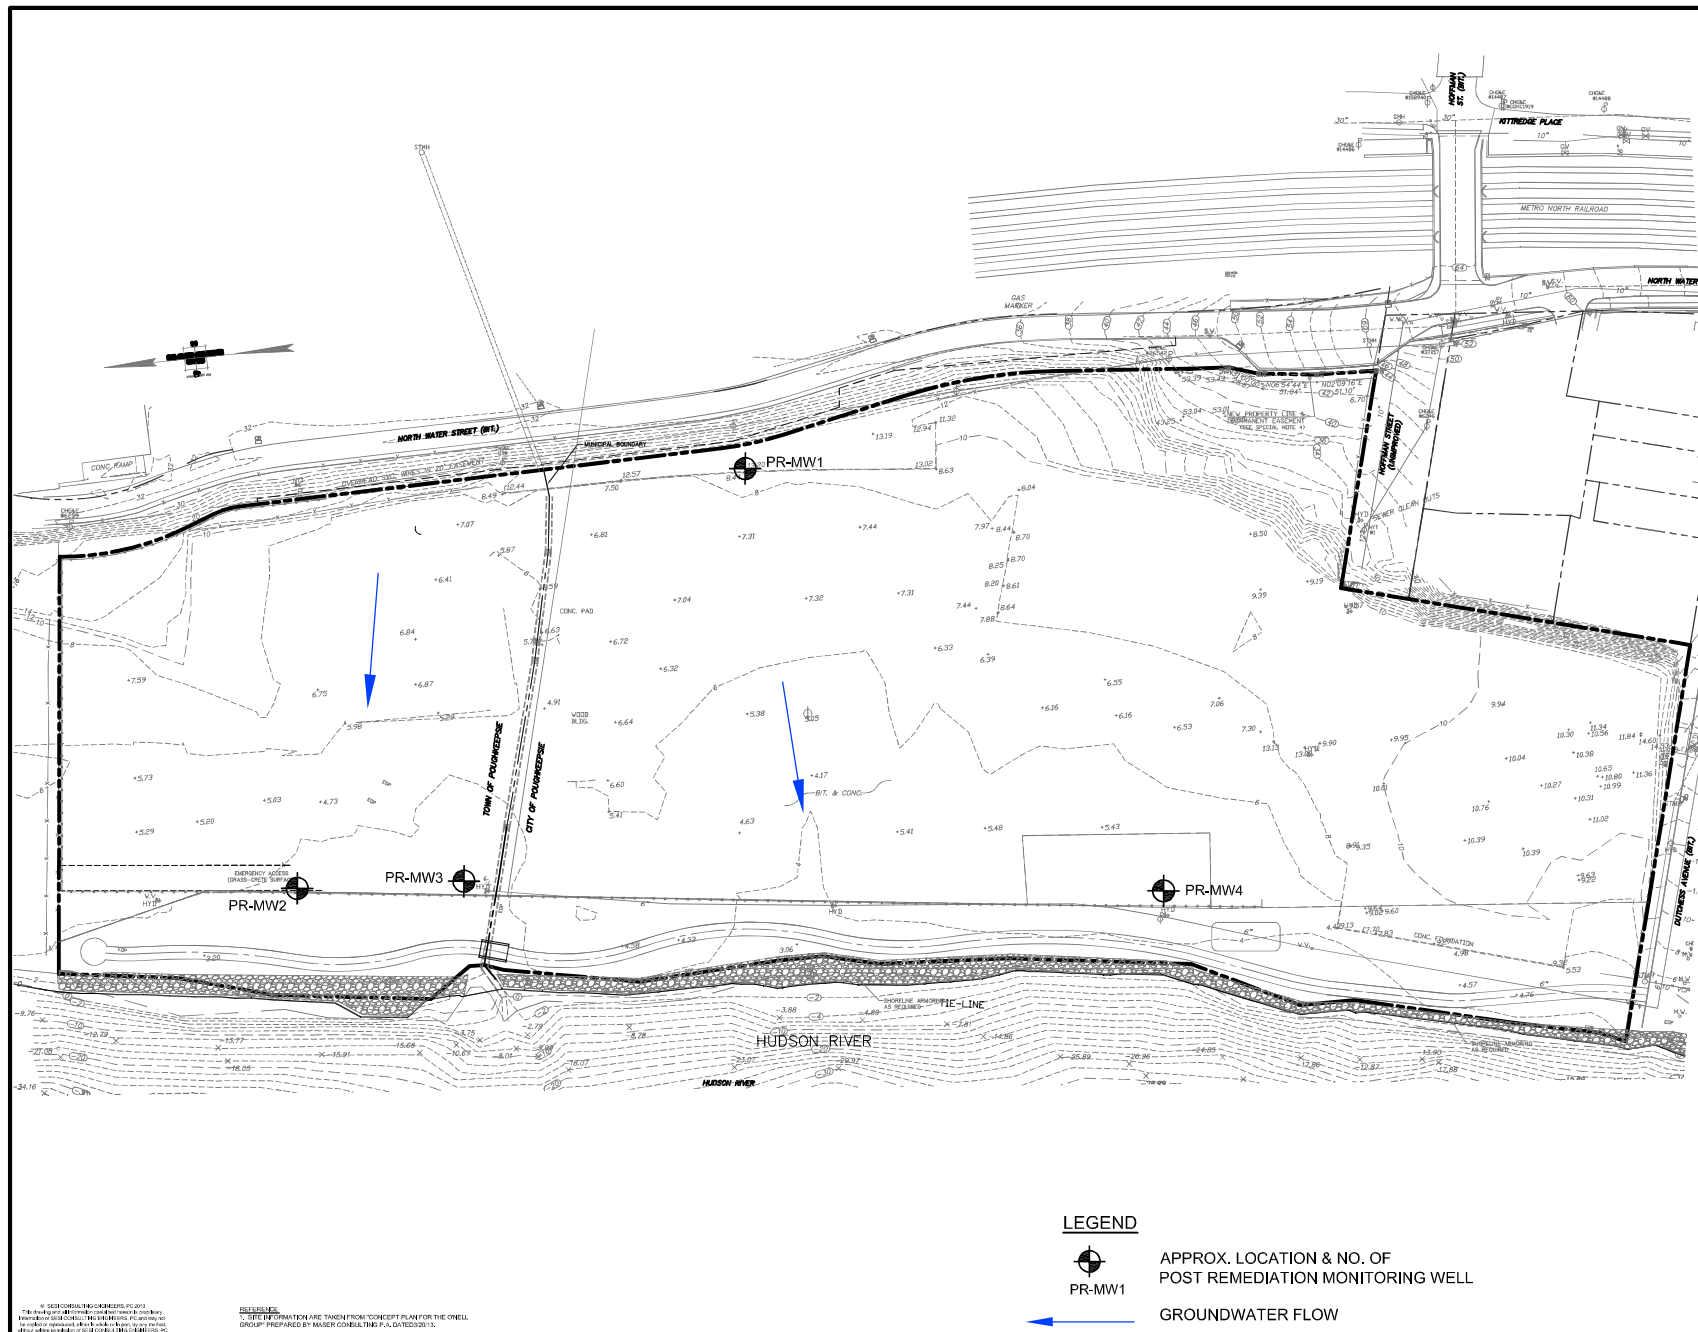
project	THE ONELL GROUP - DUTTON LLC CHARTERED FOUNDRY-PSIE DUTTONS COUNTRY	drawing no.	5004
GROUNDWATER FLOW (2014 DATA)		FUAD DAHAN P.E. PROJECT ENGINEER NY LIC. NO. 06931 (13A-WA0001 AND PREP. BRIDGE: N.Y. 07008 INTL 07-000000)	
SESI CONSULTING ENGINEERS, P.C. SITE DESIGN ENVIRONMENTAL		drawings analyzed by: FD scale date: 9/5/14	17 N.T.S. 1/8"=1'-0" 9/5/14

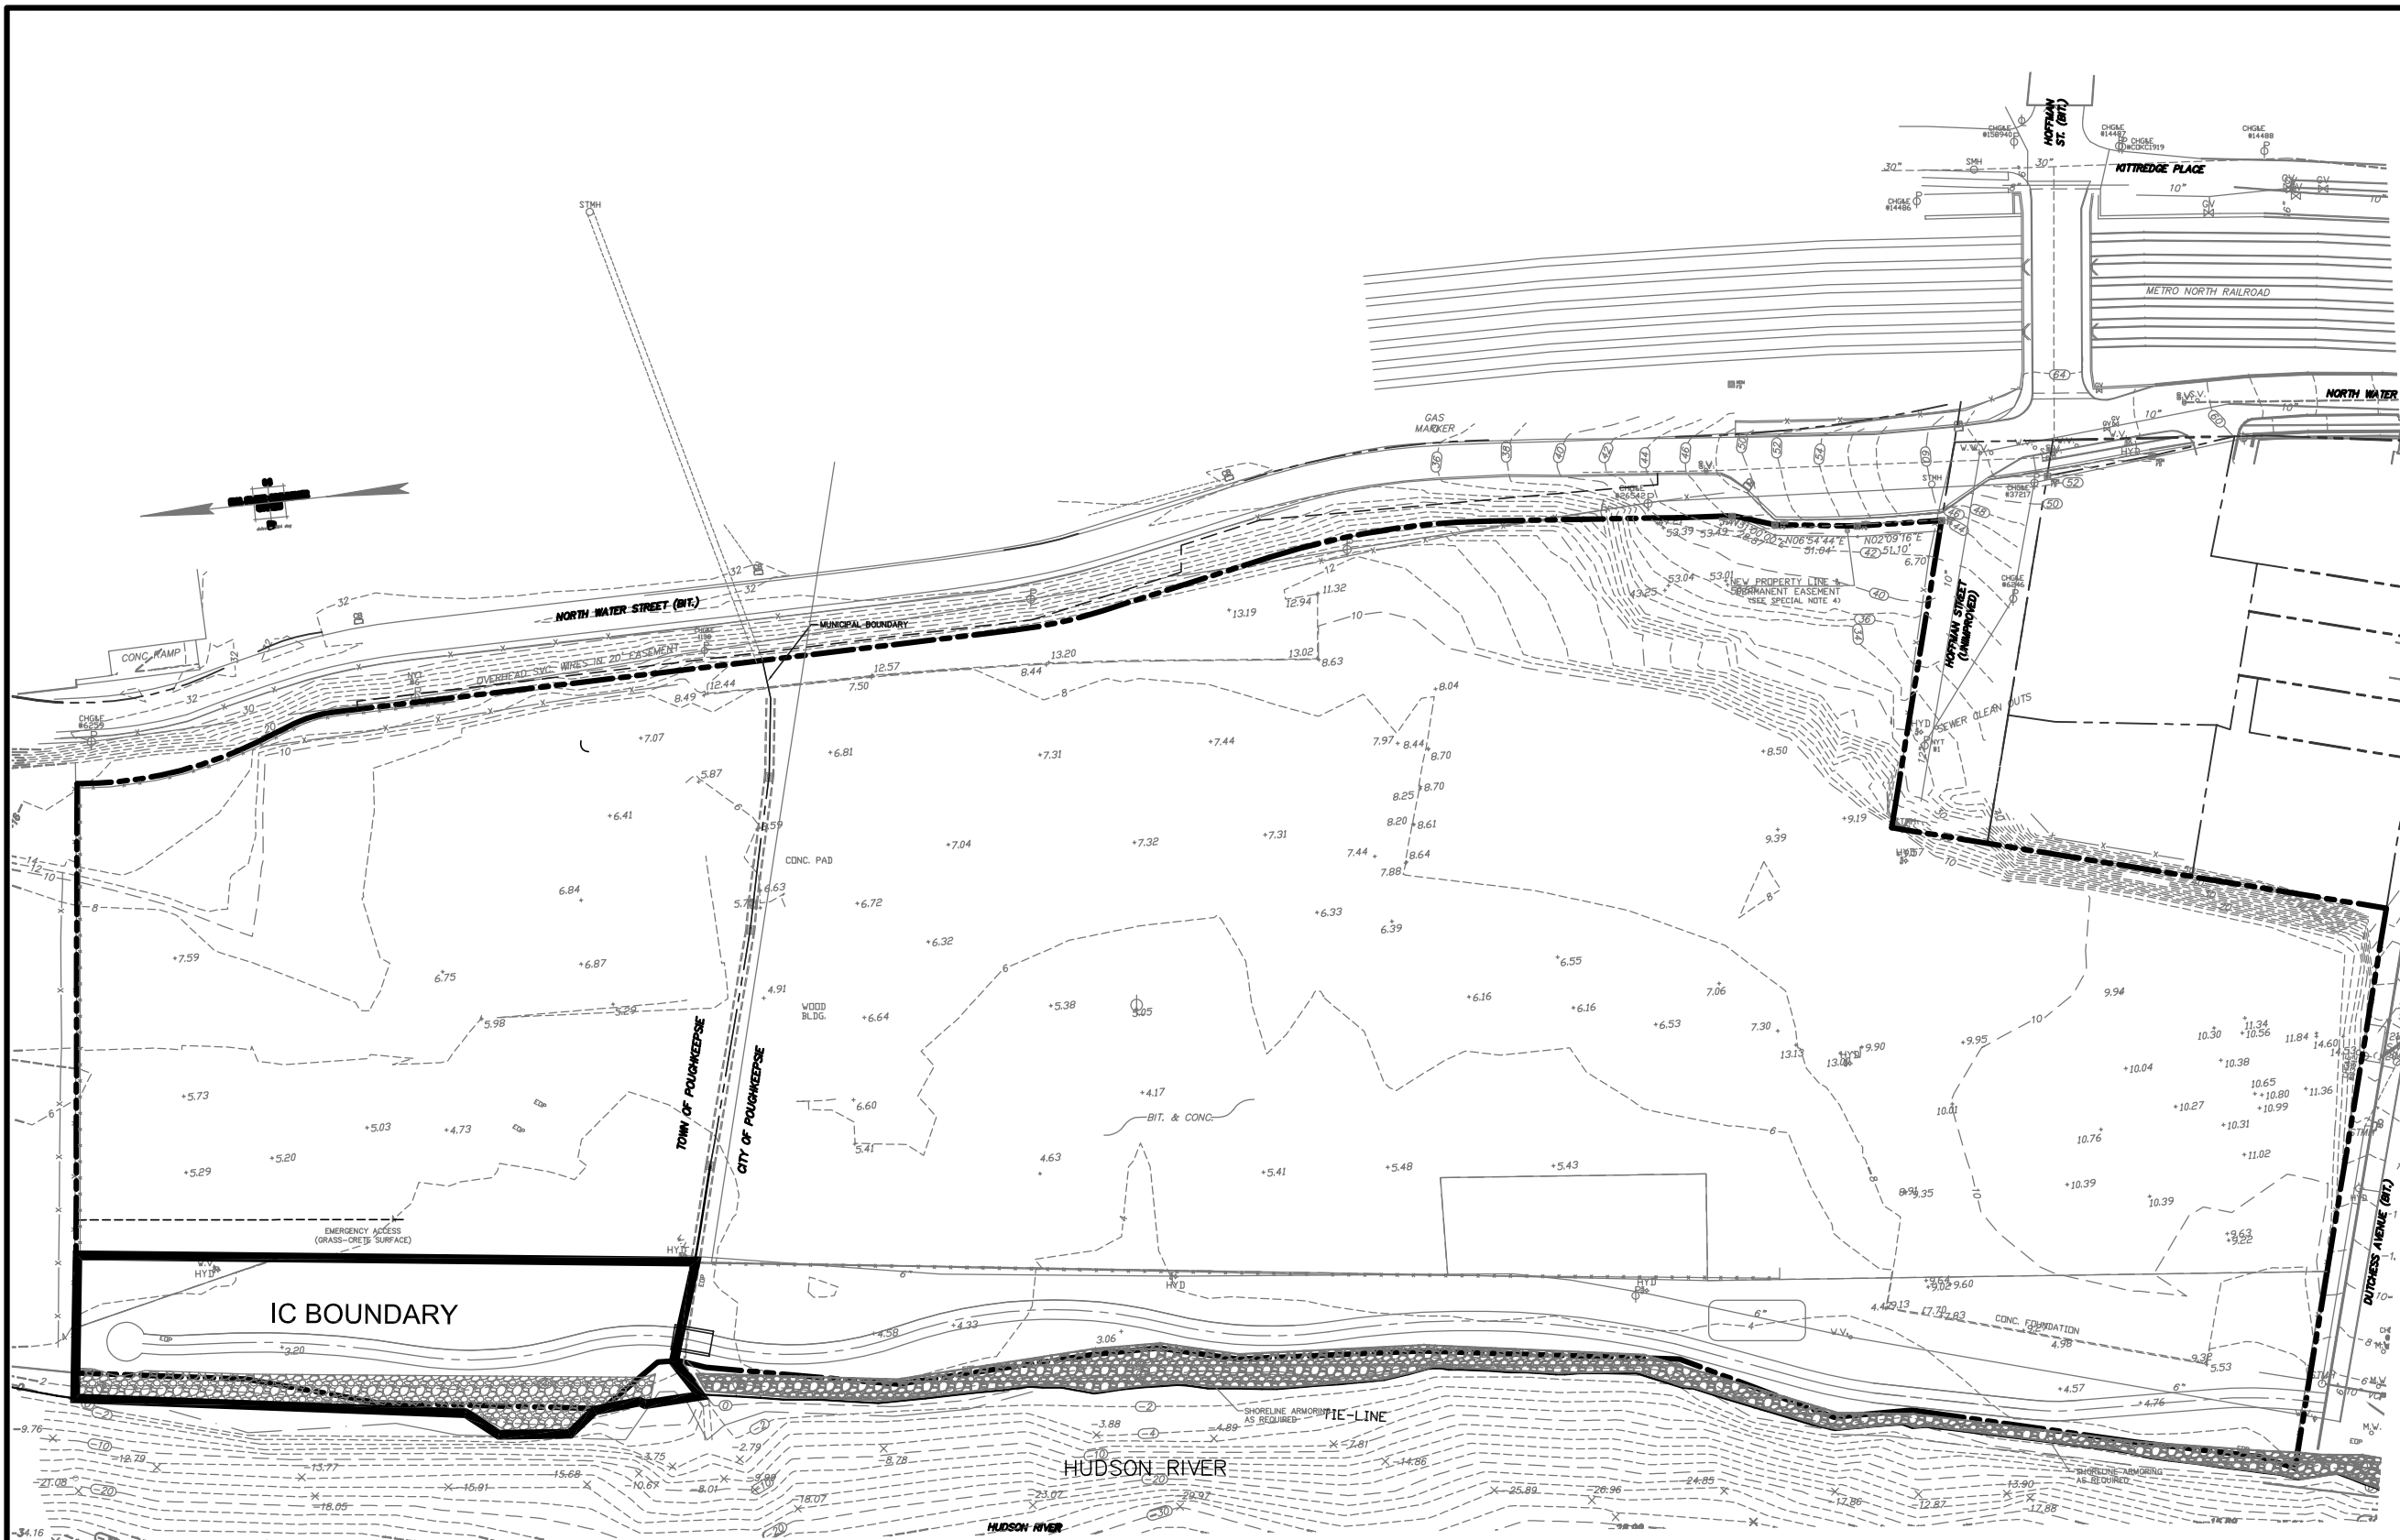
A series of ICs is required by the RAWP to: (1) implement, maintain and monitor Engineering Control systems; (2) prevent future exposure to remaining contamination; and, (3) limit the use and development of the Site to restricted-residential (public greenway/waterfront district) uses only. Adherence to these ICs on the Site is required by the Environmental Easement and will be implemented under this SMP. ICs identified in the Environmental Easement may not be discontinued without an amendment to or extinguishment of the Environmental Easement. The IC boundaries are shown on Figure 3.1 of the SMP. These ICs are:

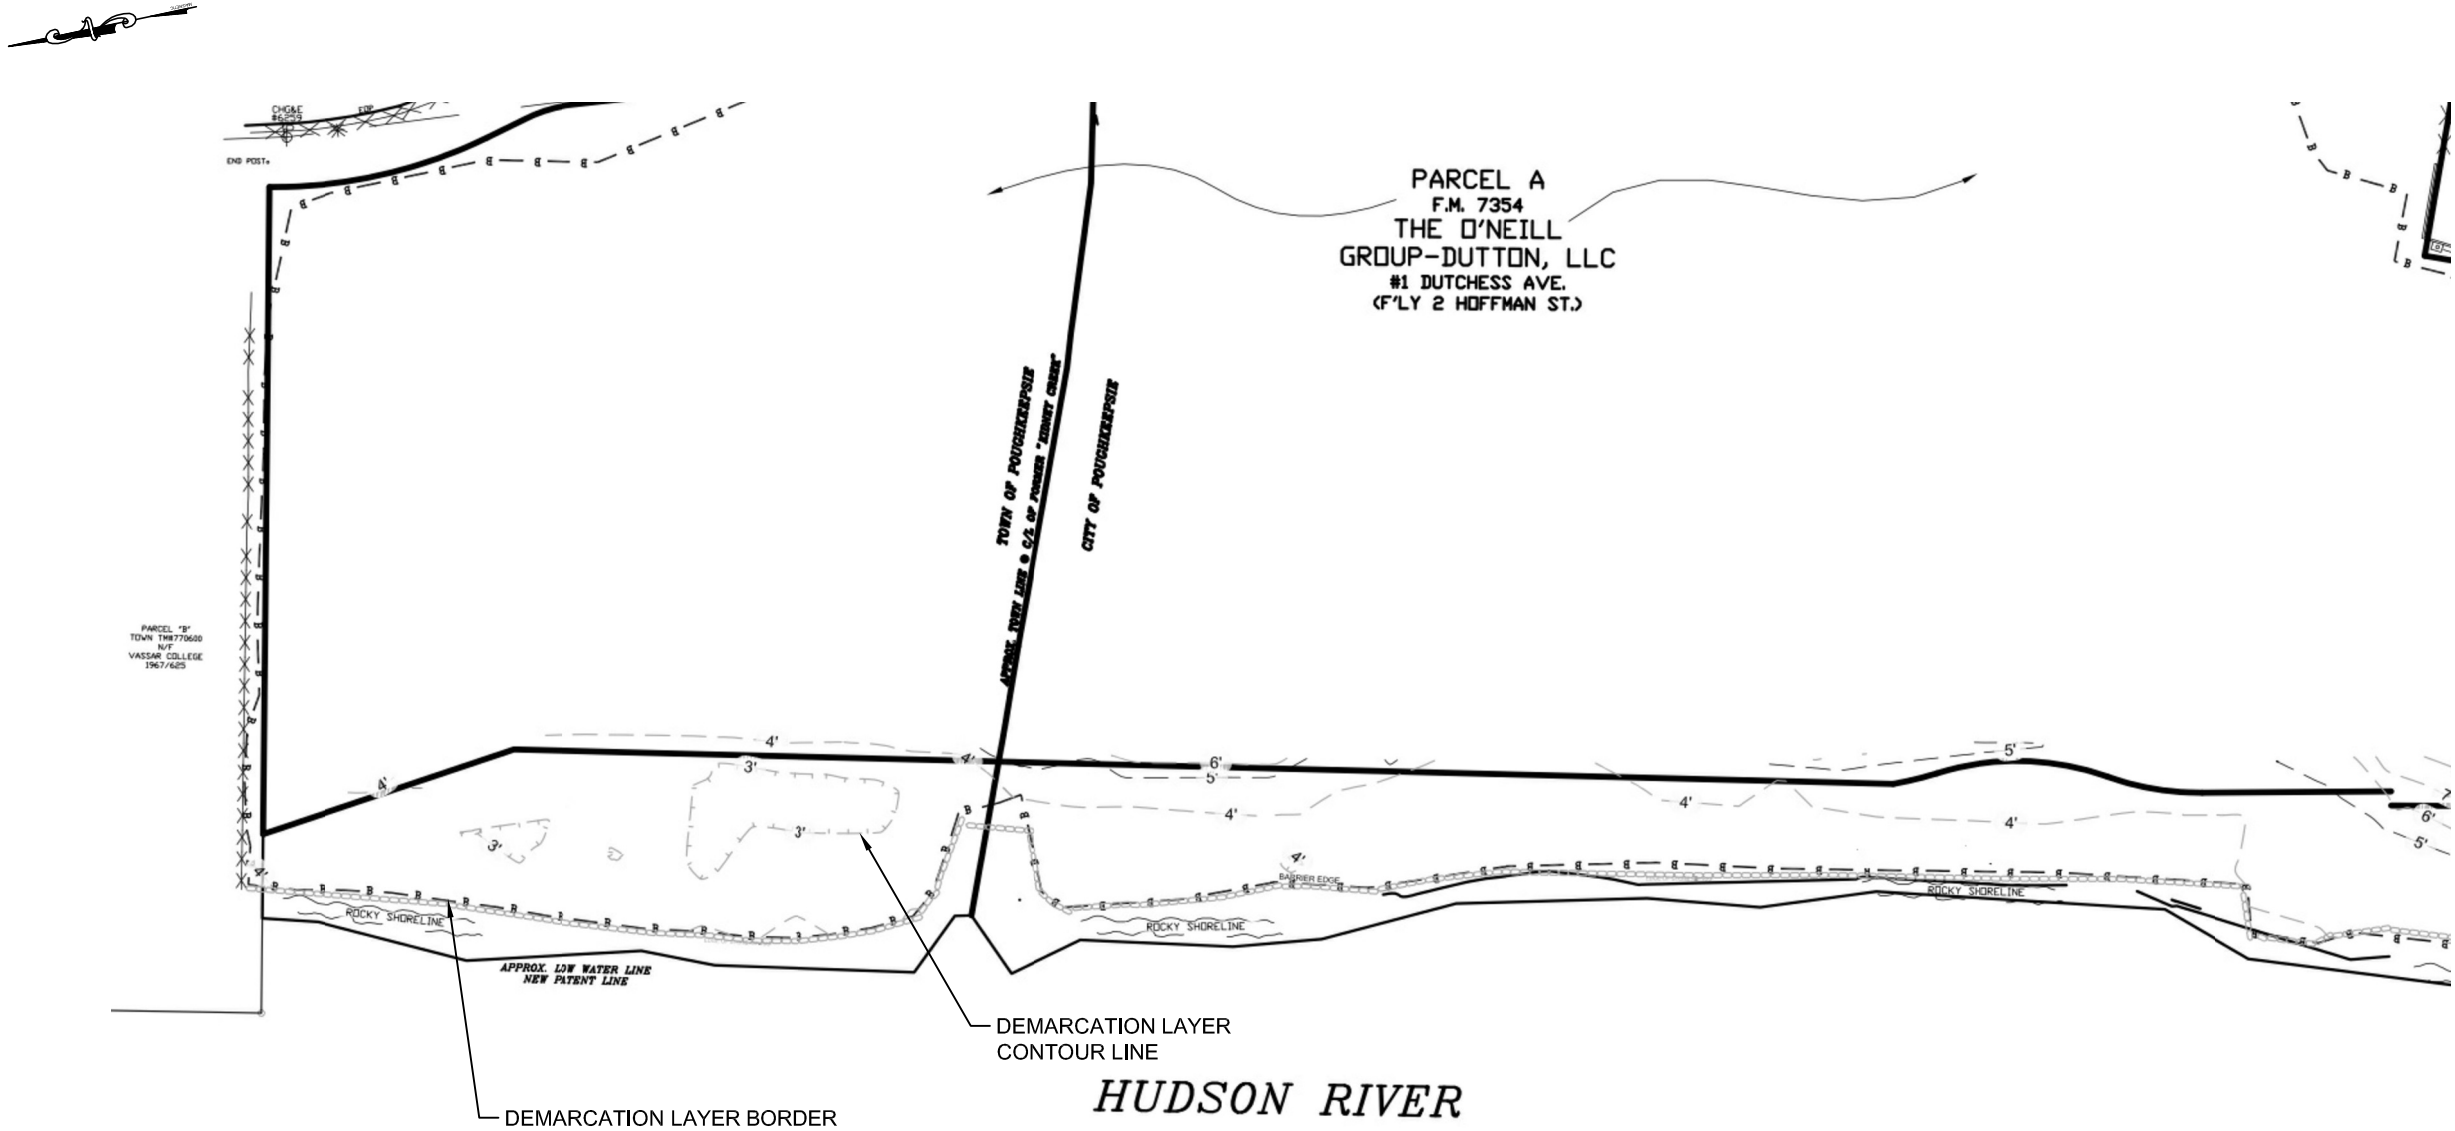
drawing title: DEMARCATION LAYER AS
BUILT PLAN

A demarcation layer consisting of an easily identifiable, non-biodegradable layer orange Mirafi Geotextile is placed under the entire Site. The approved fill was placed and compacted in lifts not exceeding 12 inches on top of the demarcation layer.

Figure 3.2 of the SMP presents the location of the cover system and applicable demarcation layers, where installed. The Excavation Work Plan (EWP) provided in Appendix F of the SMP outlines the procedures required to be implemented in the event the cover system is breached, penetrated or temporarily removed, and any underlying remaining contamination is disturbed. Procedures for the inspection of this cover are provided in the Monitoring and Sampling Plan included in Section 4.0 of the SMP.
