TANK CLOSURE SITE ASSESSMENT

SPILL FILE CLOSURE REPORT

**Property located at 164 Garden Street
City of Poughkeepsie
Dutchess County, New York**

NYSDEC Spill Number: 0804049

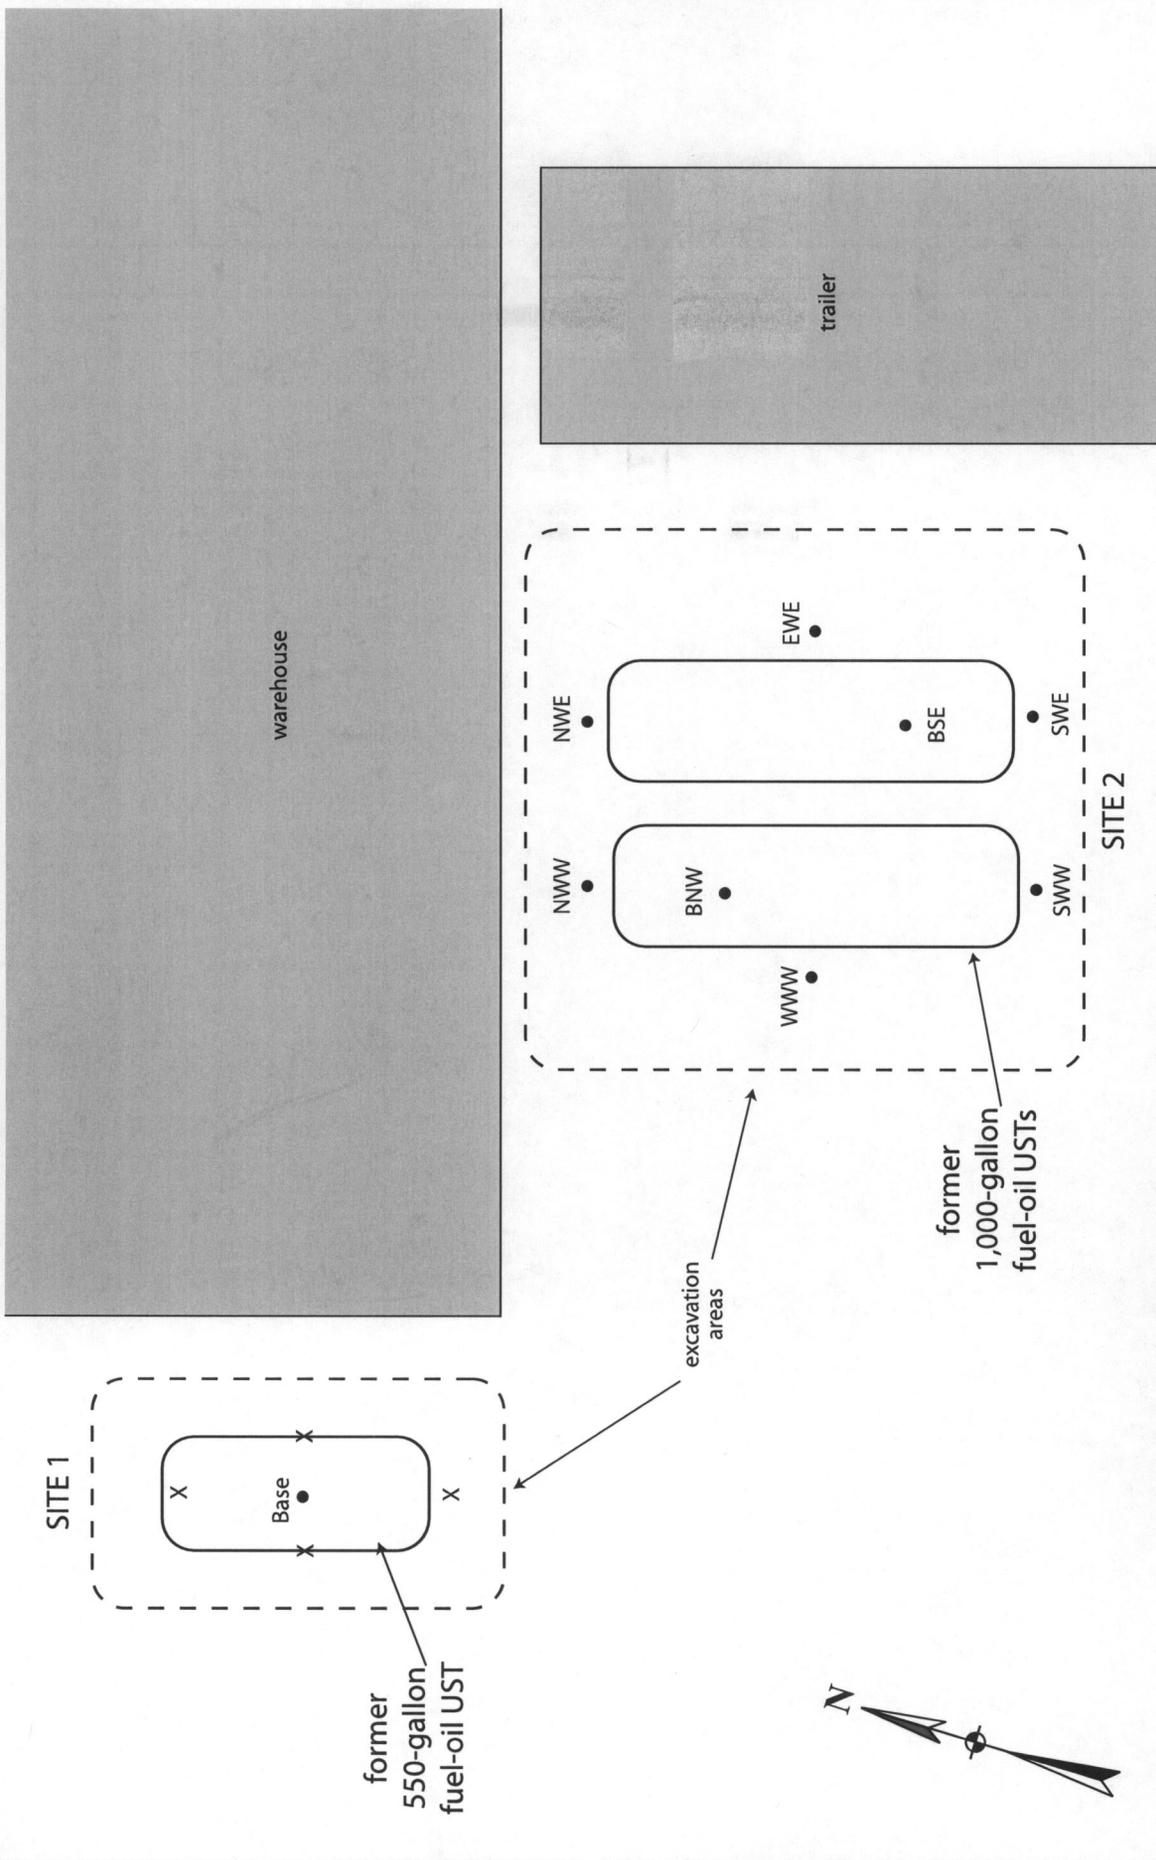
Fieldwork Map

<p>Fieldwork Map 164 Garden Street City of Poughkeepsie Dutchess County, New York</p>	<p>Legend:</p> <ul style="list-style-type: none"> ● sample location X Sides-Comp sample location 	<p>ESI File: HP08112.40</p>
		<p>July 2008</p>
		<p>Not to scale</p>
		<p>Appendix A</p>

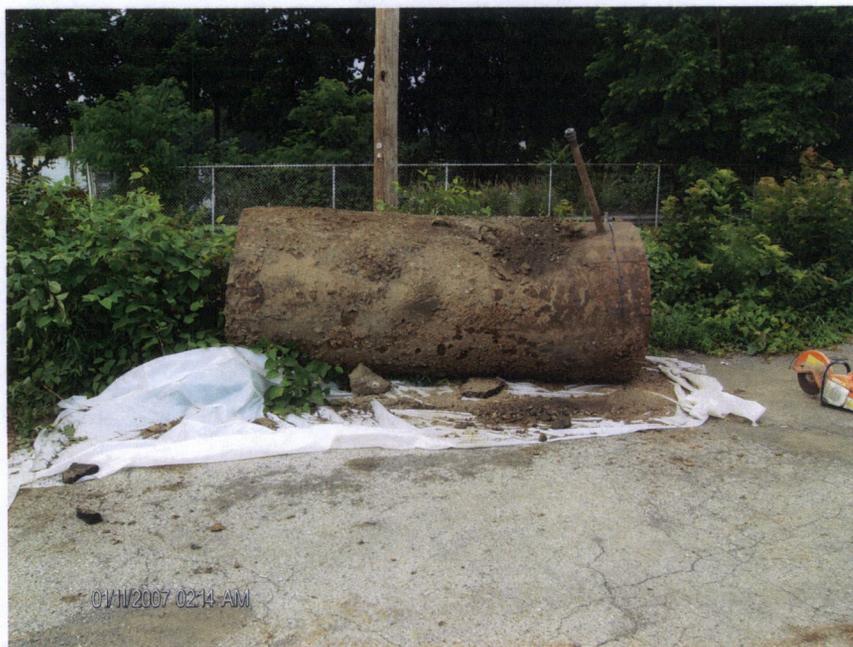
1. 1000-gallon fuel oil UST facing south from the southern side of building. One of the two tanks removed from Site 2.

On June 26, 2008, two, 1000-gallon fuel oil tanks from Site 2 were observed to have been removed and temporarily stockpiled on 6-mil plastic sheeting. Both tanks were cut open and partially filled with product. Visual examination of the tanks indicated mild to moderate surface corrosion and pitting. A small hole was observed on the underside exterior of one of the tanks. Mannain personnel indicated that the USTs had been located adjacent to each other, oriented in a north-south direction.

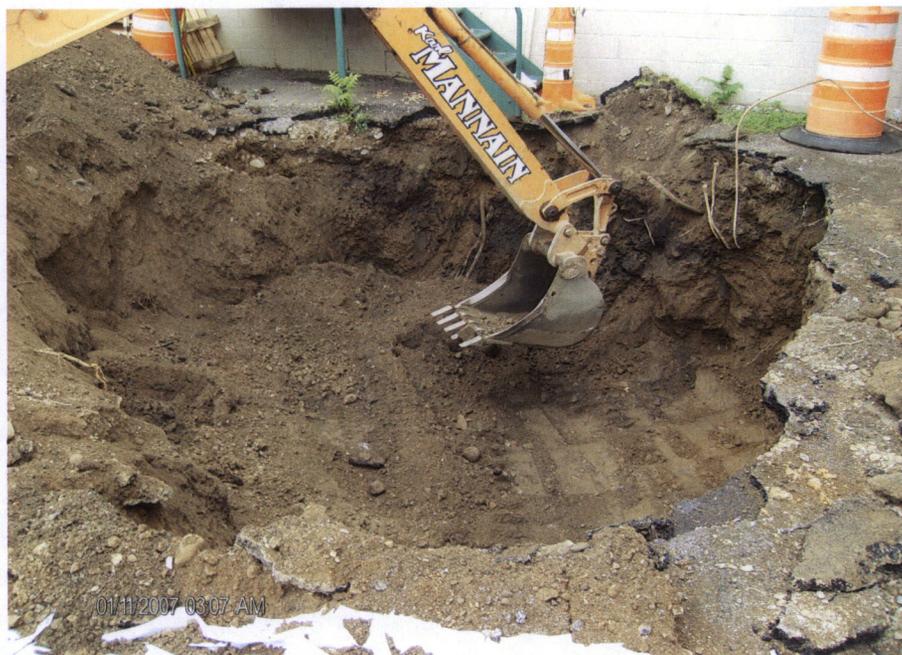
2. View of Site 2 from southern side of property facing north.

Site 2 was inspected and soils at the base and walls of the tank grave were screened for evidence of contamination. Minor odors and discoloration indicating potential petroleum contamination were observed in soils at the northwest corner of the tank grave. A spill was reported to the NYSDEC and Spill number 0804049 was issued. Groundwater was not observed in the excavation.
