HAZARD EVALUATION UNIVERSAL/HAZARD/REGULATED WASTES

**164 Garden Street
Poughkeepsie, NY 12601**

*Project Number: Q20-3106
Report Date: February 3, 2020
Report Prepared by: James Klemm*

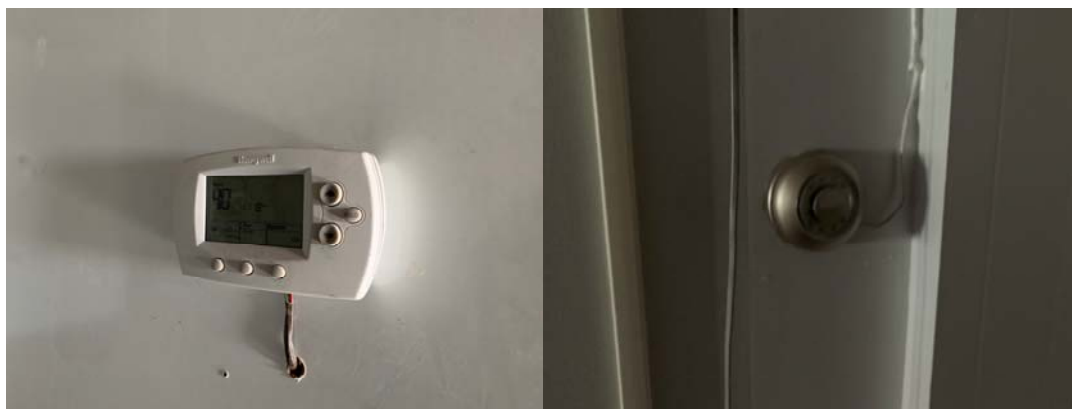
Picture 2.0-2.1: Both Varieties of Thermostats

- All Mercury-containing devices should be properly disposed of in accordance with all Federal, State and Local Regulations.
- Suspect PCB-containing items should be tested to determine if they are classified as a PCB-containing material prior to removal and disposal.

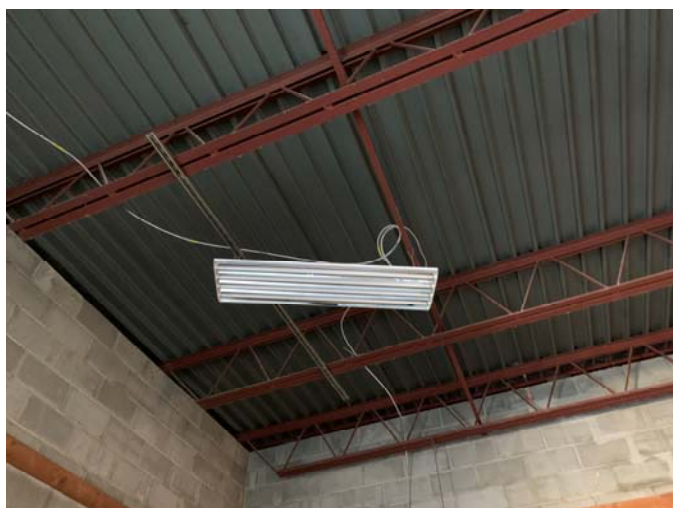
Much of the building is lighted by fluorescent light fixtures. These fixtures typically contain bulbs that contain Mercury and ballasts that would be suspected of containing Polychlorinated Biphenyls.

Picture 3.0: Fluorescent Bulbs in Ballasts
