**NYSDEC BROWNFIELD CLEANUP PROGRAM
REMEDIAL INVESTIGATION WORK PLAN**

**STANDARD GAGE & COAL STORAGE SITE
NYSDEC SITE #TBD
58 PARKER AVENUE & 164 GARDEN STREET
CITY OF POUGHKEEPSIE, DUTCHESS COUNTY, NEW YORK**

June 24, 2020
PVE File #560532

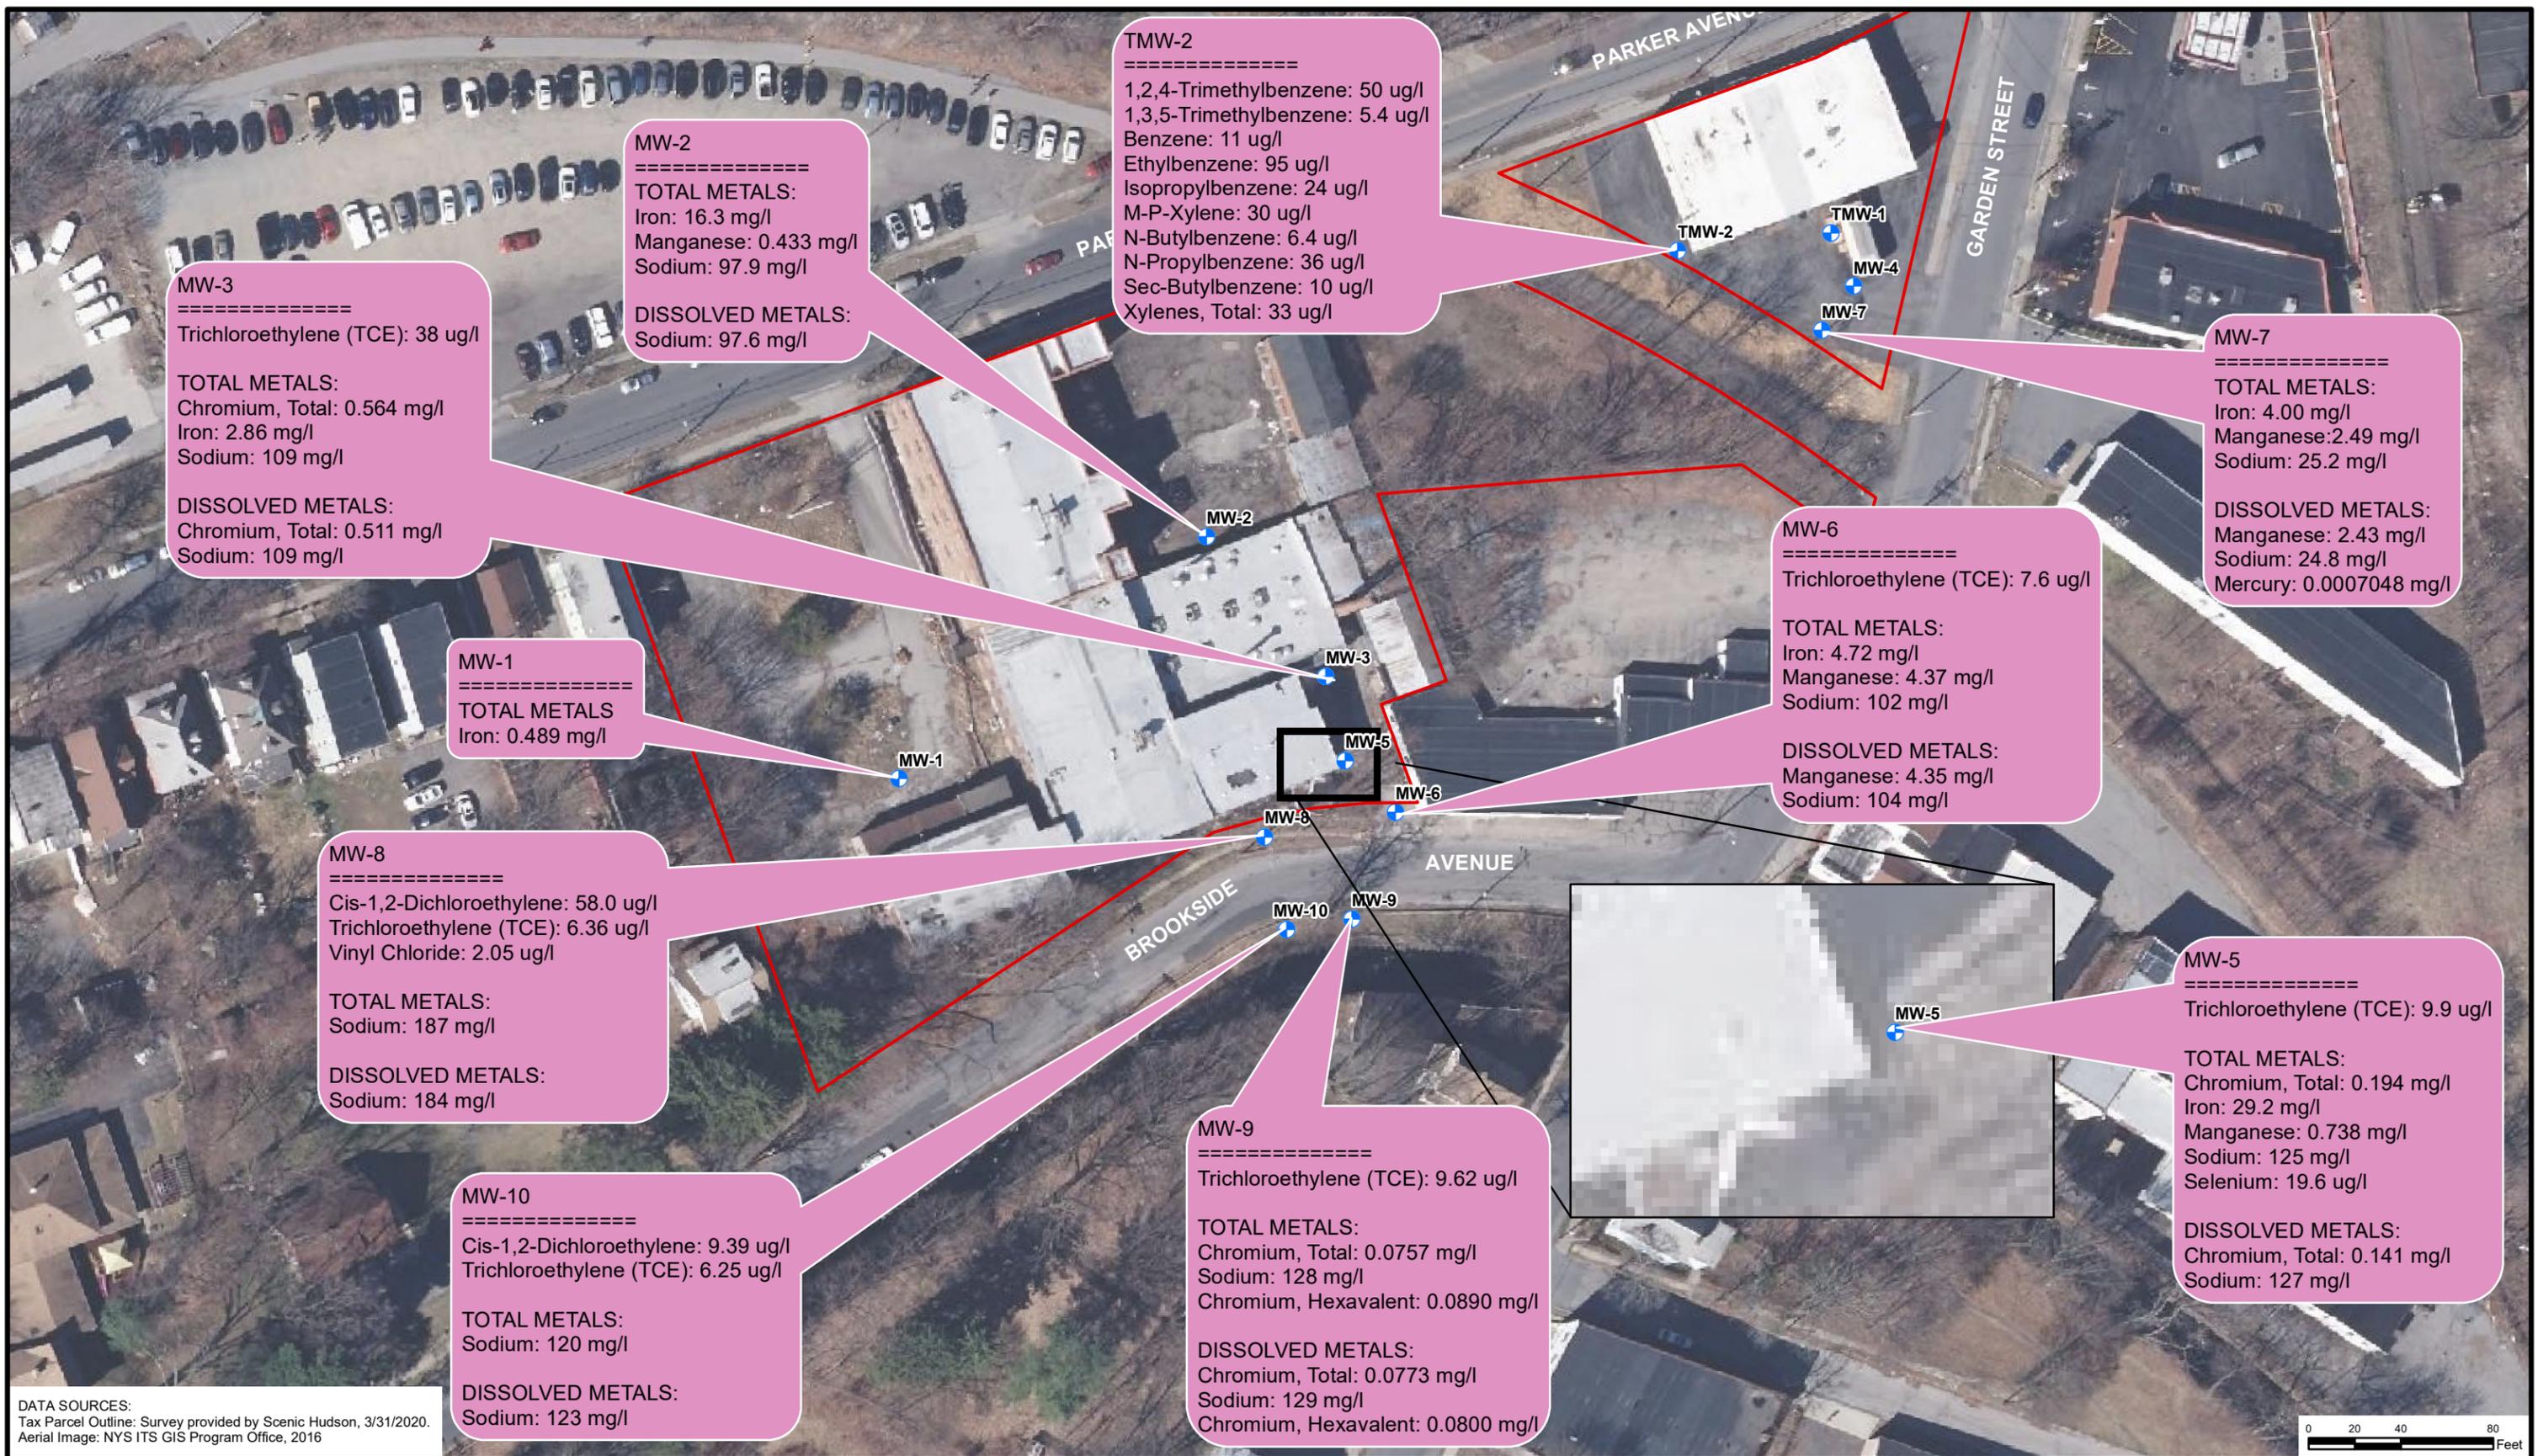
Figure 5

<p>48 Springside Avenue Poughkeepsie, NY 12603 Office: 845.454.2544 Fax: 845.454.2655</p>	<p>GROUNDWATER SAMPLES EXCEEDING CLASS GA GQS - 6 NYCRR PART 700-705</p> <p>58 PARKER AVENUE & 164 GARDEN STREET CITY OF POUGHKEEPSIE DUTCHESS COUNTY, NEW YORK</p>	<p>LEGEND</p> <p> TAX PARCEL OUTLINE</p> <p>+ MONITORING WELL</p>	<p>PROJECT NO. 560532</p>	<p>FIGURE 5</p>
		<p>DATE: 06/03/2020</p>	<p>SCALE: AS INDICATED DATUM: NAD83</p>	
			<p>PROJECTION: STATE PLANE NY EAST (FT)</p>	
		<p>ALL LOCATIONS APPROXIMATE</p>
