Brownfield Cleanup Application  
Willow Brook Rentals LLC

**ASTM E1527-13 All Appropriate Inquiries Phase I  
Environmental Site Assessment Report For The Property  
Identified As:**

**Commercial Property  
10-14 Tucker Drive  
Poughkeepsie, New York 12603**

**LCS PROJECT No. 15H2721.39**

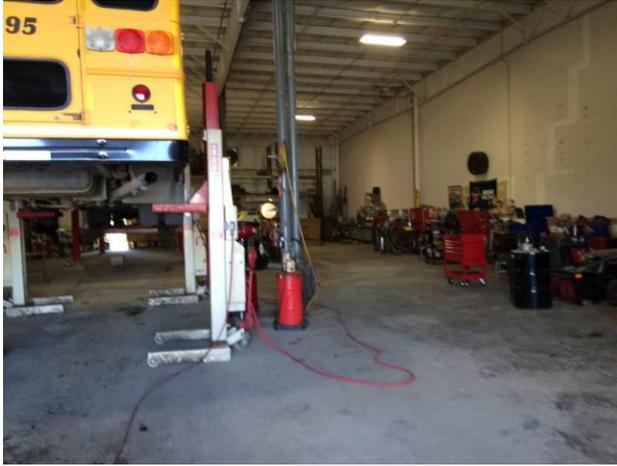
- On-site operations include bus service and fueling since at least 1989. No floor drains were noted in the service area.
- Surficial staining, typical of repair operations, was noted to the floor in the bus service area.
- Disturbed land was noted on-site in at least 1970 and 1980 (possibly associated with land a landfill). According to an on-site spill listing, the subject property was historically utilized as a landfill.
- The subject property was listed as an ICIS site (involving an enforcement action/compliance activity); no details were provided.
- McCollister's Transportation Group was noted west adjacent and was identified as a UST facility.

- Photo 1: View of the inspection garage.
- Photo 2: View of the inspection garage.
- Photo 3: View of the AST on-site.
- Photo 4: View of the AST on-site for fueling buses.

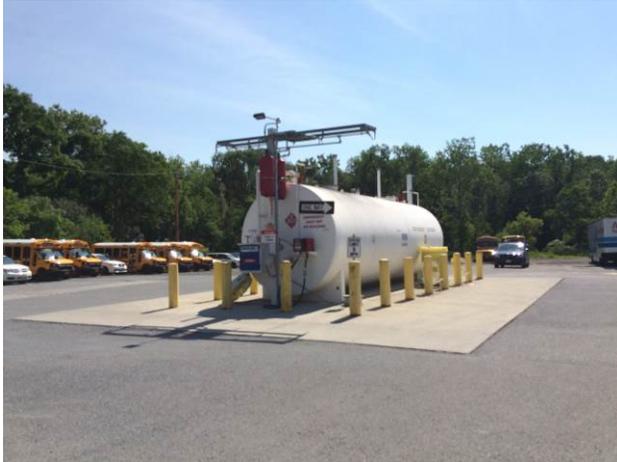
Photo 3:

At the time of the site inspection, the following tanks were noted on-site.

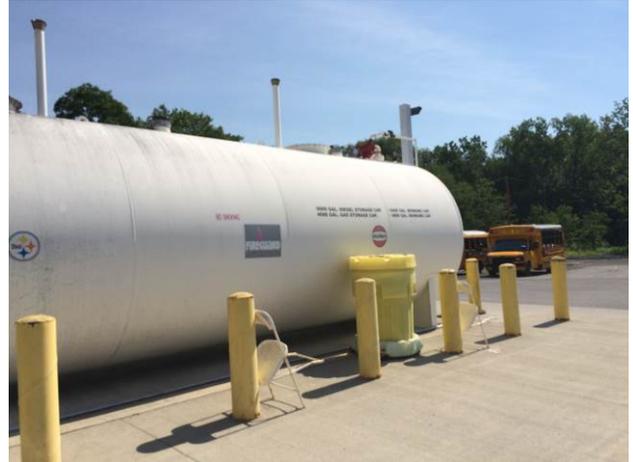
Photo 4:

- On-site operations include bus service and fueling. No floor drains were noted in the service area.
- One 10,000-gallon baffled diesel/gasoline AST was noted on the northern portion of the property, utilized for fueling of buses. No releases were noted in the area of the AST.
- One 300-gallon washer fluid AST and one 275-gallon waste motor oil AST were noted in the service area. Additional hazardous/regulated materials were noted stored in 55-gallon drums and smaller containers. No releases were noted in the area of those containers.
- Surficial staining, typical of repair operations, was noted to the floor in the bus service area.
- McCollister's Transportation Group was noted west adjacent.

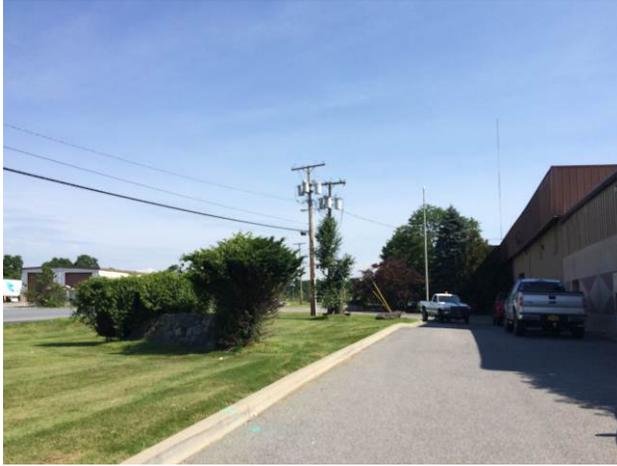
Suspect PCB Container	Location	Owner	Evidence of Leaks (Y/N)
Transformer (pole-mounted)*	Six along Tucker Drive	Utility	None
Lifts (aboveground)	Four in bus service area	Property owner	None
Fluorescent lights**	Throughout structure	Property owner	N/A

Photo 1: View of the transformers on-site.

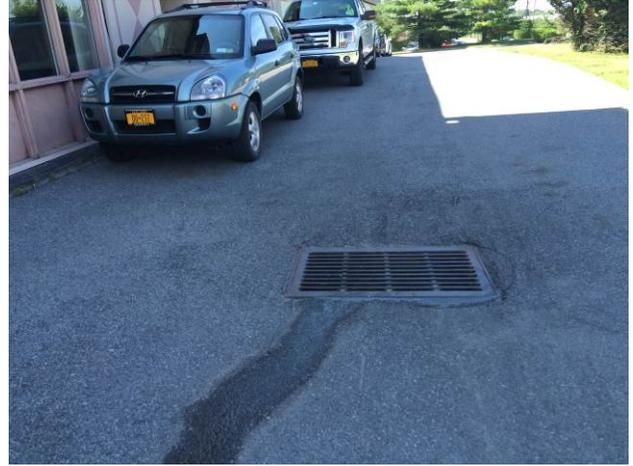
Municipal sanitary and storm sewers service the subject property. However, the exact date of connection was not reported to LCS. Due to vehicle service operations, LCS' experience suggests that treatment or monitoring of the site's wastewater is typically required prior to discharge to the site's sewer system. Typically, this would include an oil/water separator; however, no floor drains were noted in the subject structure.

Photo 2: View of a storm drain on-site.
