Cornwall Plaza
ORANGE COUNTY, NEW YORK
CORNWALL, NEW YORK

Final Engineering Report

NYSDEC Site Number: C336070

NOVEMBER, 2015

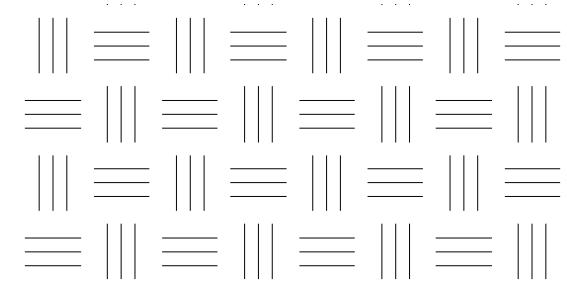
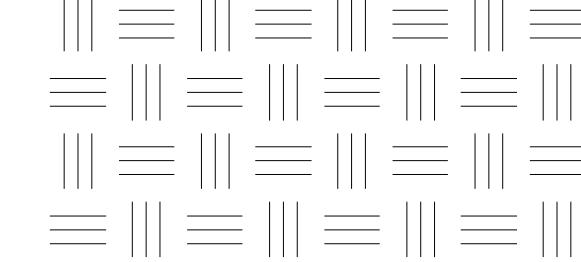
FIGURE NO. 6

CONCRETE CAP

CONCRETE SLAB
4–6 in.

NATIVE SOIL

GRAVEL

2–4 in.

ASPHALT CAP

3. Maintenance of a cover system consisting of asphalt parking lot areas and concrete building slabs to prevent human exposure to residual contaminated soil/fill remaining at the site (Figures 5 and 6);
