# BROWNFIELD CLEANUP PROGRAM (BCP) APPLICATION FORM

<b>Section IV. Property Information - See Instructions for Further Guidance</b>				
PROPOSED SITE NAME 201 Charles Street				
ADDRESS/LOCATION 201 Charles Street				
CITY/TOWN Maybrook, NY		ZIP CODE 12543		
MUNICIPALITY(IF MORE THAN ONE, LIST ALL): Village Maybrook, Towns Hamptonburgh & Montgomery				
COUNTY Orange		SITE SIZE (ACRES) 2.944		
LATITUDE (degrees/minutes/seconds)		LONGITUDE (degrees/minutes/seconds)		
41 ° 28 ' 51.54 "		74 ° 13 ' 06.12 "		
<p><b>Complete tax map information for all tax parcels included within the proposed site boundary. If a portion of any lot is proposed, please indicate as such by inserting "P/O" in front of the lot number in the appropriate box below, and only include the acreage for that portion of the tax parcel in the corresponding far right column. ATTACH REQUIRED MAPS PER THE APPLICATION INSTRUCTIONS.</b></p>				
Parcel Address	Section No.	Block No.	Lot No.	Acreage

PROPOSED SITE NAME 201 Charles Street

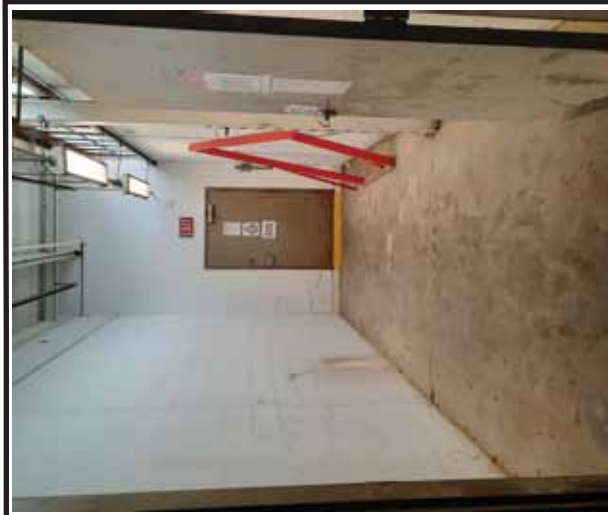
Former Vapor-Degreasing Room Looking N

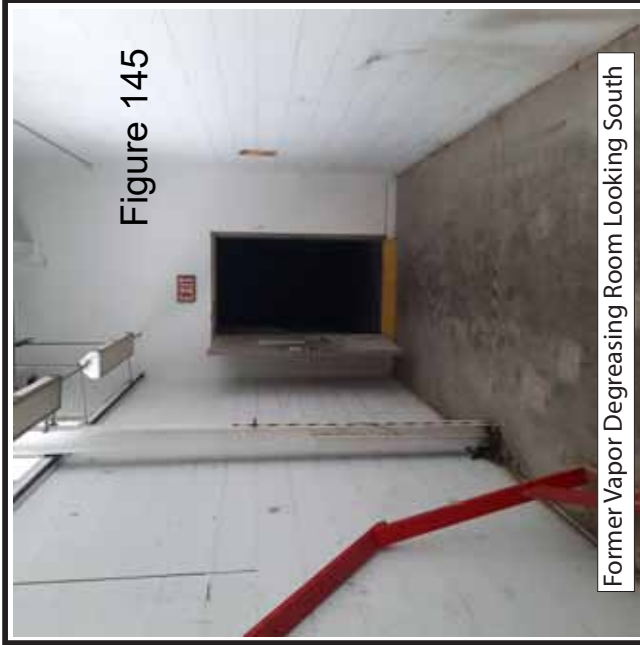
Figure 145

Former Vapor Degreasing Room Looking South

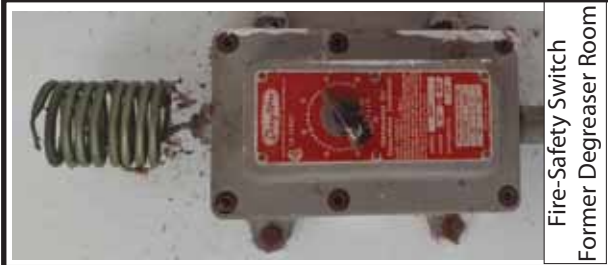
Fire-Safety Switch  
Former Degreaser Room

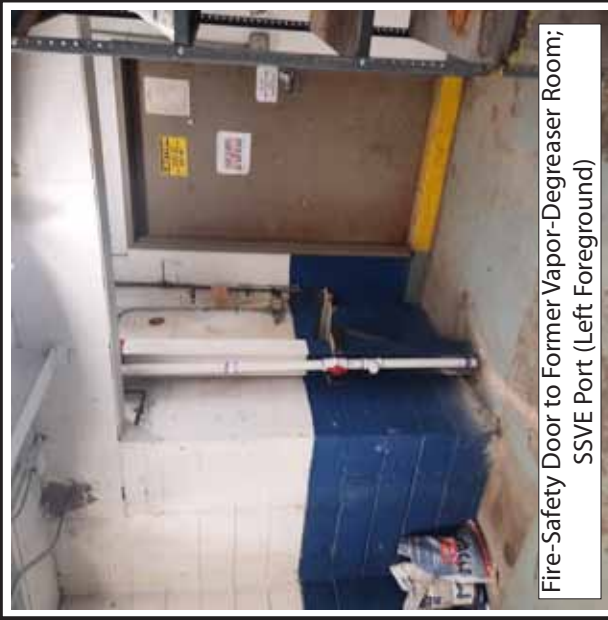
Fire-Safety Door to Former Vapor-Degreaser Room;  
SSVE Port (Left Foreground)

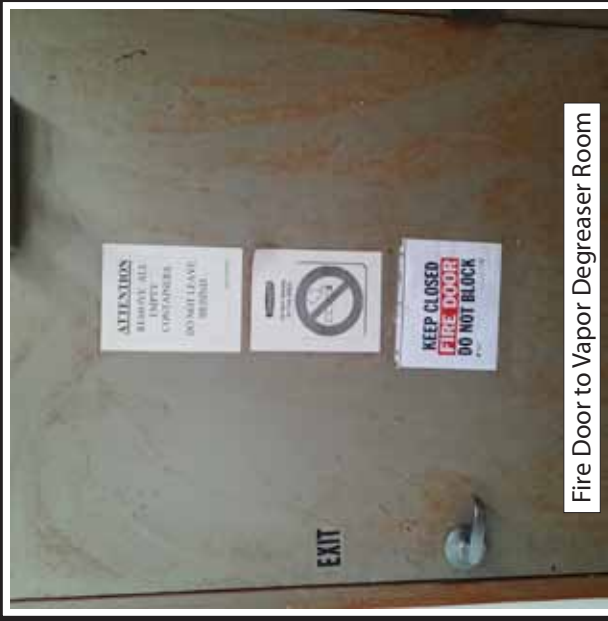
Fire Door to Vapor Degreaser Room
