**201 Charles Street, Maybrook
Orange County, New York**

Remedial Investigation Report

**Brownfield Cleanup Application
NYSDEC Spill Number: 1601483**

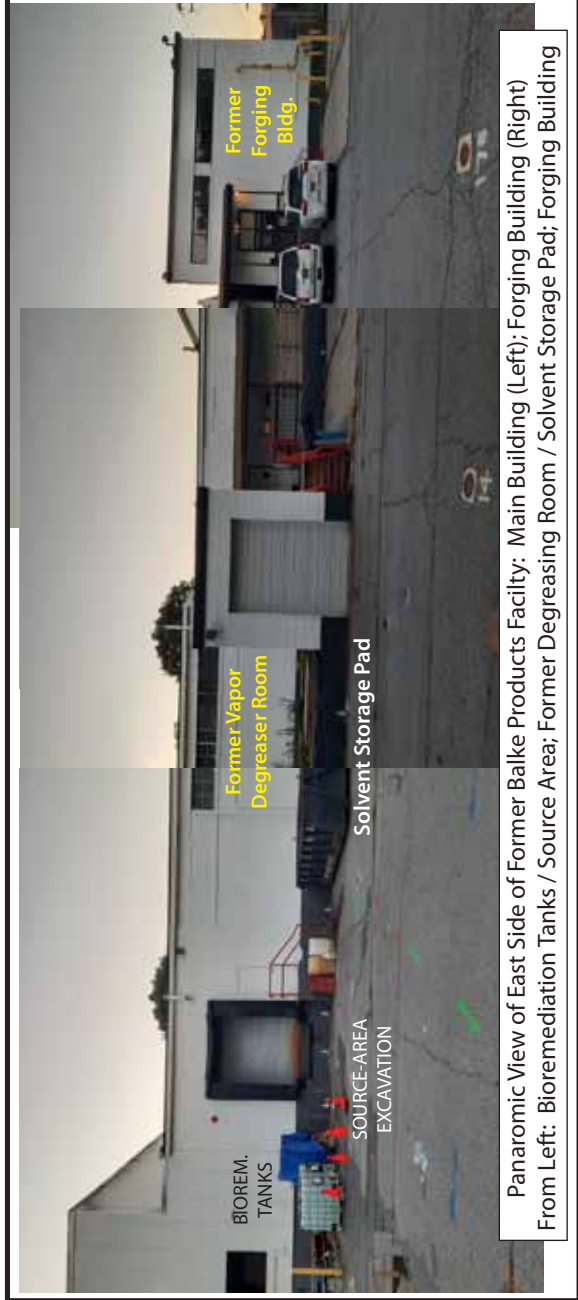
Panoramic View of East Side of Former Balke Products Facility: Main Building (Left); Forging Building (Right)
From Left: Bioremediation Tanks / Source Area; Former Degreasing Room / Solvent Storage Pad; Forging Building

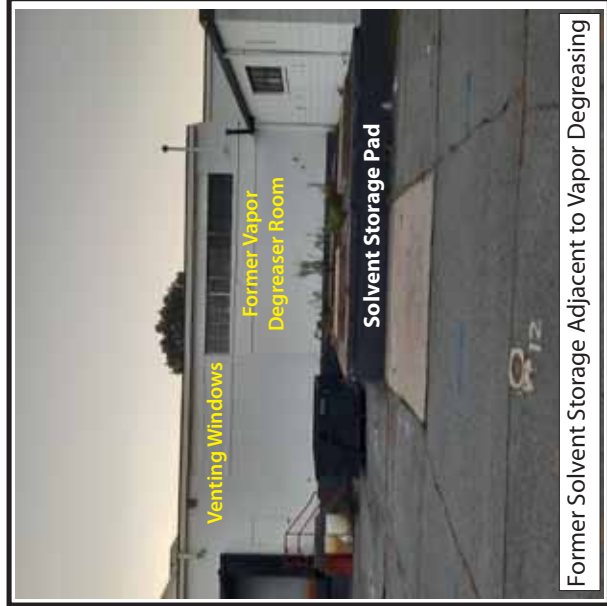
Former Solvent Storage Adjacent to Vapor Degreasing

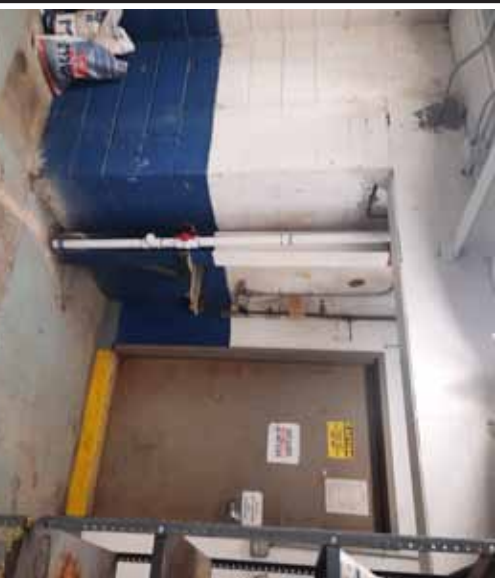
Fire-Safety Door to Former Vapor-Degreaser Room;
SSVE Port (Left Foreground)

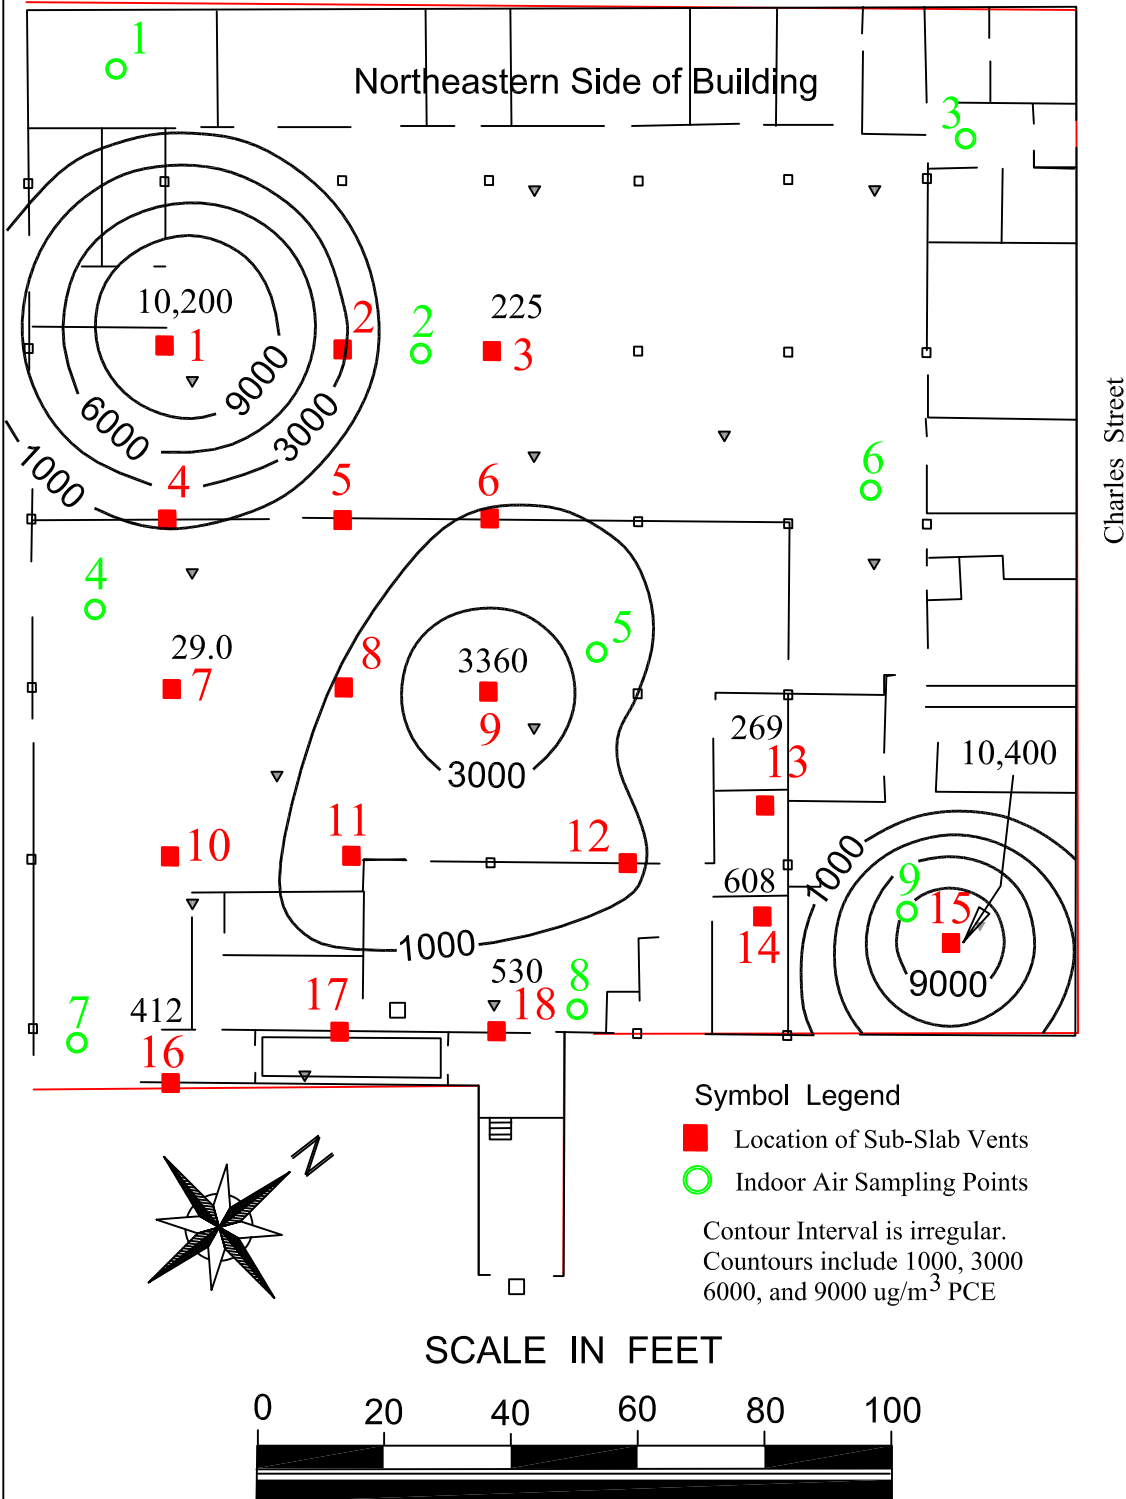
Figure 545 Concentrations of Tetrachloroethylene (PCE) in sub-slab vents. Summa Canister samples collected for US EPA Method TO-15 November 23, 2019. Measurement units are $\mu\text{g}/\text{m}^3$.
 Basemap from Survey by T. M. Depuy (April 5, 2016).
 Location: 201 Charles Street, Maybrook, NY.
