**PHASE I ENVIRONMENTAL  
SITE ASSESSMENT REPORT**

**BERNICKER PROPERTY  
317 MAIN STREET  
CORNWALL, NEW YORK 12518**

**TEAM ENVIRONMENTAL  
CONSULTANTS, INC.  
30 INDUSTRIAL DRIVE  
MIDDLETOWN, NEW YORK  
(845) 692-8124**

**SEPTEMBER 28, 2016**

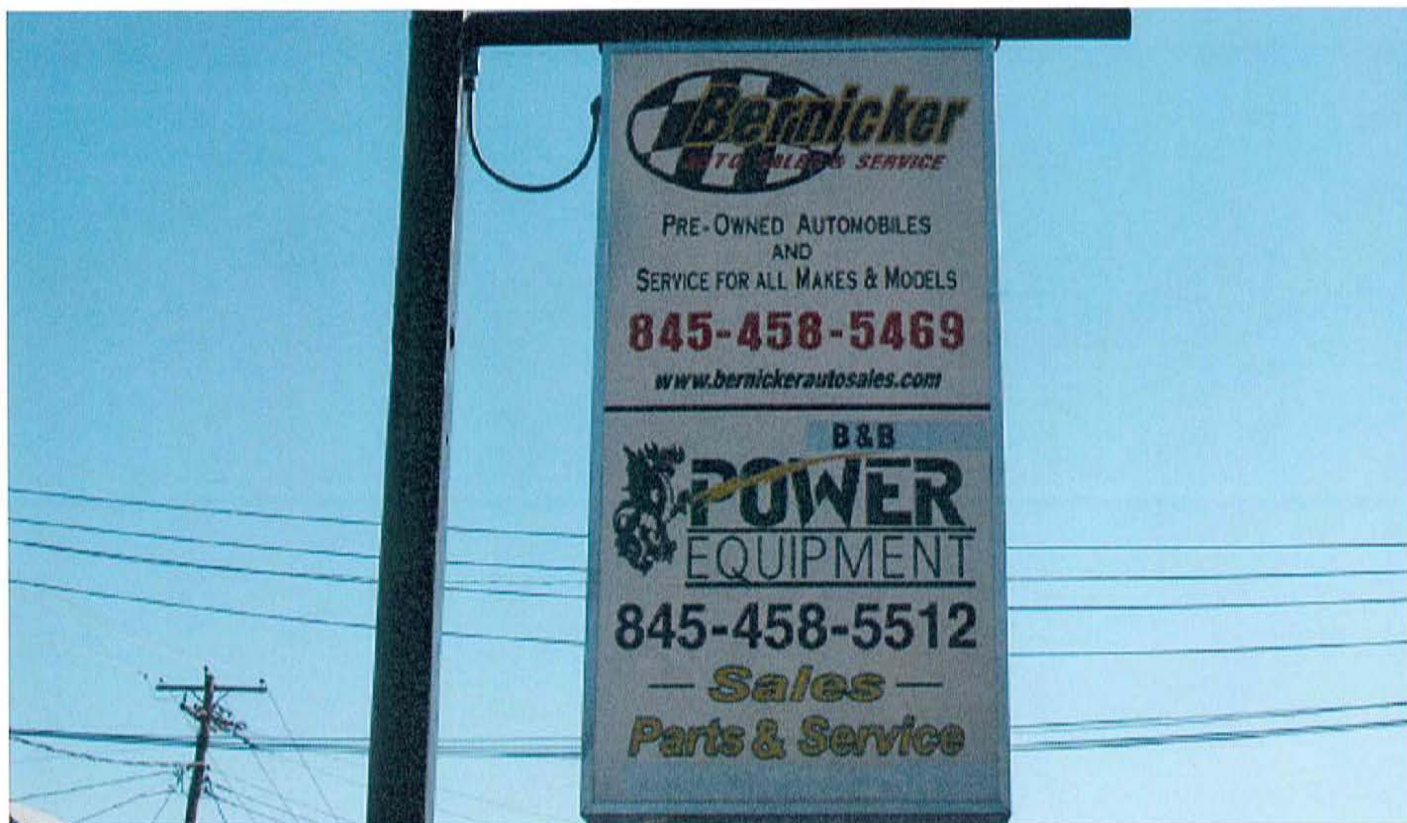
<u>Photo No.</u>	<u>Description</u>
1	Business signpost located along northwestern property border with Main Street.
2	Southern view from Main Street towards subject property.
3	Southeastern view from Main Street.
4	View along southwestern side of structure.
5	View towards southeastern side of building.
6	View along northeastern side of building.
7	Heating oil AST found along southwestern side of building.
8	Heating oil ASTs situated along northeastern side of structure.
9	Eastern view towards metal storage container.
10	Interior view within product showroom and service counter area.
11	Storage area shared by power equipment business and used automobile dealership.
12	Interior view within site office.
13	Interior view within shared service shop.
14	View towards ceiling mounted fuel oil fired heating system located within service shop.
15	Interior view within shop area towards two waste oil ASTs and associated waste oil fired heating system.

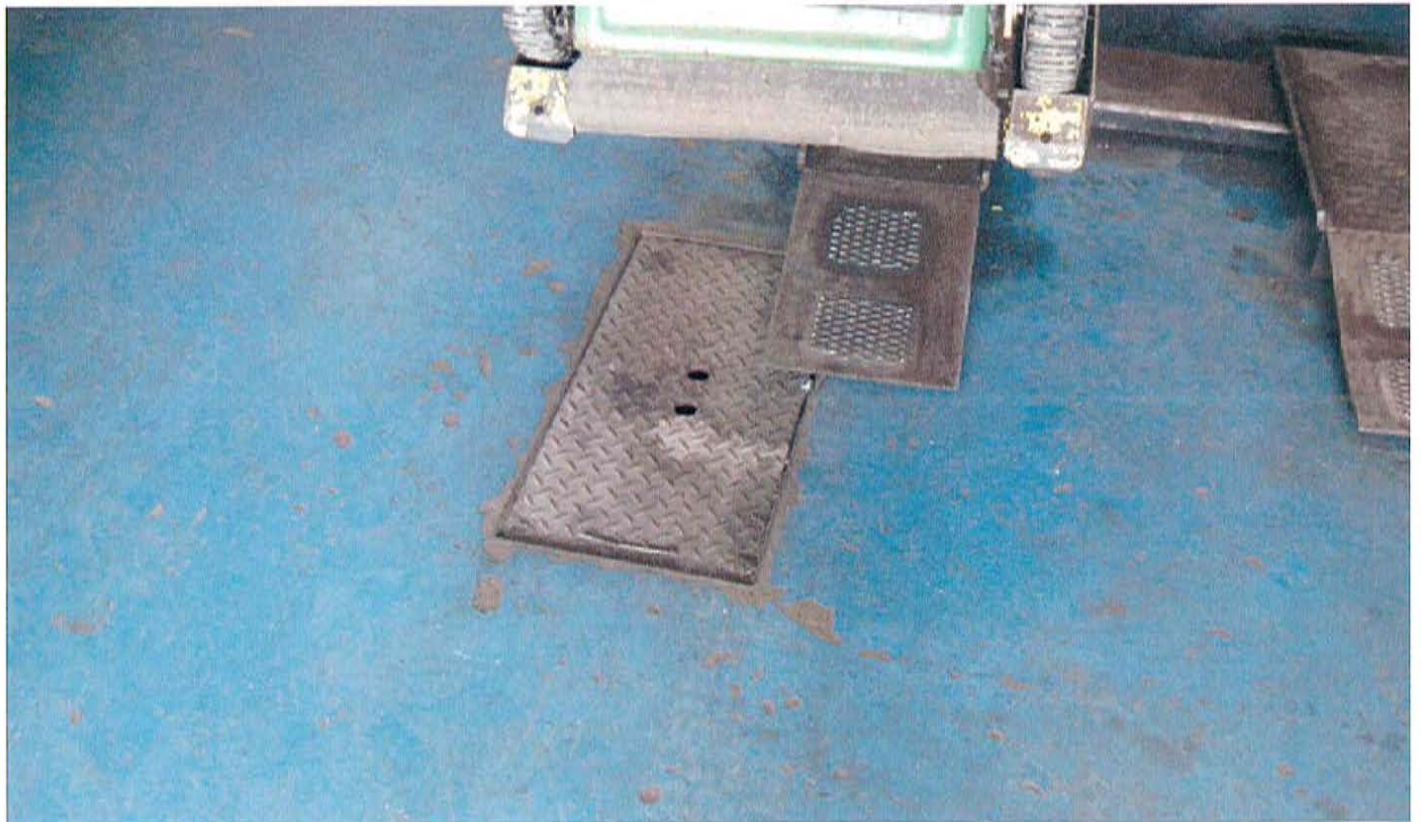
All generated waste products are removed for offsite disposal on a routine basis by Safety Kleen. TEAM was informed that no hazardous waste products requiring RCRA manifesting and tracking procedures are generated as a result of current site use or routine building maintenance activities. No auto body repair work or vehicle painting activities are performed onsite. Used automotive batteries are returned to the vendor for recycling. Four aboveground electric vehicle lift assemblies are situated within the service garage. The remnant of an older hydraulic lift was observed in the floor. William Bernicker informed TEAM that all mechanics and hydraulic fluid previously associated with the lift have been removed. A floor drain which reportedly discharges to the municipal sewer was identified within one of the service bays. No unusual odors or significant surface stains noted proximate to this drain.

16	View towards virgin motor oil AST.
17	Second virgin motor oil AST located within shop area.
18	Active floor drain found within service bay.
19	Remnant of former vehicle lift assembly.
20	Commercial parts washer located in machine shop.

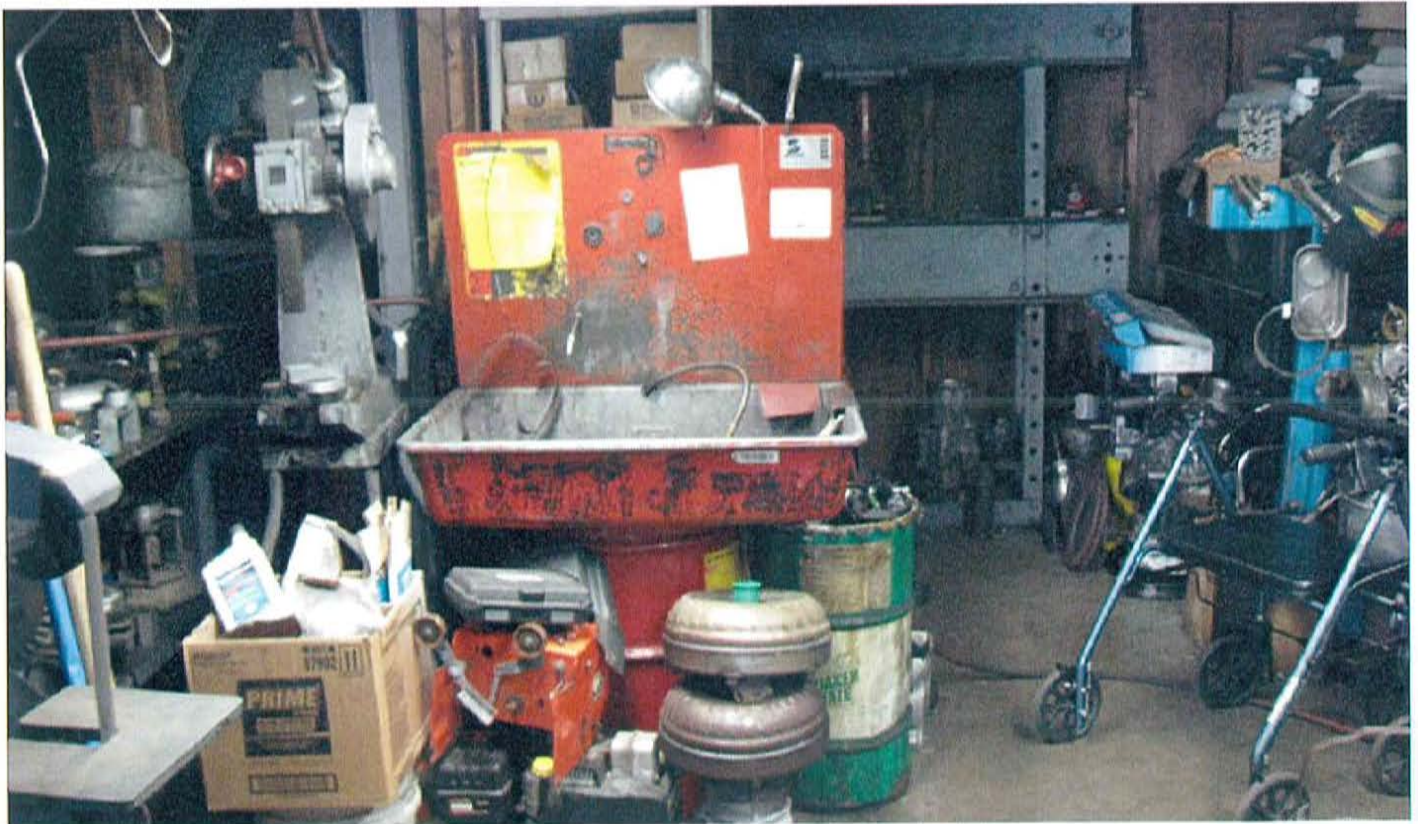
20

equipment, and assorted tools and supplies associated with automotive servicing and repair operations. A commercial parts washer (serviced and maintained by Safety Kleen) was found within a small machine shop room. No unusual odors or significant surface stains were noted proximate to inspected containers of the parts washer unit.
