PHASE I ENVIRONMENTAL SITE ASSESSMENT

NEWBURGH DEVELOPMENT SITE

NEWBURGH, NEW YORK

**December ##, 2015
Langan Project No. 190027401**

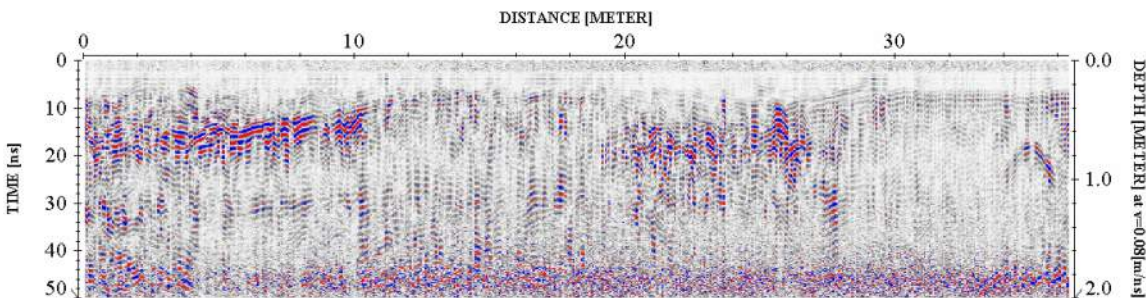
Step 5. Mute horizontal ringing/noise (*subtracting average*)

The above example shows the significance of data processing. The last image (step 5) has higher resolution than the starting image (raw data – step 1) and describes the subsurface anomalies more accurately.
