**RE: Periodic Review Report**  
Orangeburg Shopping Center, Orangetown, NY  
NYSDEC Site Number C344066

**PERIODIC REVIEW REPORT**  
**July 2015**

**Orangeburg (Orangetown) Shopping Center**  
**Rockland County, New York**

**NYSDEC Site Number: C344066**

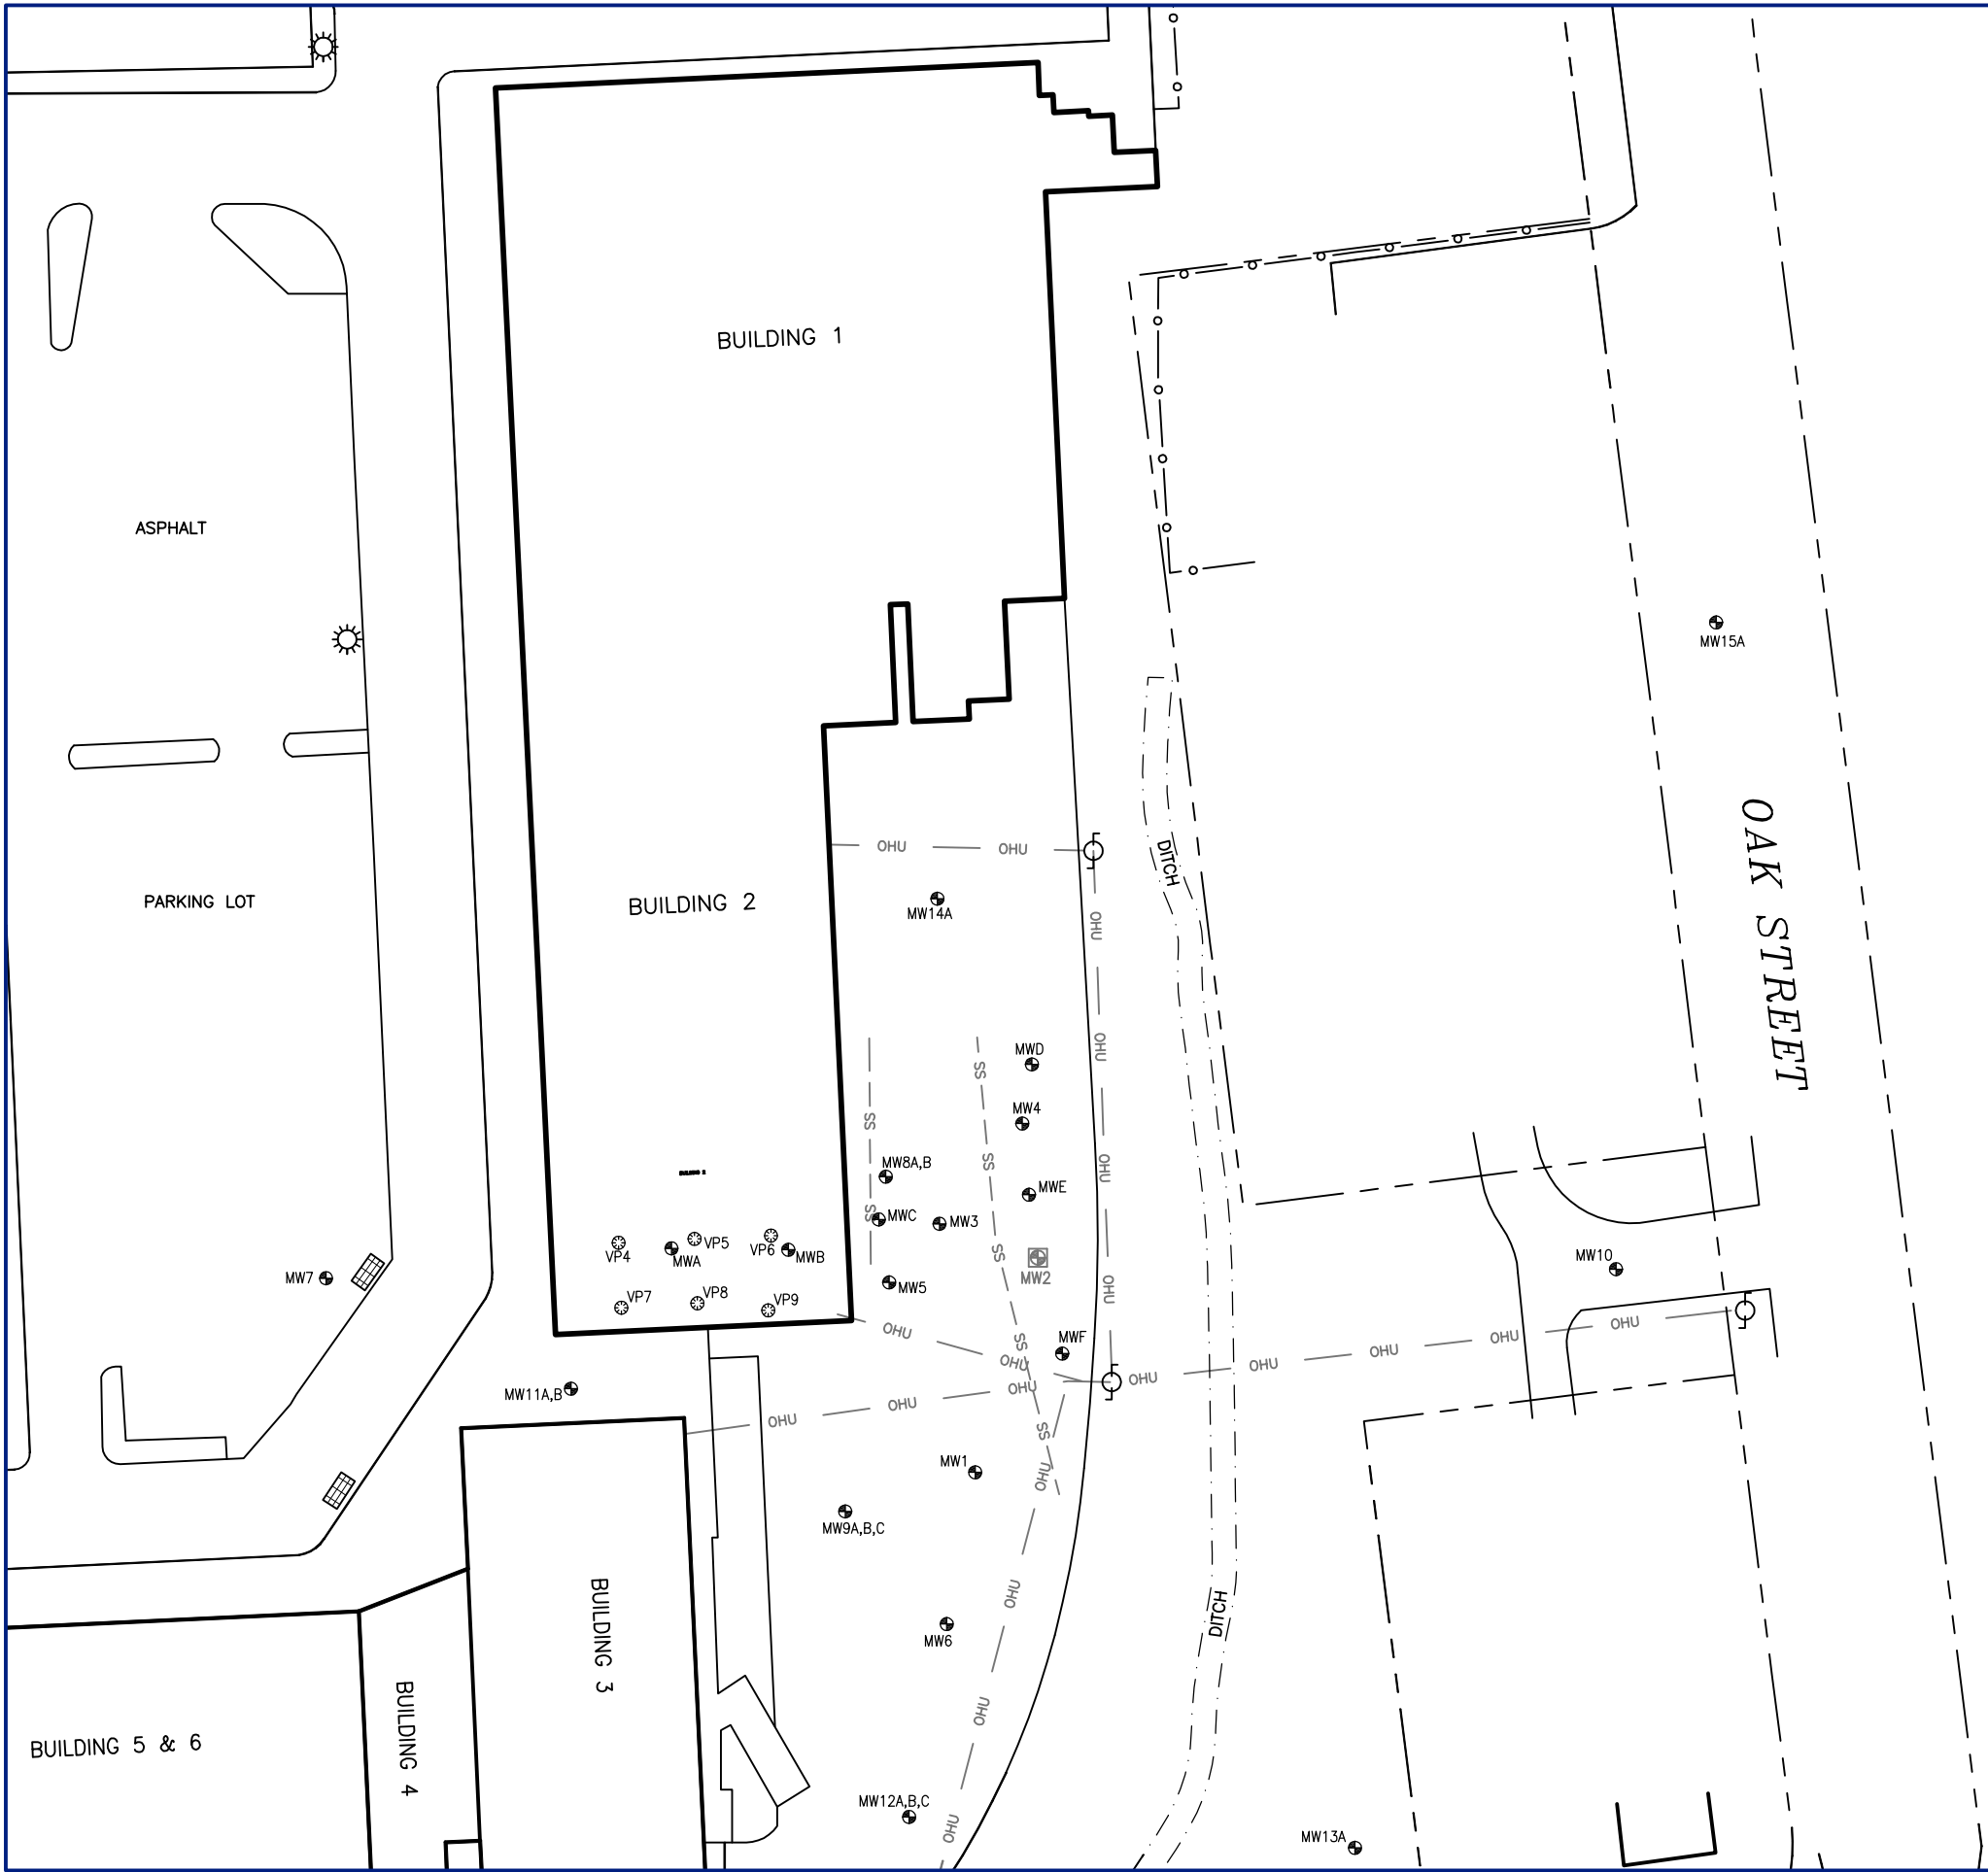
DRAFTED BY: W.G.S. (N.J.)	SITE MAP		
CHECKED BY: CA	UB ORANGEBURG, LLC 1-45 ORANGETOWN SHOPPING CENTER ORANGEBURG, NEW YORK		
REVIEWED BY: MD	Groundwater & Environmental Services, Inc. 16 MT. EBO ROAD SOUTH, SUITE 21, BREWSTER, NEW YORK 10509		
 NORTH	SCALE IN FEET  0 APPROXIMATE 50	DATE 6-26-14	FIGURE 2

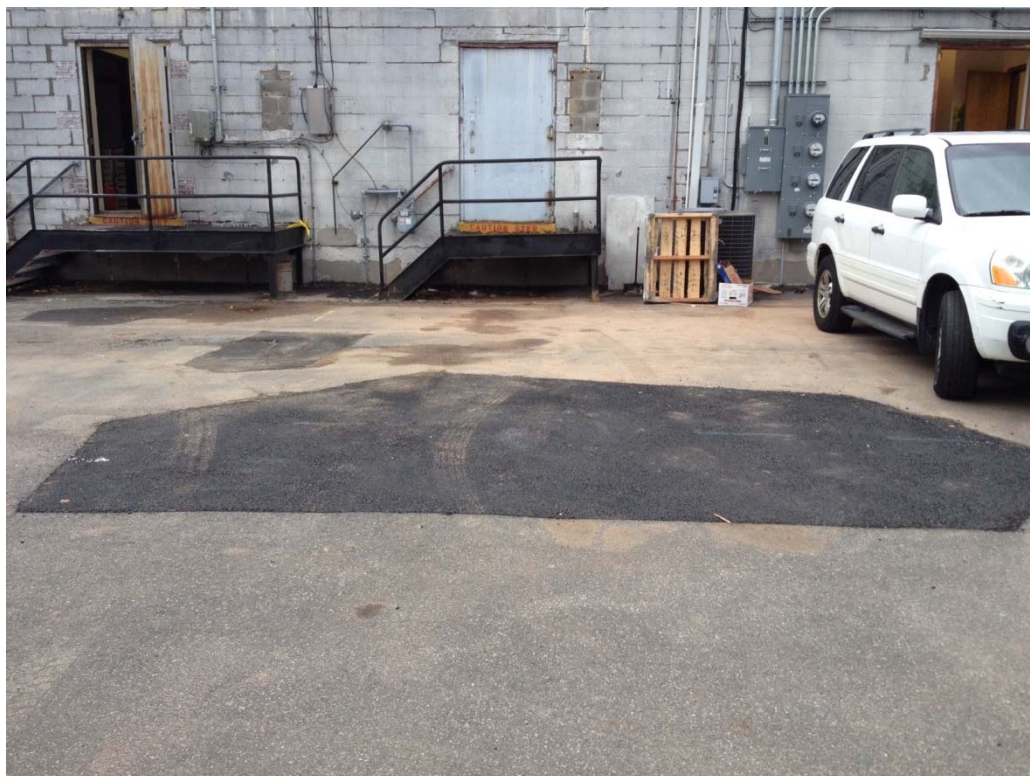
View to the west of the waterline and gas line repairs made to the east of building #2 in November 2014

On November 5, 2014, GES was notified of a water main break located within the composite cover system, an EC, for the site at the above-referenced facility. The NYSDEC was immediately notified via e-mail of the emergency response activities required to repair the line. Regulatory correspondences are attached as **Appendix A**. Kings Capital Construction Group of White Plains, New York was contracted to complete the repairs. All soil excavated to access the water main was temporarily stockpiled within a lined and covered roll-off pending approval to transport the soil to a permitted facility.

During the emergency water line repairs, a natural gas line leak was also detected adjacent to the shopping center and within the composite cover system. Orange and Rockland (O&R) was immediately notified and repairs to the gas line were coordinated. Under GES oversight, American Environmental Assessment Corp. (AEAC) and O&R completed the scheduled repairs

Following utility repairs, the composite cover was restored to match the surrounding area. A photograph of the restored composite cover is included in **Appendix D**.

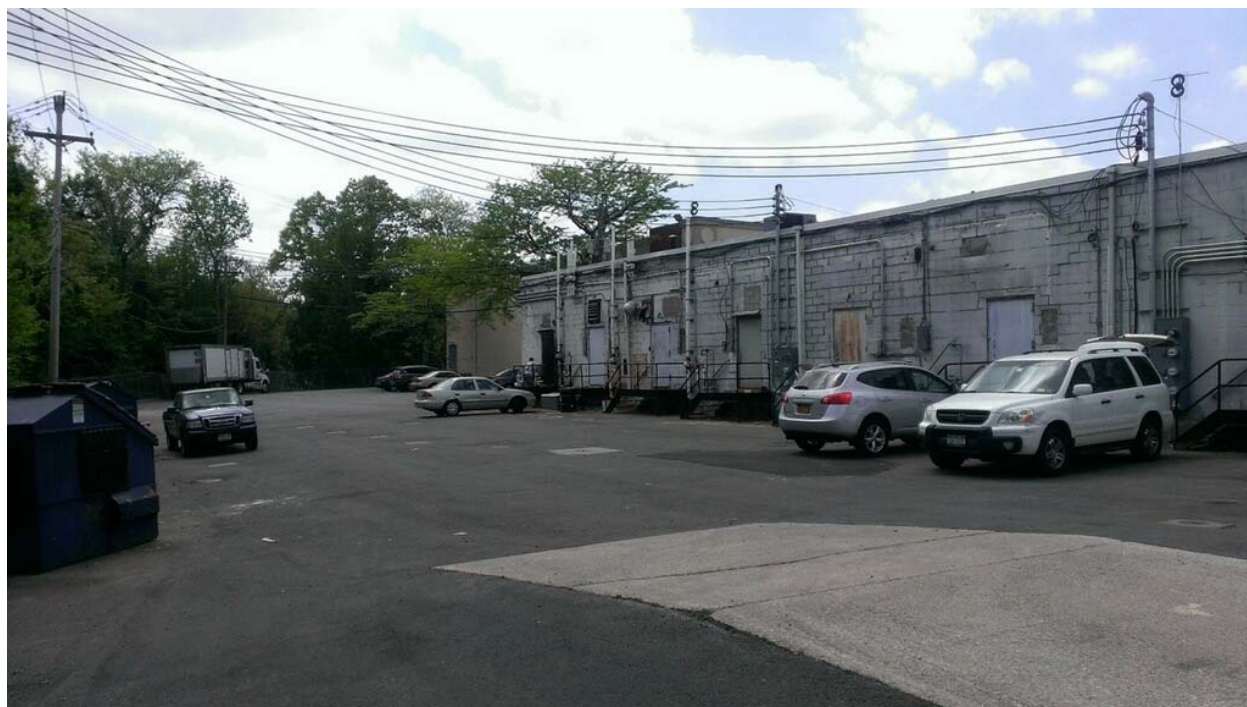
View to the southwest of the eastern side of the site

On June 16, 2015, the composite cover system was inspected by a qualified environmental professional. The composite cover system was determined to be intact and impervious to surface water infiltration. Photographs of the composite cover system are provided in **Appendix D**. Additional inspections occurred during one or more of the following activities: quarterly groundwater sampling, quarterly SSDS OM&Ms, and/or site visits.

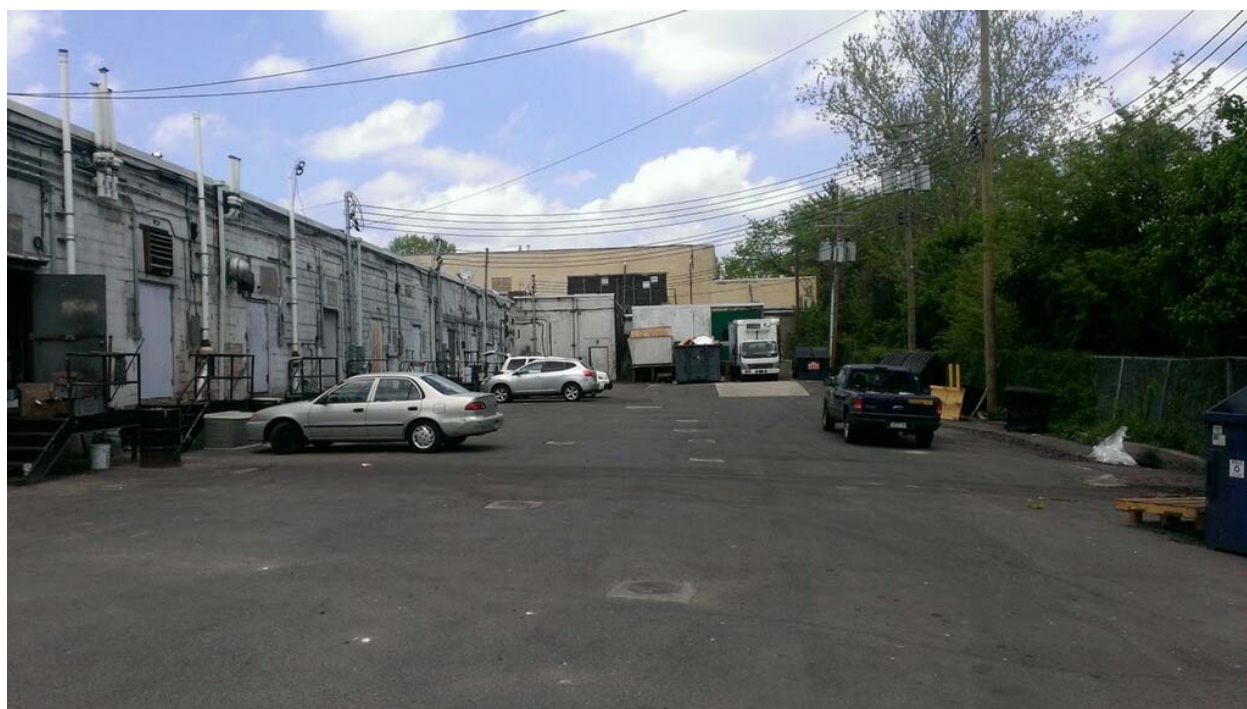
View to the north of the eastern side of the site
