**RE: Periodic Review Report**  
Orangeburg (Orangetown) Shopping Center  
NYSDEC Site Number C344066  
I-45 Orangetown Shopping Center  
Orangetown, NY 10962

**PERIODIC REVIEW REPORT**  
**July 2017**

**Orangeburg (Orangetown) Shopping Center**  
**Rockland County, New York**

**NYSDEC Site Number: C344066**

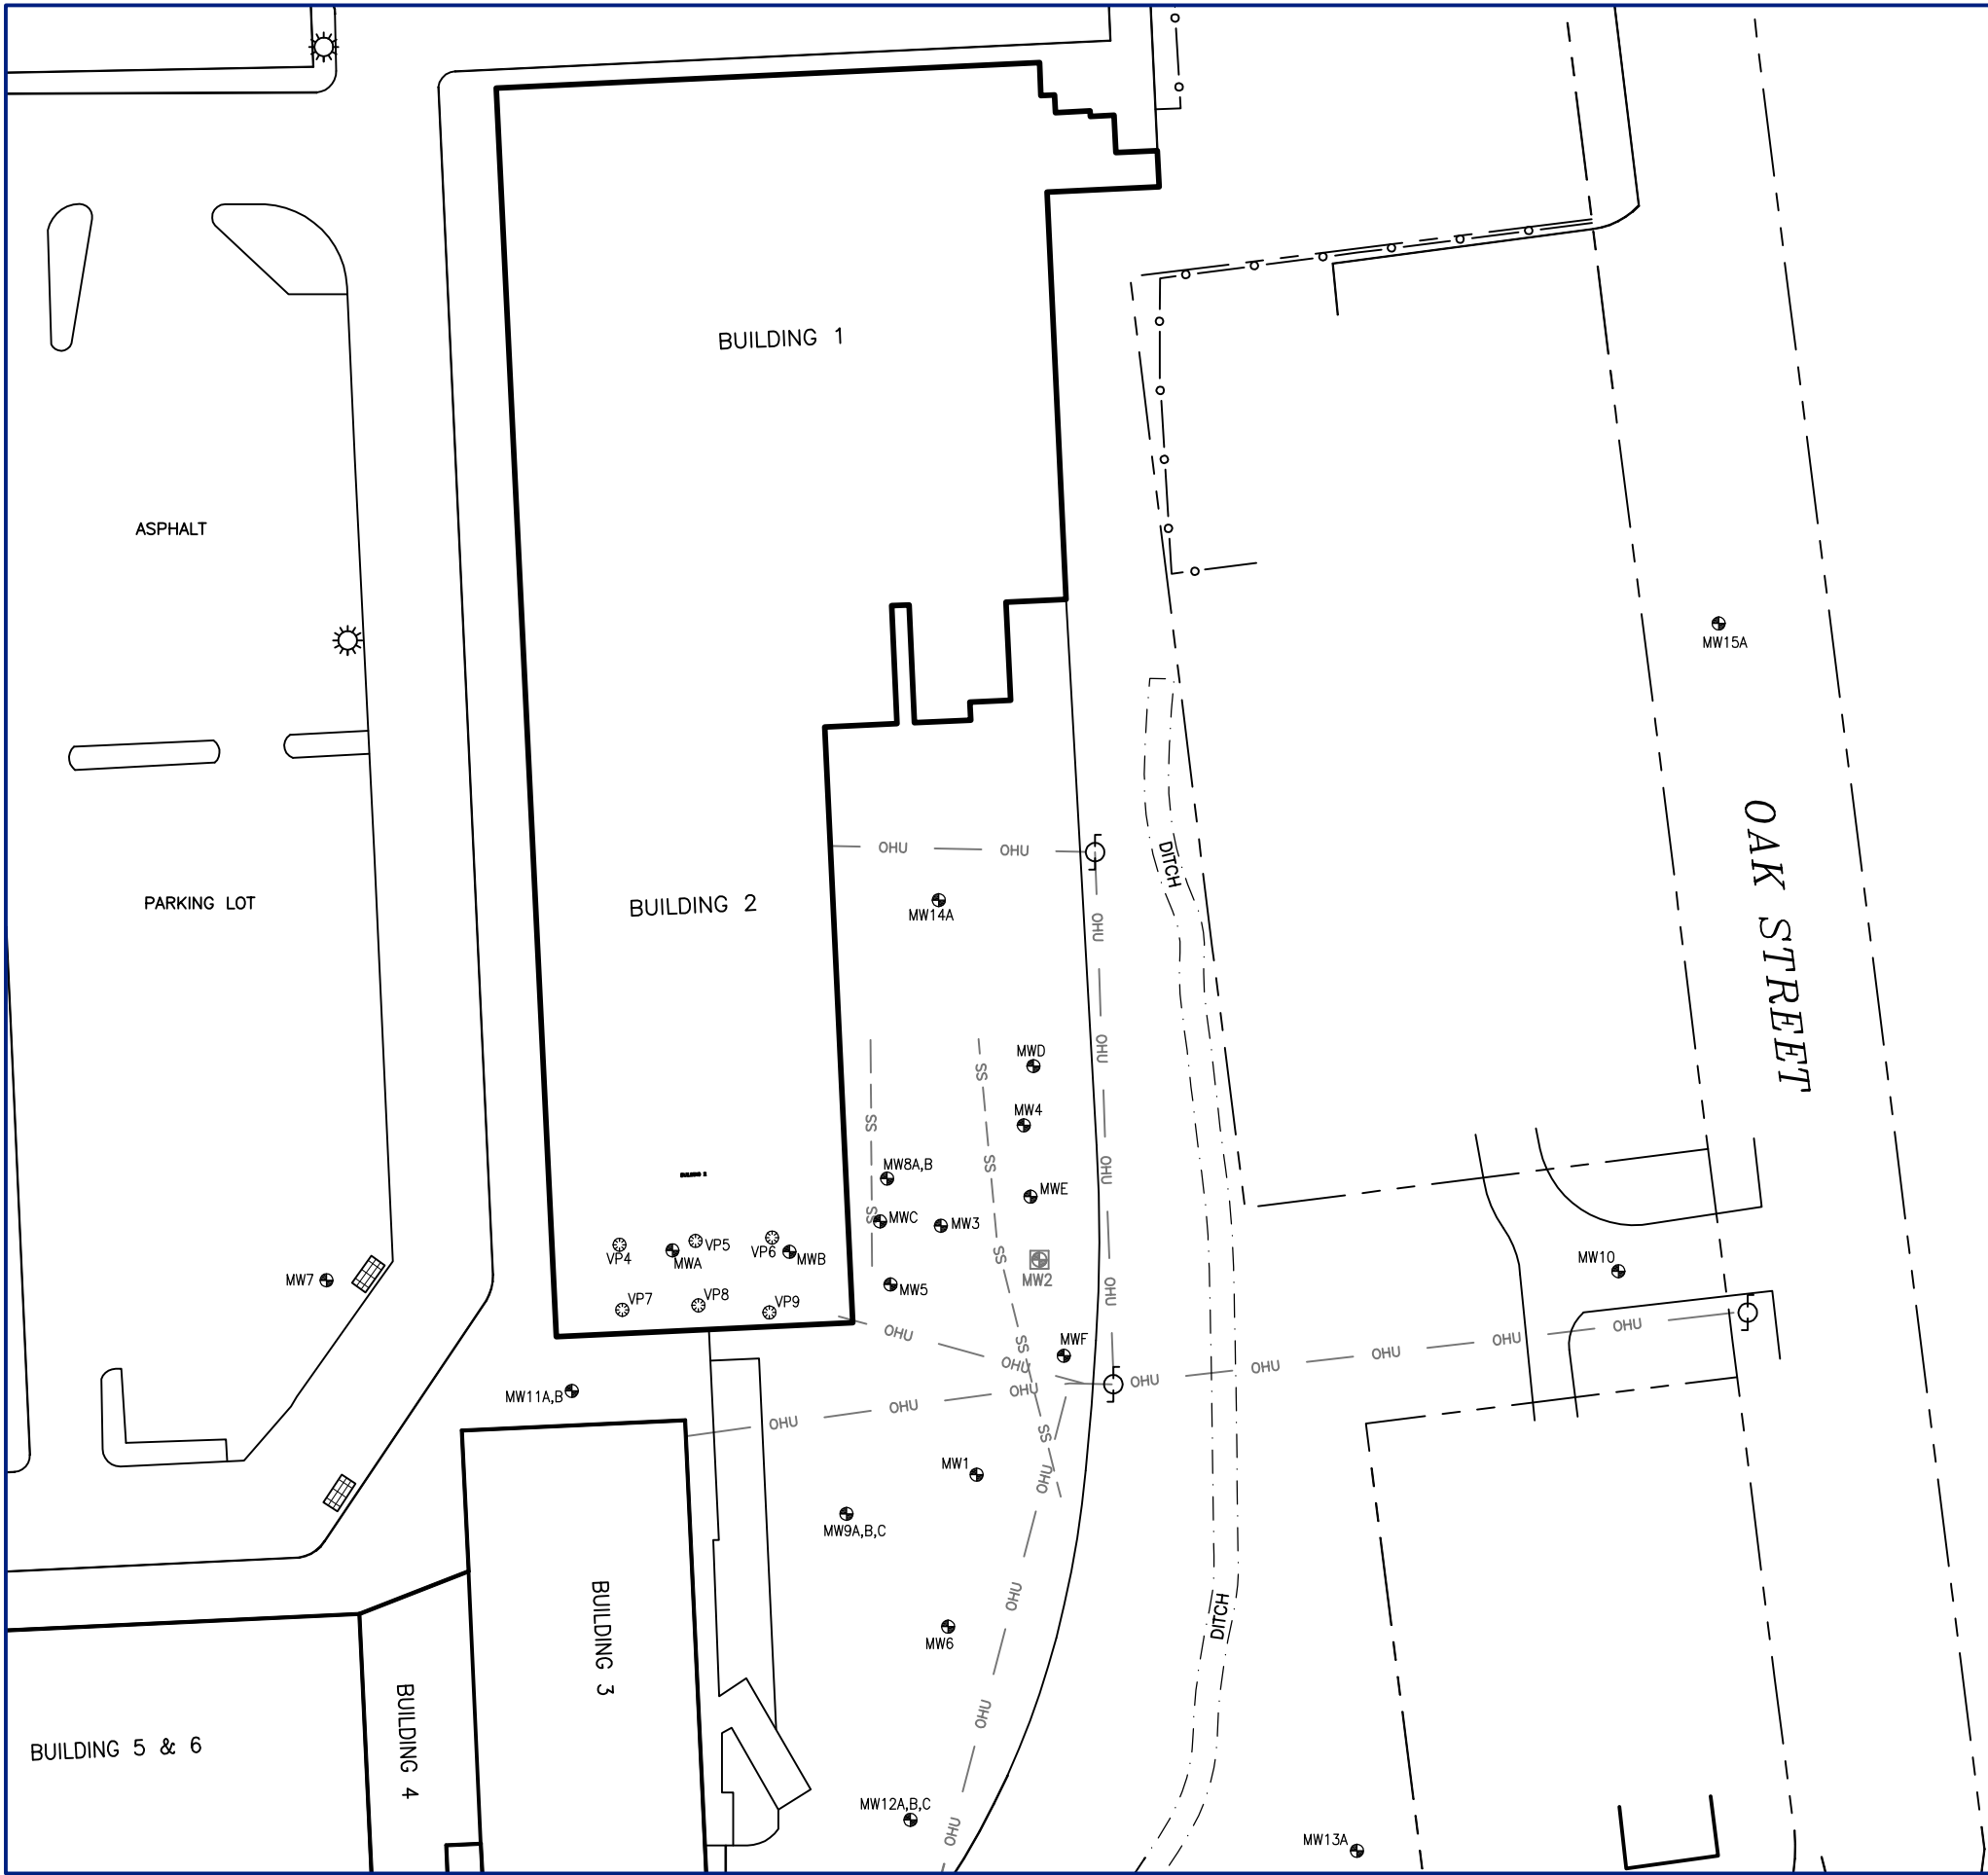
The approximate geographical coordinates for the Property are 41 degrees, 2 minutes, 41.6 seconds North (Latitude) by 73 degrees, 57 minutes, 10.4 seconds West (Longitude). The Property is comprised of one (1) parcel (Section, Lot & Block: 74.10-67-1) that covers an area of approximately 11 acres. Included are the following: a Site Location Map (**Figure 1**) for the general Property location, a Site Map (**Figure 2**) showing the current key site features at the subject Property, and a Bio-Augmentation System Well Locations map (**Figure 3**) showing the current locations of active injection and monitoring well points near building #2.

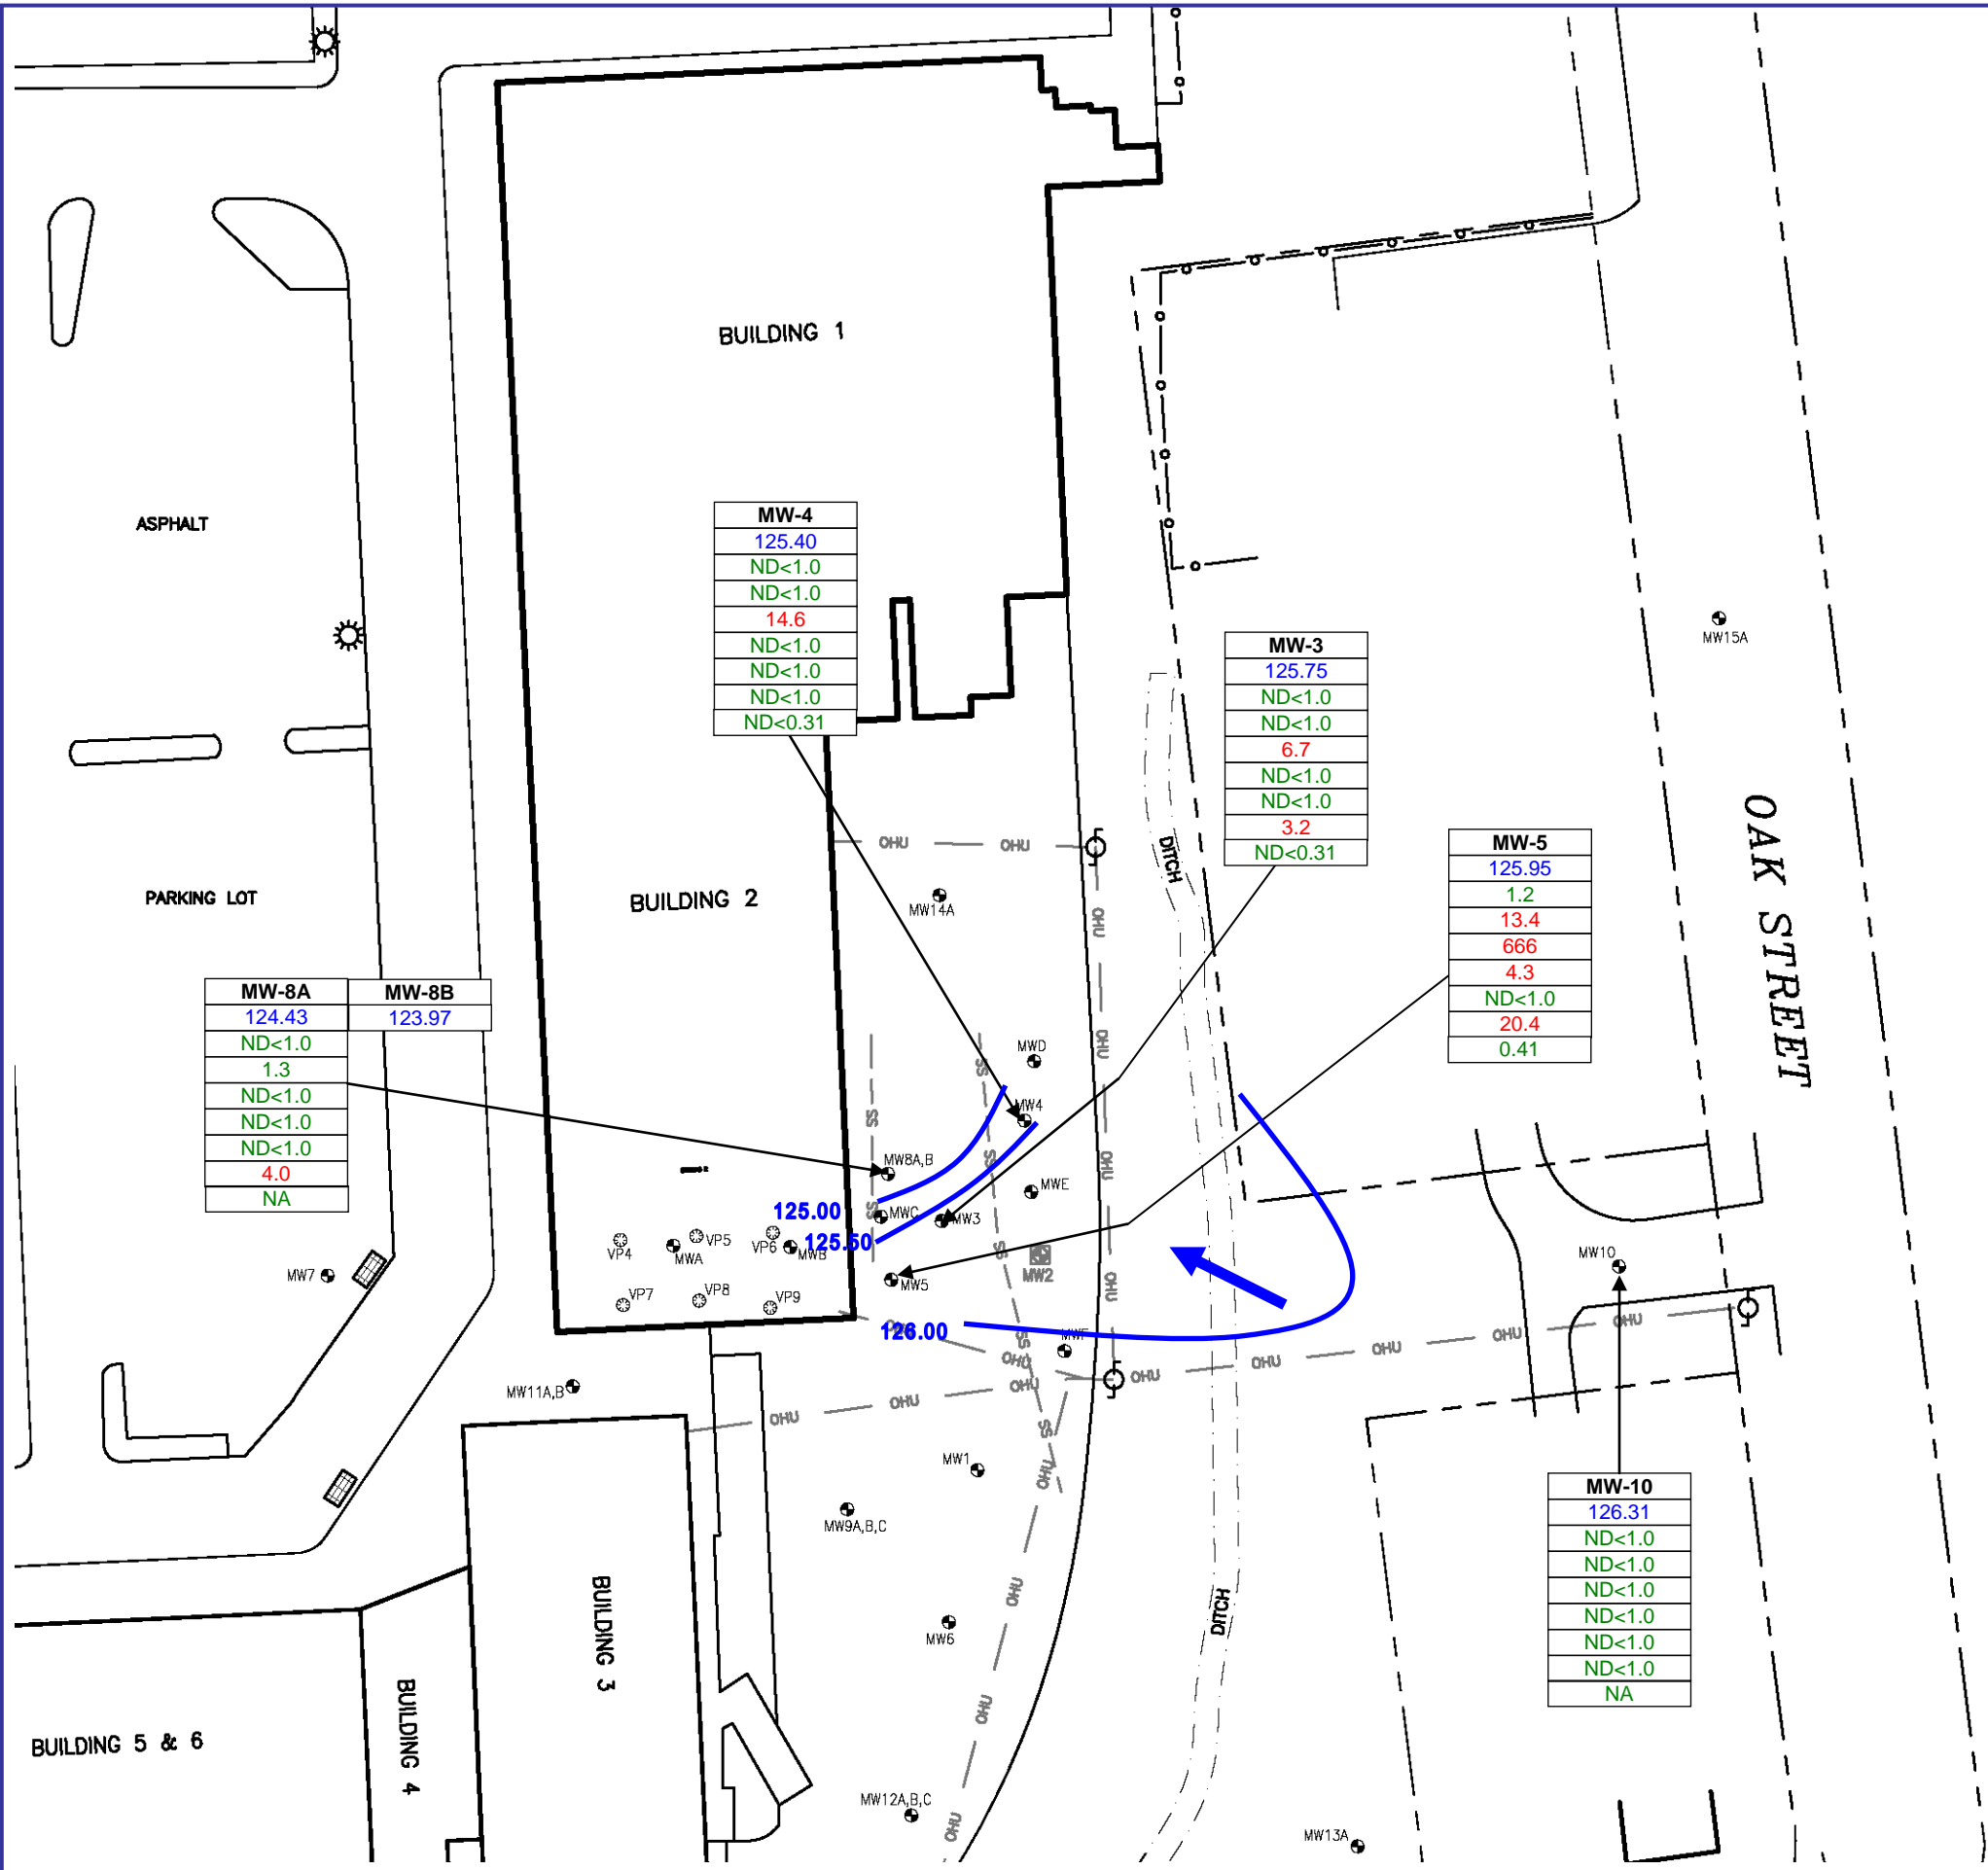
\*Monitoring well MW-8B not sampled due to an obstruction in the well.

Please refer to **Figures 4** through **7** and **Table 4** for a summary of the concentrations and trends of the constituents of concerns at all sampled monitoring wells. **Figure 8** and **Tables 2** and **3** present the general chemistry analytical results and measured bio-parameter readings including optimal geochemical target range for TOC concentrations (50 mg/L and 500 mg/L) and pH (6 to 8) at the monitoring wells. Bio-parameter levels were outside the target range at monitoring well MW-5 during the September 9, 2016 event with pH of 5.87 measured and during the March 3, 2017 event when TOC was 44.4 mg/L. Therefore, these bio-parameters will continue to be monitored and evaluated during the 2<sup>nd</sup> quarter 2017 sampling event to determine if an additional bio-augmentation event is required.
