# Periodic Review Report

UB Orangeburg

1-45 Orangeburg Shopping Center

NYSDEC Site Number C344066

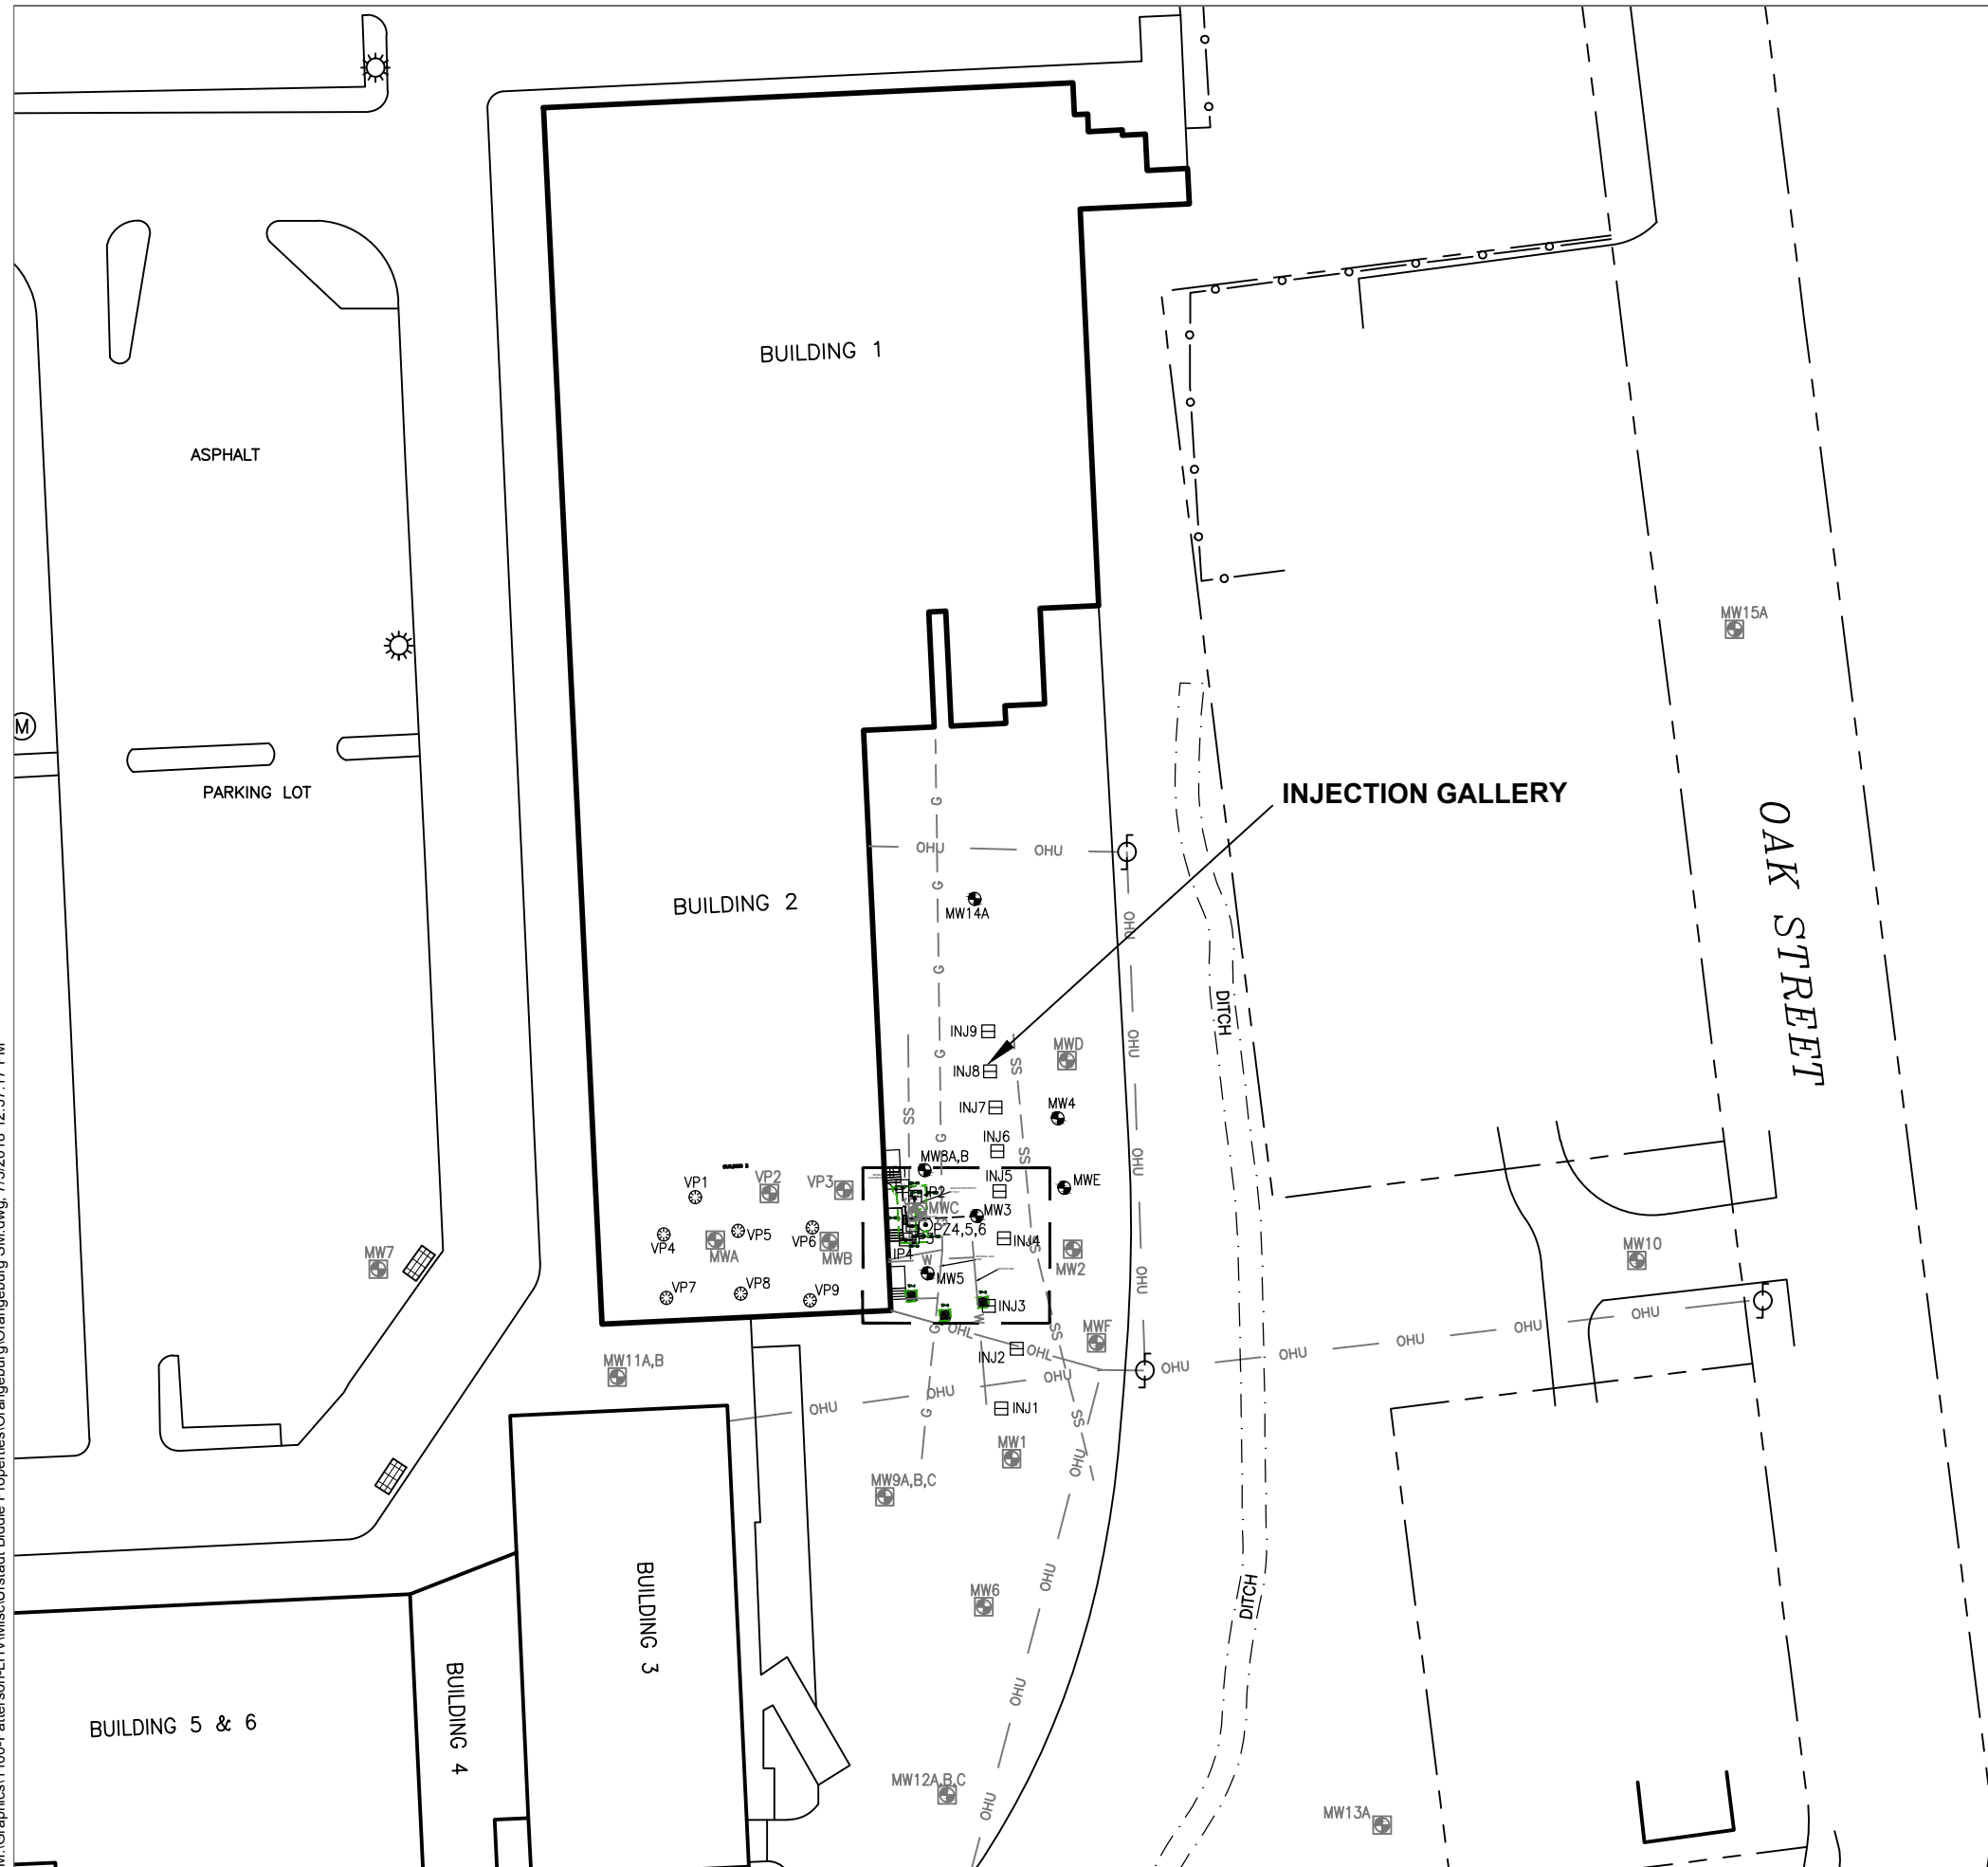
**Site Map**

The approximate geographical coordinates for the Site are 41 degrees, 2 minutes, 41.6 seconds North (Latitude) by 73 degrees, 57 minutes, 10.4 seconds West (Longitude). The Site is comprised of one (1) parcel (Section, Lot & Block: 74.10-67-1) that covers an area of approximately 11 acres. Included are the following: a Site Location Map (**Figure 1**) for the general property location, a Site Map (**Figure 2**) showing the current key Site features at the subject Site, and a Detail Site Map (**Figure 3**) showing the current locations of active injection and monitoring well points near building #2.

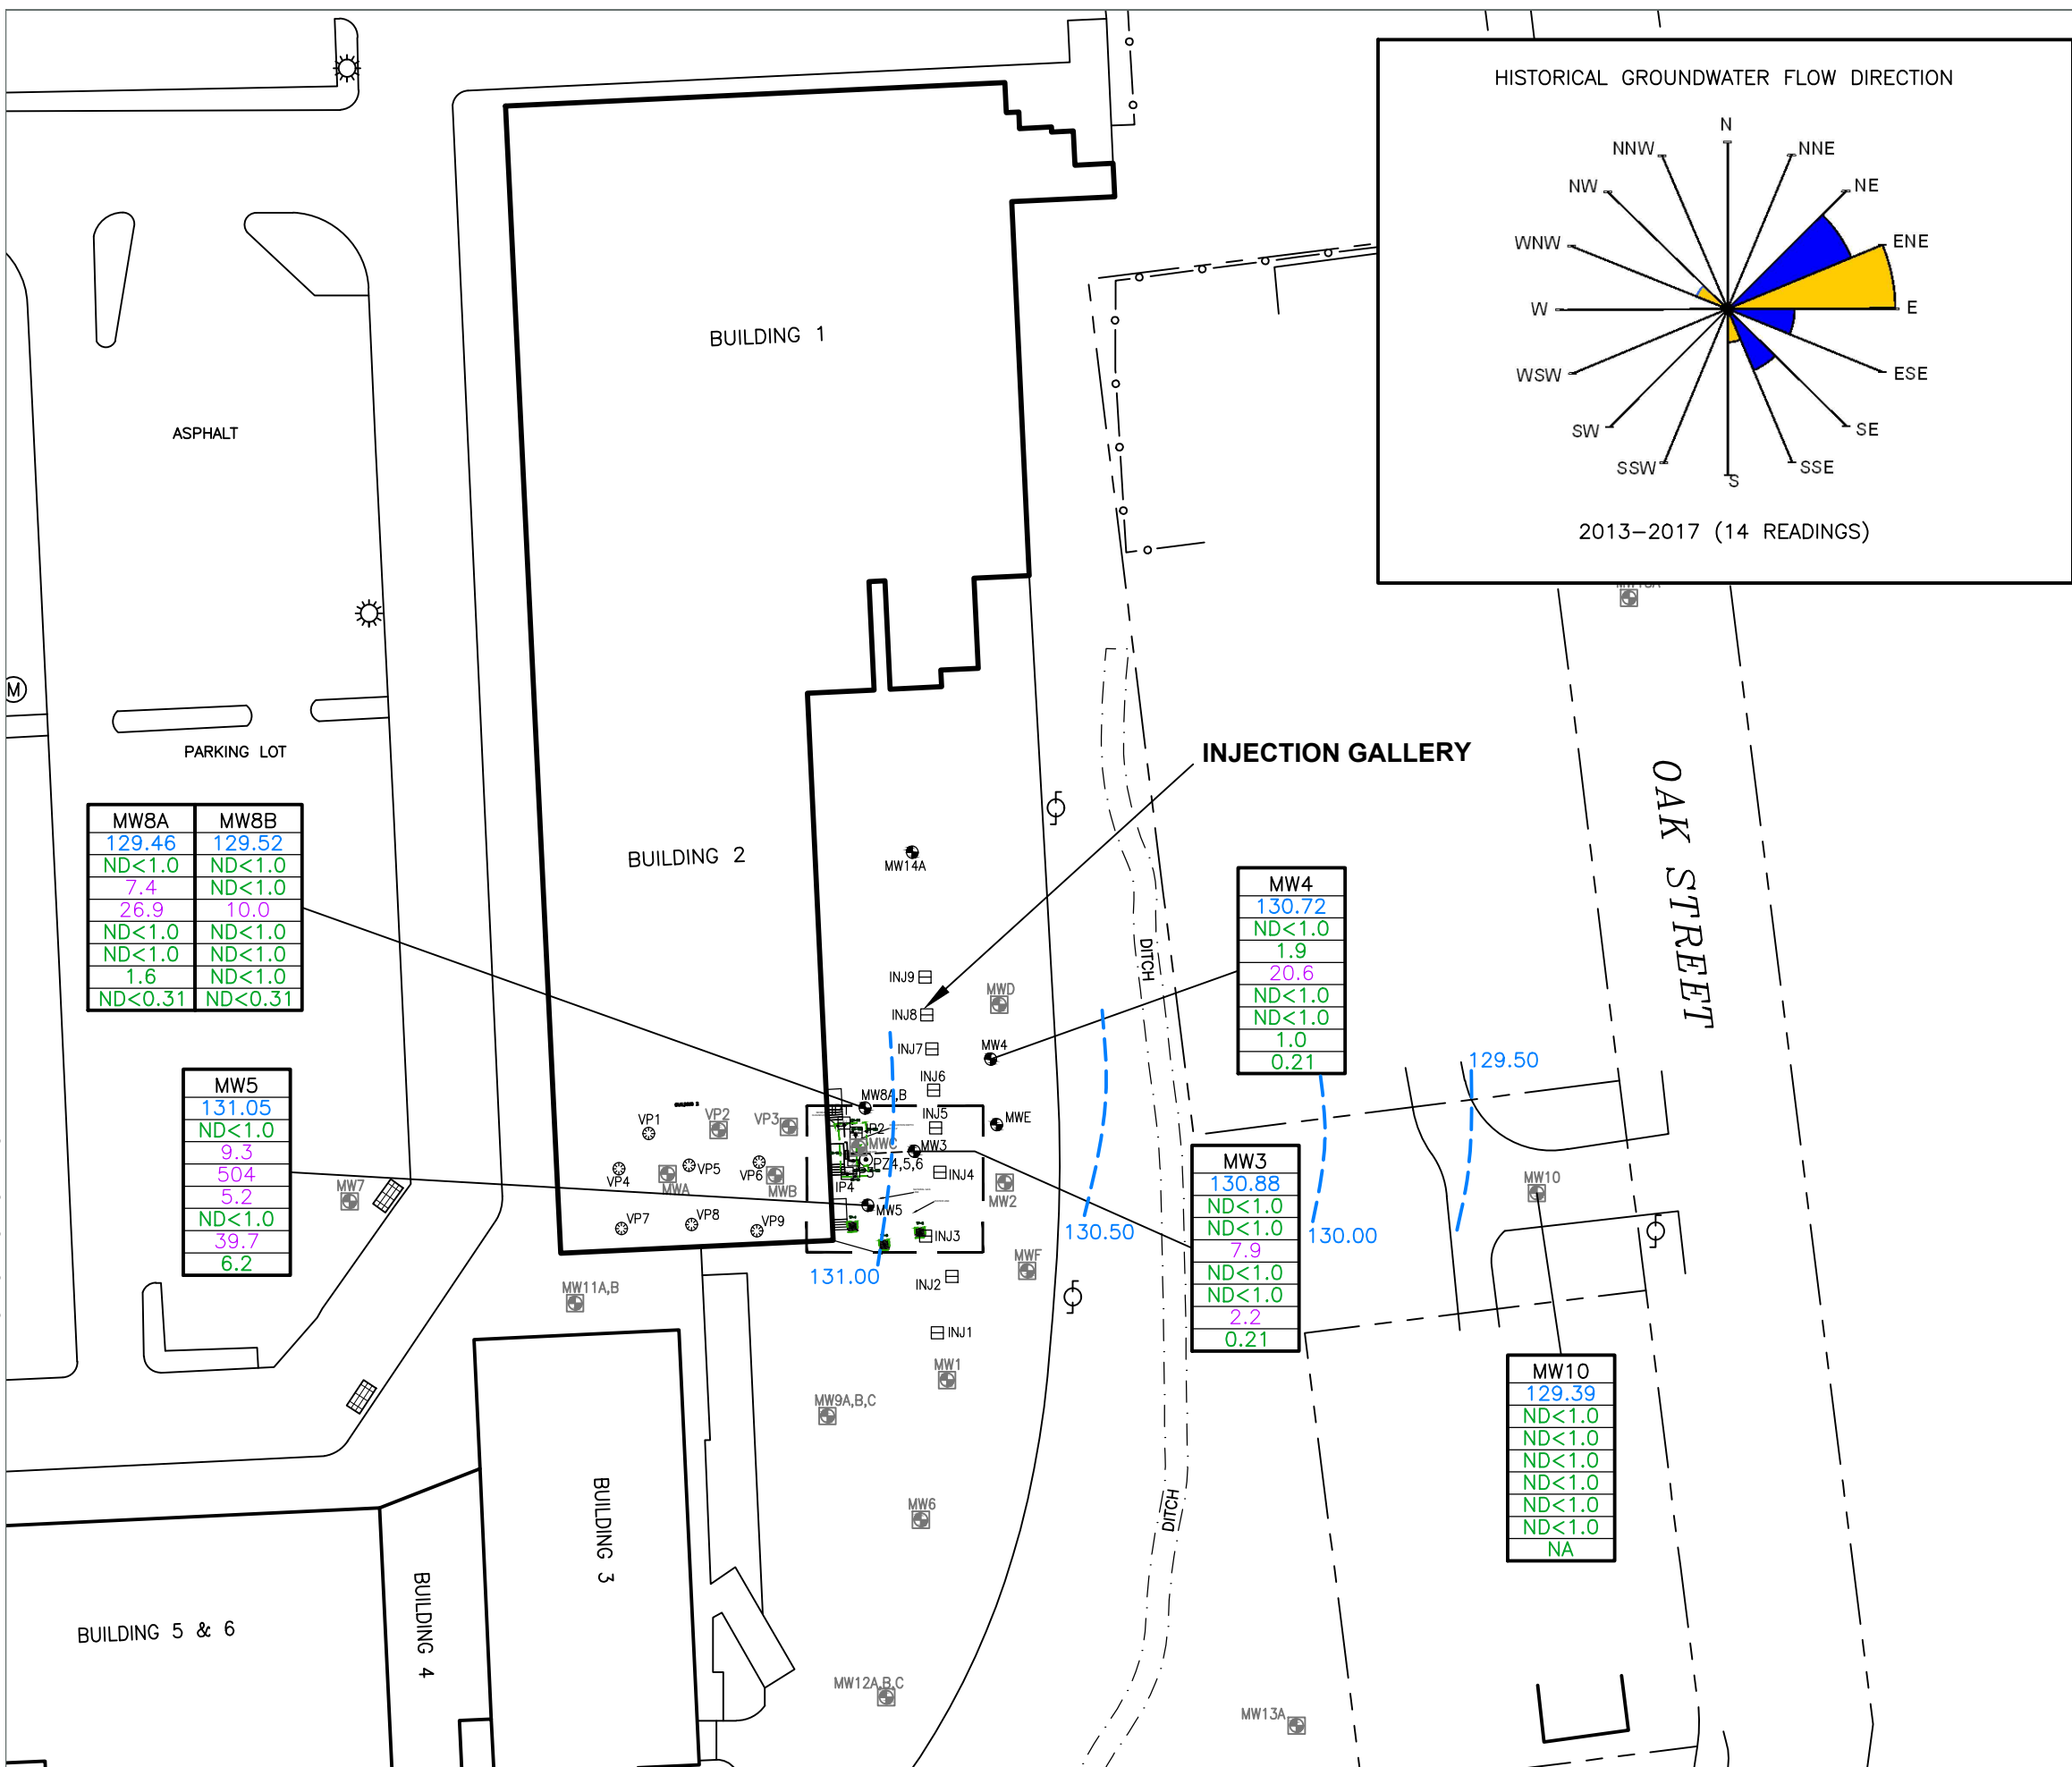
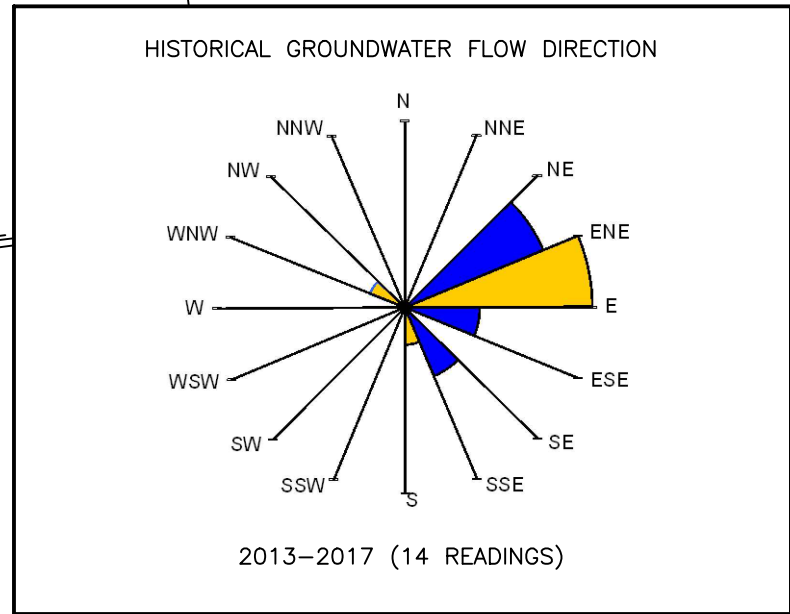
Groundwater well logs updated during each quarterly sampling event are included as **Appendix C**. Please refer to **Figures 5** through **9** and **Table 1** and **2** for a summary of groundwater elevation and concentrations of the COCs at all sampled monitoring wells. **Figure 10** and **Tables 3** and **4** present the general chemistry analytical results and measured bioparameter readings including optimal geochemical target range for TOC concentrations (50 mg/L through 500 mg/L) and pH (6 to 8) at the monitoring wells. Groundwater trends observed at monitoring well MW-5 during the monitoring period are illustrated in **Figure 11**.

MW5
131.05
ND<1.0
9.3
504
5.2
ND<1.0
39.7
6.2
