**Re: Periodic Review Report – July 2018 to July 2019  
1-45 Orangetown Shopping Center  
Orangeburg, New York  
Site #C344066**

# Periodic Review Report (Part 1)

1-45 Orangeburg Shopping Center

NYSDEC Site Number C344066

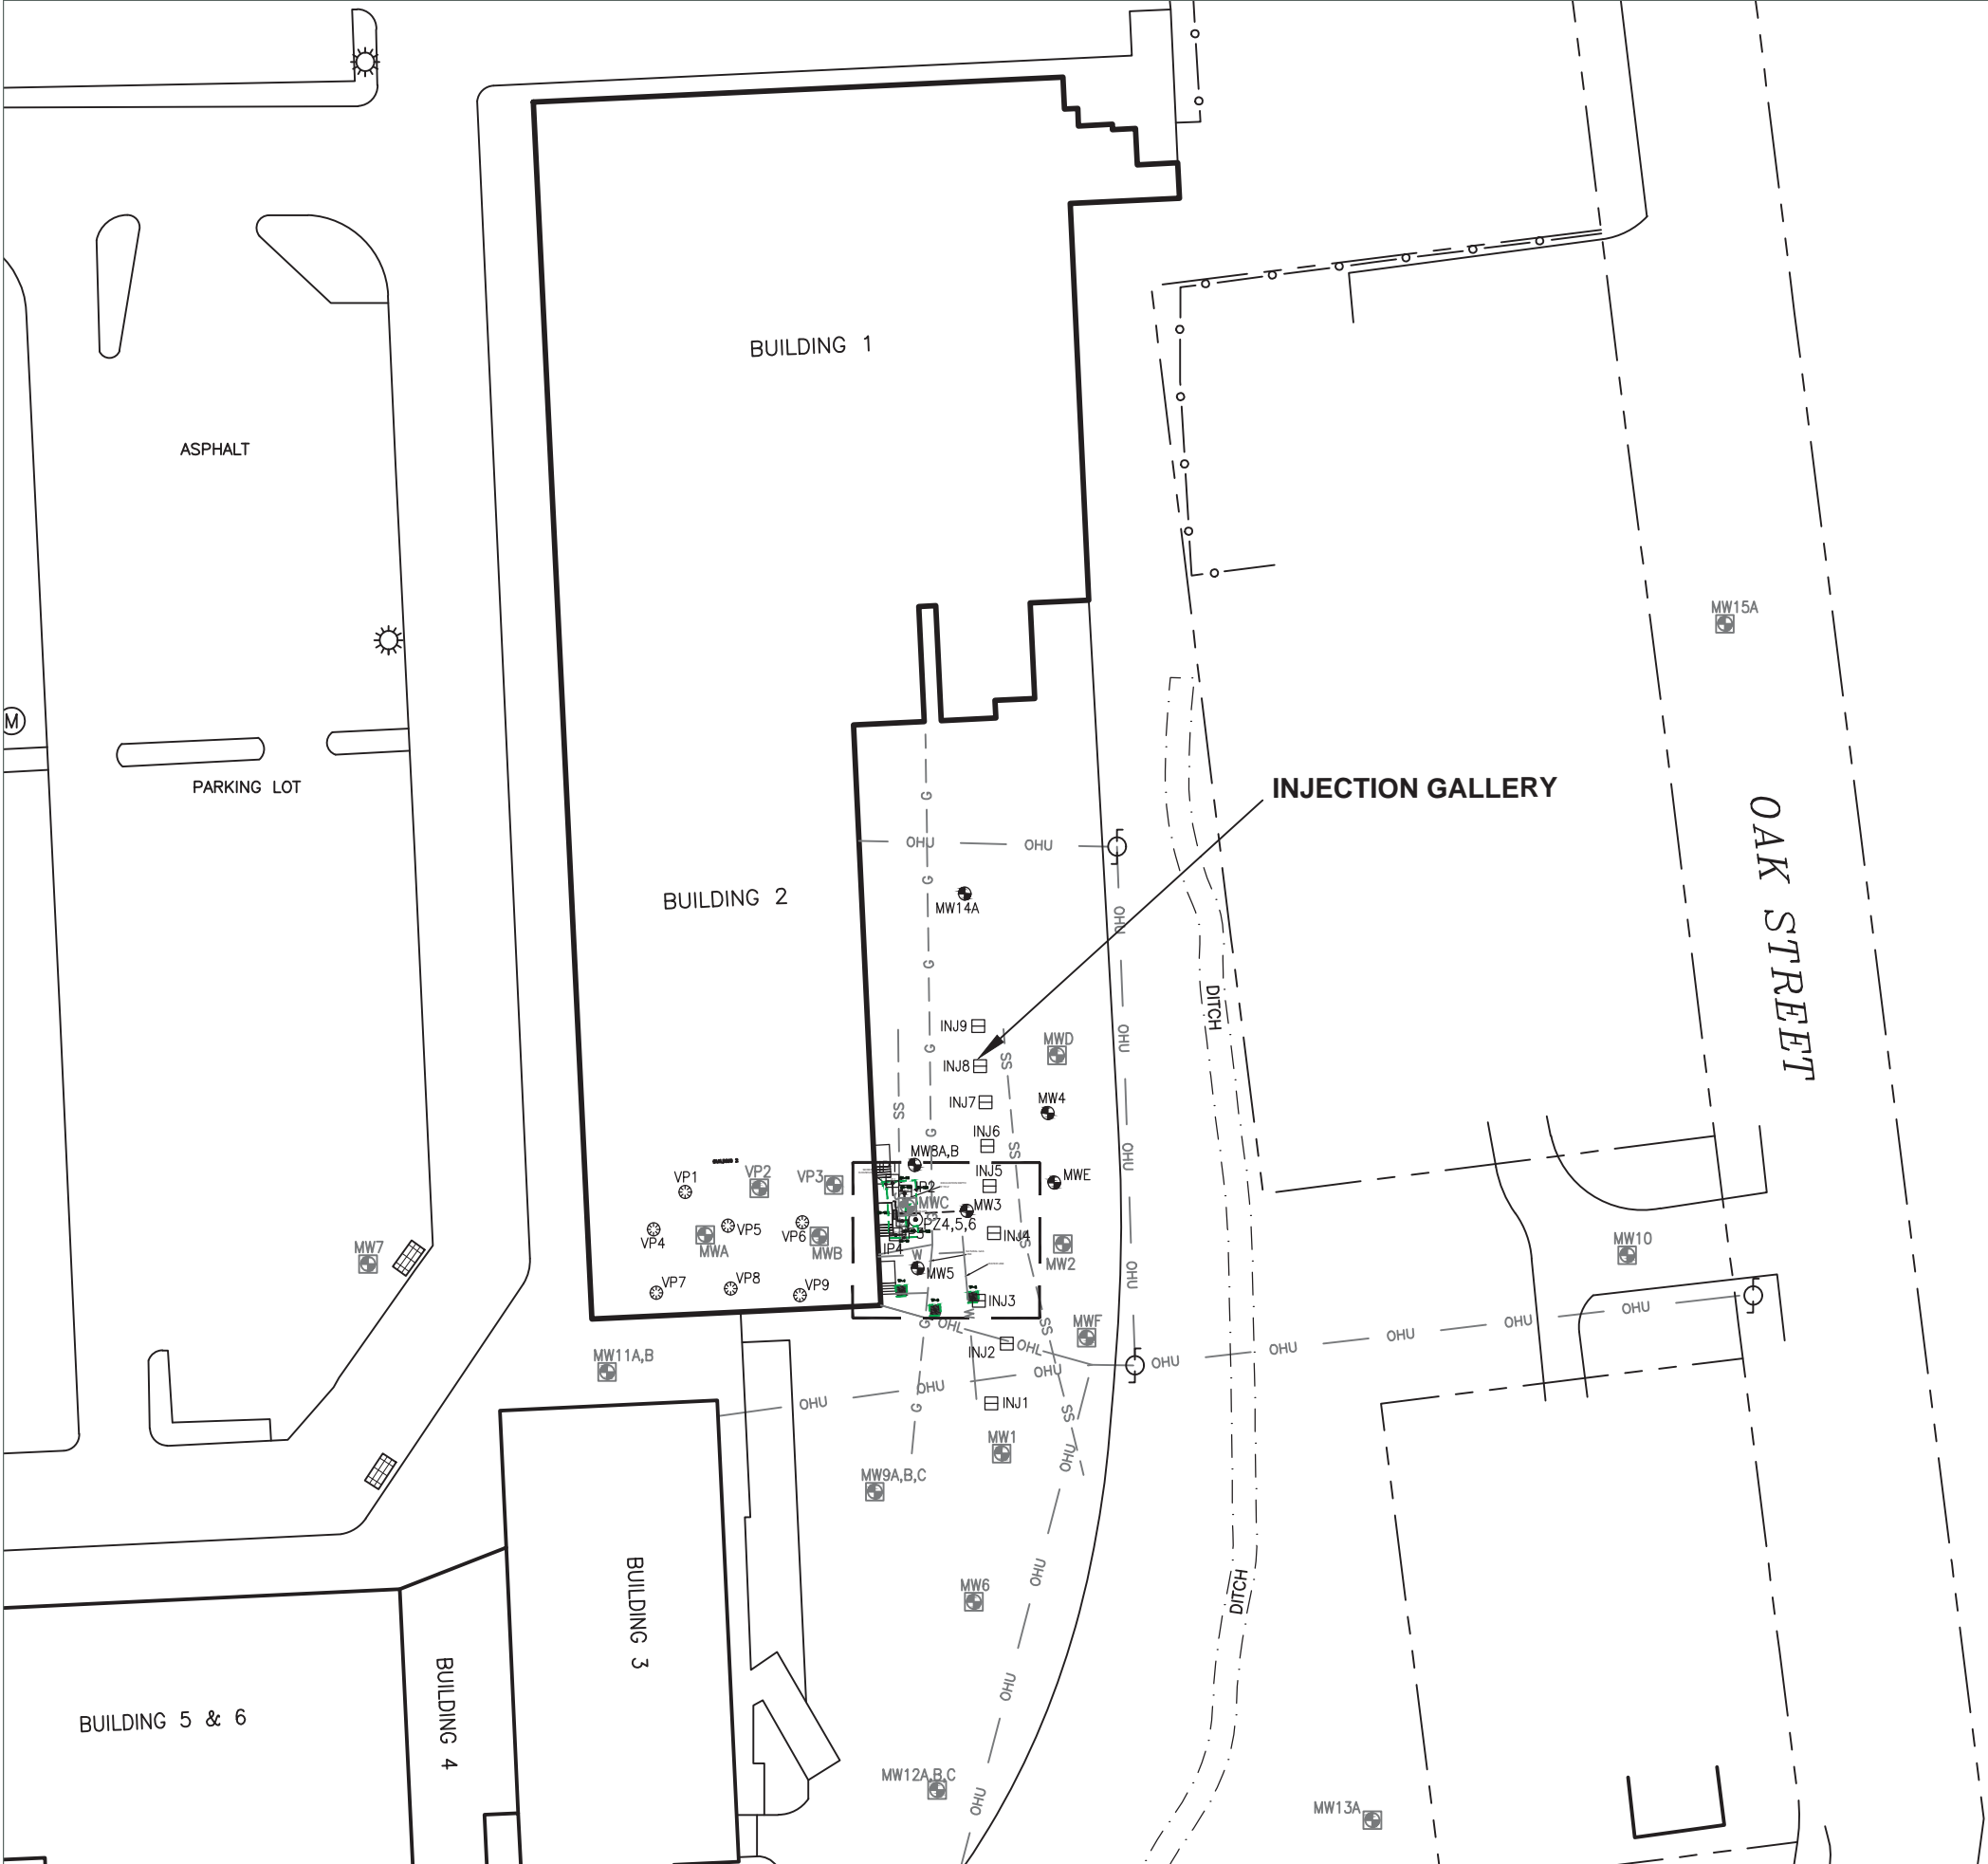
Date  
3/18  
Figure  
3

Detail Site Map

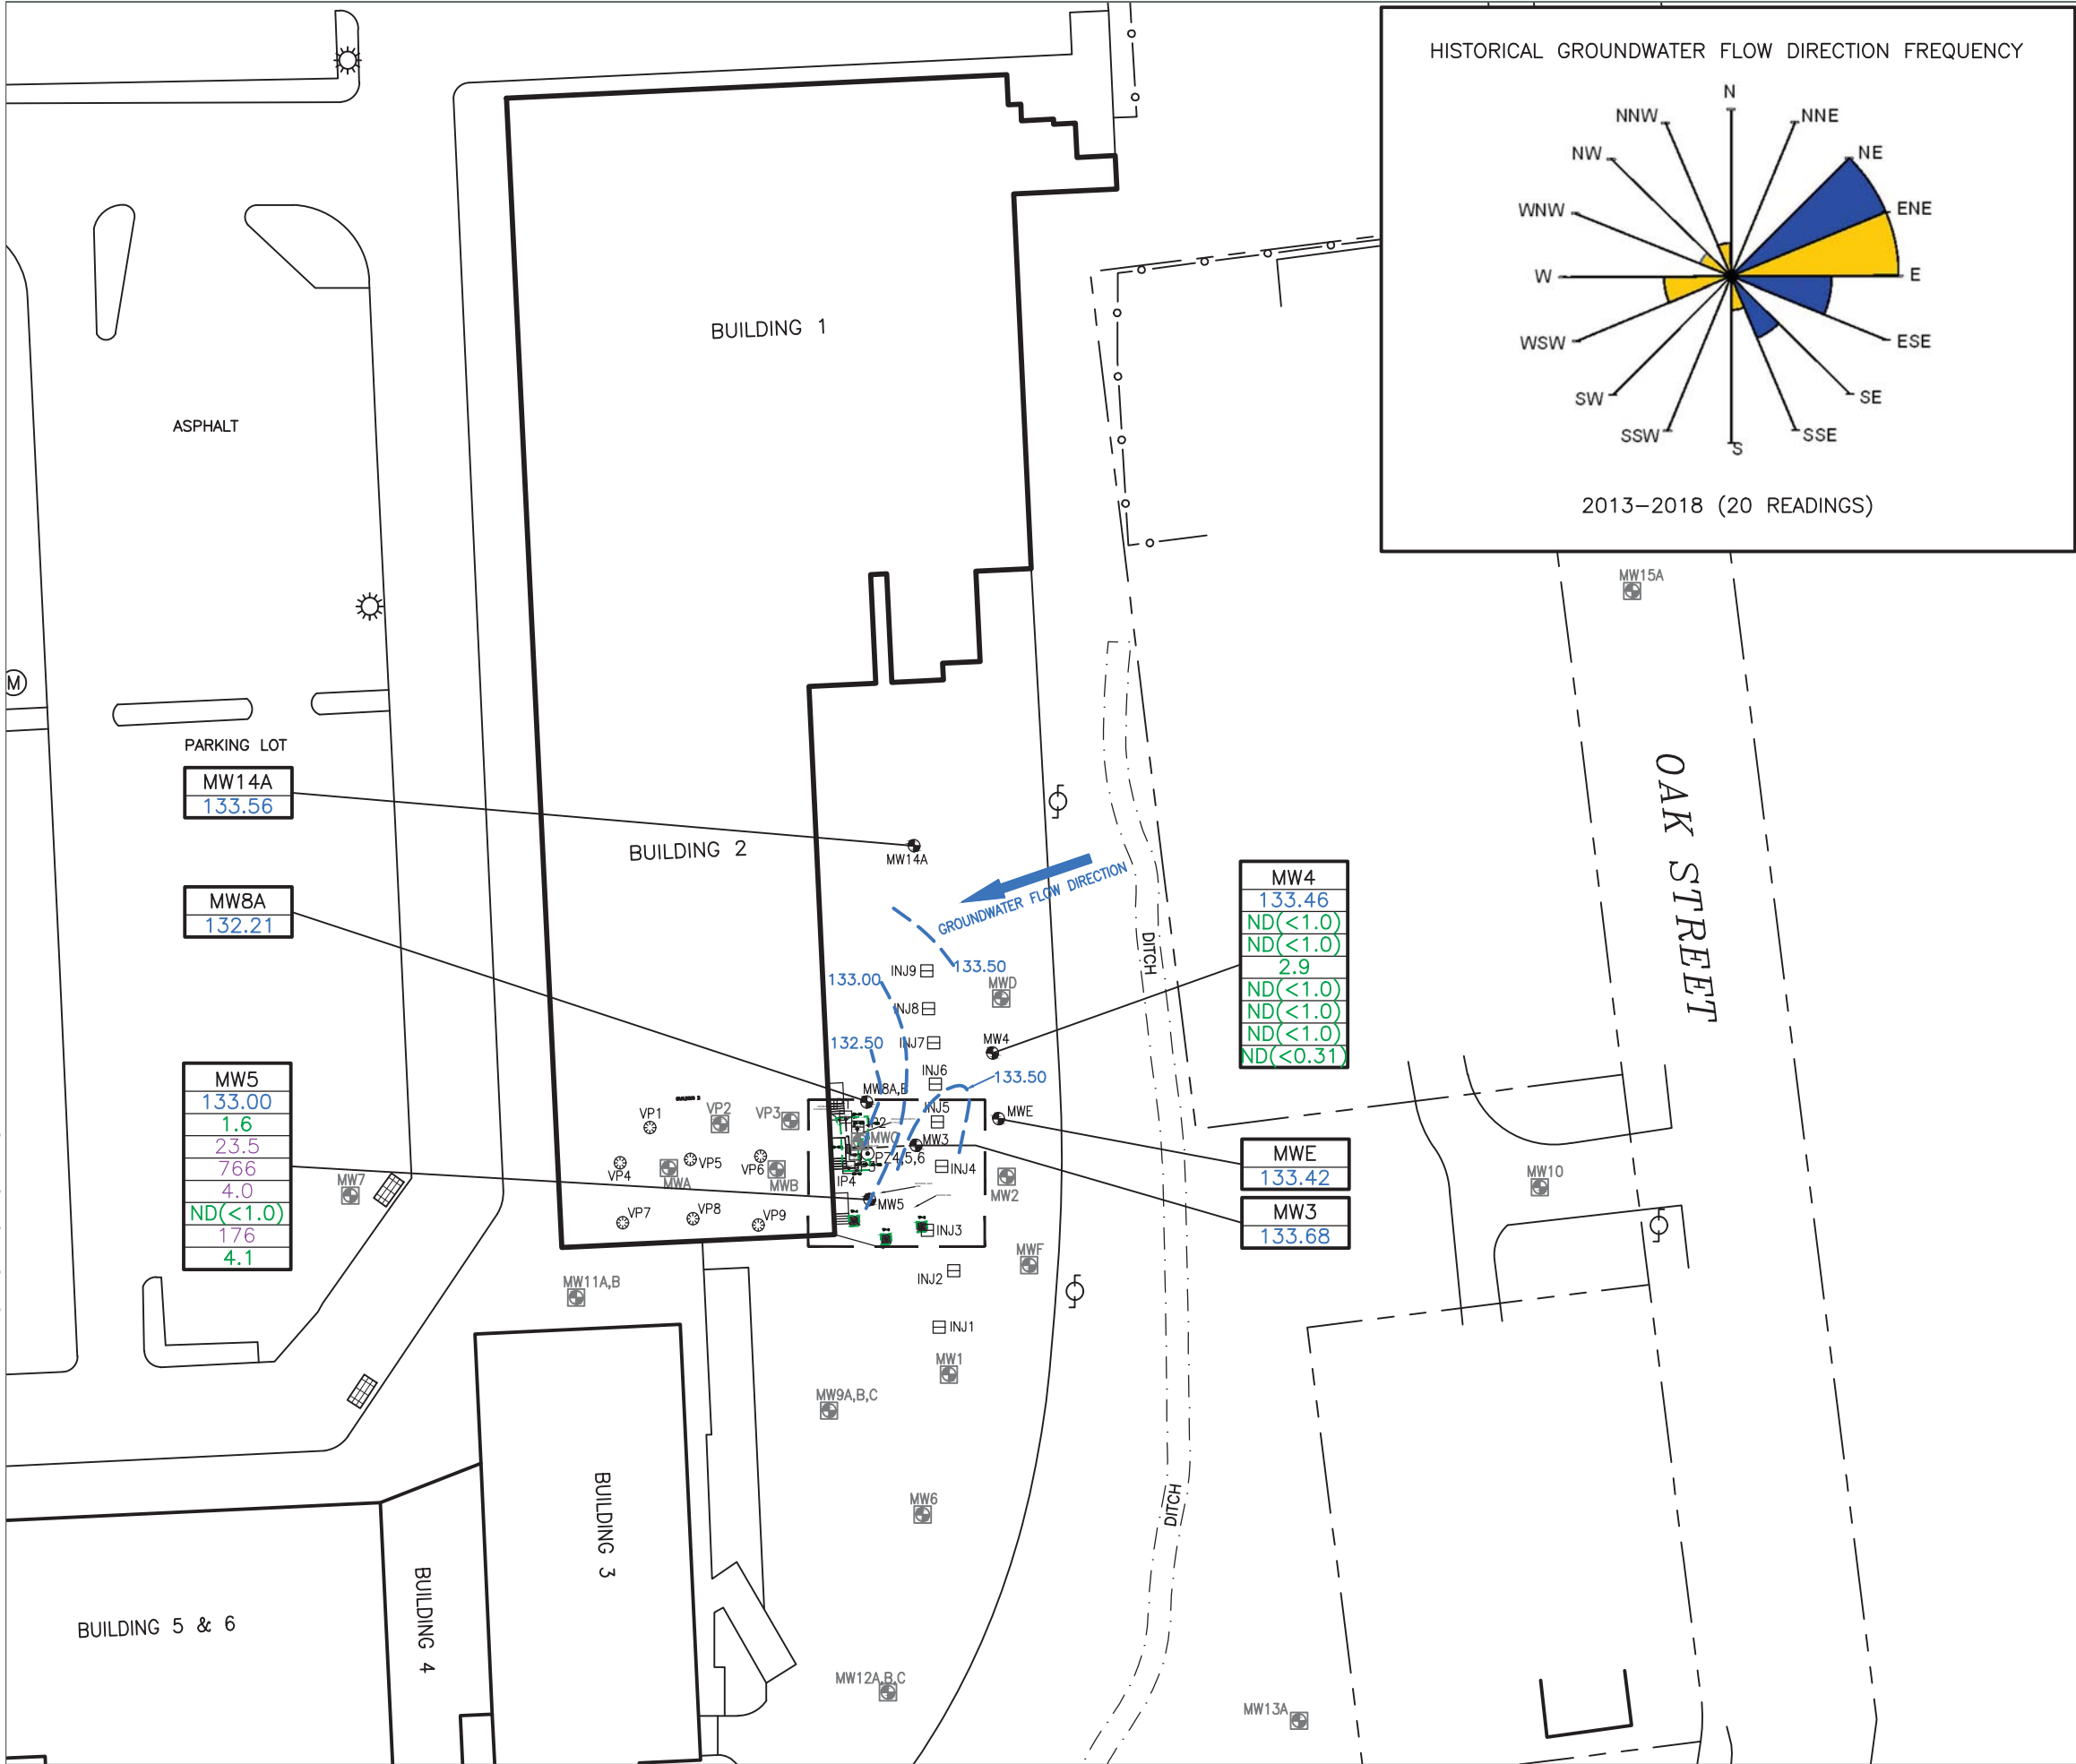
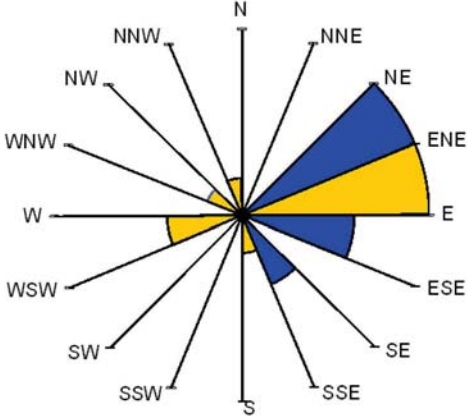
Date  
1/23/19  
Figure  
6

HISTORICAL GROUNDWATER FLOW DIRECTION FREQUENCY

2013-2018 (20 READINGS)

Groundwater well logs updated during each quarterly sampling event are included as **Appendix B**. Please refer to **Figures 5 through 8** and **Table 1 and 2** for a summary of groundwater elevation and concentrations of the COCs at all sampled monitoring wells. **Figure 9** and **Tables 3 and 4** present the general chemistry analytical results and measured bioparameter readings including optimal geochemical target range for TOC concentrations (50 mg/L through 500 mg/L) and pH (6 to 8) at the monitoring wells. Groundwater trends observed at monitoring well MW-5 during the monitoring period are illustrated in **Figure 10**.
