# **RPC – CORE AREA**

## **Construction Completion Report Cap Disturbance and Restoration**

**NYSDEC Site Number: C344080**

**APRIL 2022**

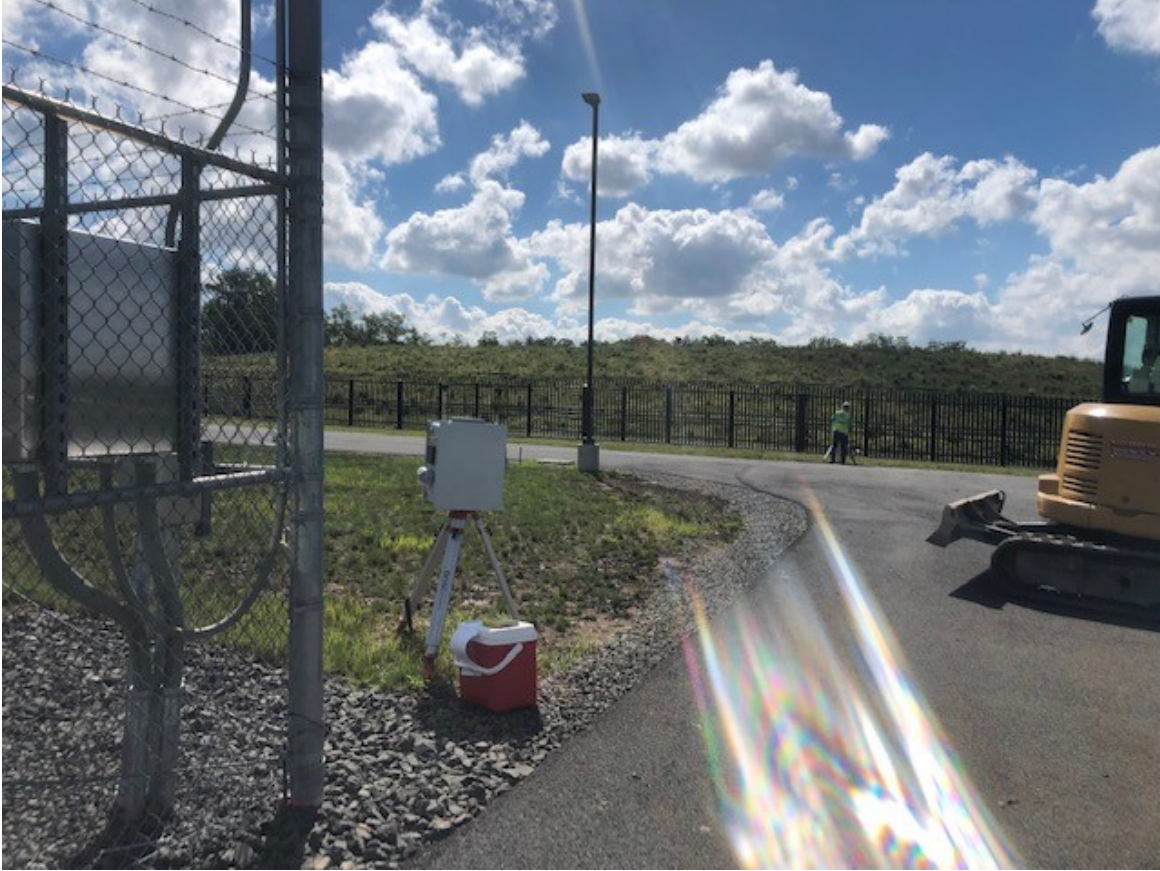
Photo 1: CAMP setup at substation.

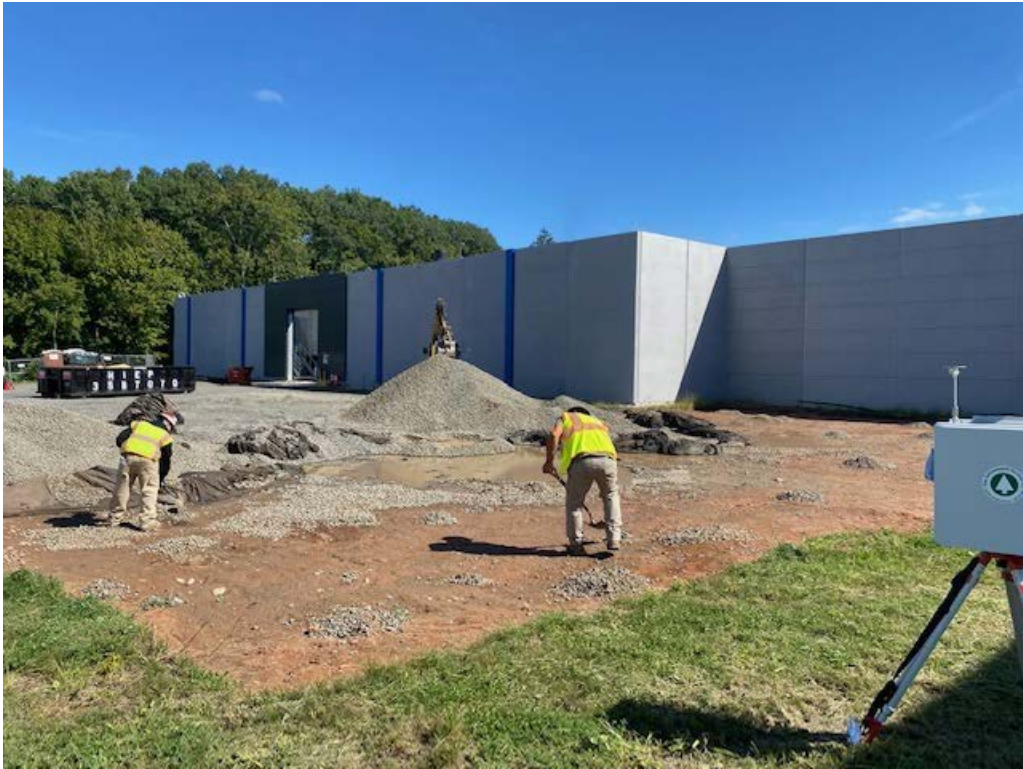
Photo 1: Removal of ¾" stone at Building G.

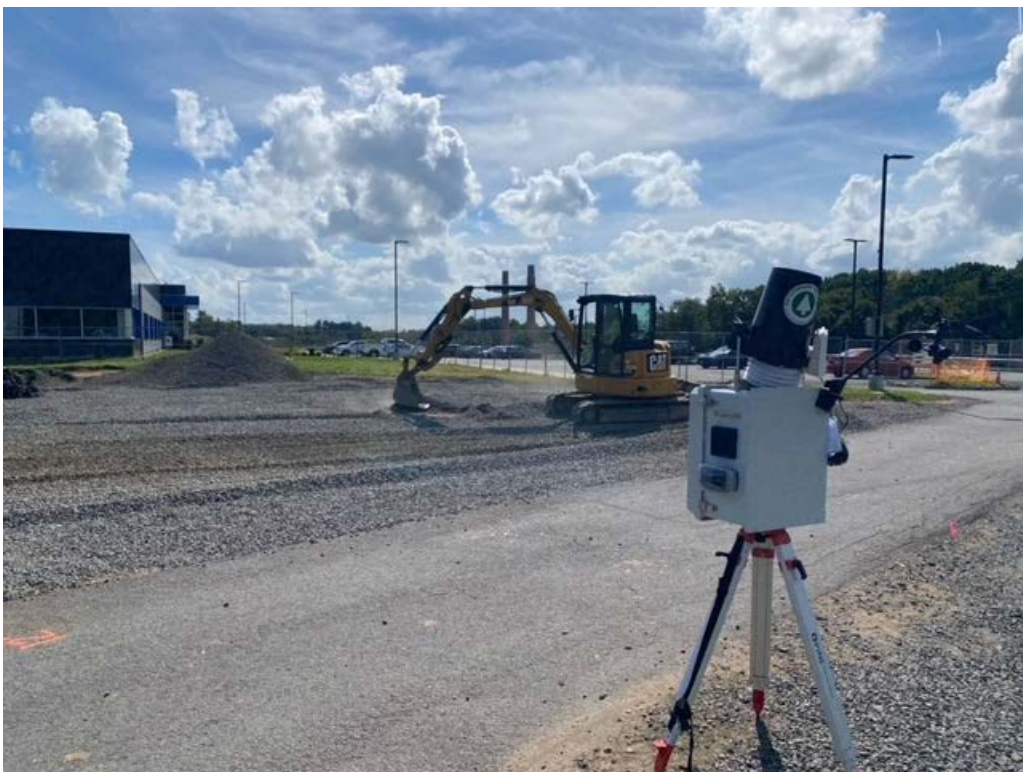
Photo 2: Removal of ¾" stone at Building G.

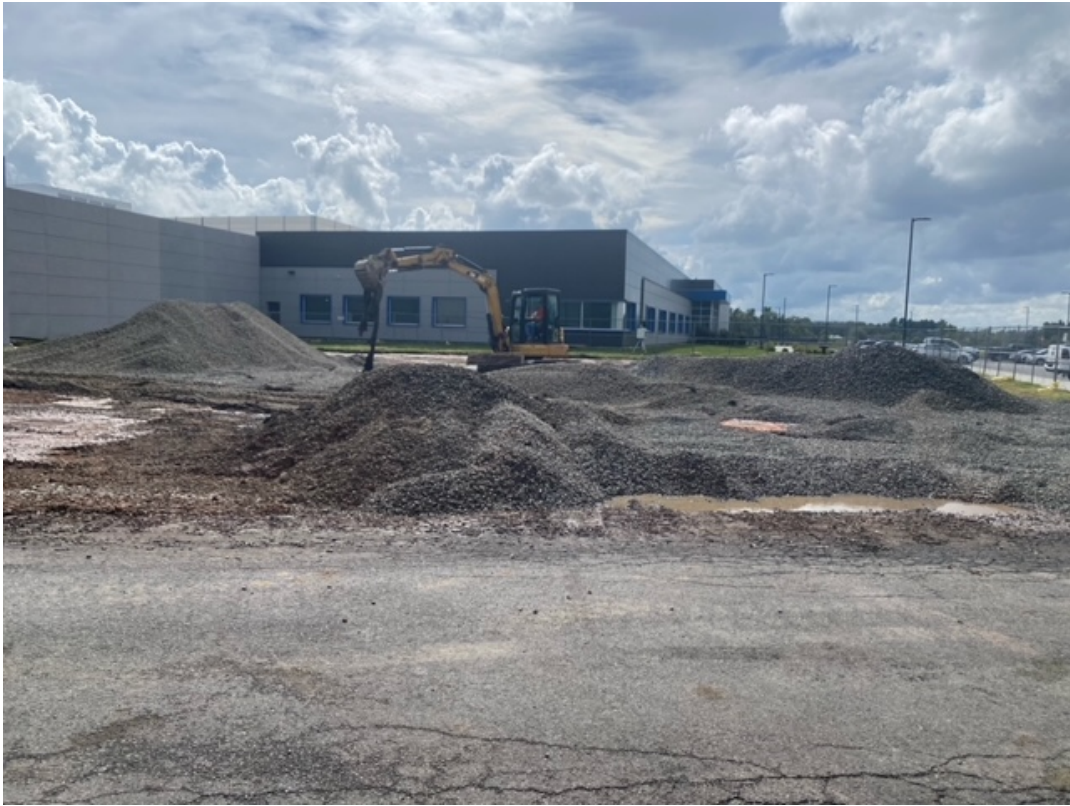
Photo 1: Removal of 3/4" stone at Building G.

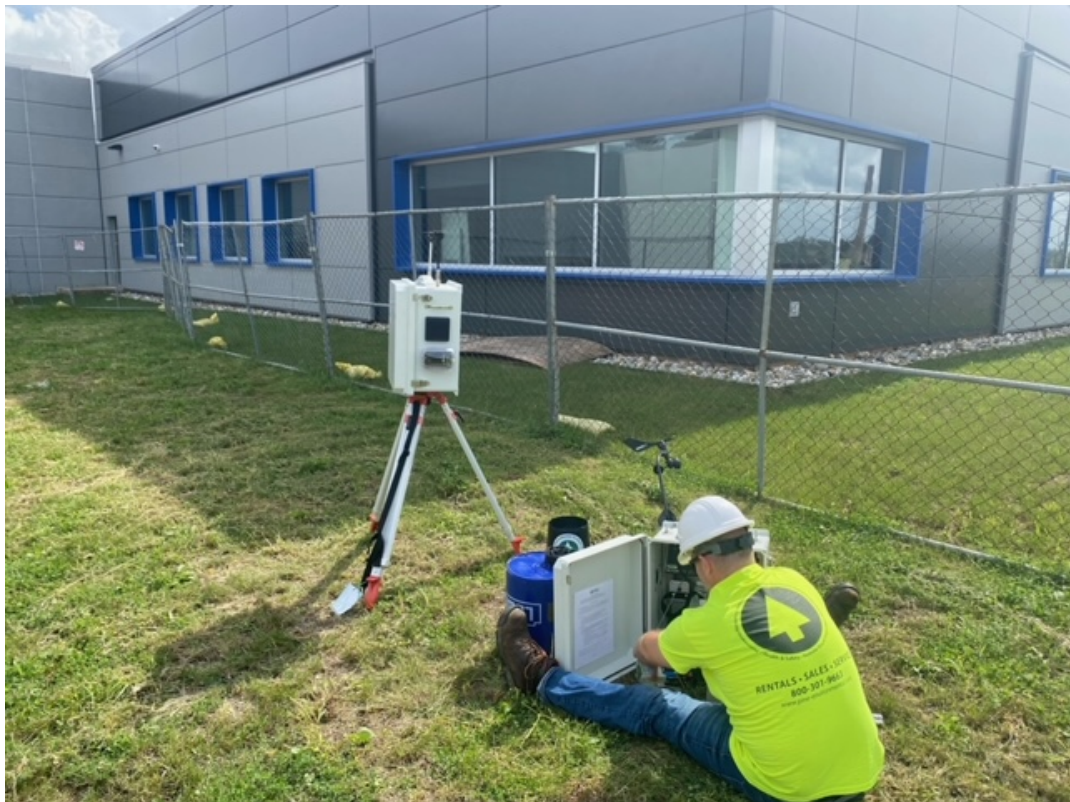
Photo 2: Troubleshooting CAMP equipment.

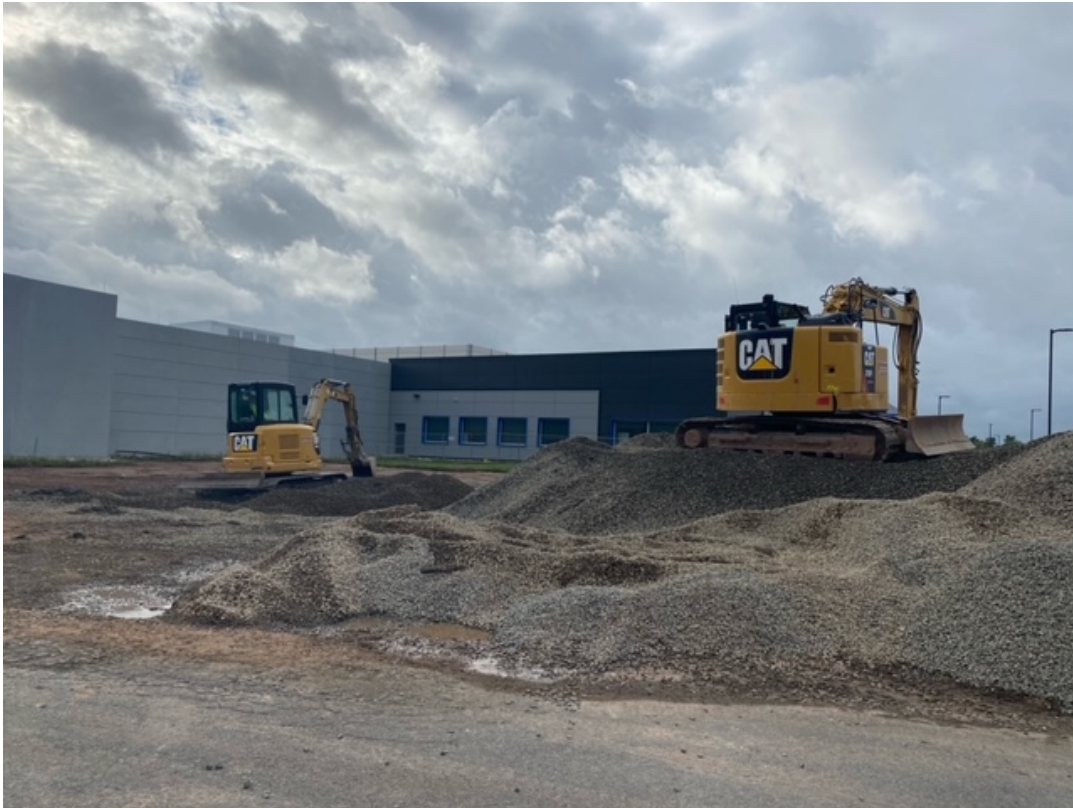
Photo 1: Removal of 3/4" stone at Building G.

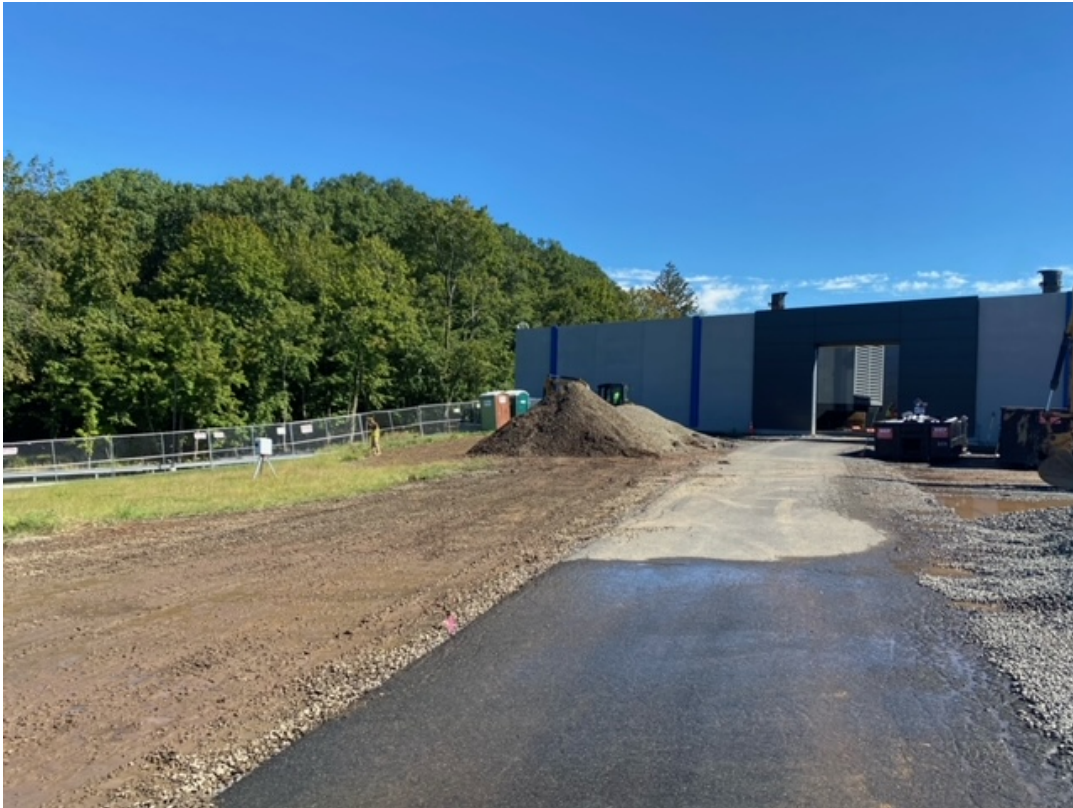
Photo 1: Completing removal of ¾" stone at Building G.

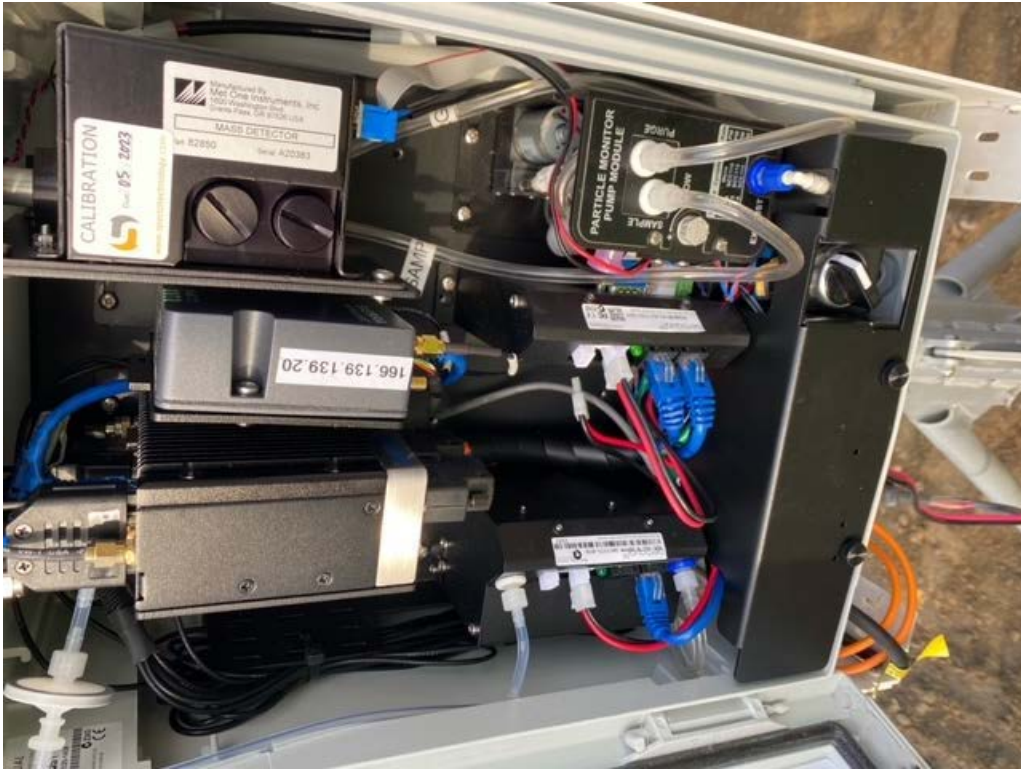
Photo 1: Troubleshooting CAMP Station 1.

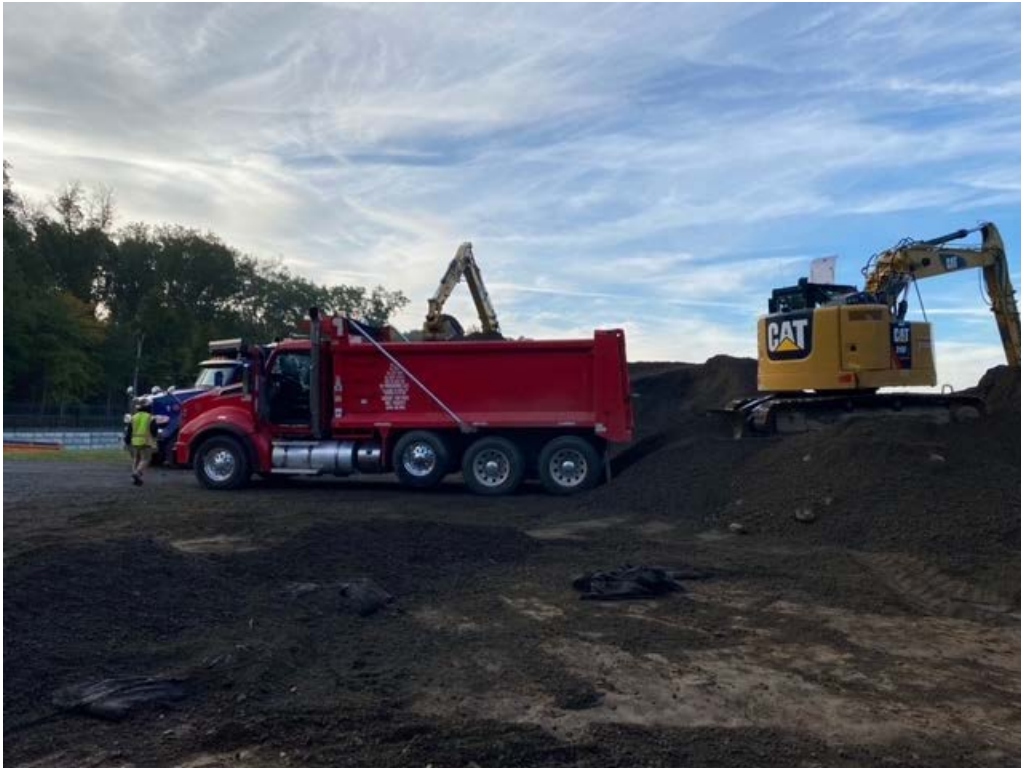
Photo 2: Spread additional stone throughout the substation area.

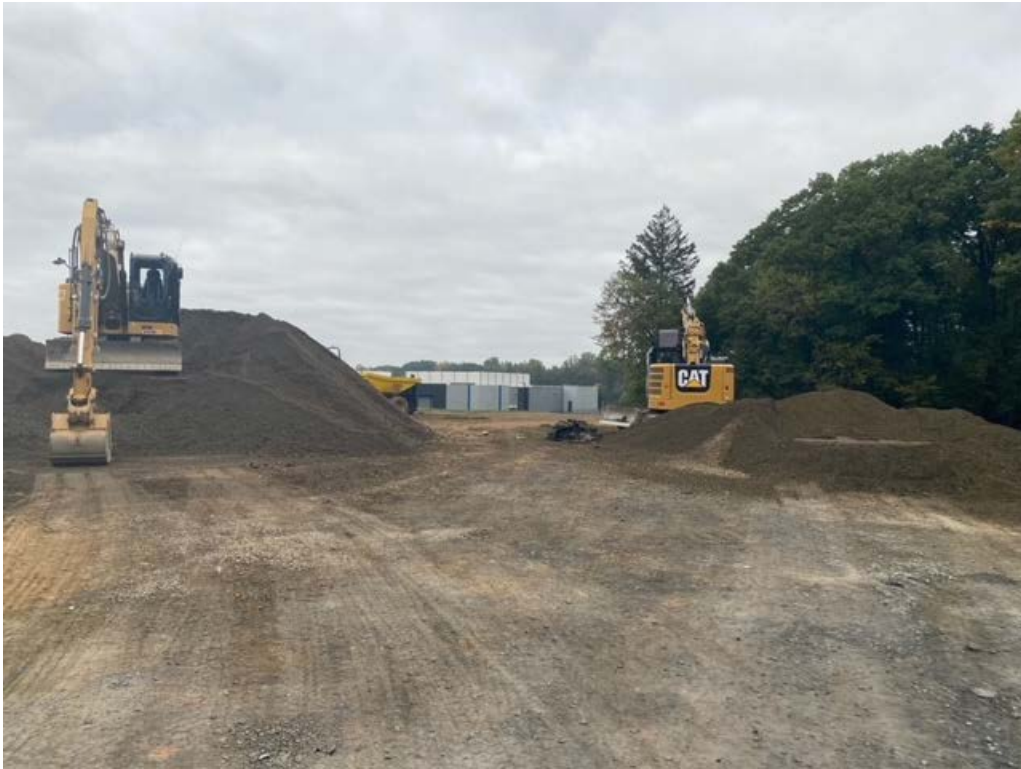
Photo 1: Removal of DGA from trailer yard.

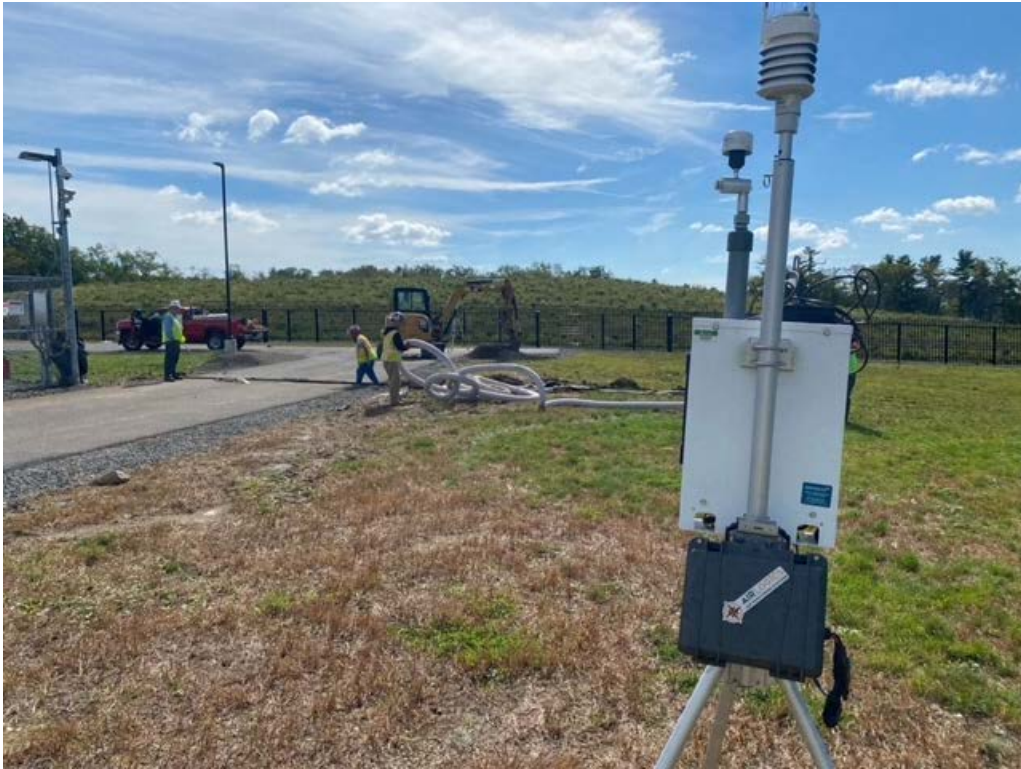
Photo 1: CAMP monitoring at drainage trench installation.

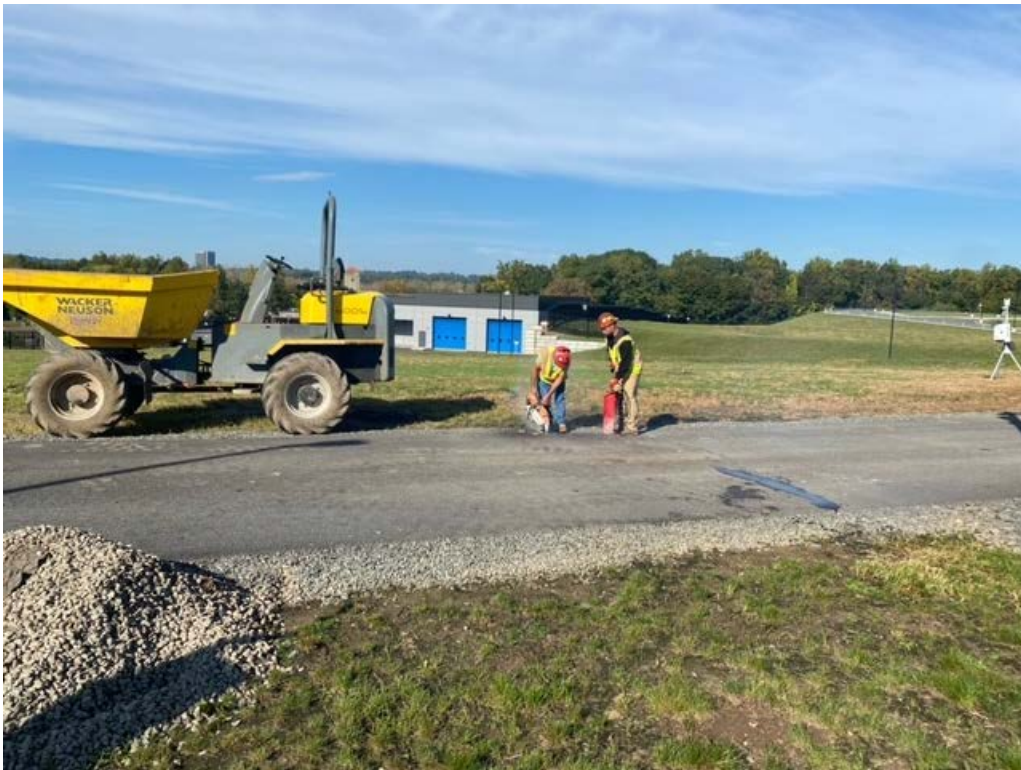
Photo 2: Demolition saw with water to cut asphalt.

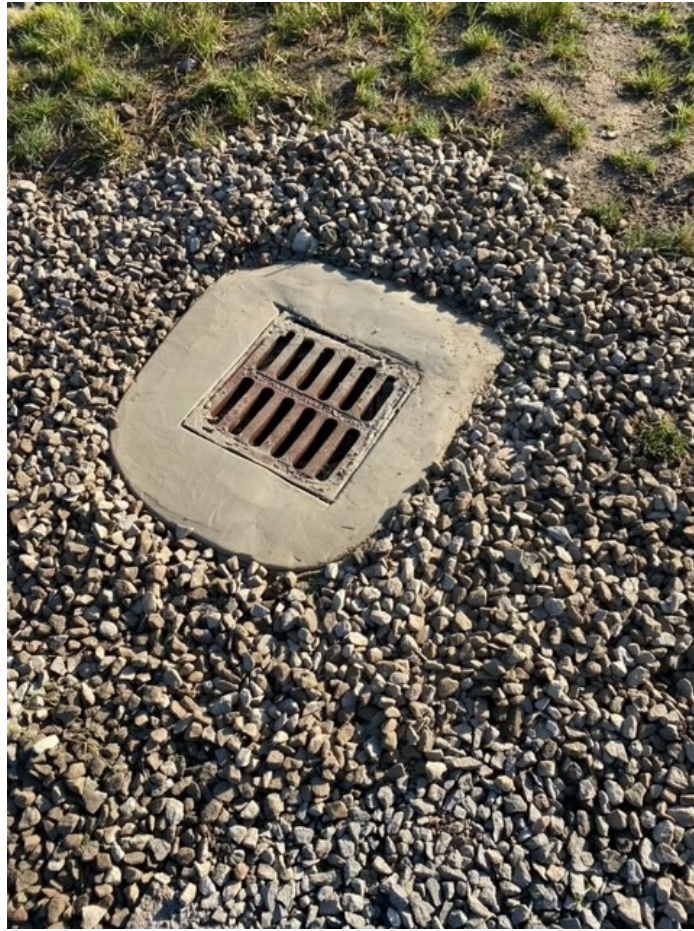
Photo 1: Cement over drainage pipe at substation and refit drainage pipe in soil.

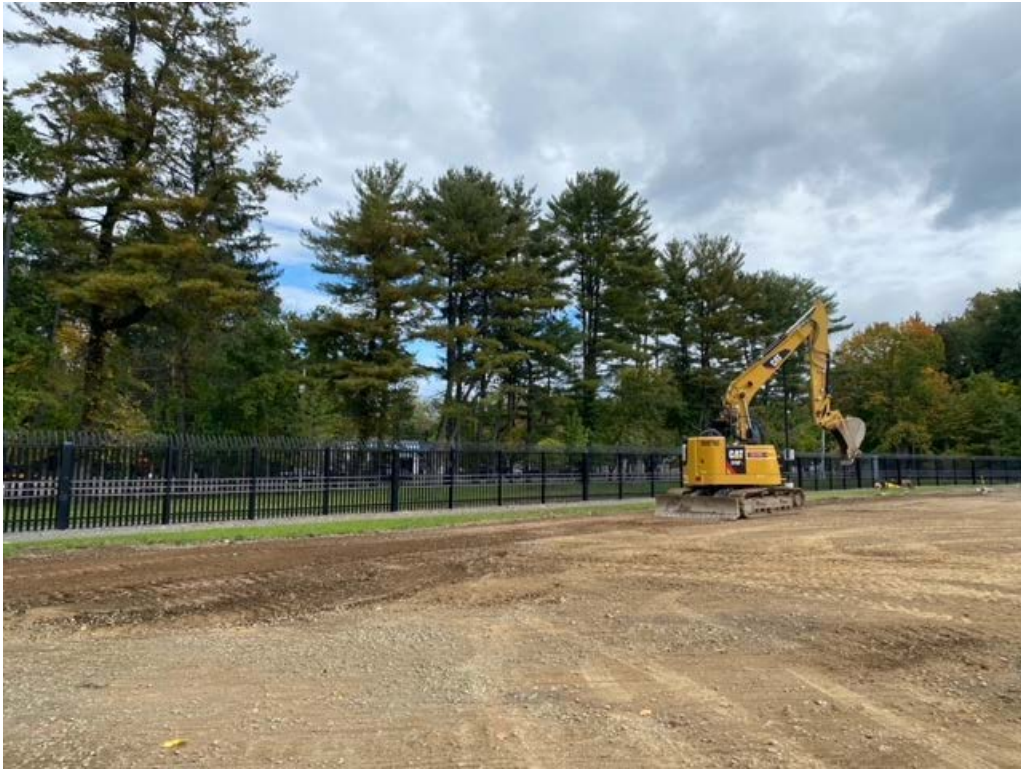
Photo 1: Grading former trailer yard.

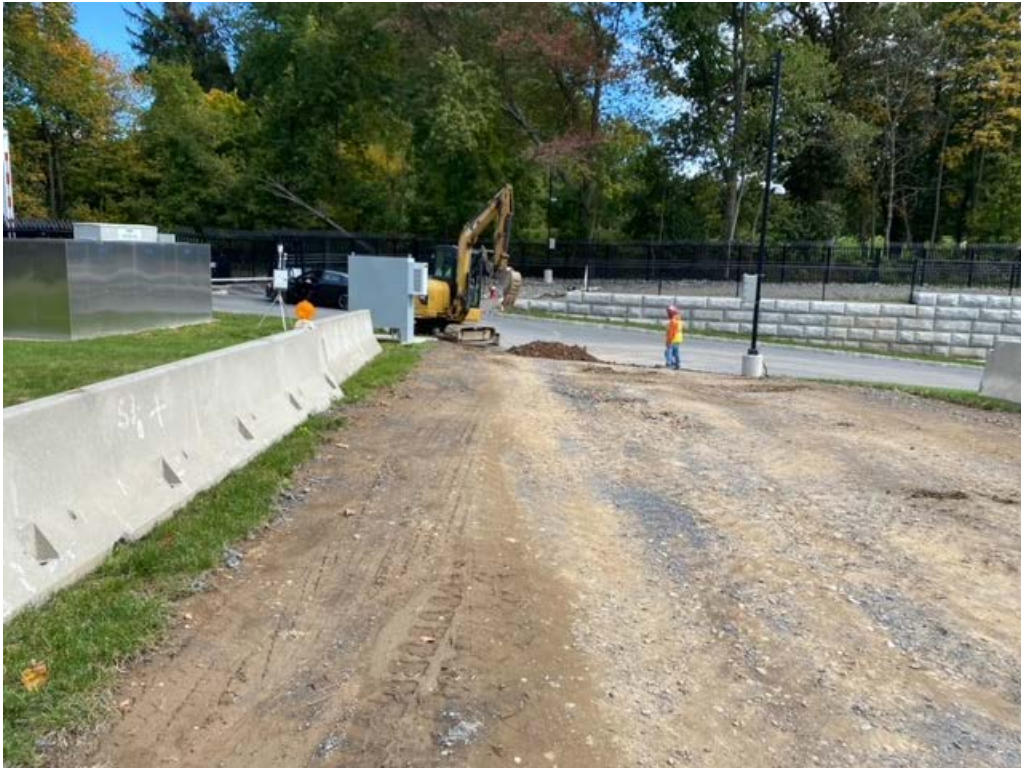
Photo 2: Northeast ramp excavation.

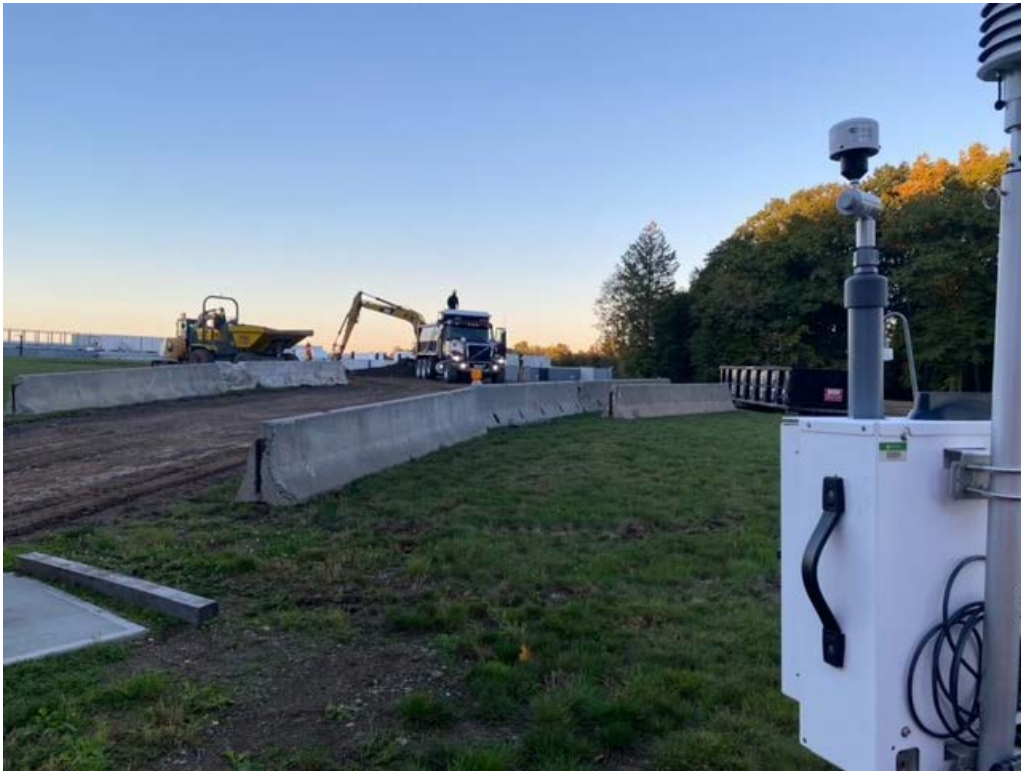
Photo 1: Backfill one of two access ramps to northern trailer area and place demarcation.

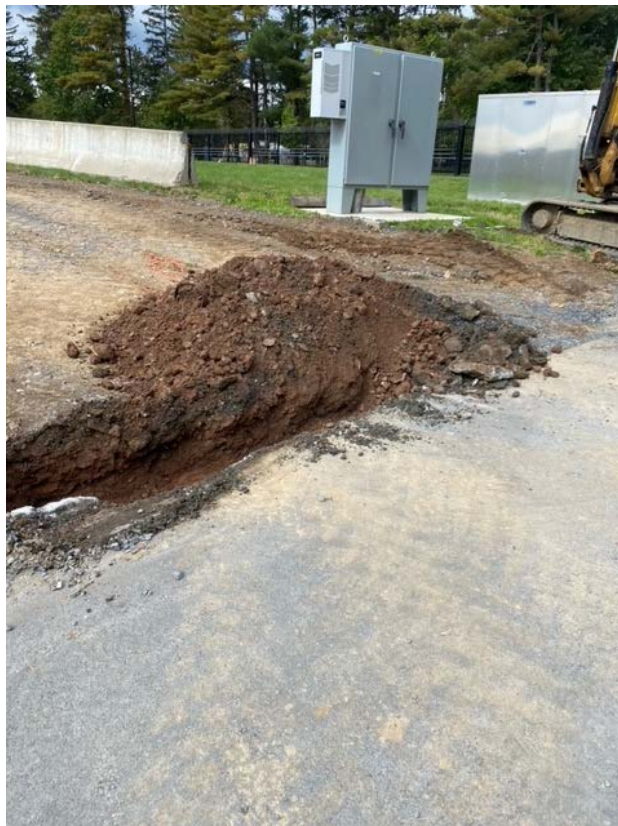
Photo 2: Excavating berms at VVRC parking area.

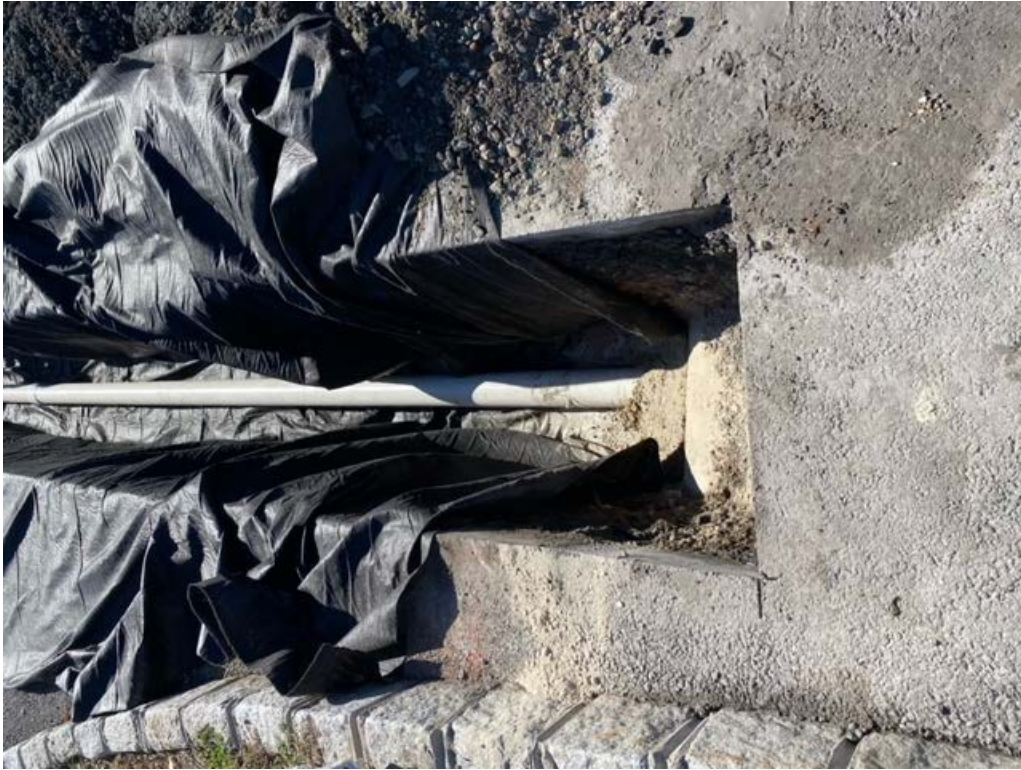
Photo 1: Excavating along VVRC roadway and tying into existing drain.

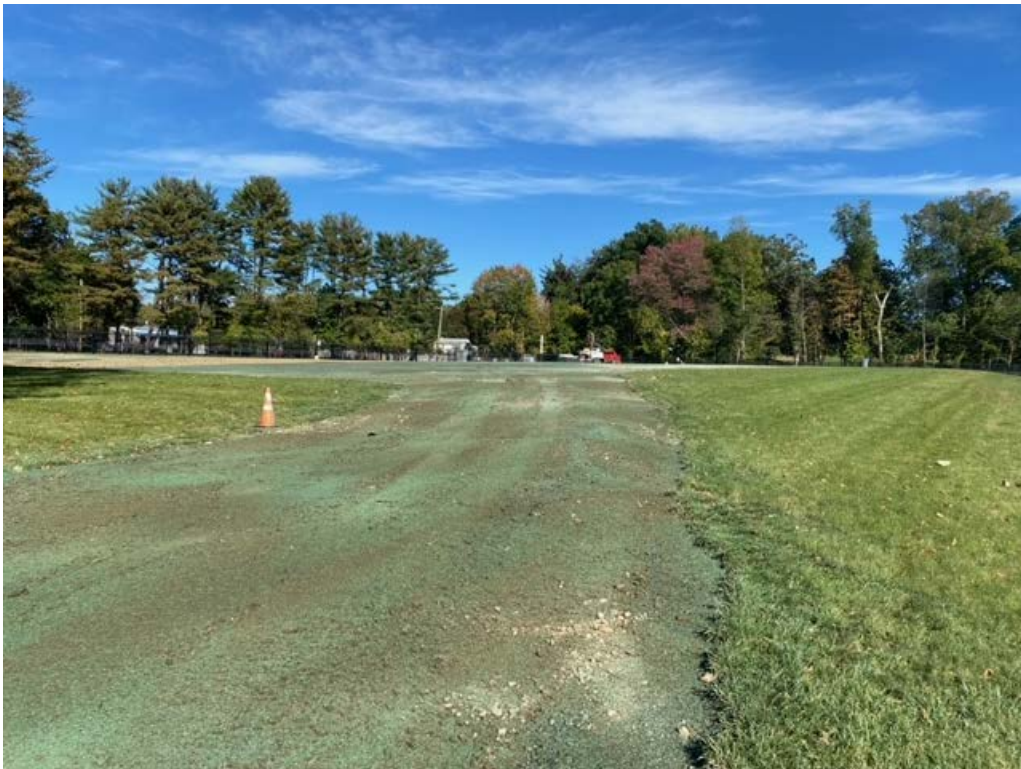
Photo 2: Hydroseeding former northern trailer area.

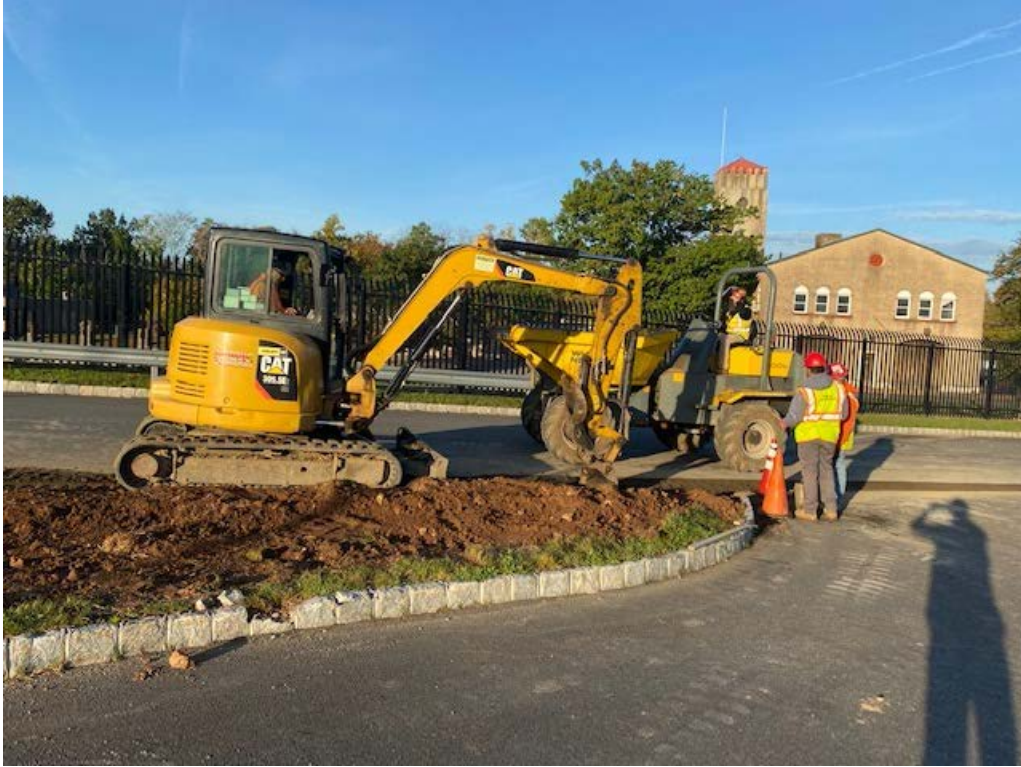
Photo 1: Placing forms at curb-line to be cemented.

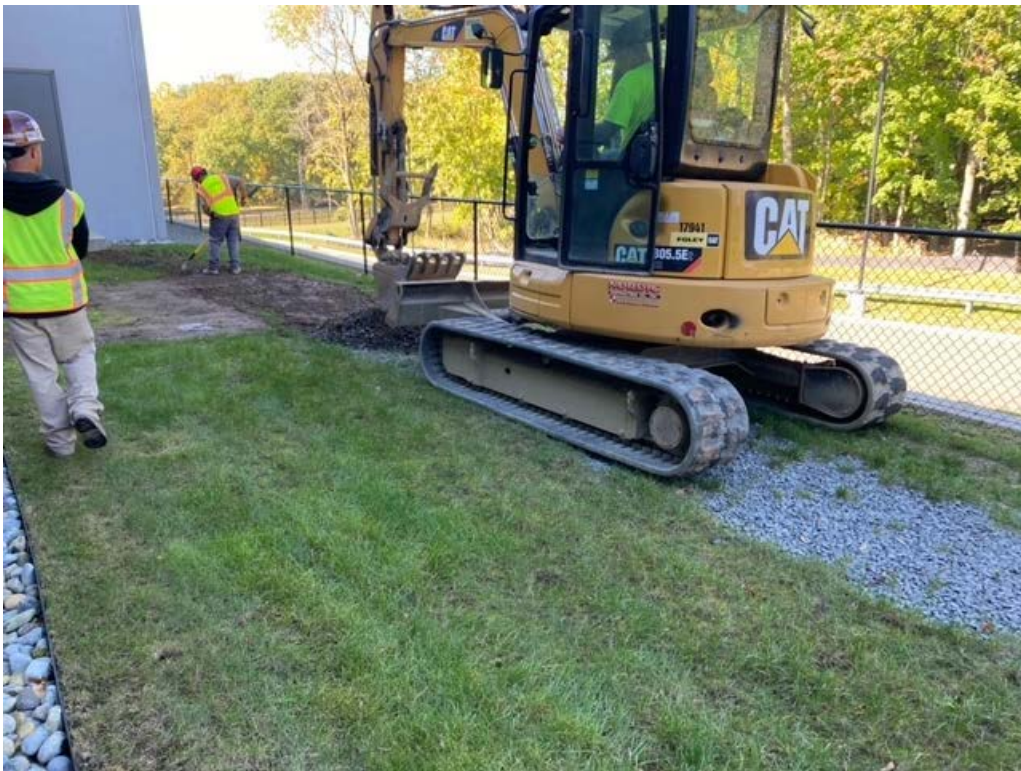
Photo 2: Scrape minimal stone from former Building G walkway.

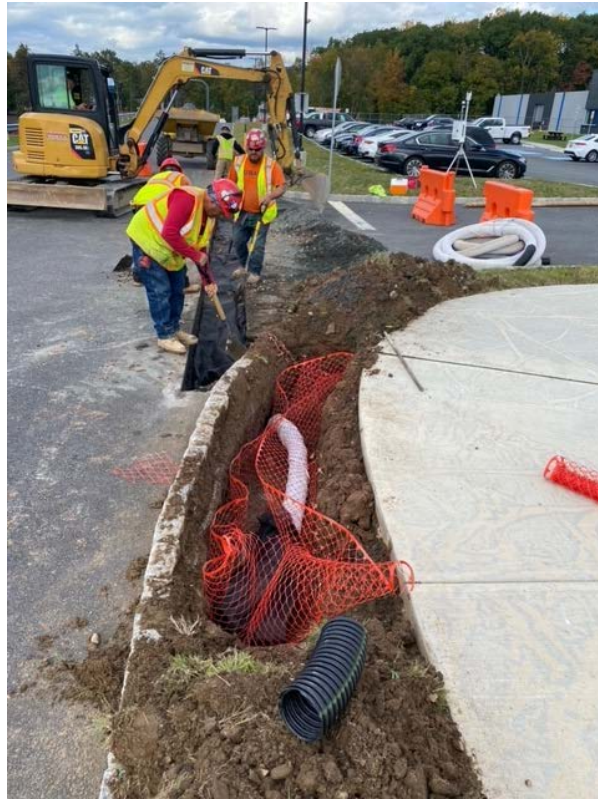
Photo 1: Wrapping with orange snow fence as demarcation layer.

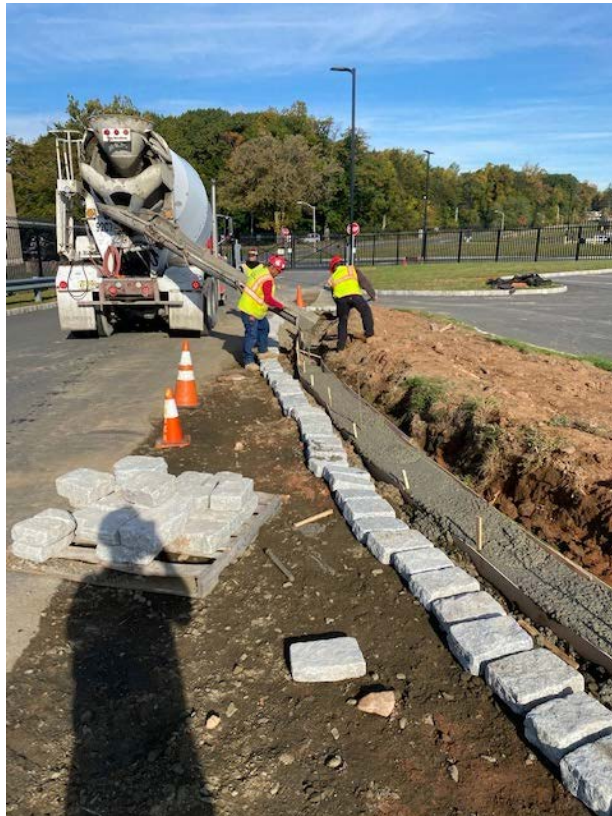
Photo 2: Pouring belgian block tie-in to existing curb-line at VVRC.

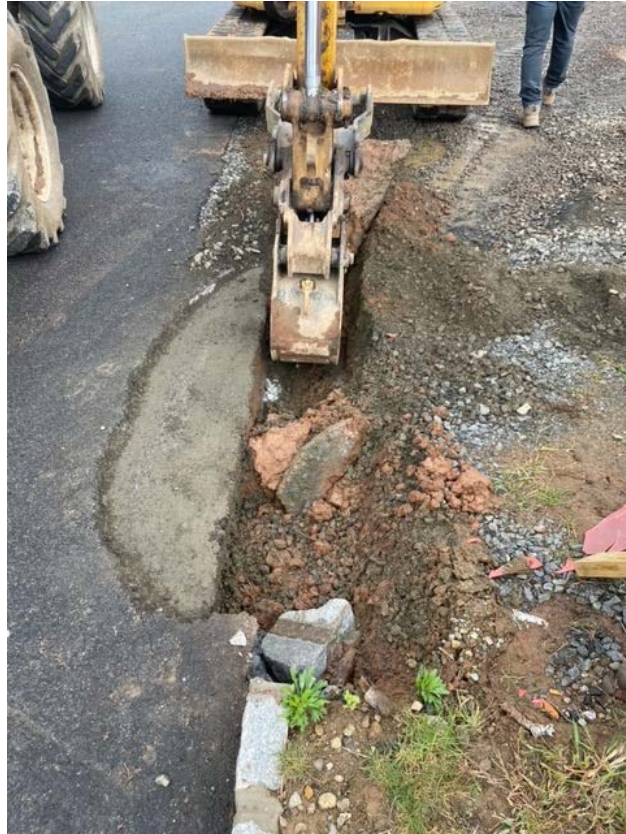
Photo 1: Excavating curb at Building G.

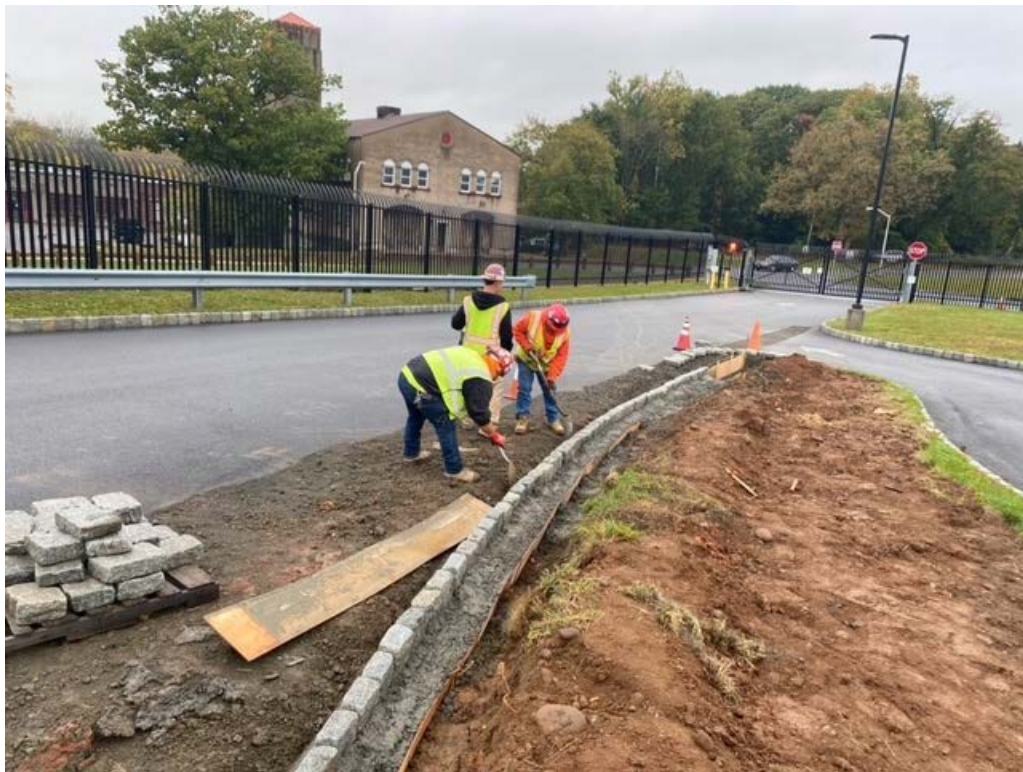
Photo 2: Removing forms from VVRC curb pour.

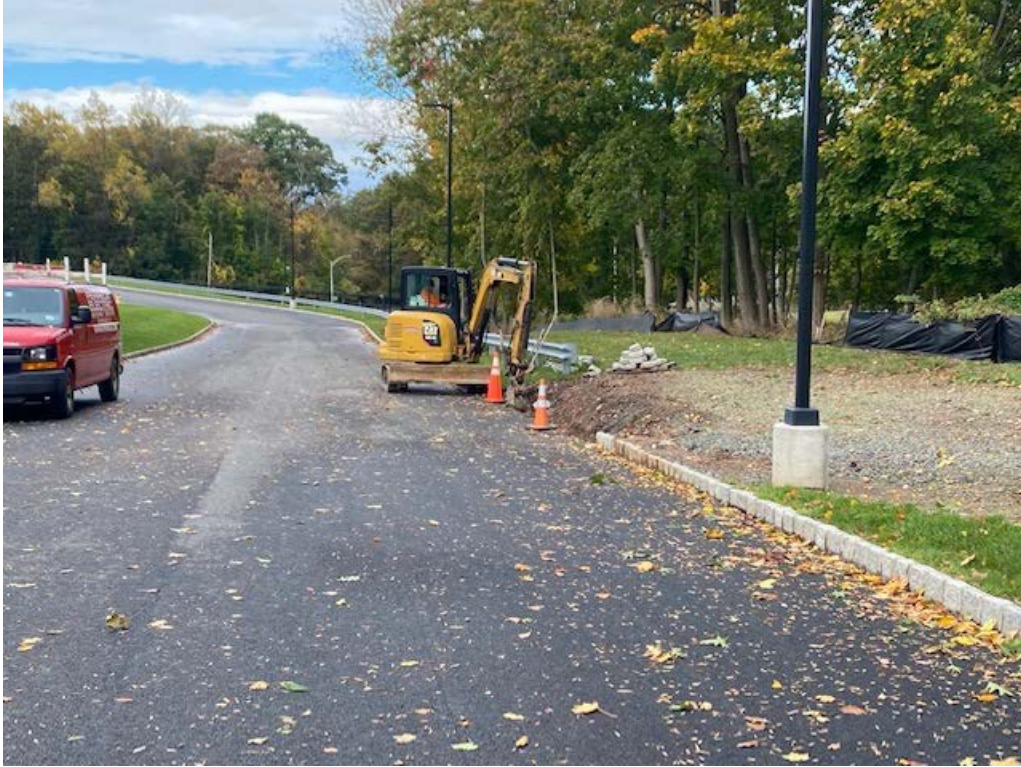
Photo 1: Clearing out curb excavations filled with water from nor'easter on previous day.

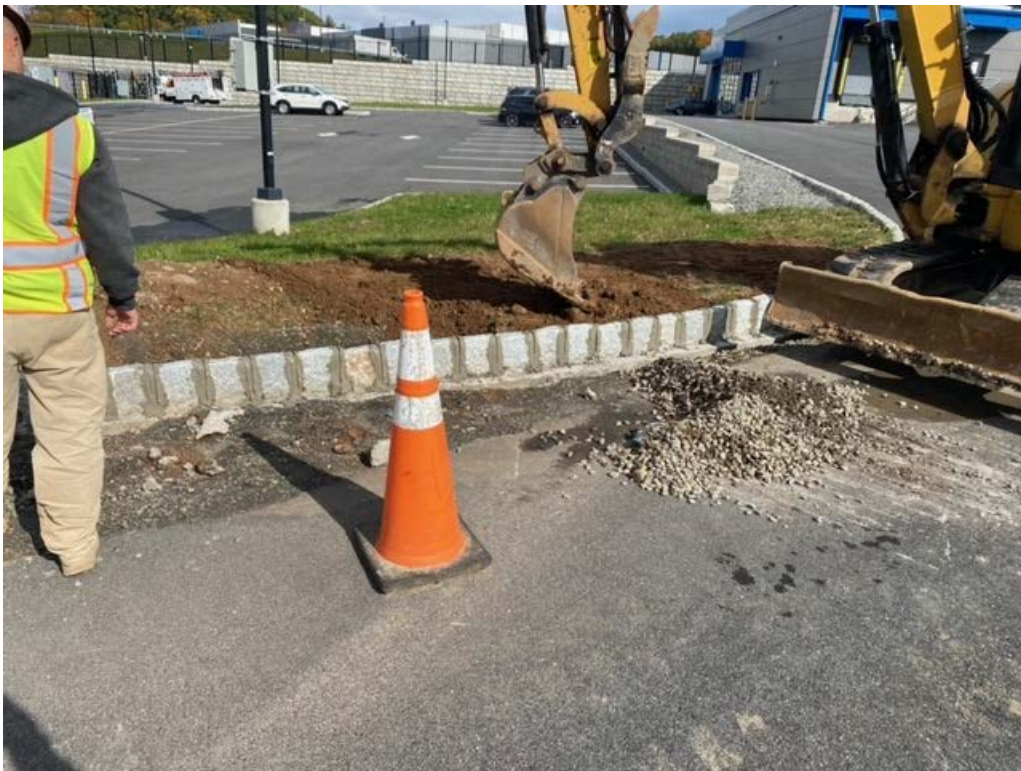
Photo 2: Applying mortar joints for VVRC curbing area.

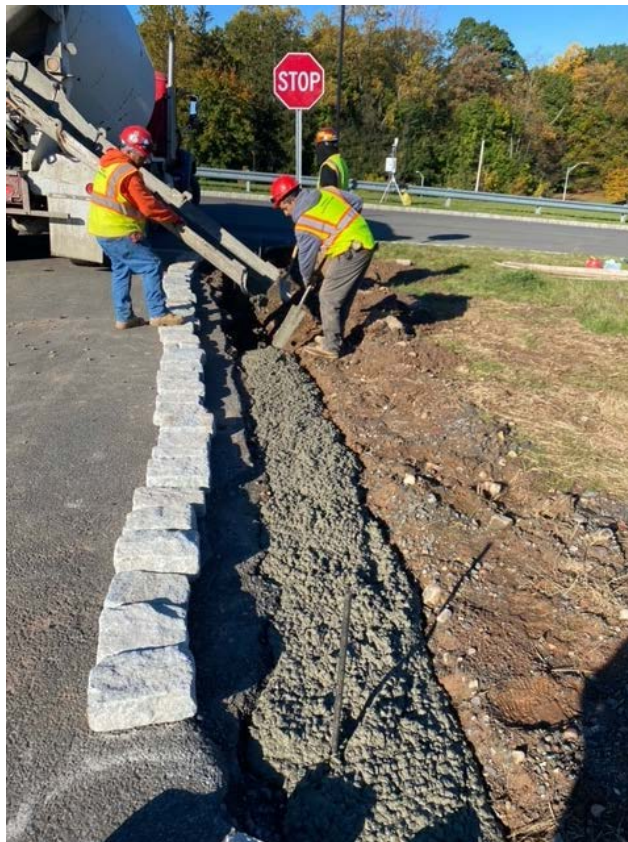
Photo 2: Pouring along sidewalk area in at Building G west.

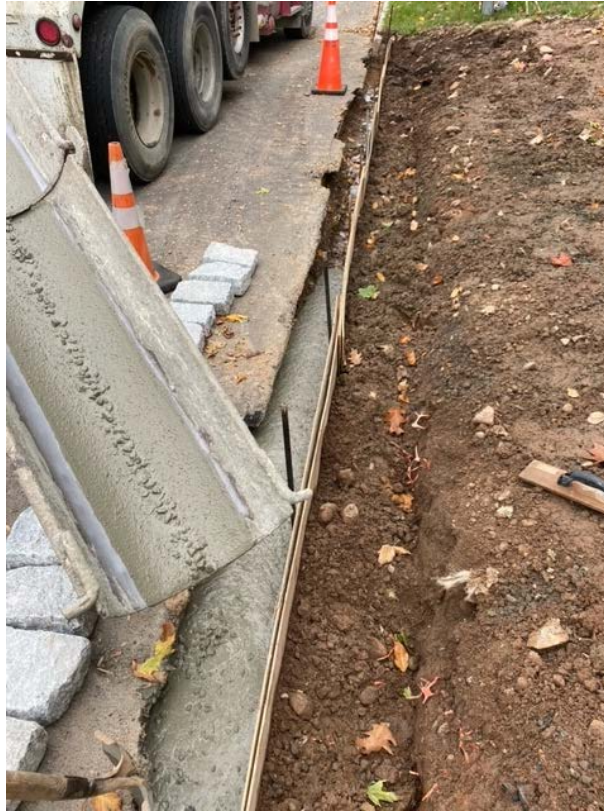
Photo 1: Concrete pouring at Building G.

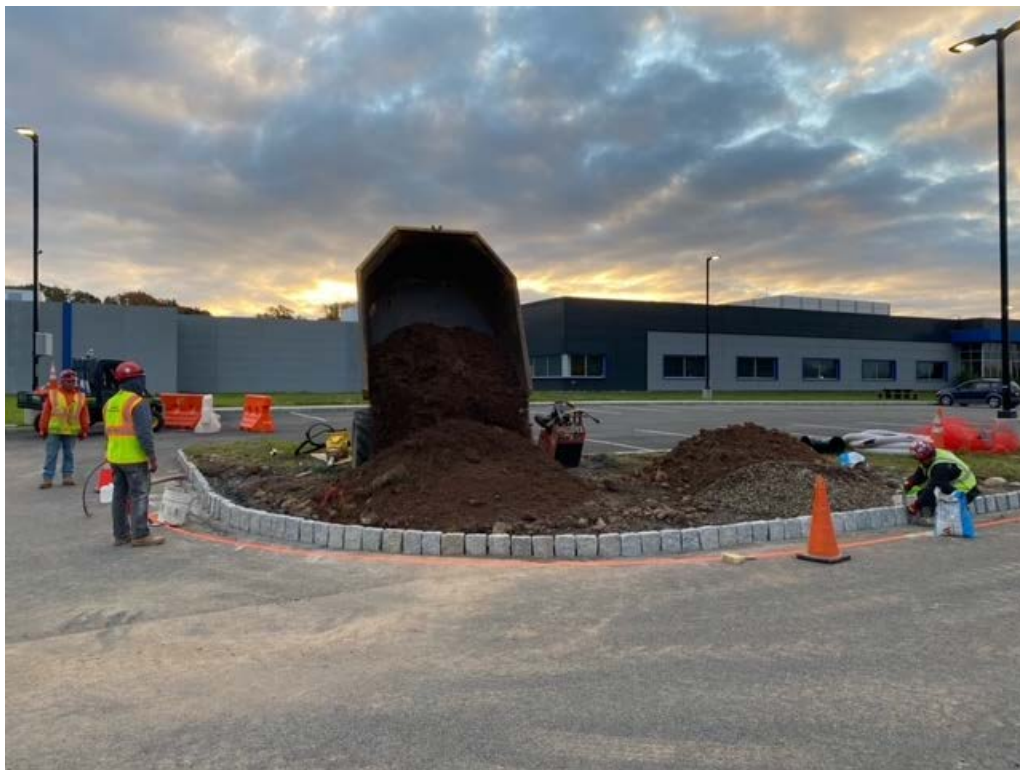
Photo 2: Backfilling curb area at Building G.
