# **RPC – CORE AREA**

## **Construction Completion Report Cap Disturbance and Restoration**

**NYSDEC Site Number: C344080**

**APRIL 2022**

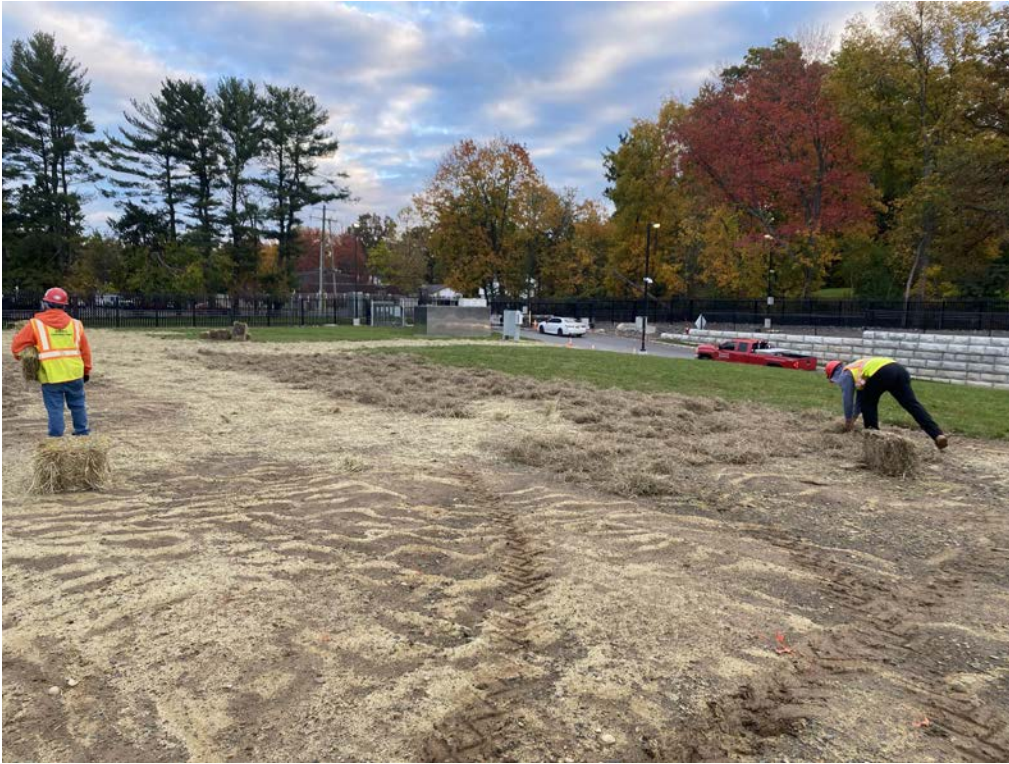
Photo 1: Continues with hay installation in northern former trailer yard.

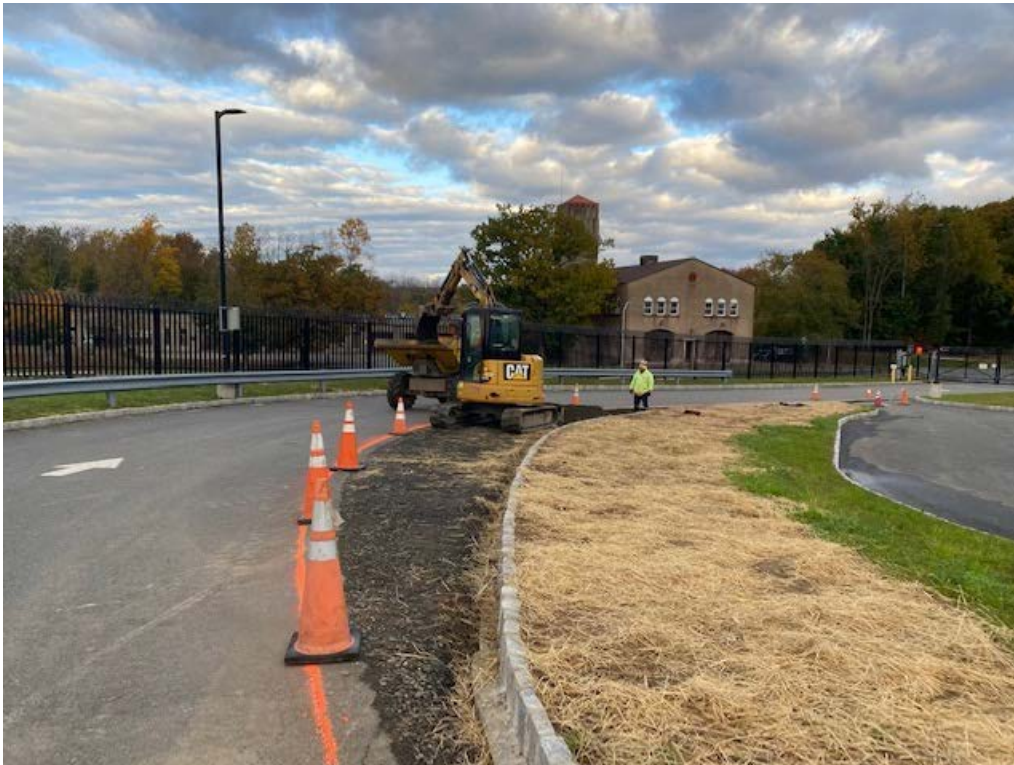
Photo 2: Milling, excavating, and cutting asphalt for tie-in at VVRC area.

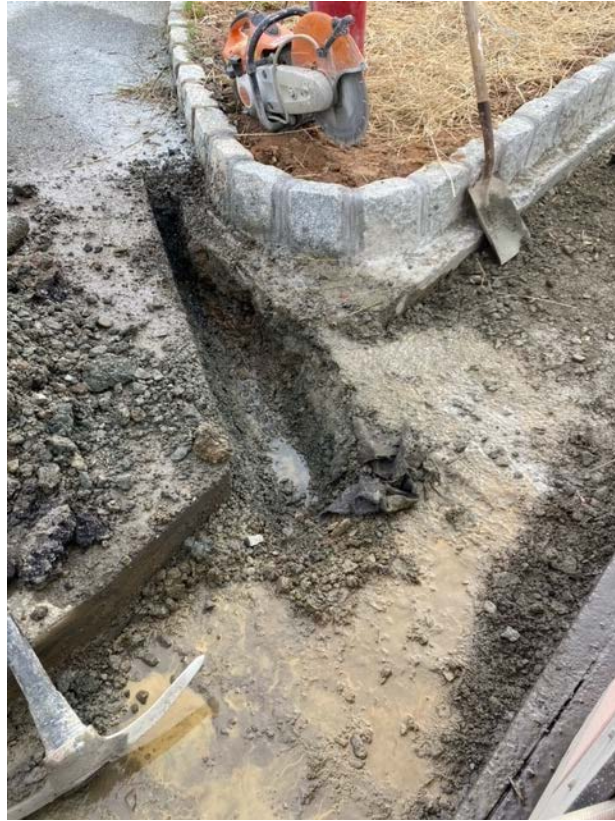
Photo 1: Expand drainage radius at far west portion of tie-in at VVRC.

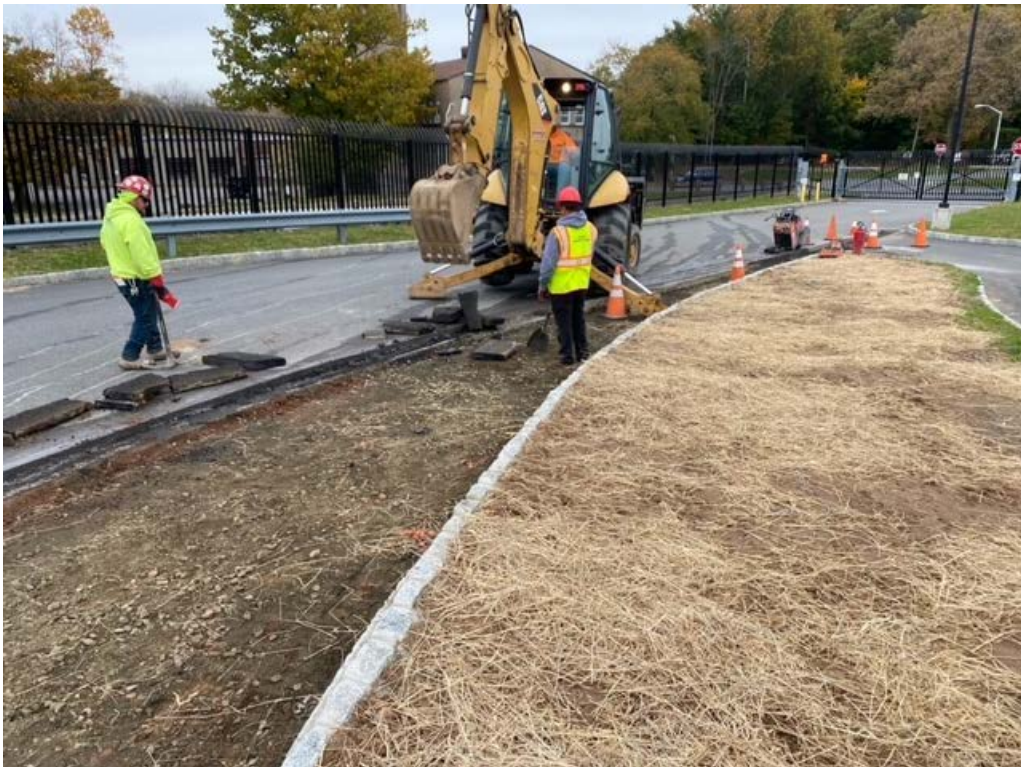
Photo 2: Wet saw cut asphalt at VVRC.
