## Phase I Environmental Site Assessment Report

**US Polychem/Woolzies  
584 Chestnut Ridge Road  
Spring Valley, New York**

LCS PROJECT NO. 18N10530.39

**JANUARY 16, 2019**

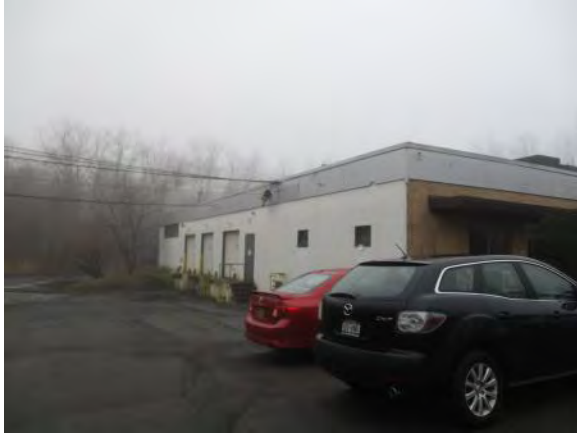
Photo 1: North side of the subject property.

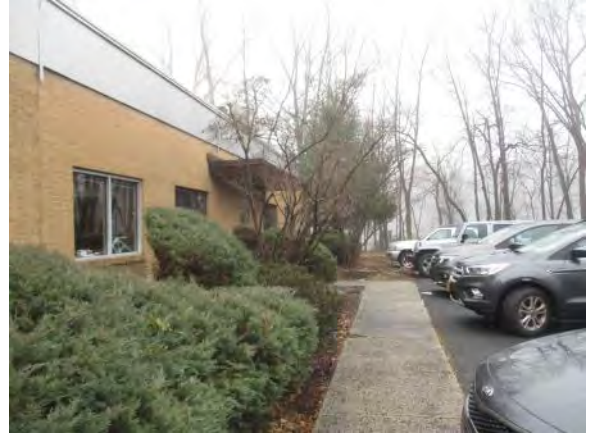
Photo 2: East side of the subject property.

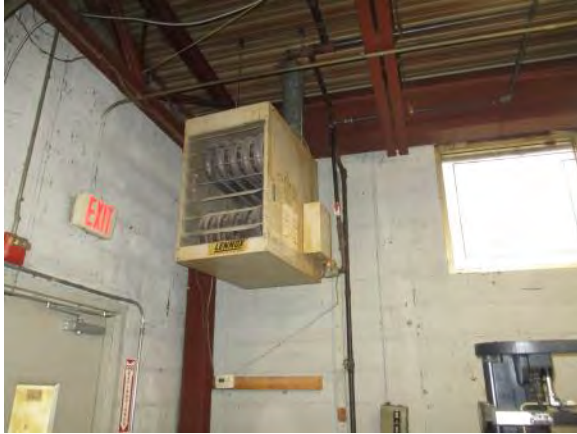
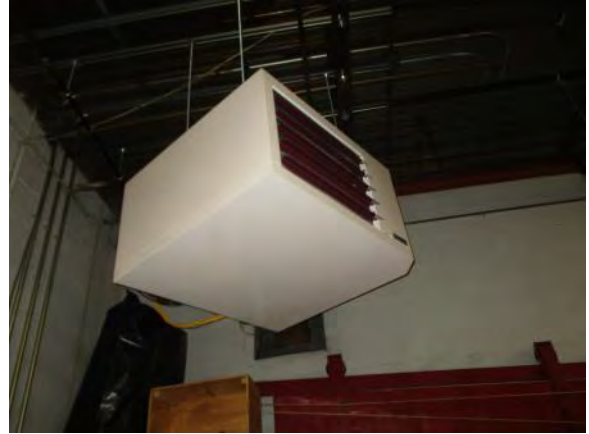
Photo 1: Ceiling mounter burner

Photo 2: Ceiling mounted burner

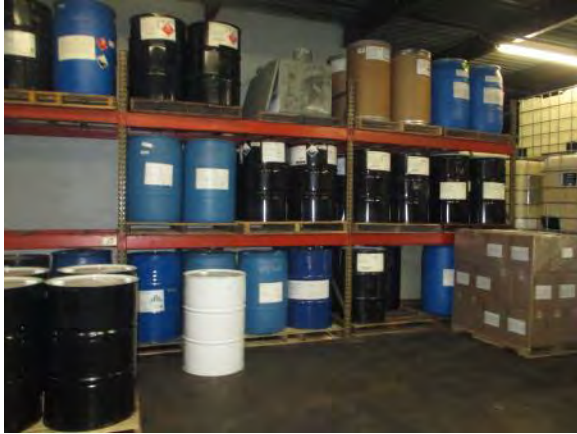
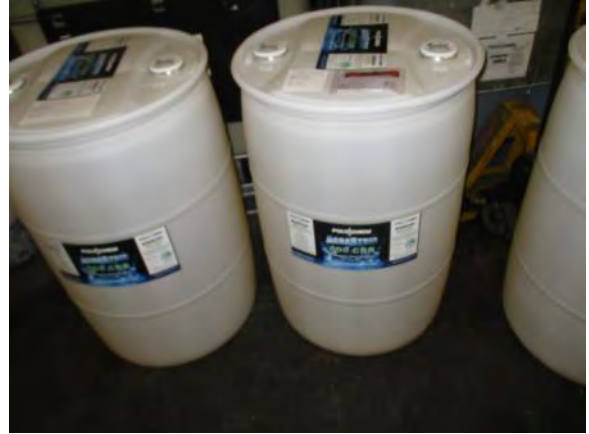
- On-site operations have included cleaning chemical manufacturing since the 1960s. Current operations include mixing/bottling of solvents; several totes and 55-gallon drums of associated solvents/glycols were noted throughout the structure. According to historical and municipal information, the subject property was previously served by a septic system and floor drains within the structure historically discharged to a swampy area southwest of the structure. The drains had been sealed by 1976 but 1977 correspondence indicated that they had not been suitably sealed at that time; it was indicated that the drains had to be sealed with concrete. Furthermore, records indicated the historical use of chlorinated solvents and other chemicals on-site and indicated that the property was identified as a potential source of odors and poor tasting water in a local waterway in the 1970s. A subsurface investigation completed by others in 2017, elevated concentrations of VOCs and SVOCs were identified in soil, groundwater, and soil gas at the subject property; based upon this, Spill No. 17-08369 was assigned to the subject property. Additional investigation was recommended to delineate the documented impacts; however, it is unknown if that work has been completed to date. As of May 2018, the NYSDEC determined that the Division of Environmental Remediation would need to review the information relative solvent contamination which may cause vapor intrusion; the spill is currently classified as "active."

Photo 1: Drums

Photo 2: Drums

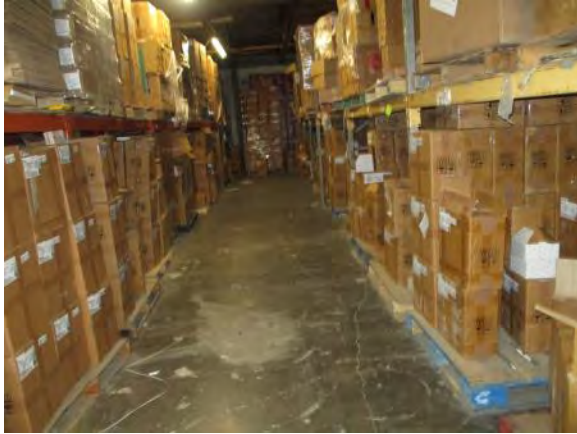
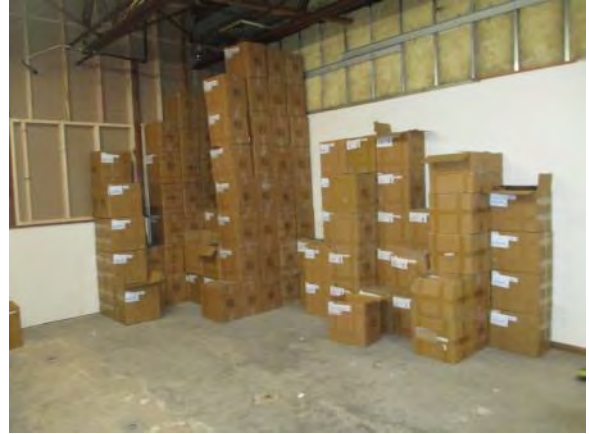
Photo 1: Warehouse interior

Photo 2: Warehouse interior

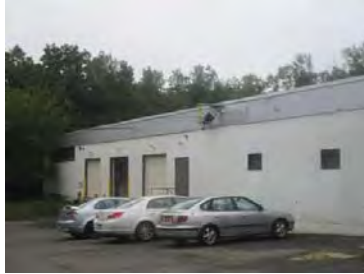
- Photo 1: View of the north side of the subject property.
- Photo 2: View of the east side of the subject property.
- Photo 3: View of the south side of the subject property.
- Photo 4: View of the west side of the subject property.

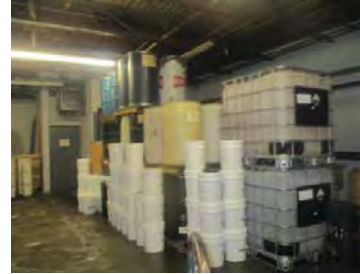
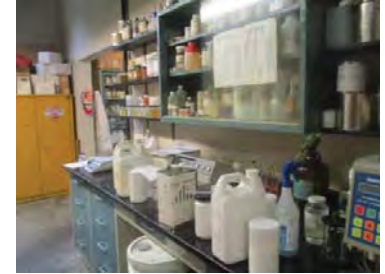
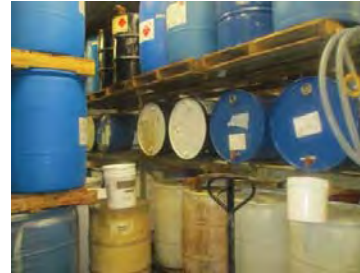
- Photo 1: View of the stored materials.
- Photo 2: View of the stored materials.
- Photo 3: View of the stored materials.
- Photo 4: View of the mixing tanks.

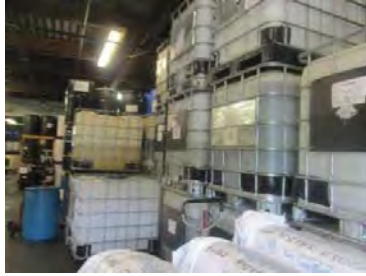
- Photo 1: View of the stored materials.
- Photo 2: View of the two mineral oil ASTs.
- Photo 3: View of the stored wastes.
- Photo 4: View of the stored wastes.

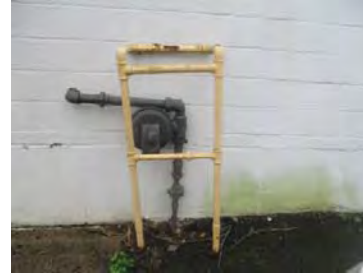
- Photo 1: View of the natural gas meter.
- Photo 2: View of the ceiling mounted burner.
- Photo 3: View of the pole-mounted transformers.
- Photo 4: View of the compressor.

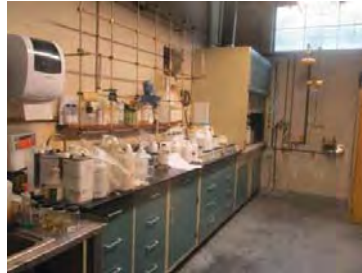
- Photo 1: View of the employee kitchen.
- Photo 2: View of the conference room.
- Photo 3: View of the typical office.
- Photo 4: View of the lab interior.
