**Sullivan County
Division of Planning &
Community Development**

**Phase II Environmental
Site Assessment (ESA)**

**Monticello Manor
15 High Street
Monticello, New York
Sullivan County**

July 2019
Work Order: 9294.01

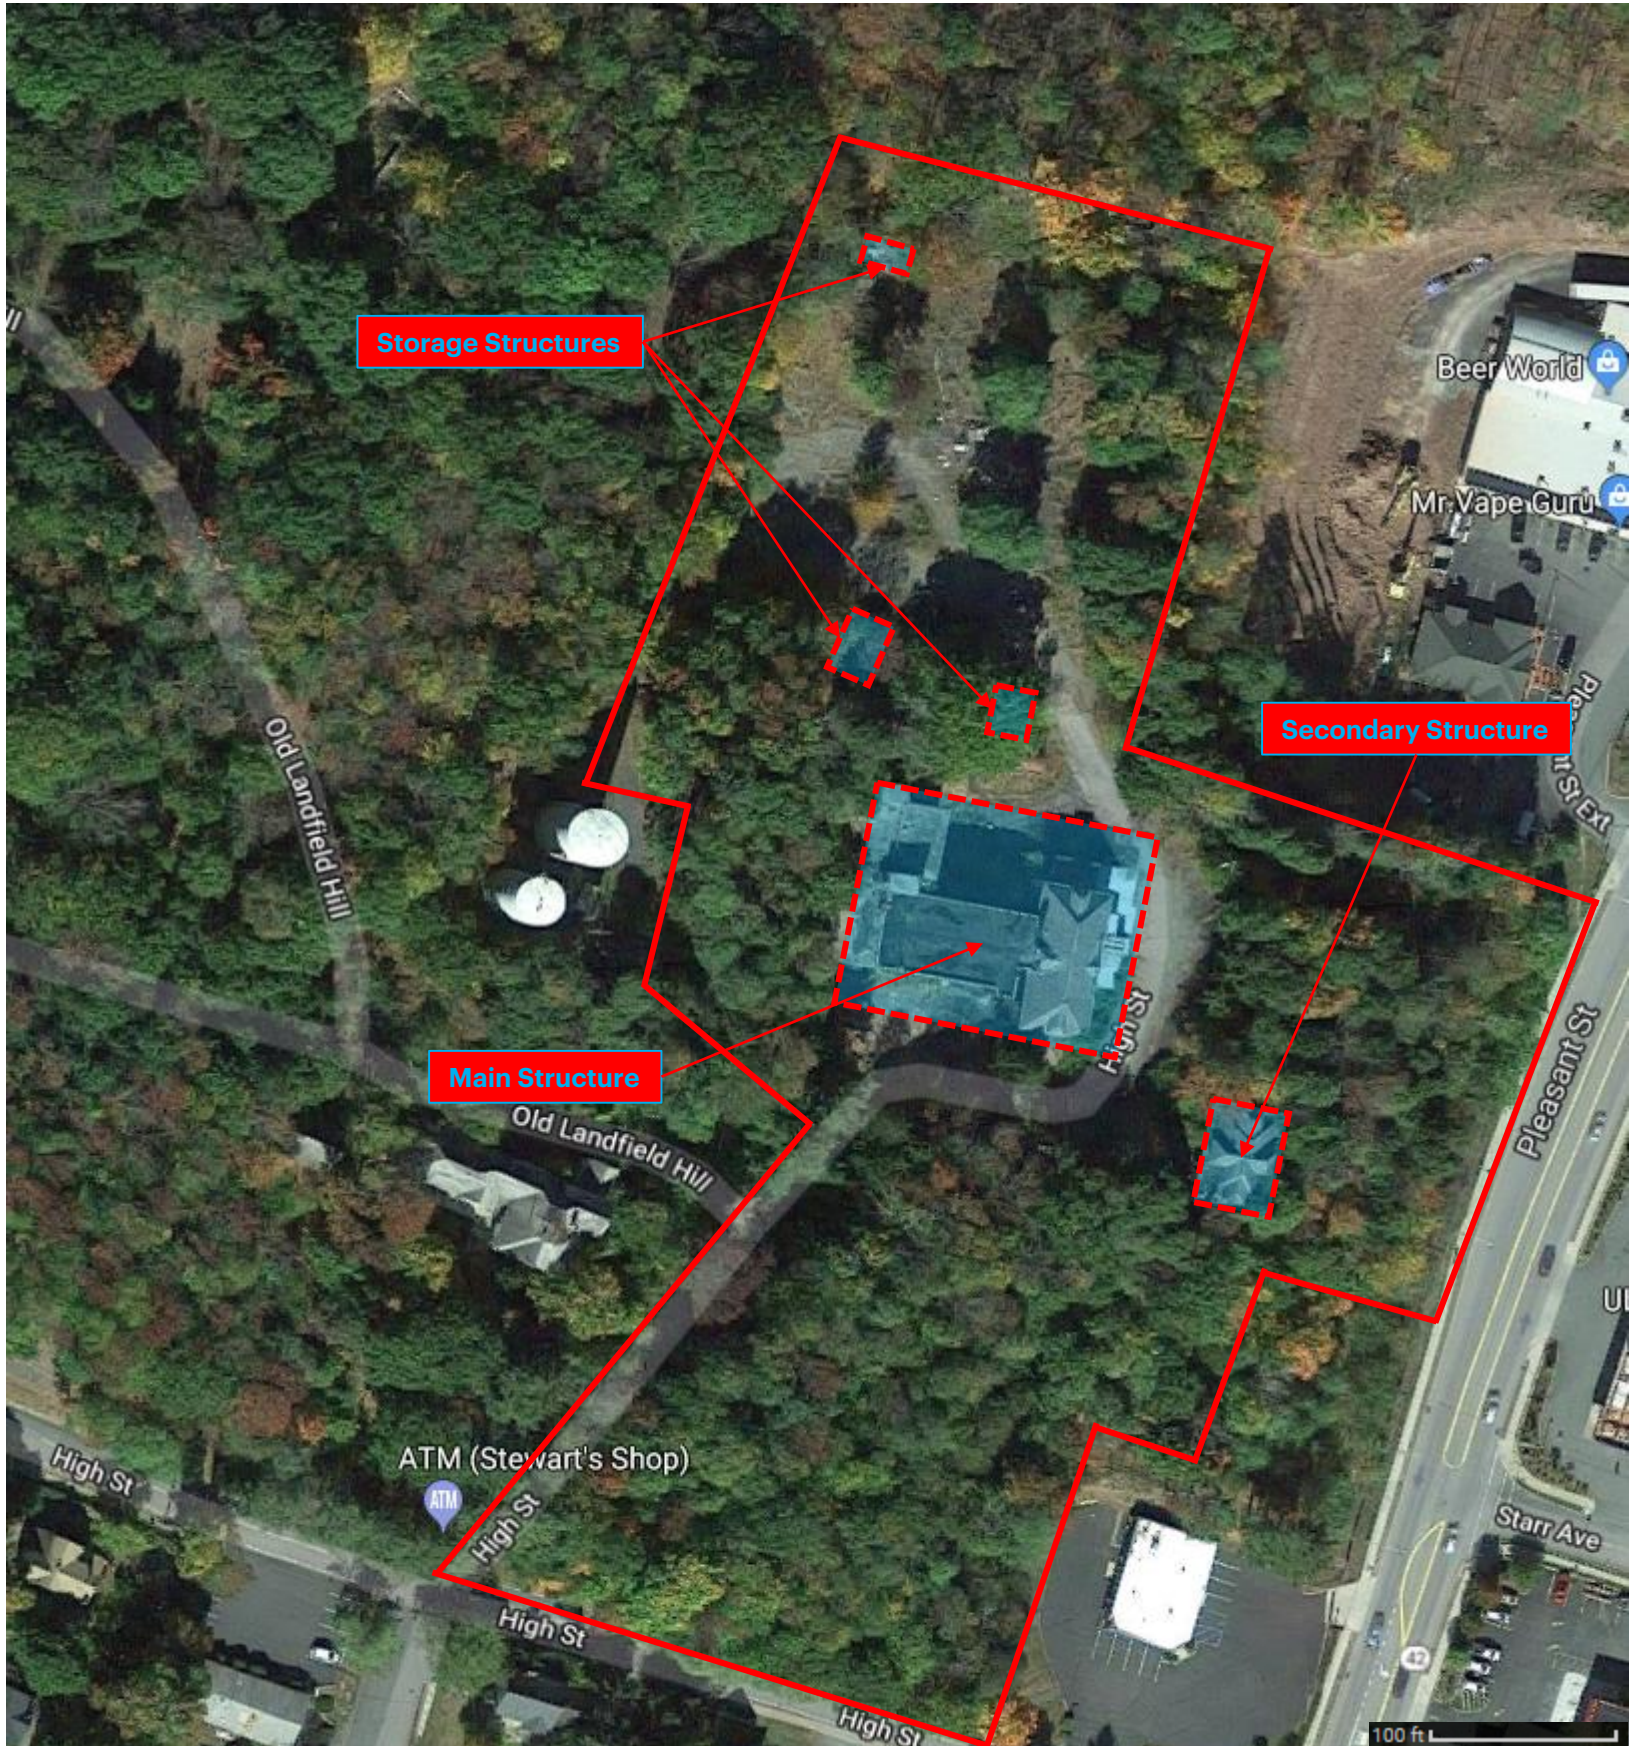
FIGURE 2

The Subject Property is improved with five (5) structures and a paved access road and parking area. Structures include:

- One (1) three-story, brick and mortar, main structure located in the approximate center of the Subject Property. According to the Sullivan County Tax Web App, the structure has an approximate gross floor area of 32,188-square feet. Based on an estimate derived using Google aerial imagery, the footprint of this structure is approximately 11,500-square feet. The oldest portion of the main structure was built circa 1920s;

- One (1) three-story, brick and mortar, secondary structure located southeast of the main structure. According to the Sullivan County Tax Web App, the structure has an approximate gross floor area of 4,748-square feet. Based on an estimate derived using Google aerial imagery, the footprint of this structure is approximately 1,600-square feet. The secondary structure was built around 1931; and

- Three (3) small storage structures that are situated to the north of the main structure. Based on estimates derived using Google aerial imagery, the footprint of these structures are approximately 370-square feet, 240-square feet, and 480 square feet.

A paved access road extends north off of High Street and leads up to the main structure and further extends to the north side of the Subject Property where there is a parking area. The remainder of the Subject Property

consists of unimproved woodlands. The approximate locations of the above referenced structures are shown in **Figure 2**.

Title Figure 2: Approximate Location of Structures at Subject Property

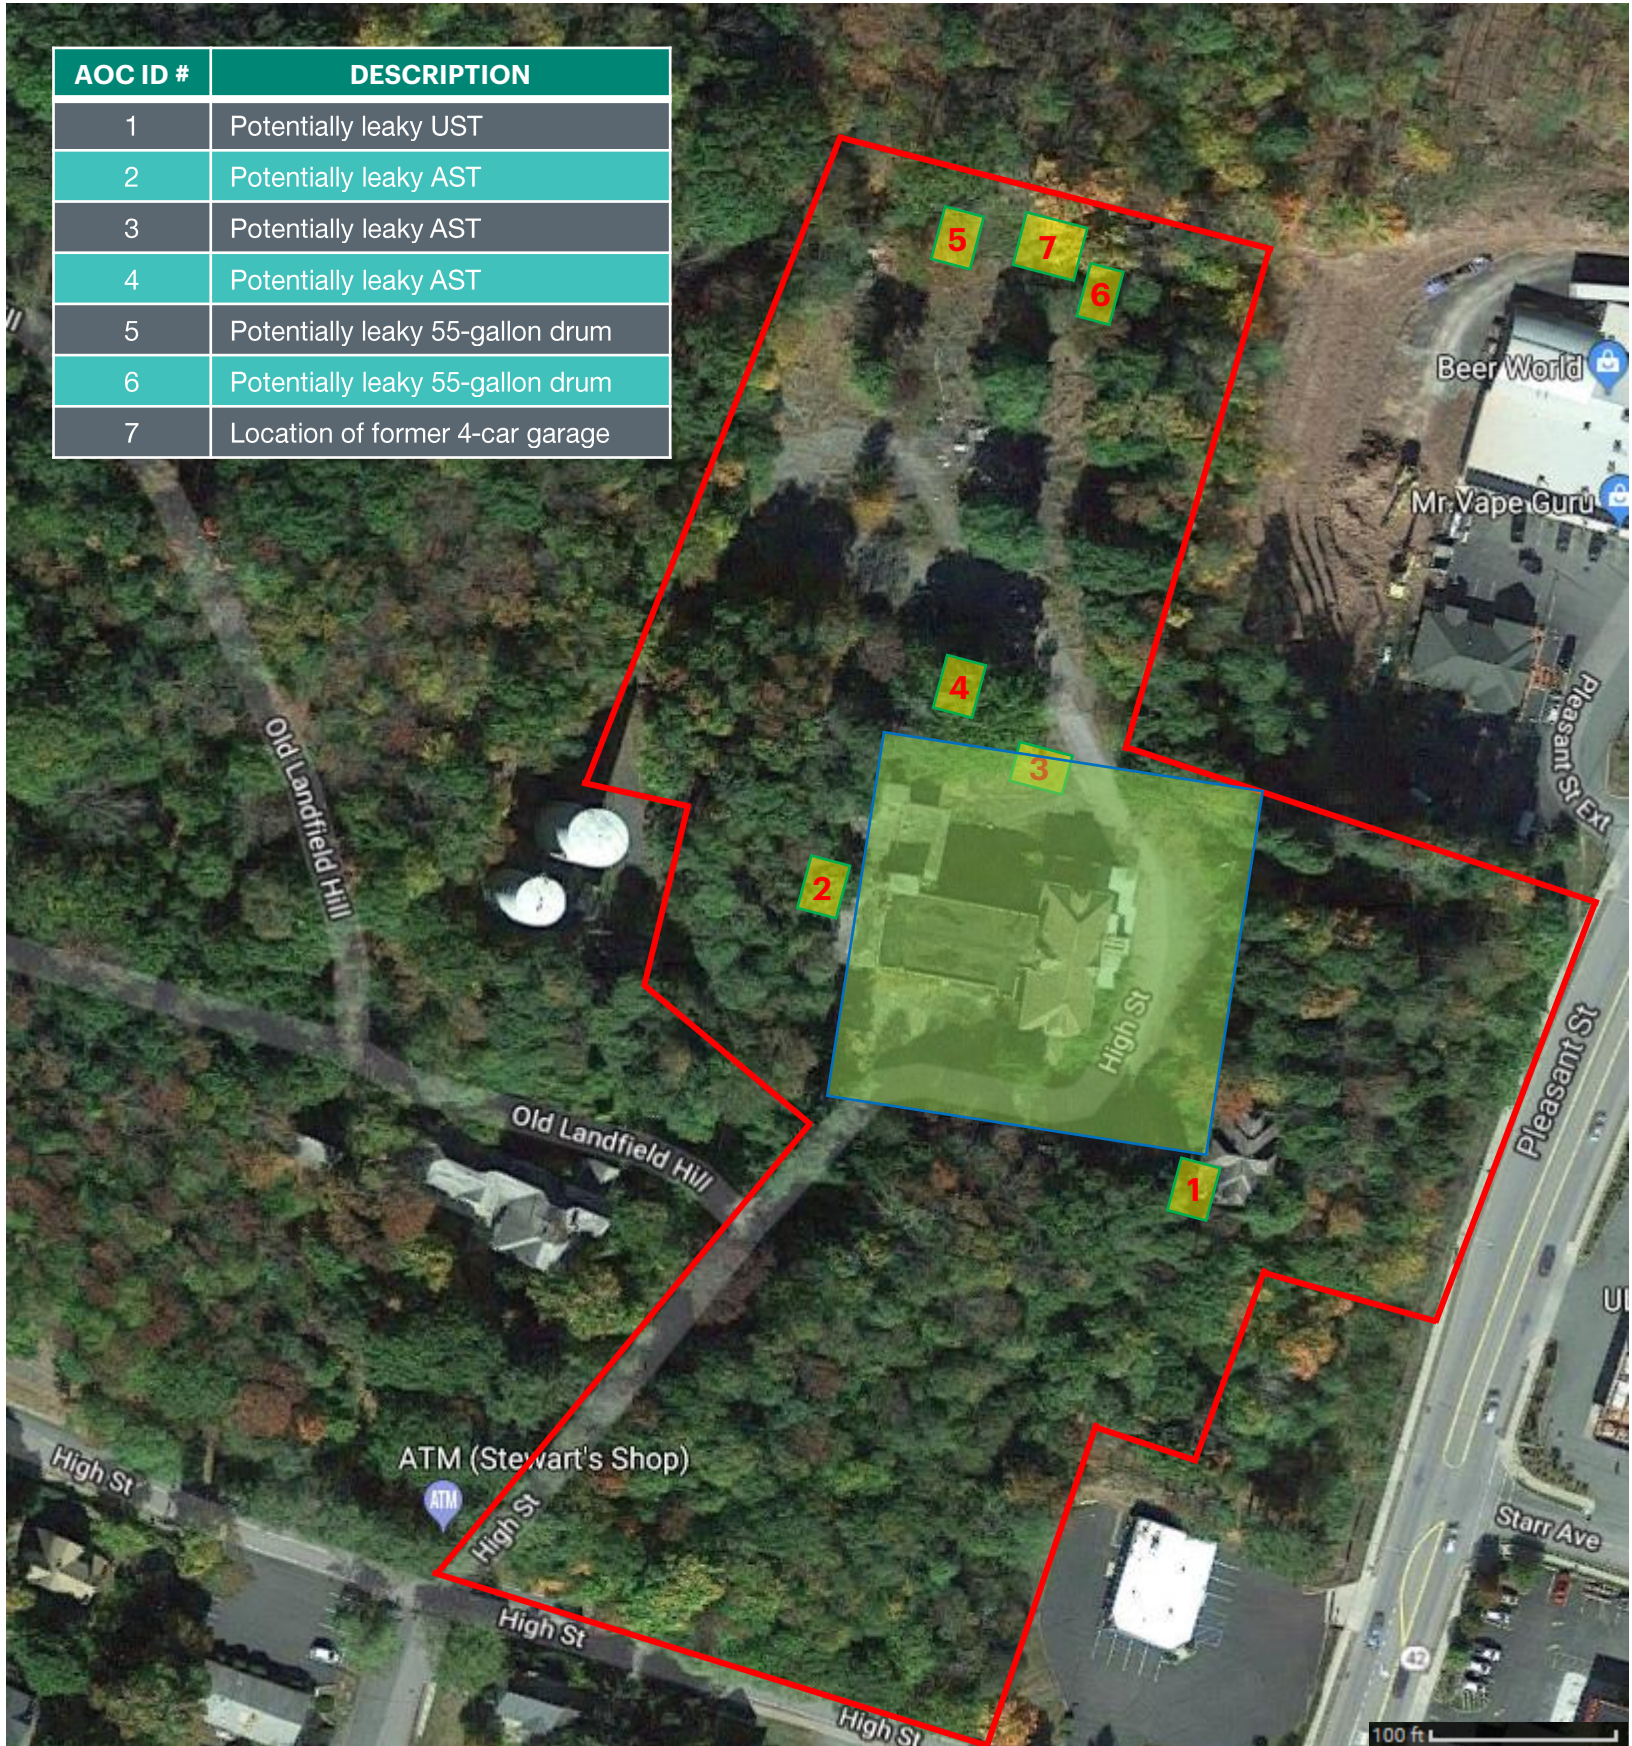
FIGURE 3

Prior to mobilization to the Site for field activities, Tectonic identified seven (7) areas of concern (AOCs) in which potential impacts and/or contamination may be present due to historic use of the Subject Property (see **Figure 3**). The identification of the AOCs was informed primarily by performing the Phase I ESA. These areas of concern include:

- AOC 1: One (1) UST was observed during the Phase I ESA site reconnaissance. Due to access limitations and the tank being below grade, it could not be assessed (visually or olfactorily) whether or not releases from the UST had impacted surrounding soils and groundwater.

- AOC 2, AOC 3, AOC 4: Three (3) ASTs were noted during the Phase I ESA site reconnaissance. No evidence of release was observed on the ground surface, however, impacts to sub-surface soils from potential releases may exist.

- AOC 5, AOC 6: Two (2) 55-gallon drums were reported during the Phase I ESA site reconnaissance. No evidence of release was observed on the ground surface, however, impacts to sub-surface soils from potential releases may exist.

- AOC 7: An interview with a former property owner revealed that a four car garage had previously existed in the rear (north of) the main structure located at the Subject Property. Potential releases from vehicles and suspect containers stored in the garage may have impacted sub-surface soils and groundwater.

The seven (7) AOCs and the approximate area of the geophysical survey are shown in **Figure 3**.

AOC ID #	DESCRIPTION
1	Potentially leaky UST
2	Potentially leaky AST
3	Potentially leaky AST
4	Potentially leaky AST
5	Potentially leaky 55-gallon drum
6	Potentially leaky 55-gallon drum
7	Location of former 4-car garage

Title	Figure 3: Approximate Location of AOCs & Geophysical Survey			
Location	Monticello Manor, 15 High Street, Monticello, NY 12701			
Client	Sullivan County			
Source	Google Maps			
Date	6/6/2019	Work Order	9294.01	Drawing No.
Scale	As Noted			1 of 1
				Rev.
				0

A geophysical survey was performed in the vicinity of the main and secondary structures of the Subject Property on June 5, 2019 using ground penetrating radar (GPR) to investigate whether an undocumented septic system is present. All areas accessible to a GPR unit within a one hundred (100) foot radius of the structures were surveyed; no evidence was observed associated with a potential septic system on the Subject Property.

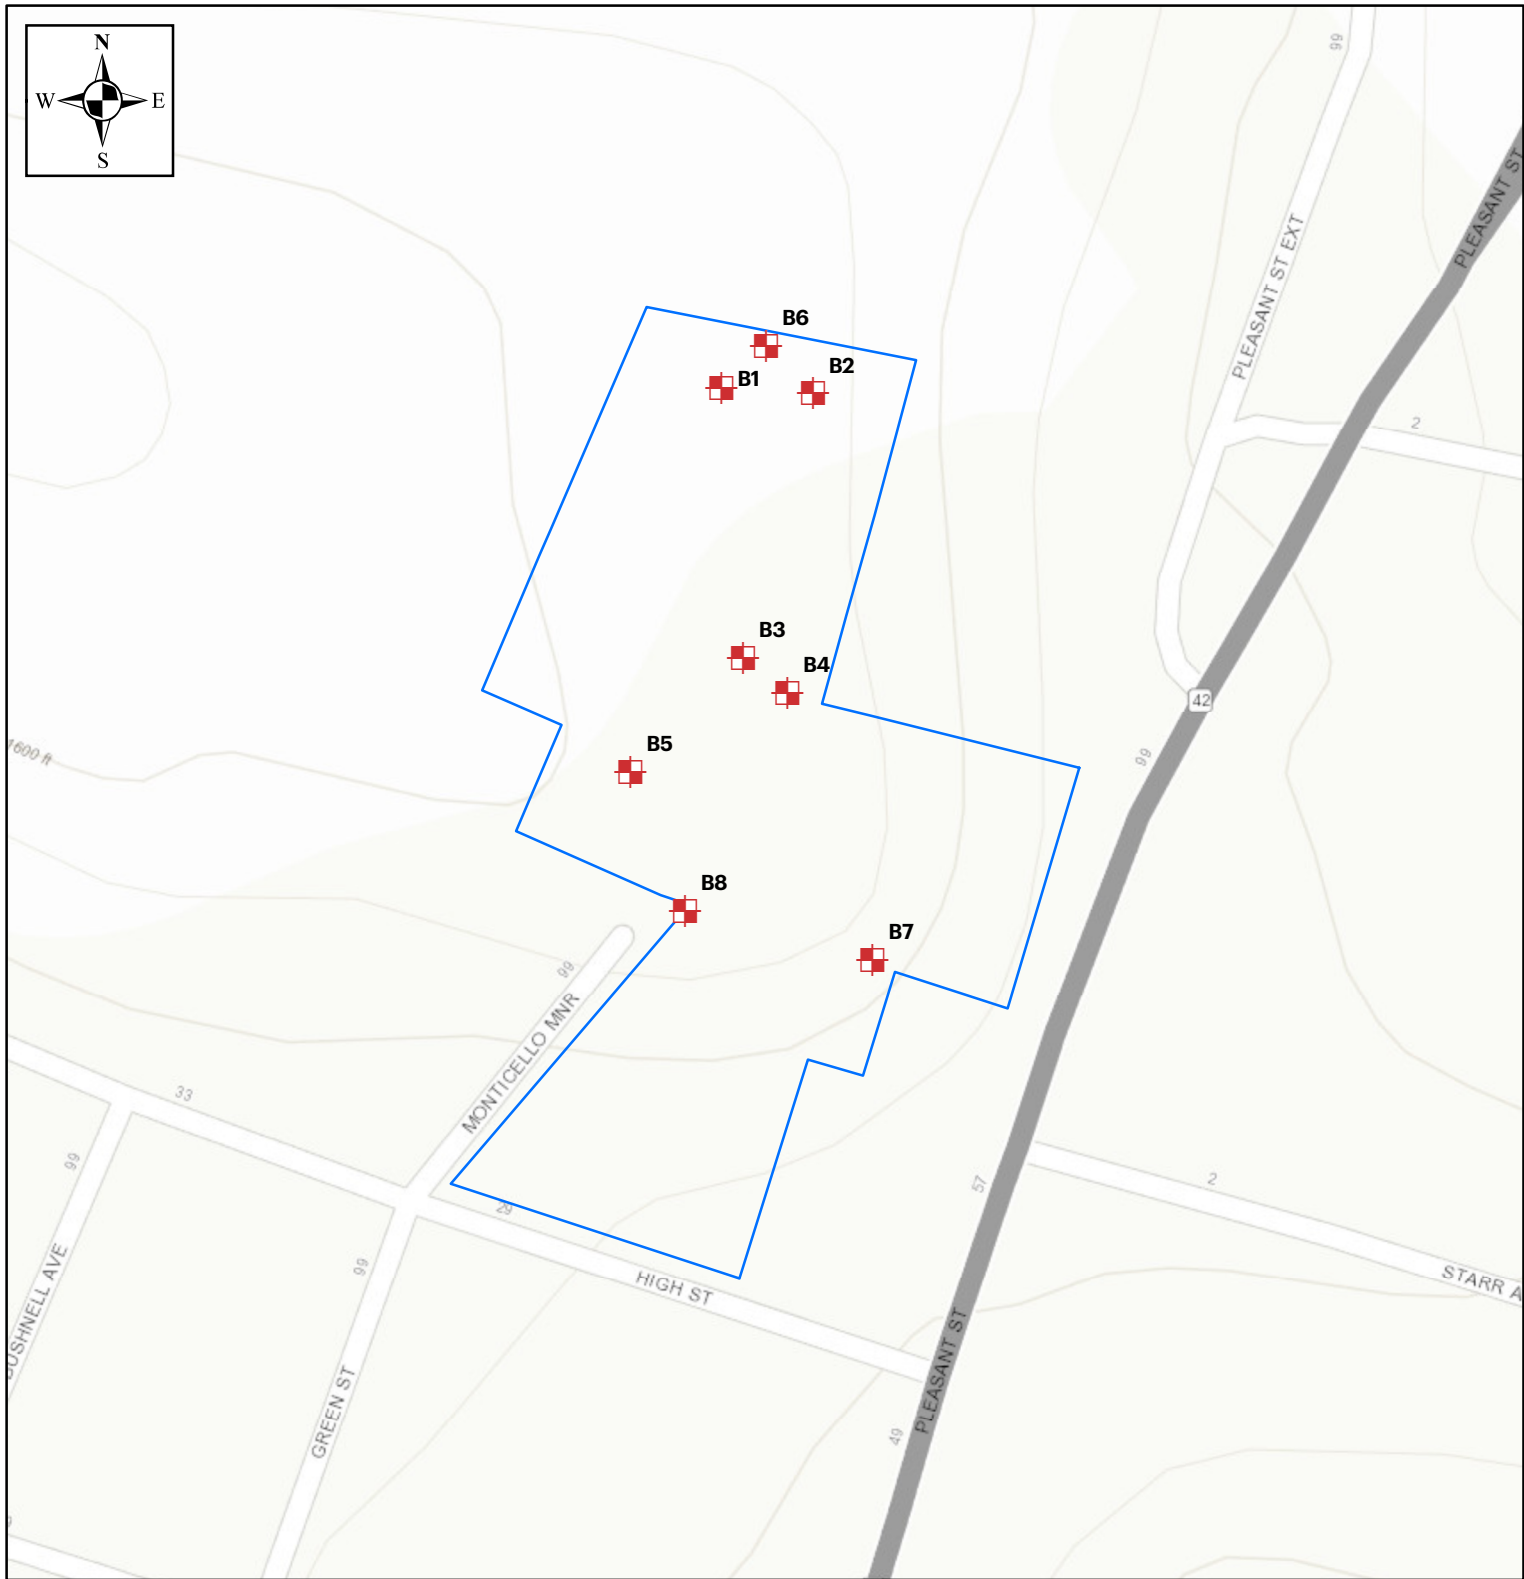
Figure: 4

On June 5 and 6, 2019, a geologist from Tectonic, with current OSHA HAZWOPER training, and representatives from General Borings, Inc. mobilized to the Site to advance eight (8) soil borings to depths ranging between approximately eight (8) inches to five (5) feet below ground surface (bgs) (see **Figure 4**). Borings were advanced continuously via AMS PowerProbe 9500-VTR direct push rig or via hand excavation to refusal at bedrock.

The eight (8) soil borings were located to address the seven (7) AOCs identified and the presence of the sanitary sewer line, as detailed below.

- Two (2) soil borings (borings B1 and B2) were advanced in the vicinity of the two (2) 55-gallon drums discovered during Tectonic’s site reconnaissance performed on June 25, 2018 as part of the Phase I ESA investigation for potential petroleum contamination. These borings were performed to address AOCs 5 and 6.
- Three (3) soil borings (borings B3, B4 and B5) were advanced in the vicinity of the three (3) ASTs discovered during Tectonic’s site reconnaissance performed on June 25, 2018 as part of the Phase I ESA investigation for potential petroleum contamination. These borings were performed to address AOCs 2, 3, and 4.
- One (1) soil boring (boring B6) was advanced in the vicinity of the former location of a four car garage behind the main structure that has subsequently been destroyed (according to an interview with a former property owner). This boring was performed to address AOC 7.

- One (1) soil boring (boring B7) was advanced in the vicinity of the one (1) UST identified during Tectonic's site reconnaissance performed on June 25, 2018 as part of the Phase I ESA investigation. This boring was performed to address AOC 1.
- One (1) soil boring (boring B8) was advanced to evaluate the soils located down-gradient from the sanitary sewer line identified by the Village of Monticello.

The soil borings locations B1 through B4, B6 and B8 were advanced via Geoprobe to approximately five (5) feet below ground surface (bgs) or to refusal at bedrock; no groundwater was encountered. Boring locations B5 and B7 could not be accessed by the track mounted Geoprobe; as such, hand tools were utilized to reach bedrock. Once bedrock was exposed, a single-use, dedicated scoop was utilized to obtain a fresh surface in the side-walls of each excavation for soil classification and to obtain analytical samples. See Boring Logs and Test Pit Logs included as **Appendix II** for details.

Approximate Boring Locations
-

Boring Location Plan

Boring logs and Test Pit logs are attached as **Appendix II**. A map showing the location of soil borings is shown in **Figure 4**. Photographs depicting the conditions at the site during sample collection activities are included as **Appendix III**.
