# Three Year Periodic Review Report September 2020 – April 2024

Walgreen Company Store 02077  
Kingston, Ulster County, New York  
BCP Site No. C356032  
Project number: 60692859

July 2024

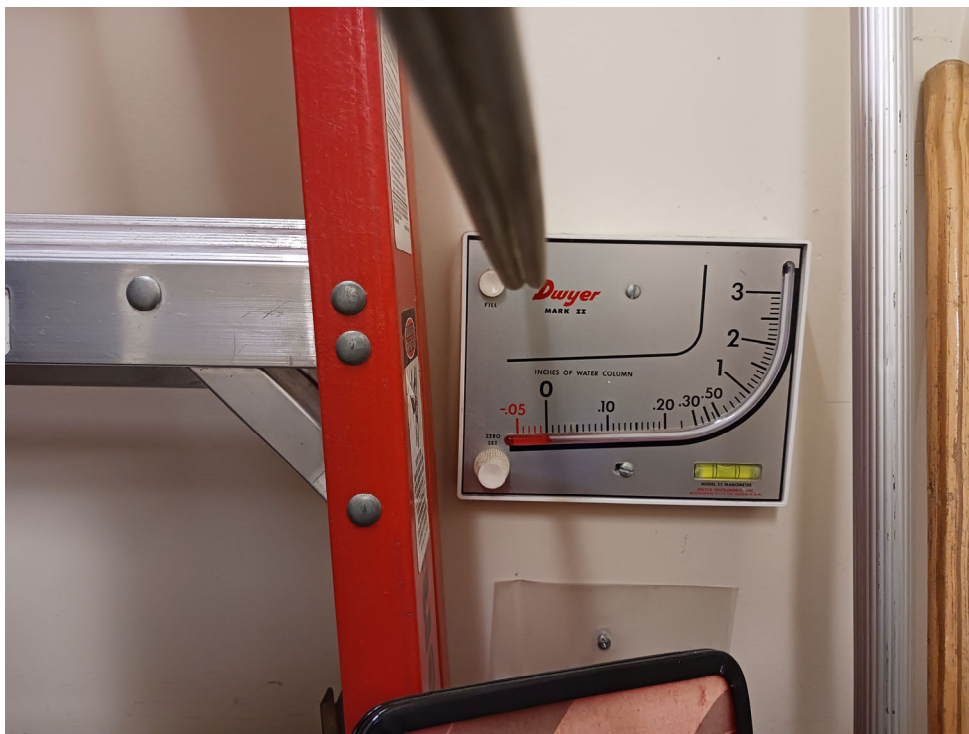
Photo No.  
**6**

- SSDS at the Walgreens retail location: This system was designed and implemented as a passive system that is monitored by Walgreens employees. During AECOMs site walk the wall mounted manometer was inspected and found to be operational. Additionally, The SSDS was checked with a digital manometer which confirmed the reading observed on the wall mounted manometer.
- Site visit to confirm no development has occurred and the ground surface cover is still intact.
- Post-injection sampling performed beginning 4 months after the completion of injections and was performed quarterly for one year.

**Description:**  
Wall mounted  
manometer connected  
to the SSDS.

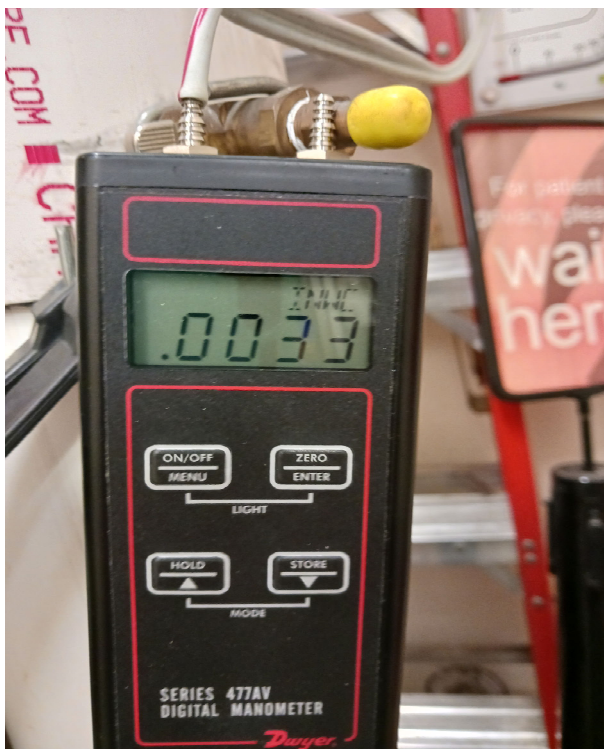
**Description:**  
Digital manometer  
reading.

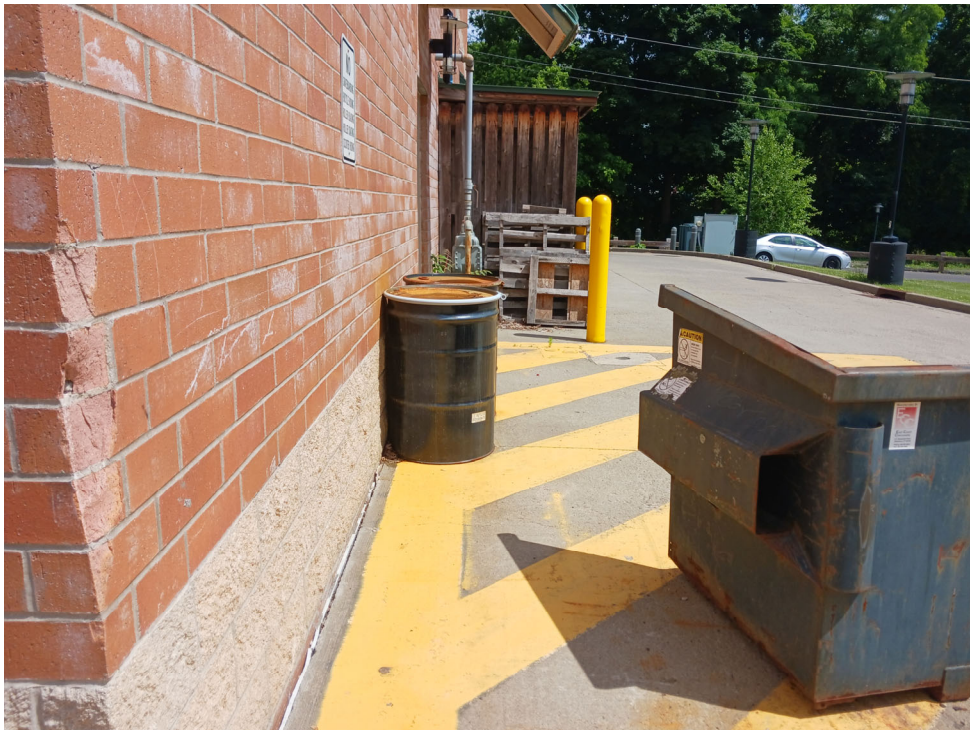
General condition of the  
storage drums

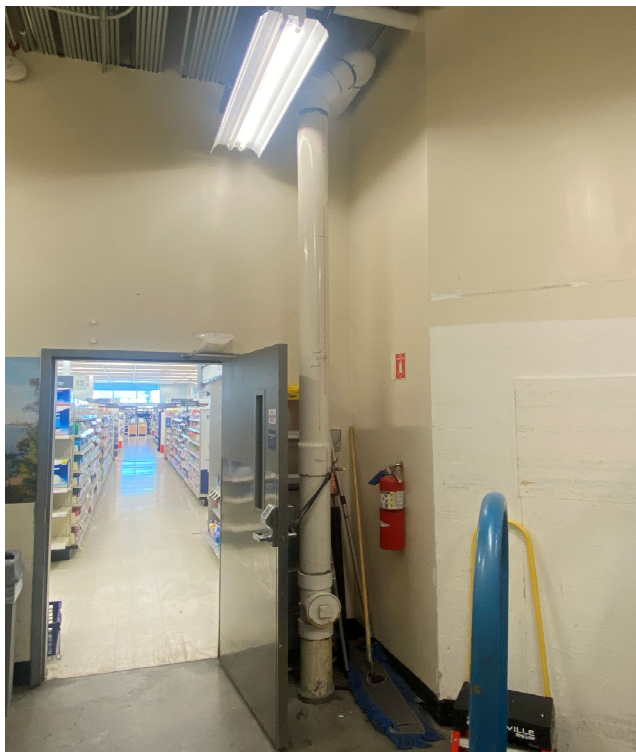
Photo No.  
**12**

General condition of the  
SSDS Vent pipe.

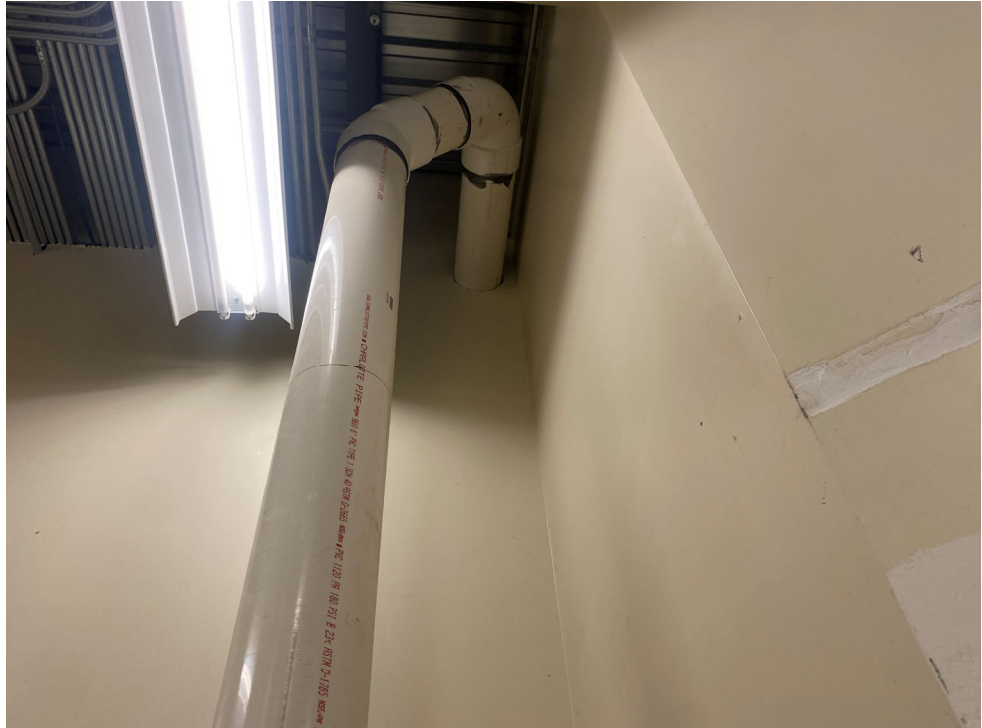
General condition of the  
interior SDSS vent pipe.

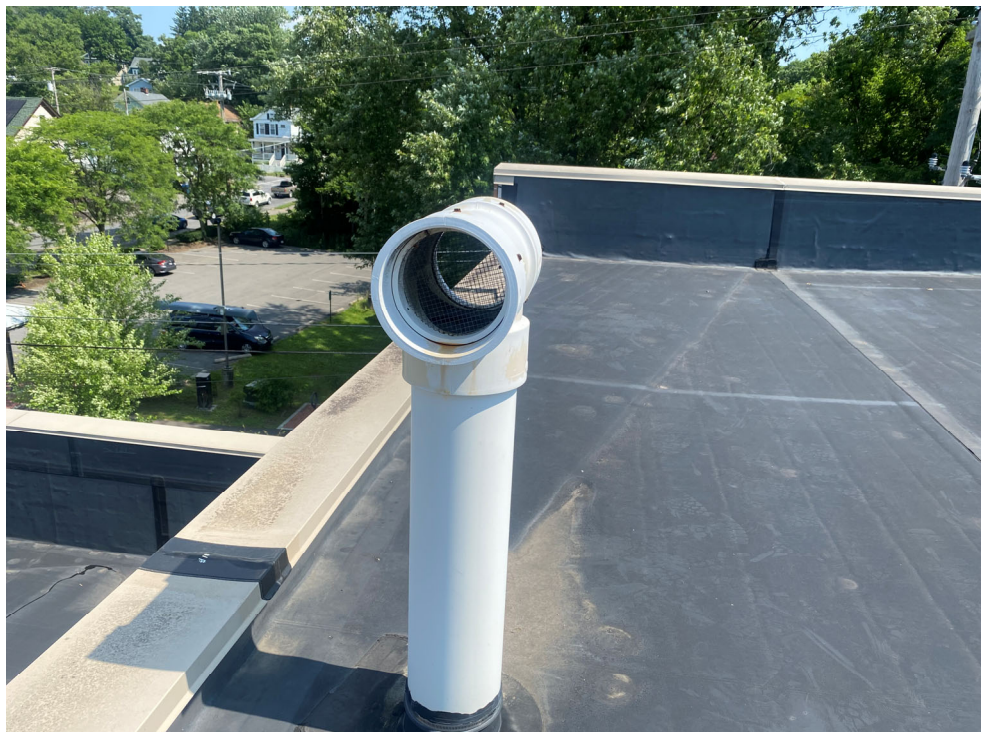
Photo No.  
**14**

General condition of the  
SSDS Vent pipe (Roof).
