Revised Alternatives Analysis and
Remedial Work Plan

Former Cornell Steamboat Company
and L&M Auto Parts BCP Site
Site # C356037
East Strand, Kingston
Ulster County, New York

C.T. Male Project No: 08.8386

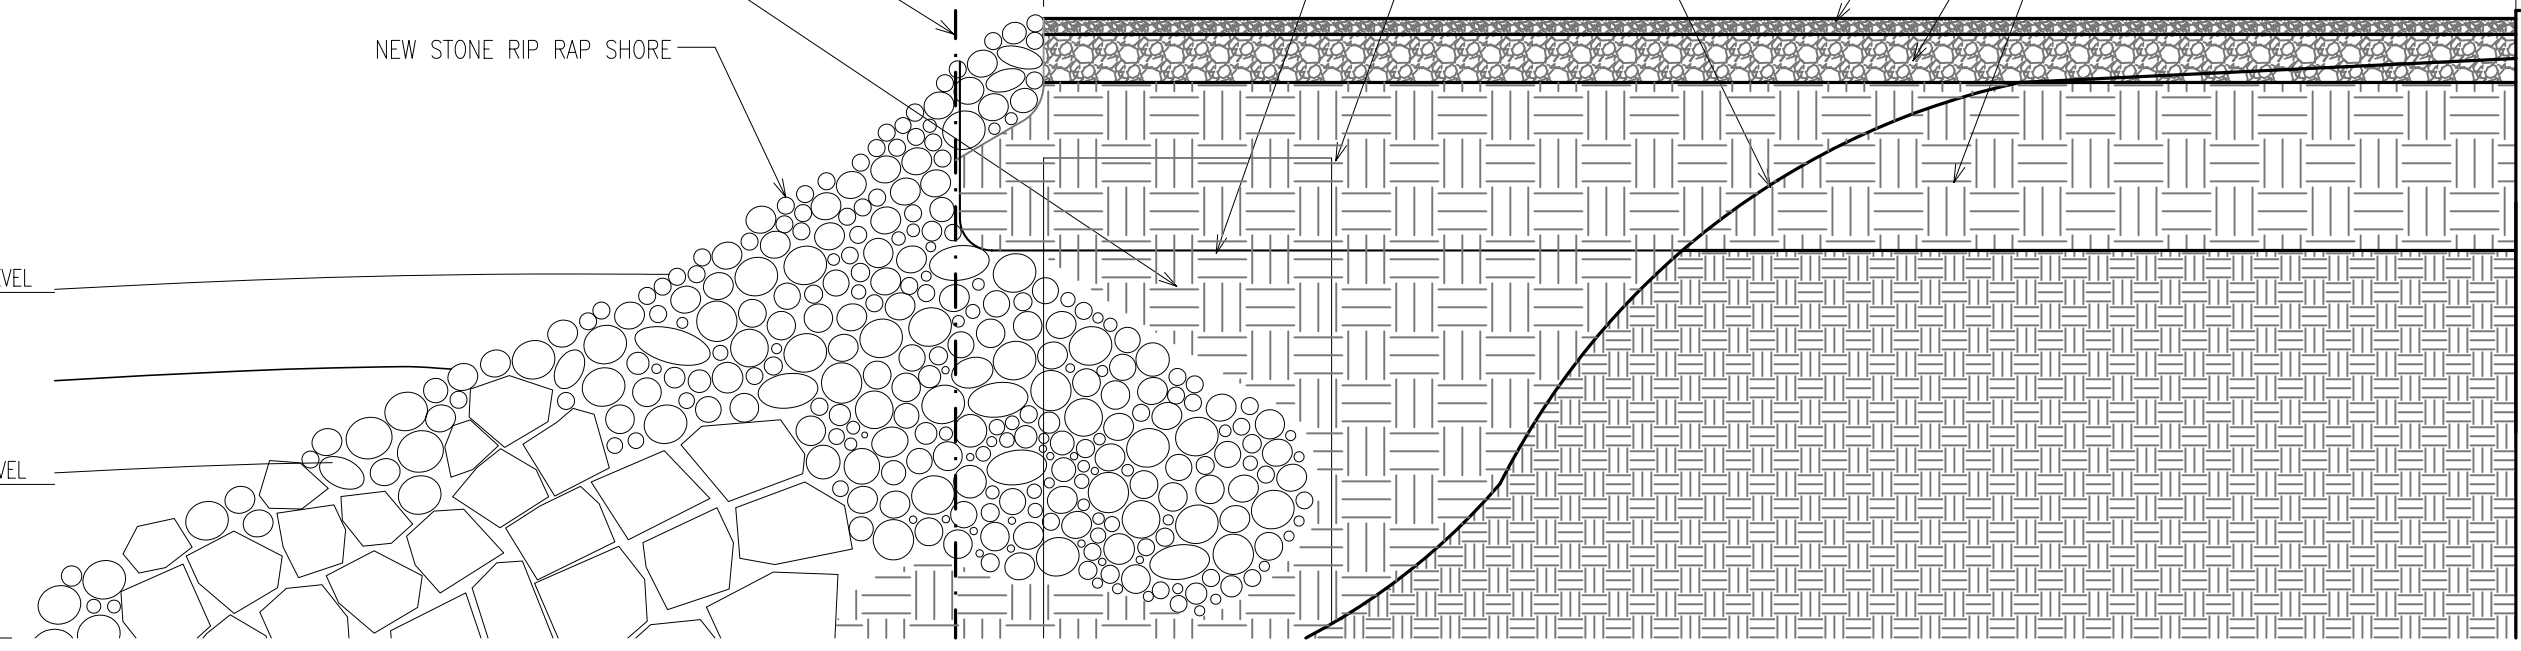
1 SITE SECTION - NEW RIP RAP SHORELINE AT CORNELL BUILDING
A401 1/2" = 1'-0"

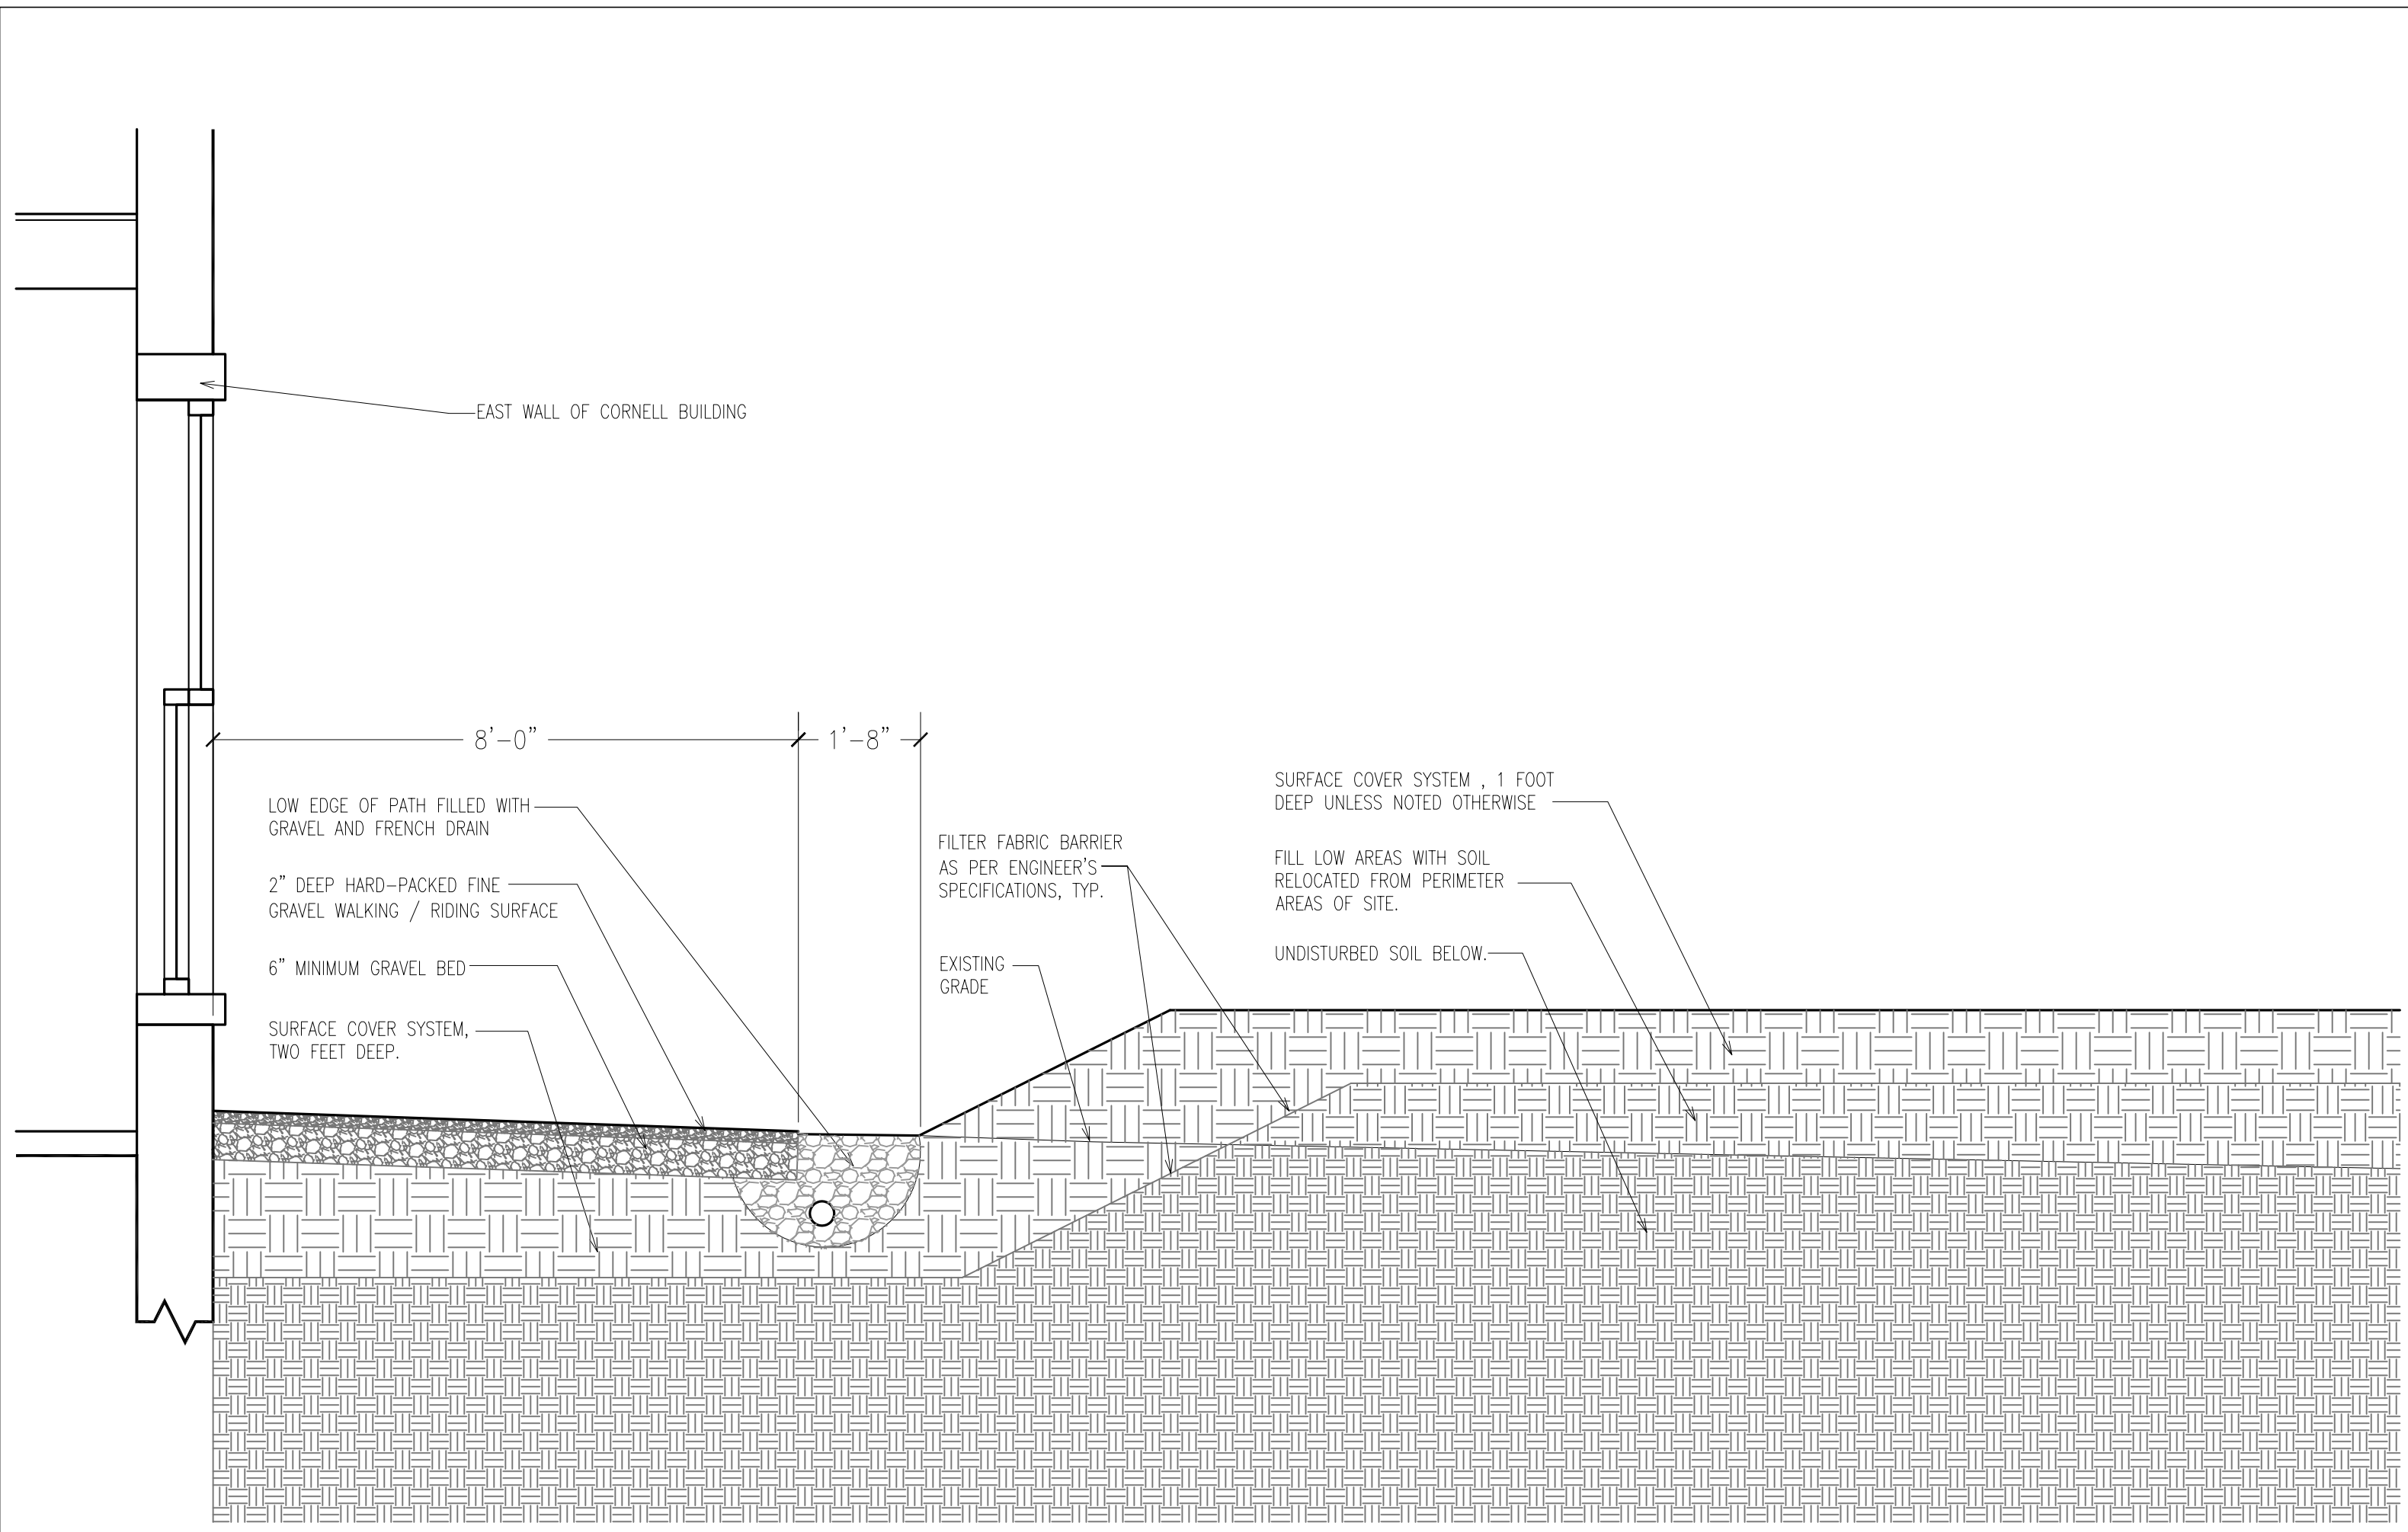
1 SITE SECTION – WALKWAY ALONG EAST WALL OF CORNELL BUILDING
 A403 1/2" = 1'-0"

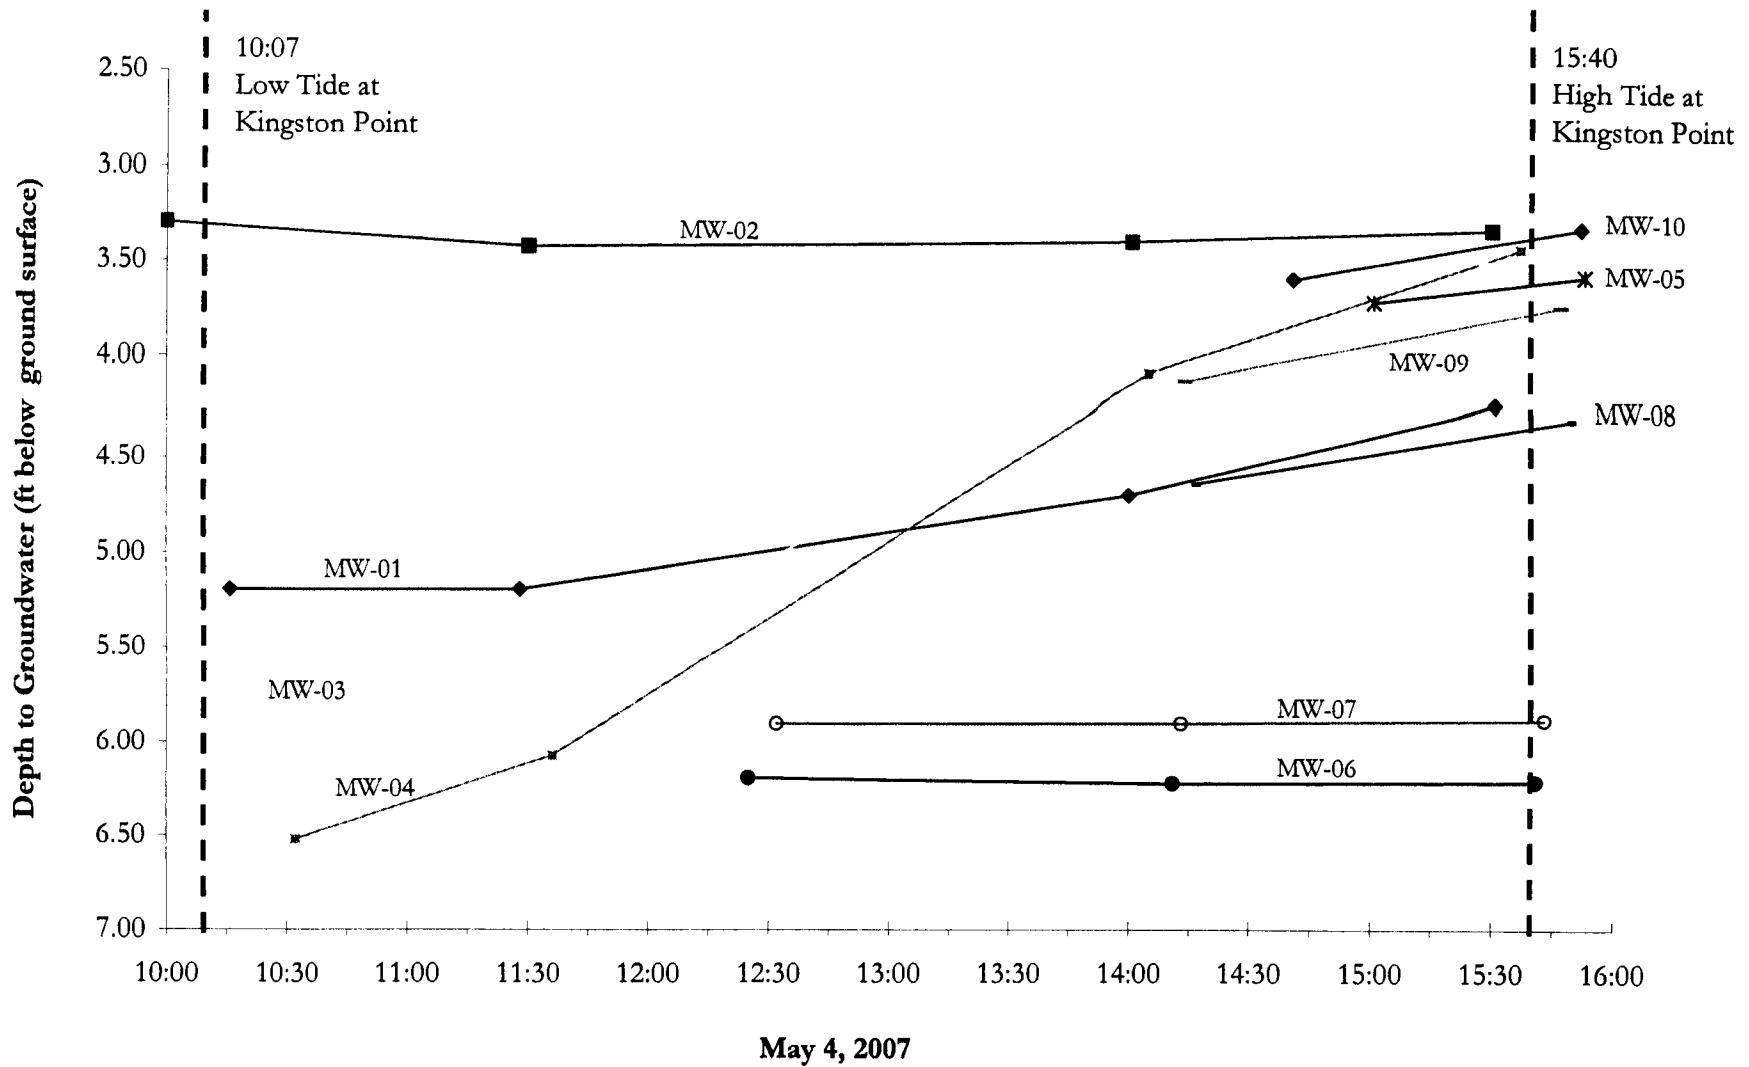
Figure 5:
Tidal Fluctuations in Monitoring Wells

Groundwater level data obtained during the remedial investigation study indicates that groundwater is tidally influenced. Groundwater levels observed in the wells installed within the shallow unconsolidated aquifer underlying the site fluctuated with changes in the tide.

The impact of tidal fluctuations is readily apparent in the areas where petroleum impacts were observed. There was a smear zone in areas where petroleum products were detected. The petroleum impacts were confined to the shallow soils in the saturated and vadose zones. However, the thickness of the saturated zone varies as a function of tidal fluctuation.

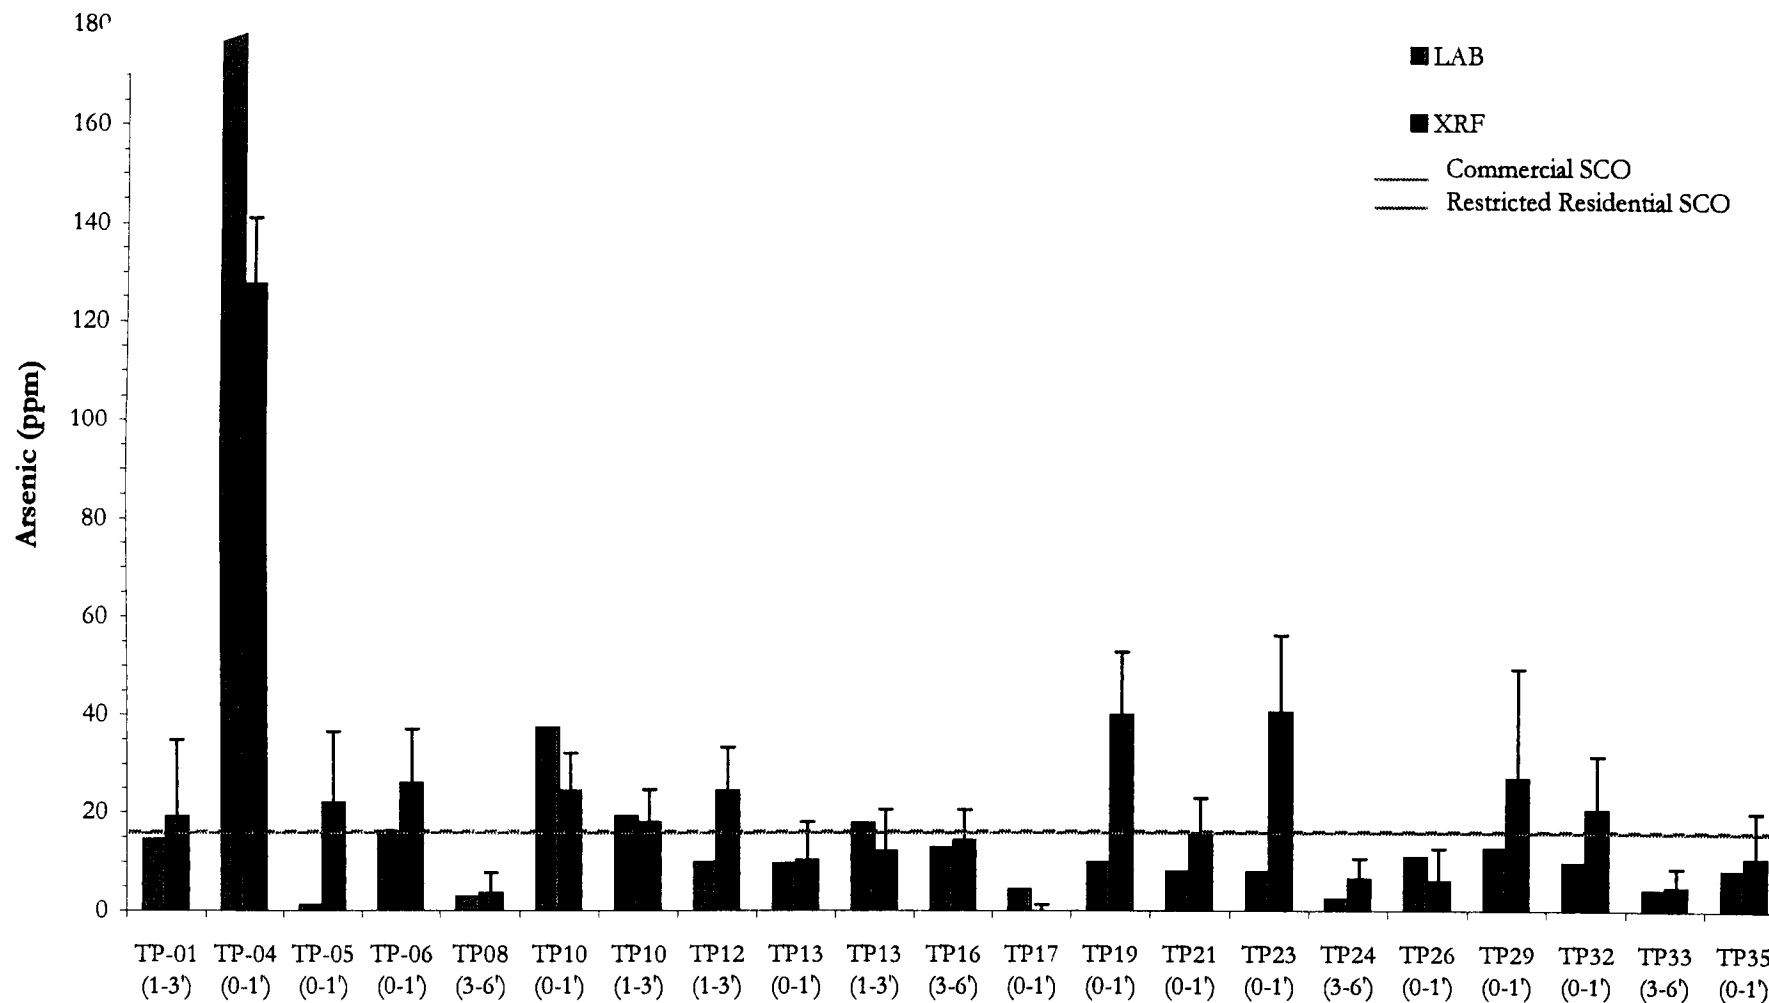
Figure C-1: Laboratory Data vs. XRF Data
Arsenic

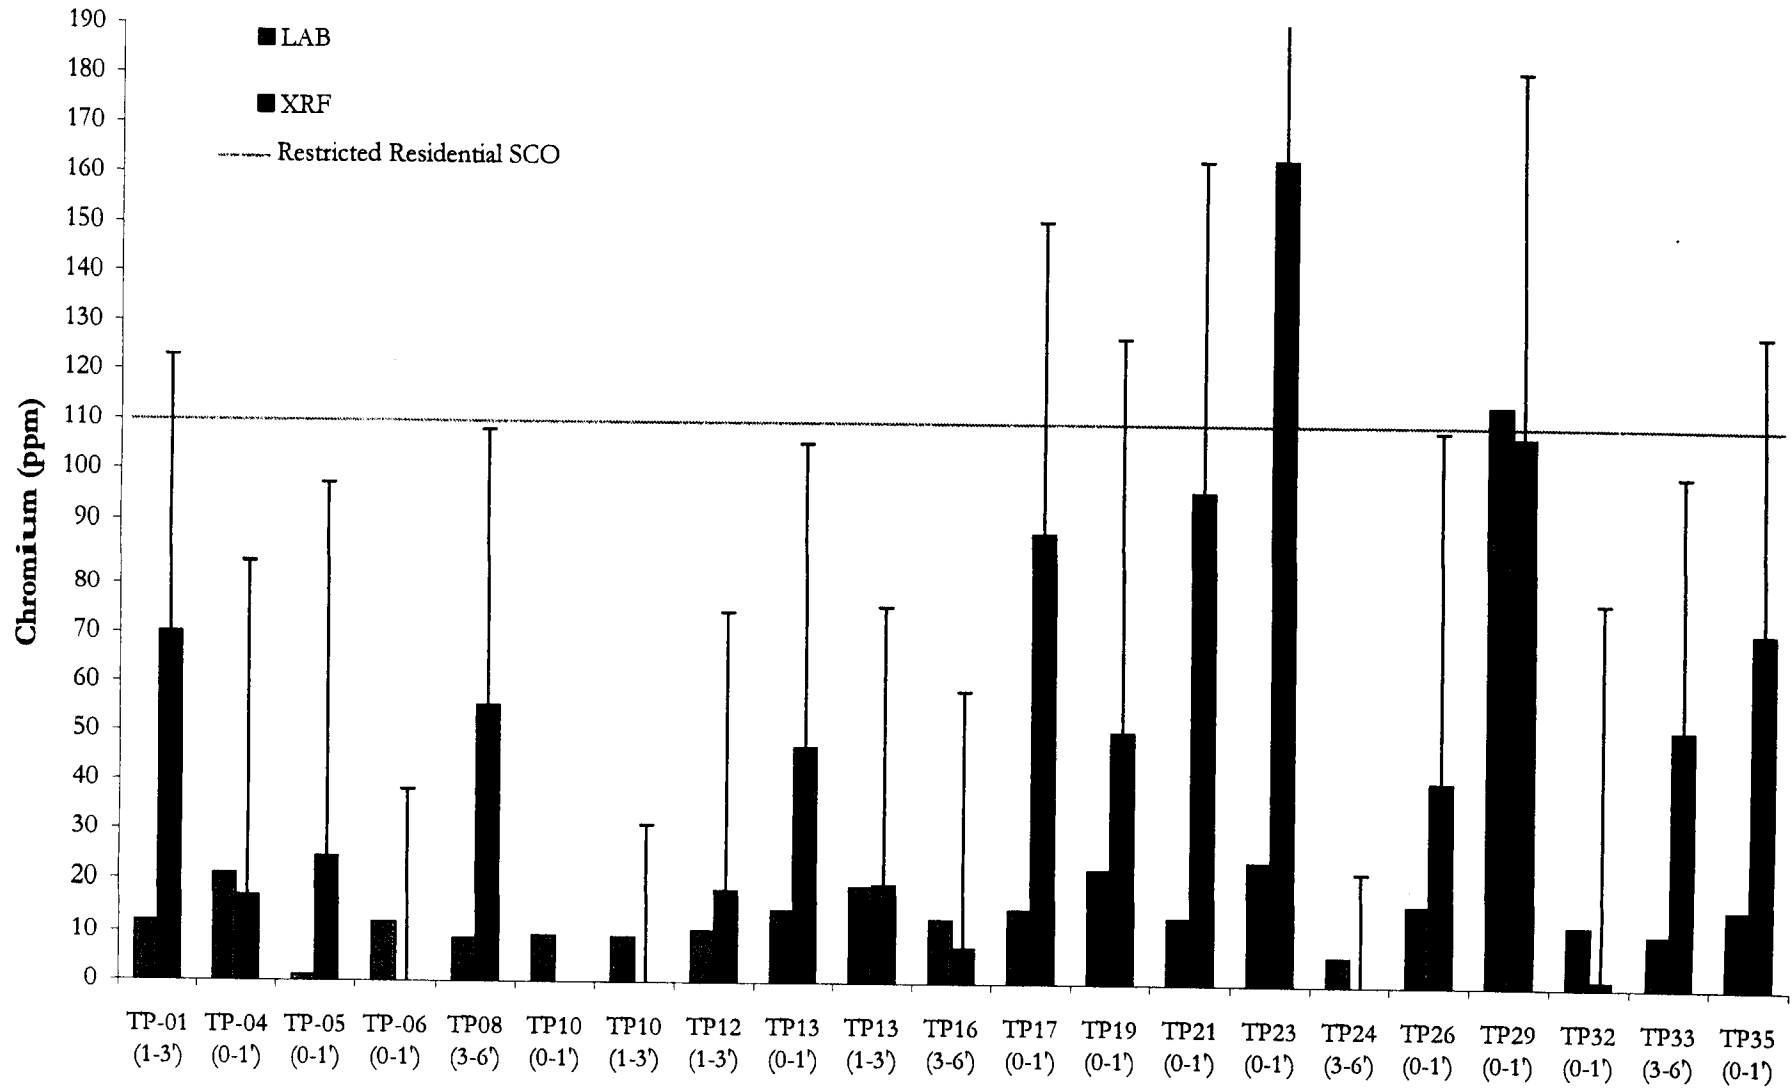
Figure C-2: Laboratory Data vs. XRF Data
Chromium

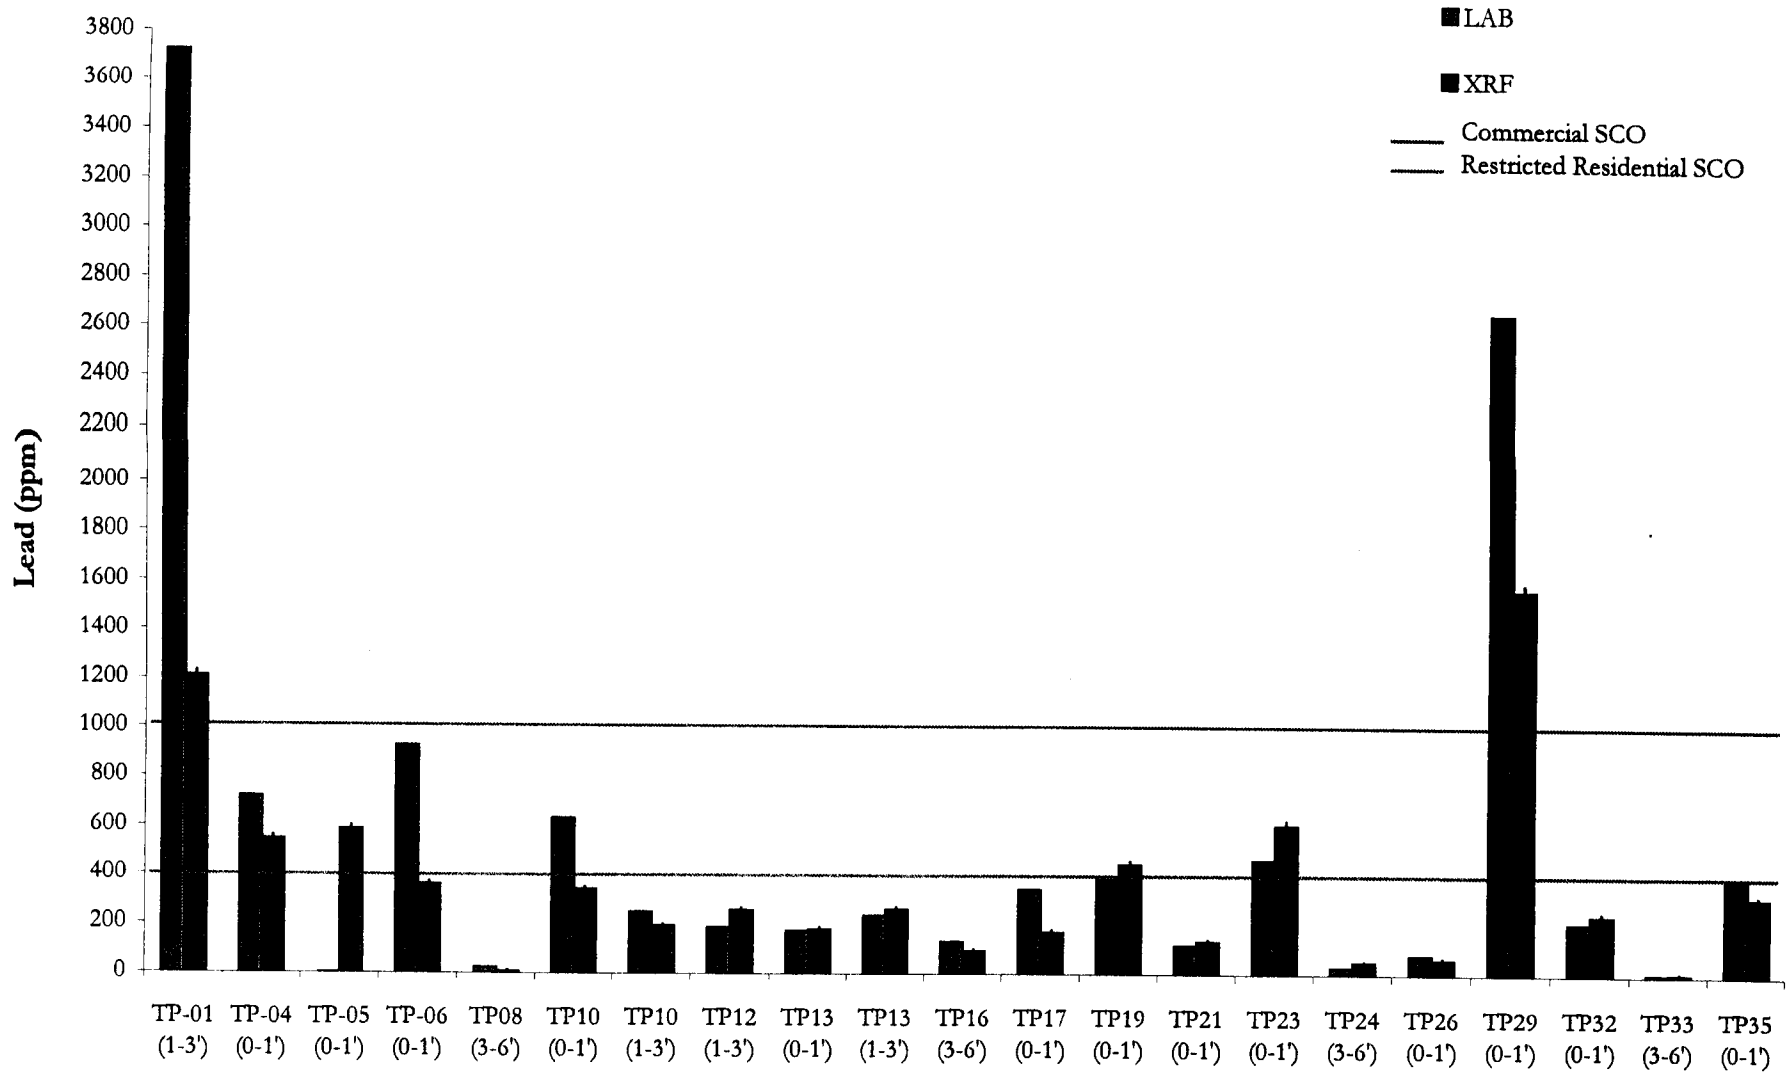
Figure C-3: Laboratory Data vs. XRF Data
Lead

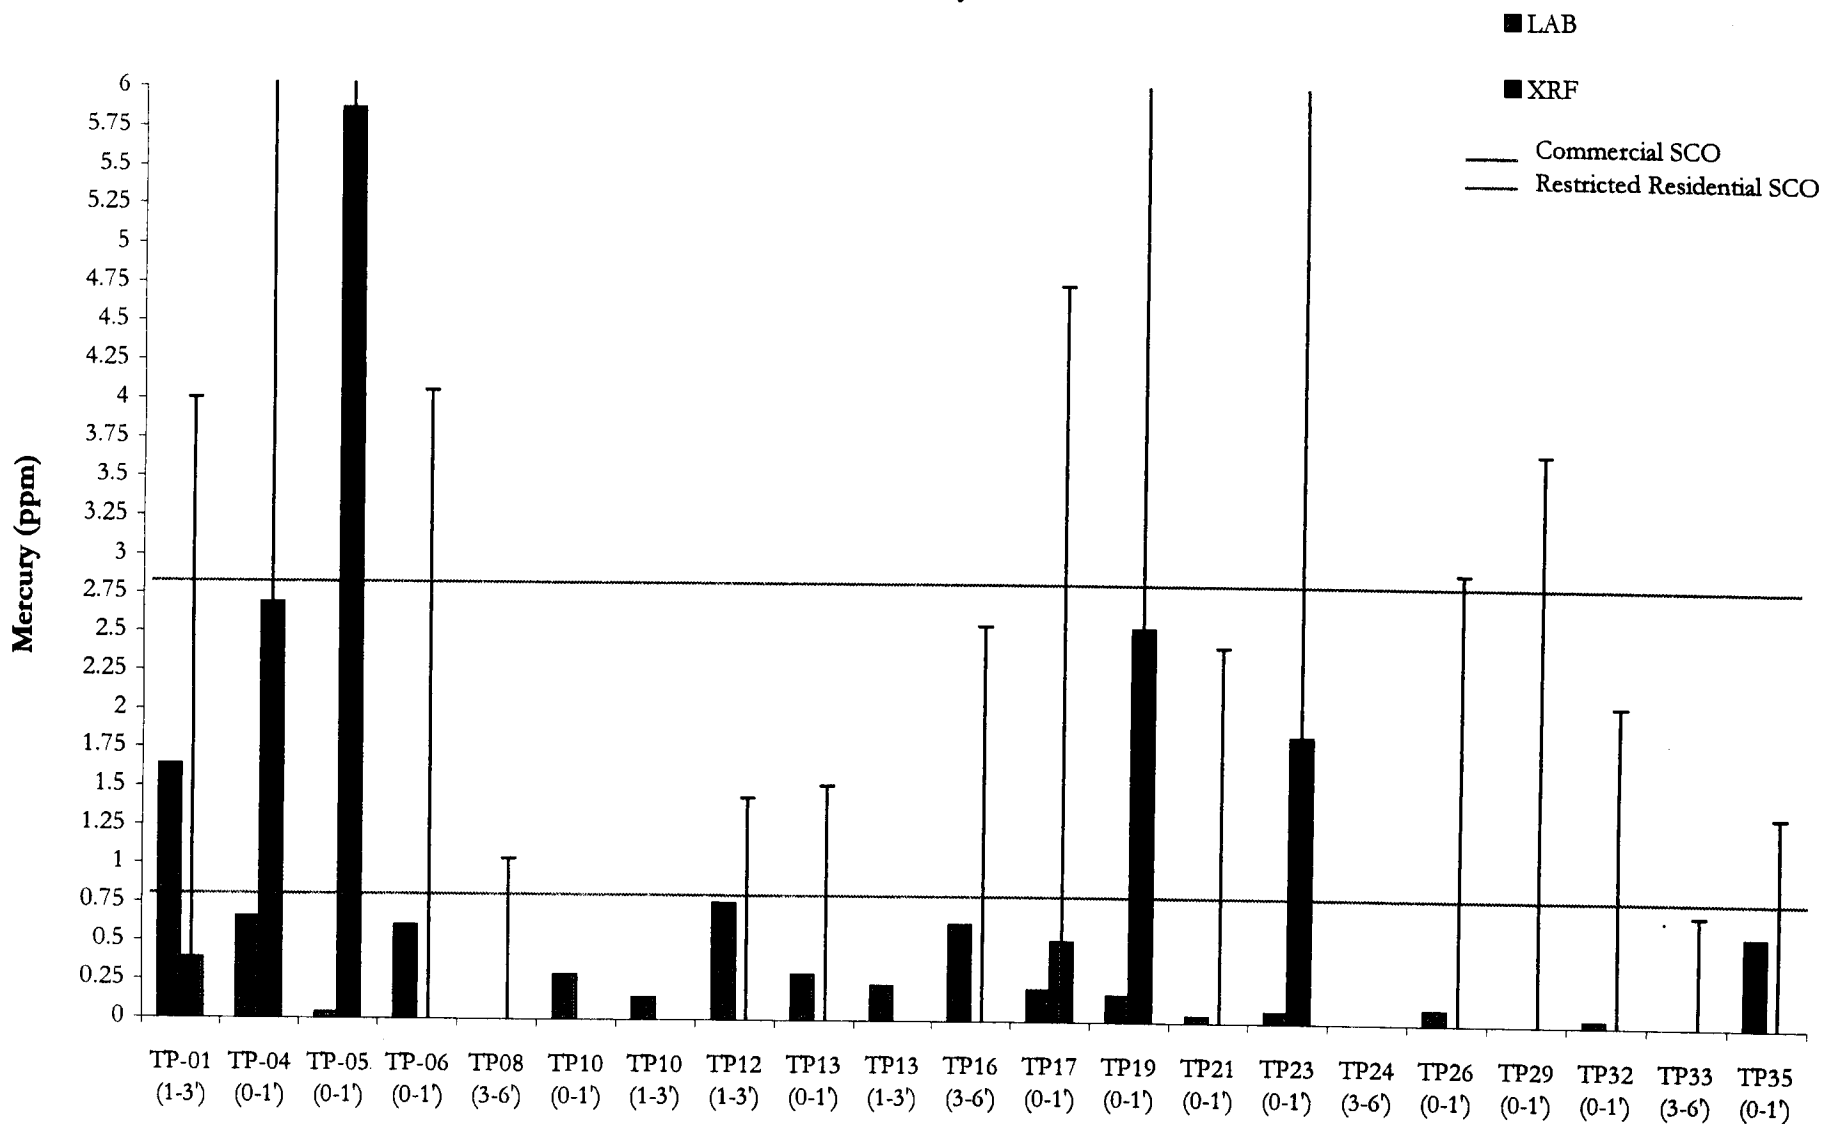
Figure C-4: Laboratory
Mercury

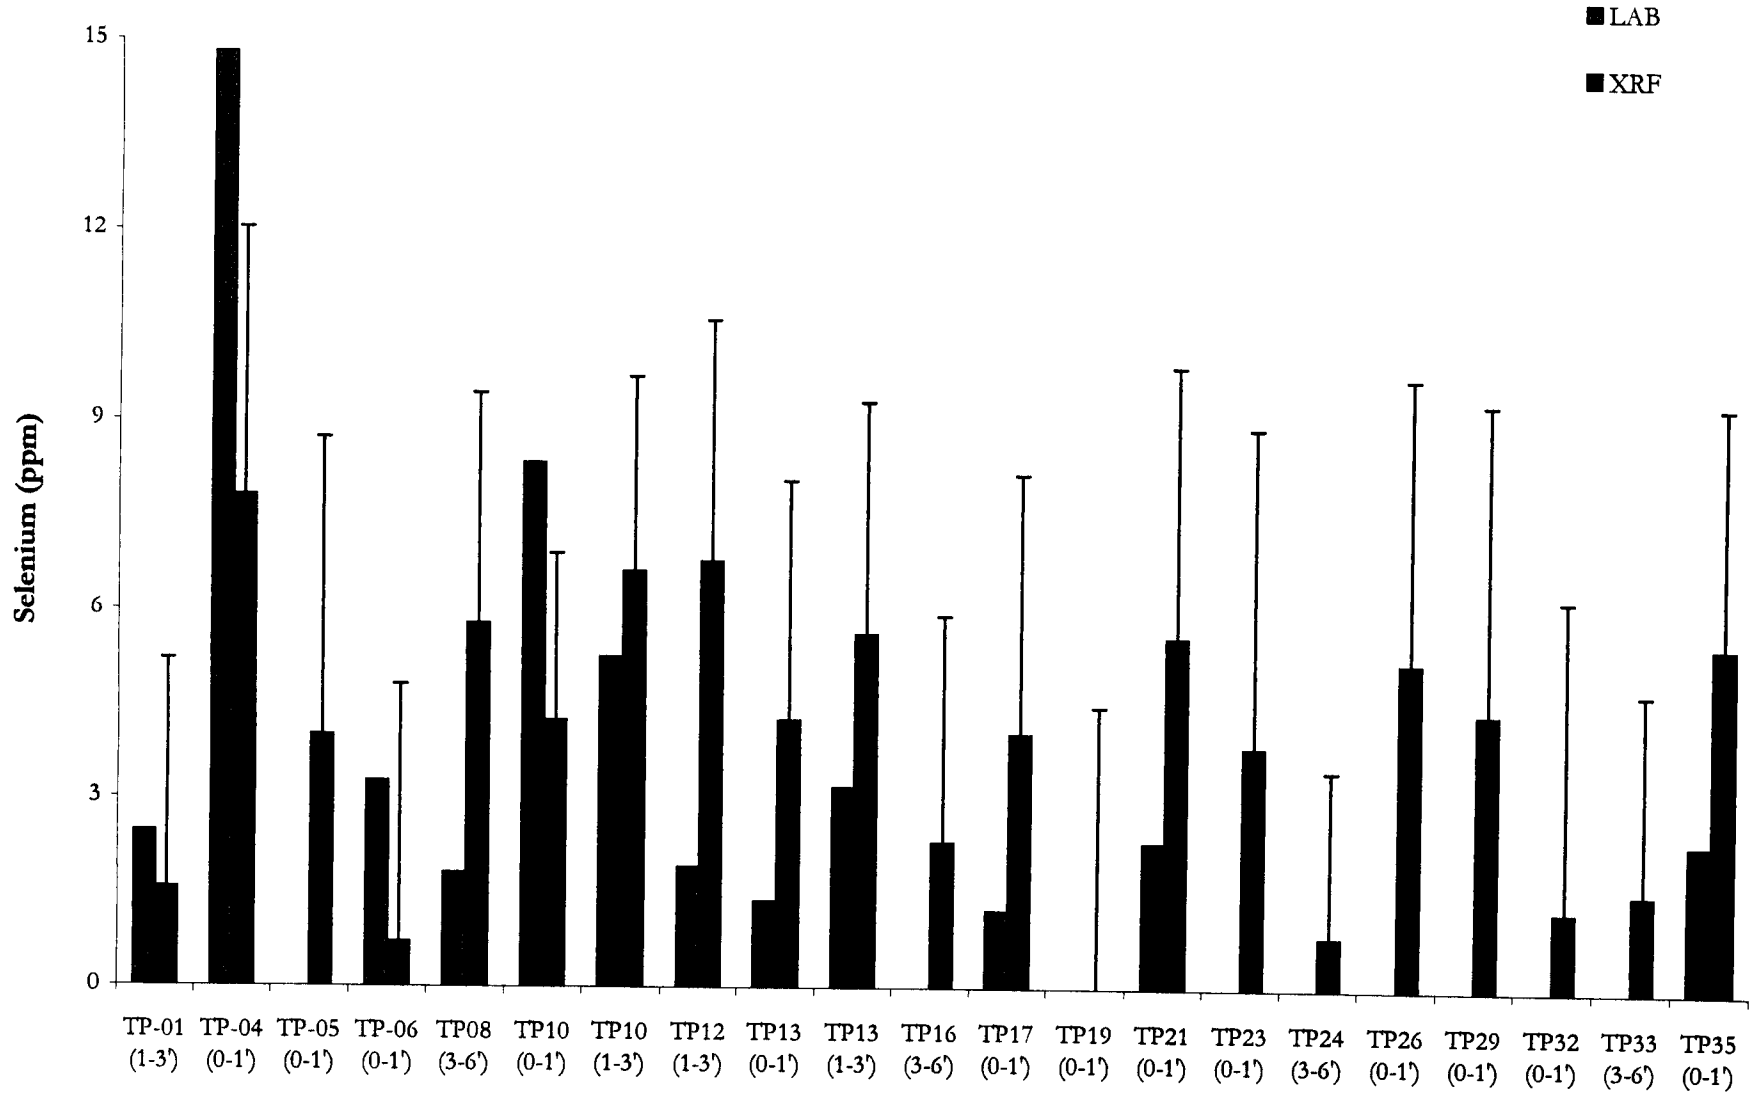
Figure C-5: Laboratory Data vs. XRF Data
Selenium

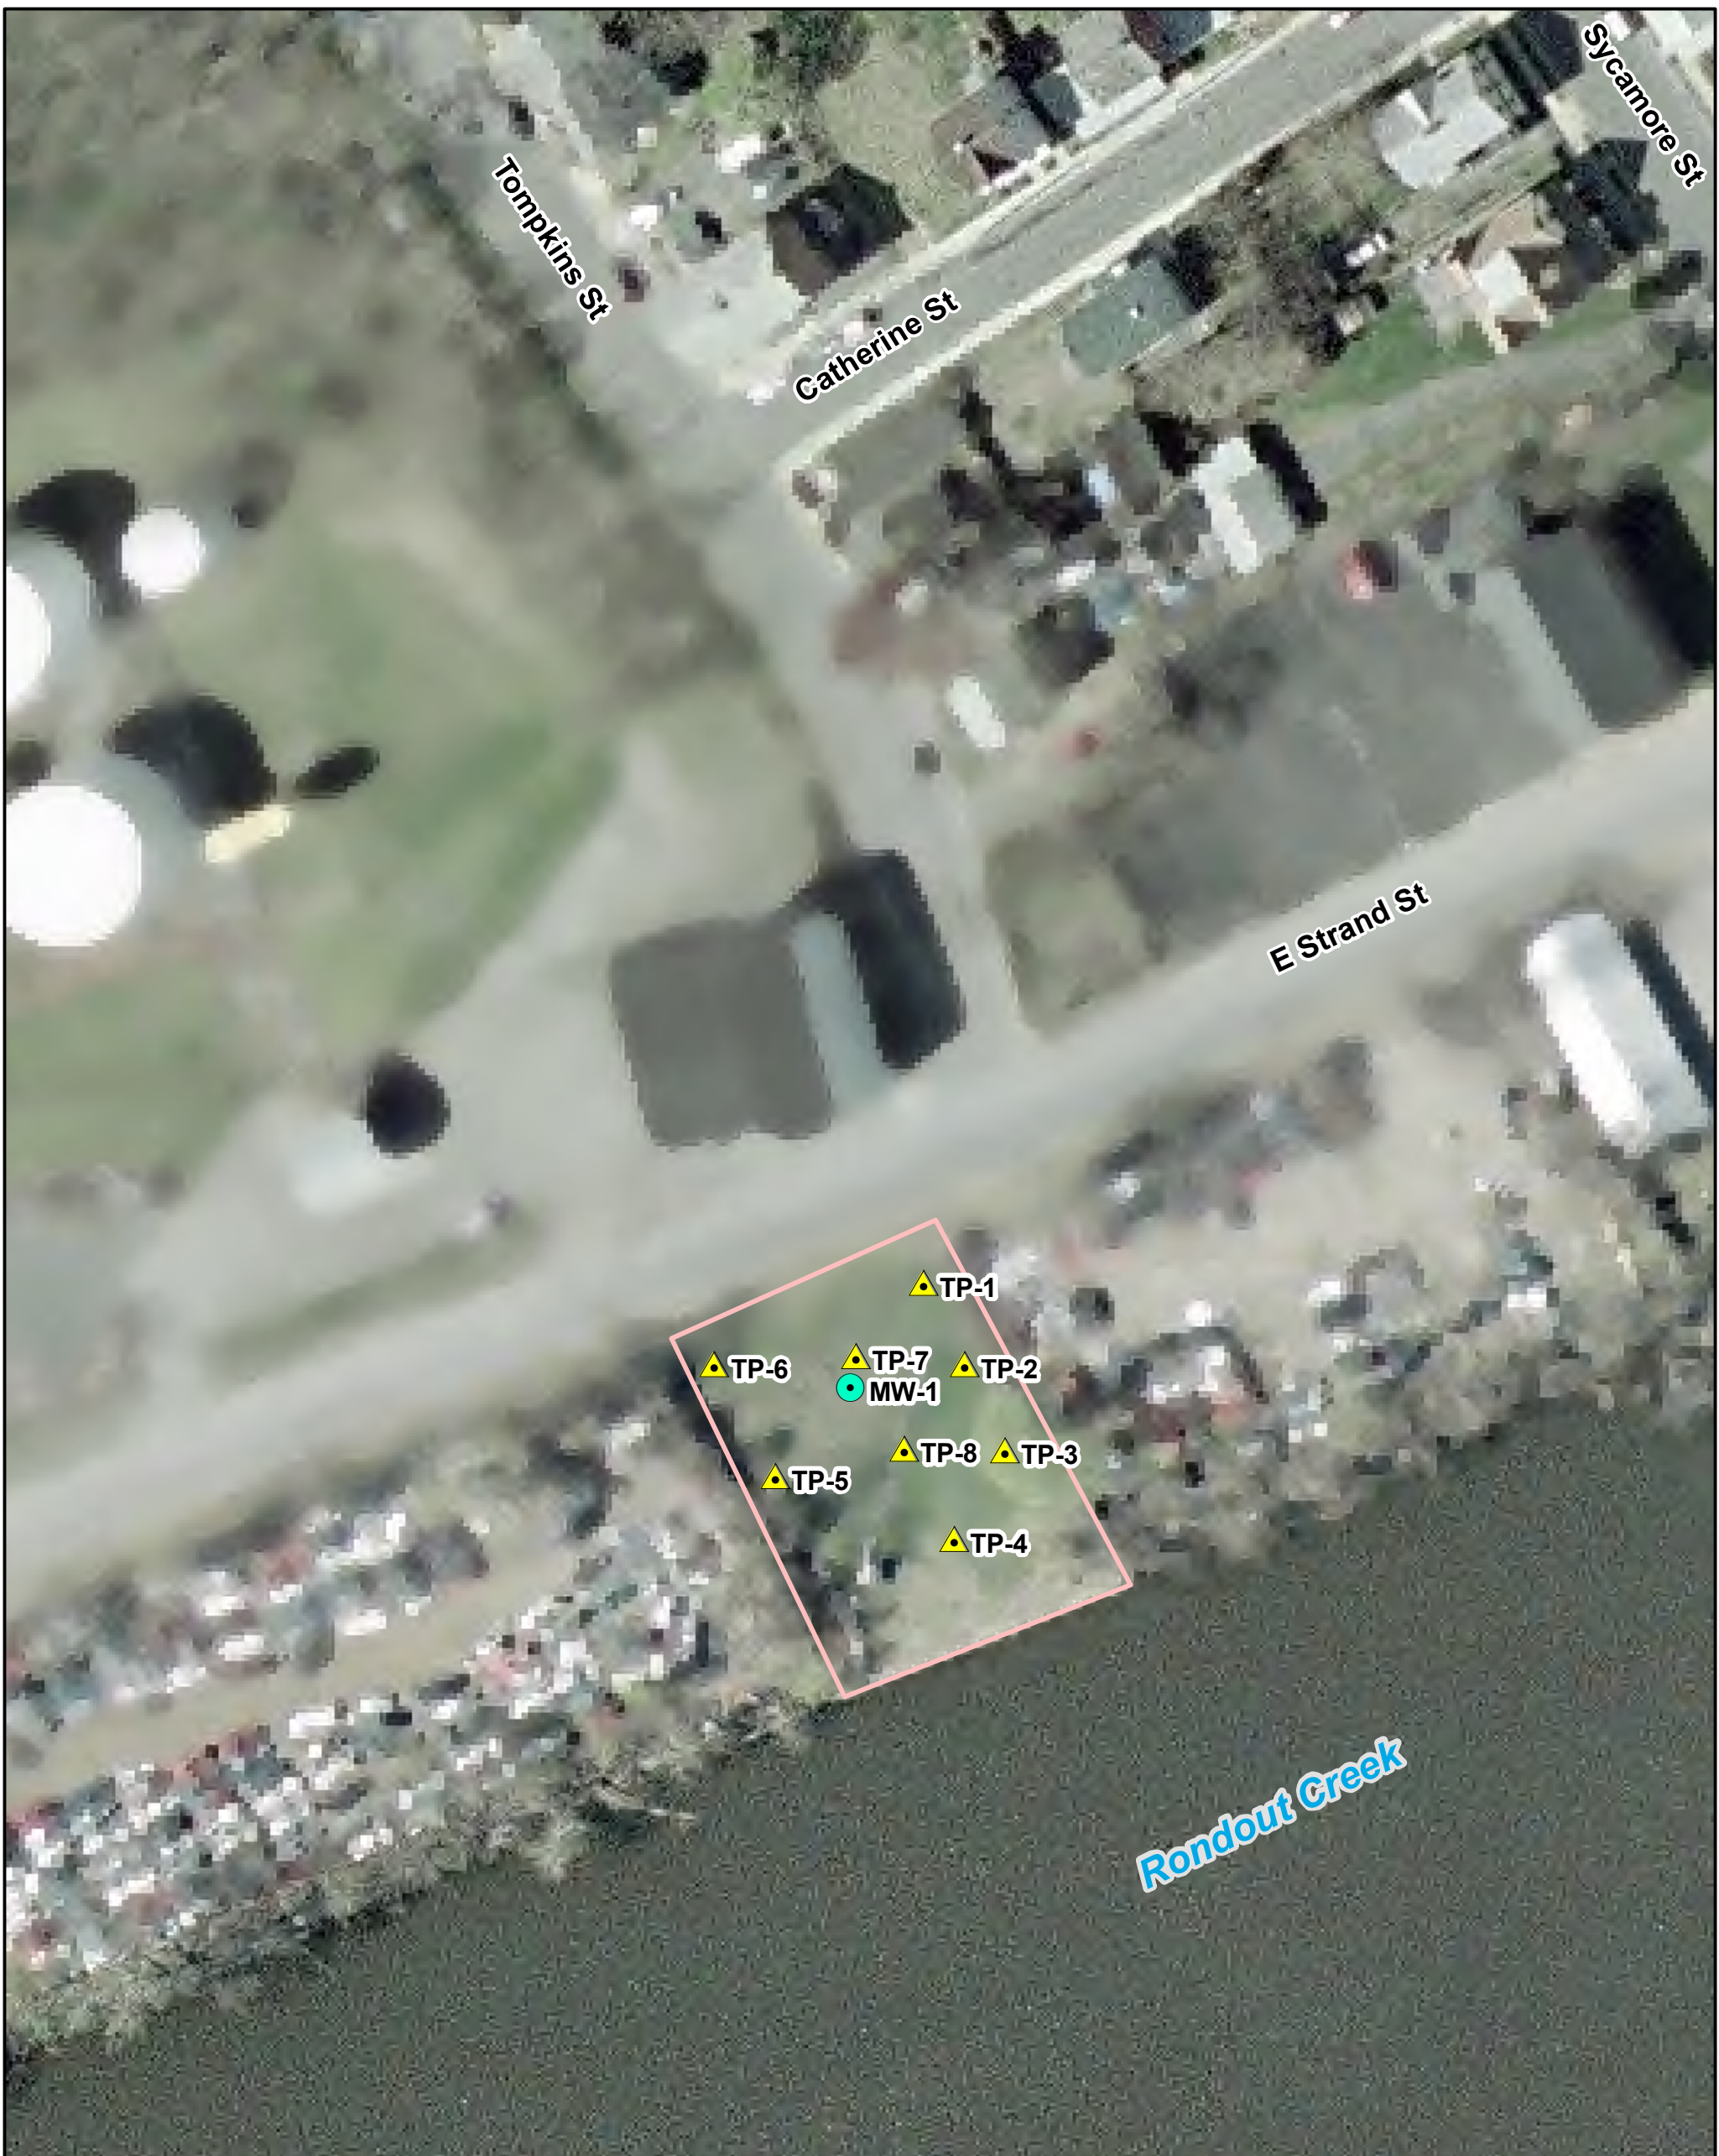
**Figure 2: Sampling Locations Map
Kingston Landing Lot #9**
